# NATIONAL TRANSPORTATION SAFETY BOARD

## MATERIALS LABORATORY FACTUAL REPORT

Report No. 22-008

Place : Saratoga, Wyoming  
Date : February 8, 2021  
Vehicle : Abbett Gerry Lancair Evolution, N7569A  
NTSB No. : WPR21LA108  
Investigator : Maja Smith, AS-WPR and Stephen Stein, AS-WPR

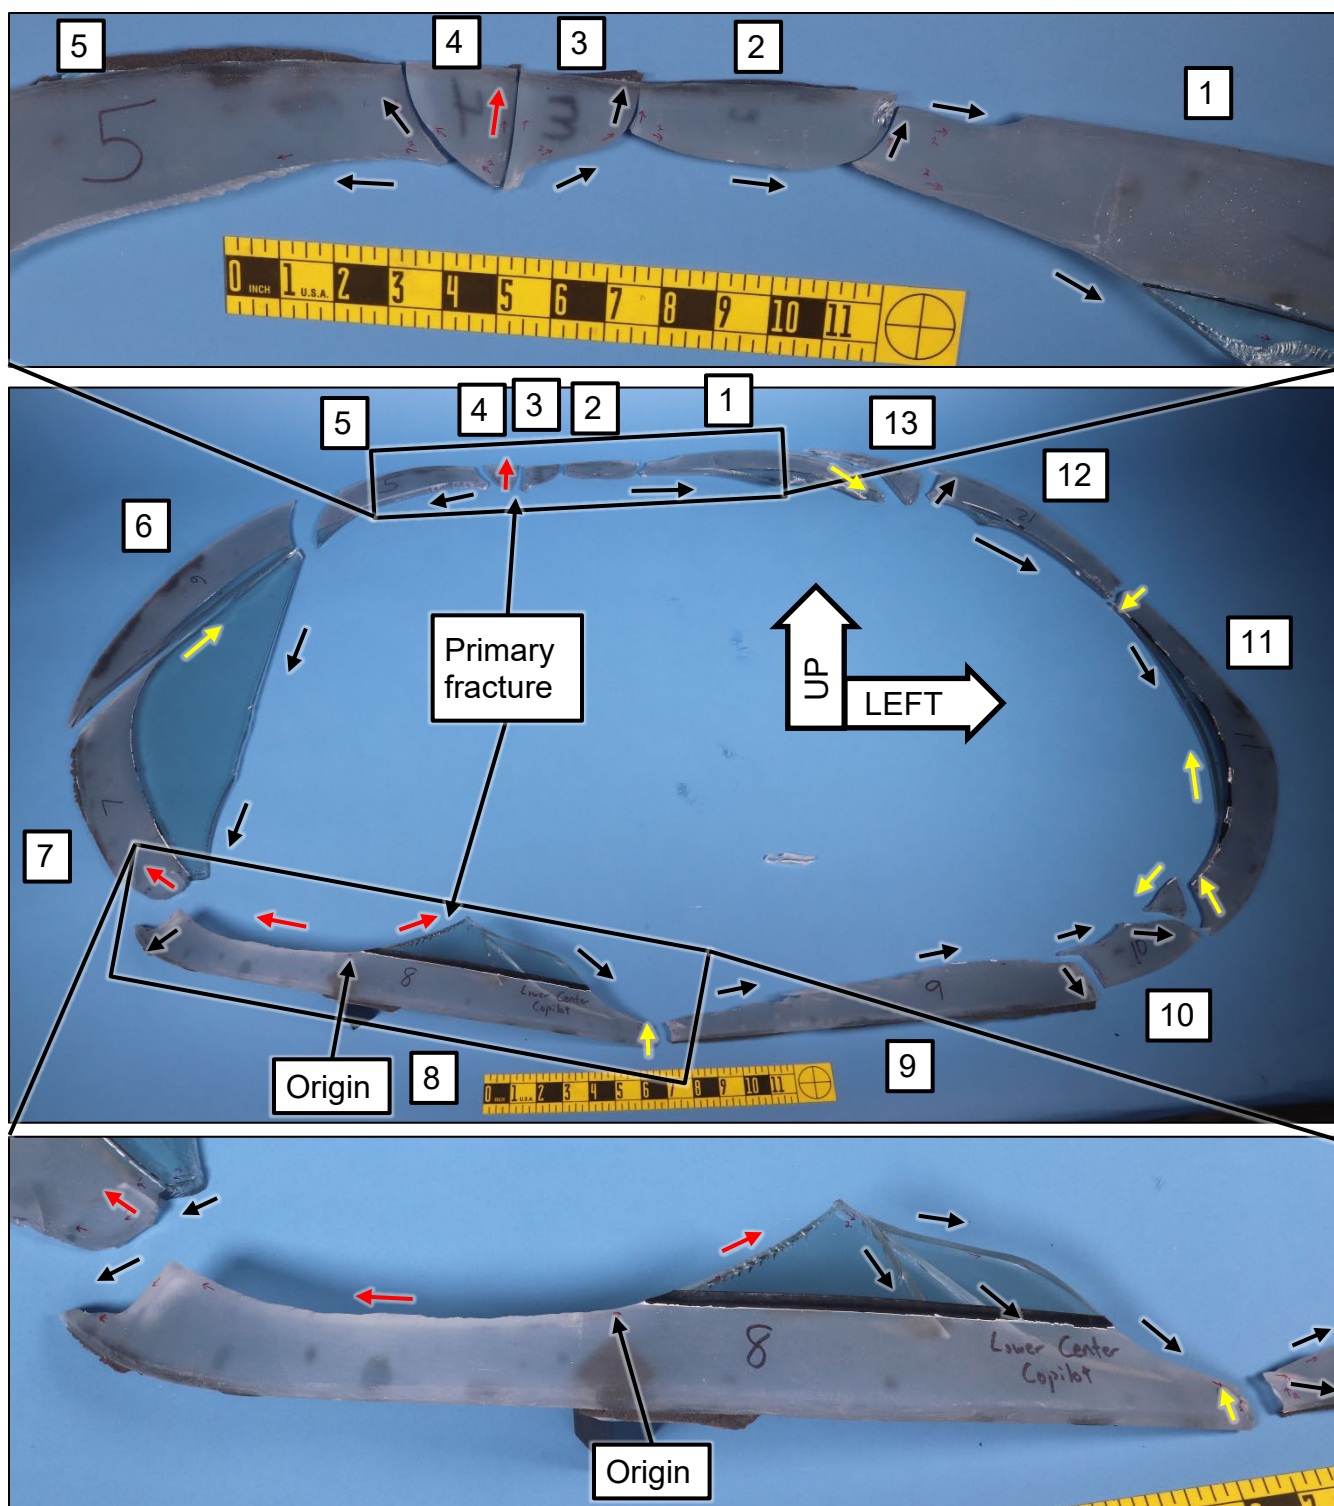
Unlabeled arrows in figure 1 indicate the general directions of fracture propagation as observed on the fractured pieces. Based on fracture features and crack branching patterns, a primary origin area was observed on piece 8 at the lower right side of the windshield, and red arrows indicate the primary fracture emanating from the origin. To the right of the origin, the primary fracture extended across piece 8 and terminated in the bond area in piece 7. To the left of the origin, the primary fracture turned upward. On the upper pieces, the fracture between pieces 3 and 4 had a mirror-like flat fracture across the thickness, consistent with fast fracture under primarily tensile loads, a feature consistent with the upper end of the primary fracture through the windshield extending from the origin in piece 8. The remaining fractures generally had fracture planes that varied across the thickness with curving hackles turning toward the interior or exterior surface, features consistent with fracture under a combination of tension and bending loads consistent with fractures that occurred after the primary fracture.

Unlabeled black arrows in figure 1 indicate fractures that emanated from the primary fracture based on crack branching patterns and secondary origin locations. Yellow arrows indicate fractures that extended from secondary origins not directly associated with a crack and had secondary intersections with the black-arrowed fractures.

Figure 1. Overall view of the submitted windshield pieces (middle image) with closer views of the primary fracture locations (upper and lower images). Unlabeled red arrows indicate the primary fracture, black arrows indicate the direction of fracture propagation emanating from the primary fracture, and yellow arrows indicate secondary fractures.

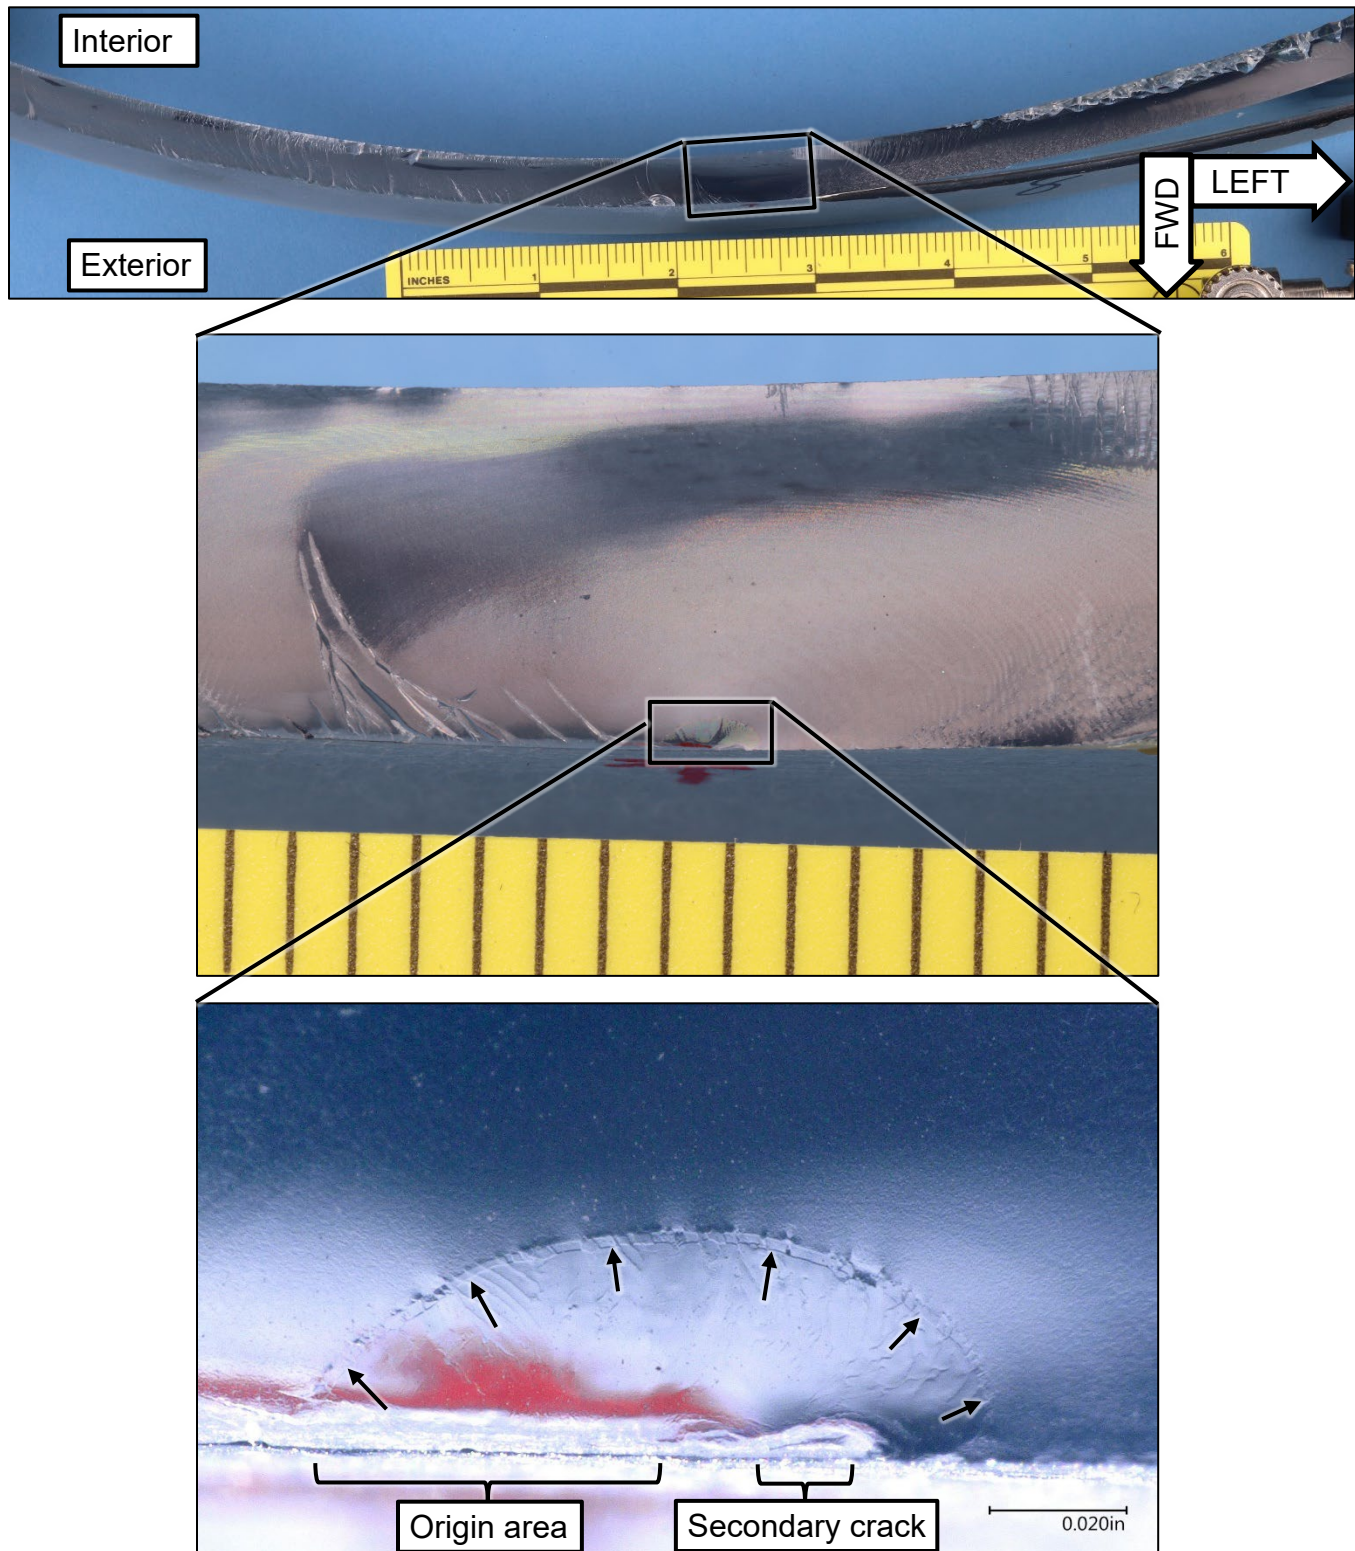
Optical images of the fracture surface at the origin area are shown in figure 2. The origin was located at the exterior surface of the windshield, and a smooth thumbnail shaped region was observed as shown in the lower image in figure 2. A curving boundary consistent with a crack arrest line was observed at the location indicated with arrows in figure 2. The crack emanated from a broad origin area that was positioned toward the right side of the thumbnail. The fracture intersected a secondary crack located to the left of the origin but within the thumbnail region.

Figure 2. Views of the origin area at progressively higher magnifications. Unlabeled arrows indicate a crack arrest line.

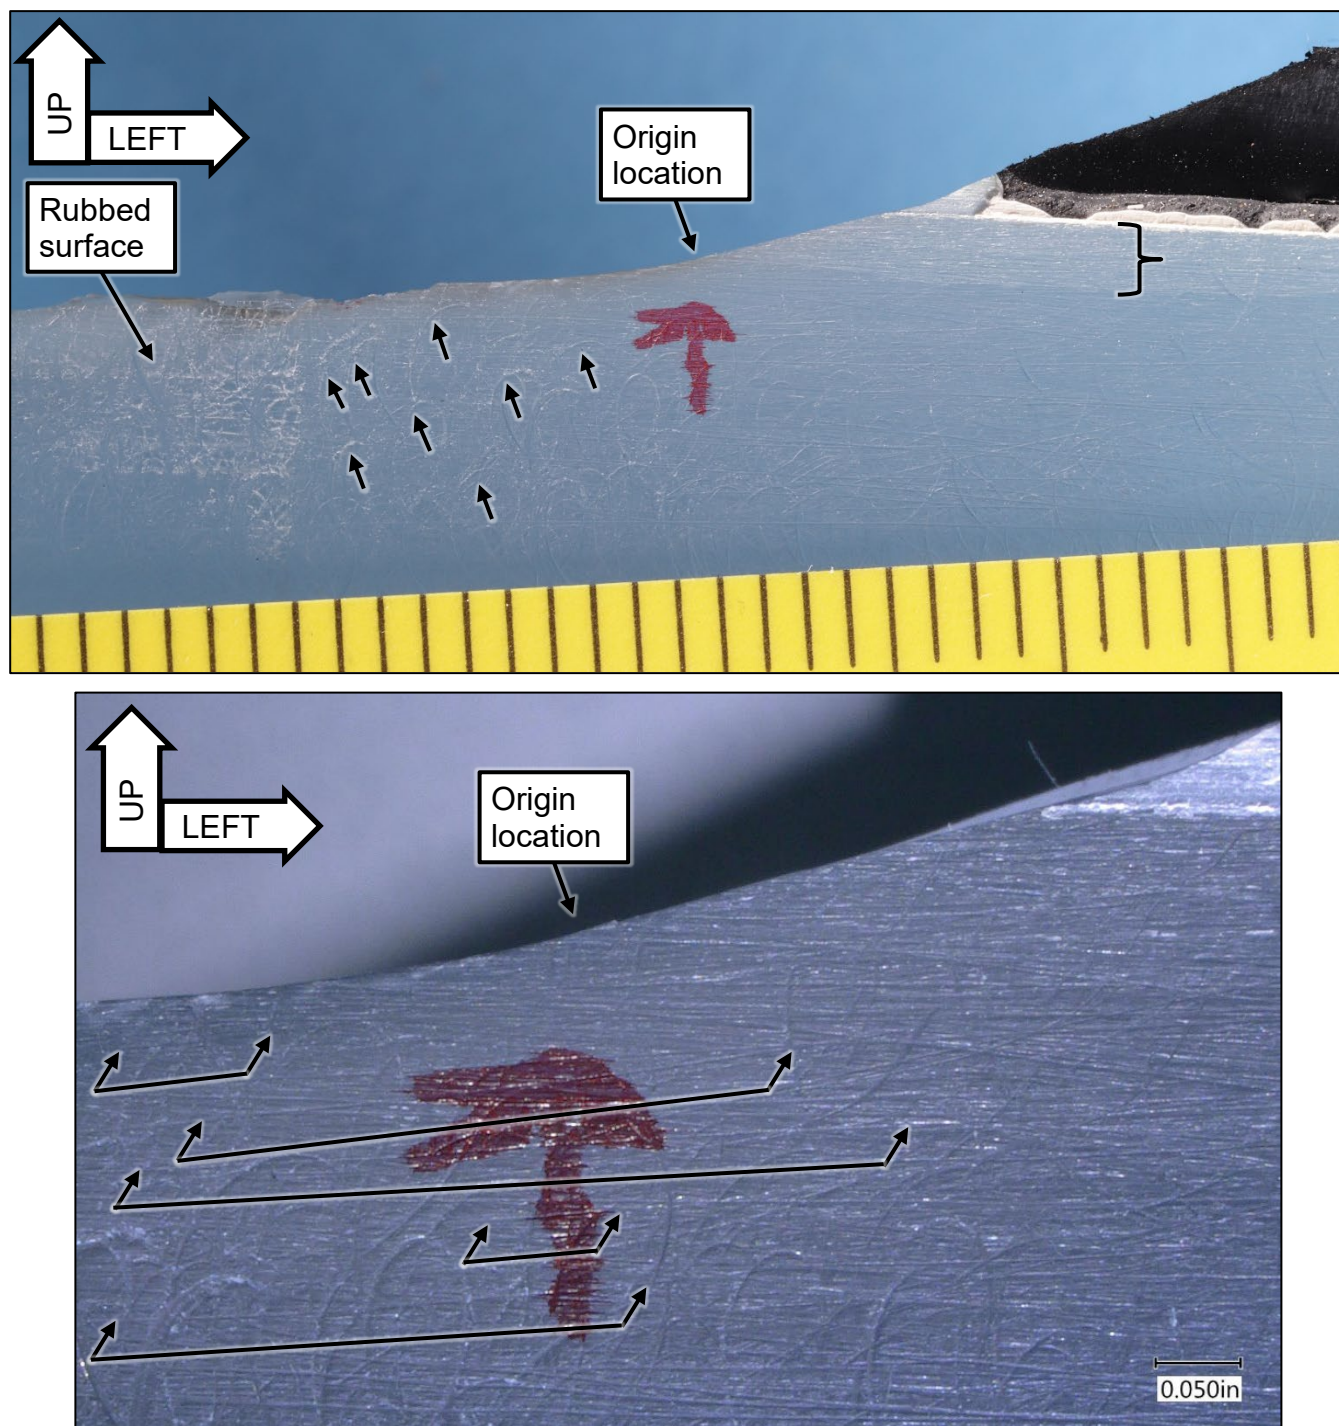
The origin was located within the bond surface on piece 8 as shown in figure 3. The red arrow on the surface was marked to help identify the origin location during the examination. The origin was located approximately 1/8 inch below the upper edge of the bond line. A bracket in the upper image in figure 3 indicates a portion of the bond area that appeared relatively lighter in some lighting conditions relative to the rest of the bond area. The area also appeared to be associated with transverse scratches that were

predominantly oriented parallel to the bond edge, consistent with the build instructions that instructed hand-sanding along the taped edge. The origin was located near the lower end of that lighter region, but the fracture plane was angled relative to the transverse scratches.

In a closer view of the exterior surface adjacent to the origin, isolated linear scratches were observed that were angled at an orientation nearly parallel to the fracture plane as indicated in the lower image in figure 3. Additionally, elliptical scratches were observed across most of the bond surface consistent with use of a DA sander. To the right of the origin, a group of elliptical scratches indicated with unlabeled arrows in the upper image in figure 3 appeared relatively deeper compared to others. To the right of the indicated group of elliptical scratches, the exterior surface had a whitened appearance with corresponding damage to the edge of the fracture consistent with rubbing contact.

Figure 3. Exterior surface adjacent to the origin. Unlabeled arrows point to relatively deep elliptical scratches in the upper image and connected arrows point to linear scratches approximately parallel to the fracture plane in the lower image. A bracket in the upper image indicates an area of the surface that had a slightly lighter optical appearance.

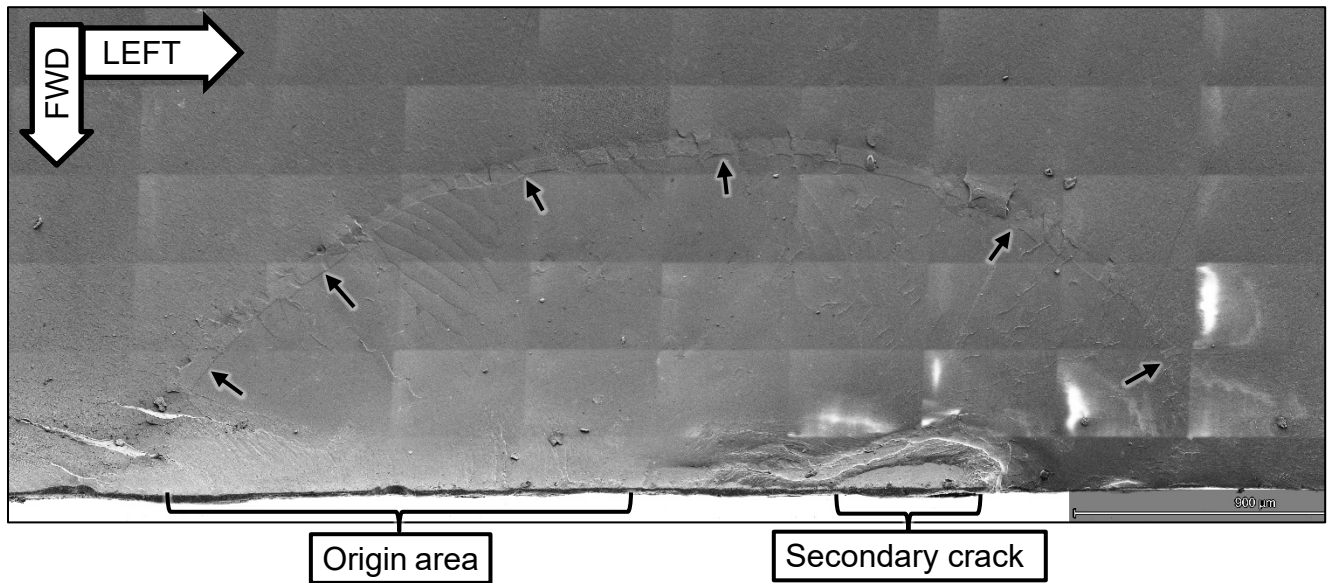
Next, the fracture surface at the origin area was examined using a scanning electron microscope (SEM), and a montage of SEM images are shown stitched together in figure 4 to show an overall view of the origin area including the arrest line indicated with unlabeled arrows. The middle left portion of the origin area is shown in figure 5 where radial features emanated from the broad origin that extended beyond the field of view shown. A closer view of the secondary crack to the left of the origin area is shown in figure 6. Unlabeled arrows in figure 6 indicate the local direction of fracture propagation for the primary crack that emanated from the origin area indicated in figure 4. Fracture features up to the crack arrest line were relatively smooth showing evidence of microductility with small tear ridges, dimple features, and isolated parabolic marks as indicated in figure 7.<sup>4</sup> Beyond the arrest line, the density of parabolic marks increased as shown in figure 8. Further from the origin, intersecting parabolic marks consistent with fast fracture in the acrylic material were observed as shown in figure 9.

Figure 4. Stitched SEM images of the origin area. Unlabeled arrows indicate the crack arrest line.

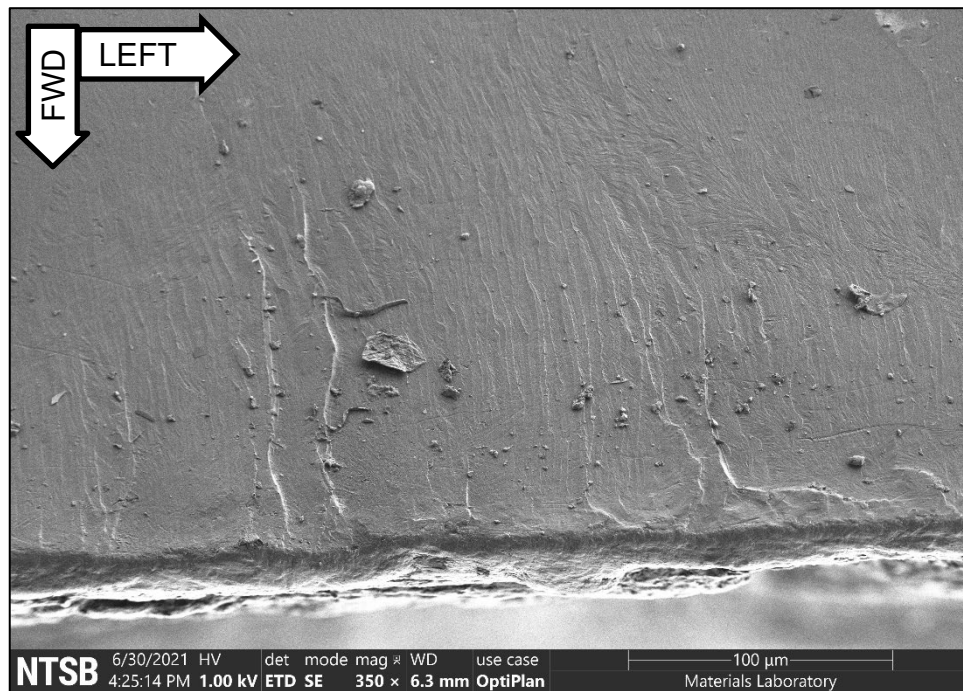
Figure 5. SEM image of the middle left (right side of the bracket as viewed in figure 4) portion of the origin area.

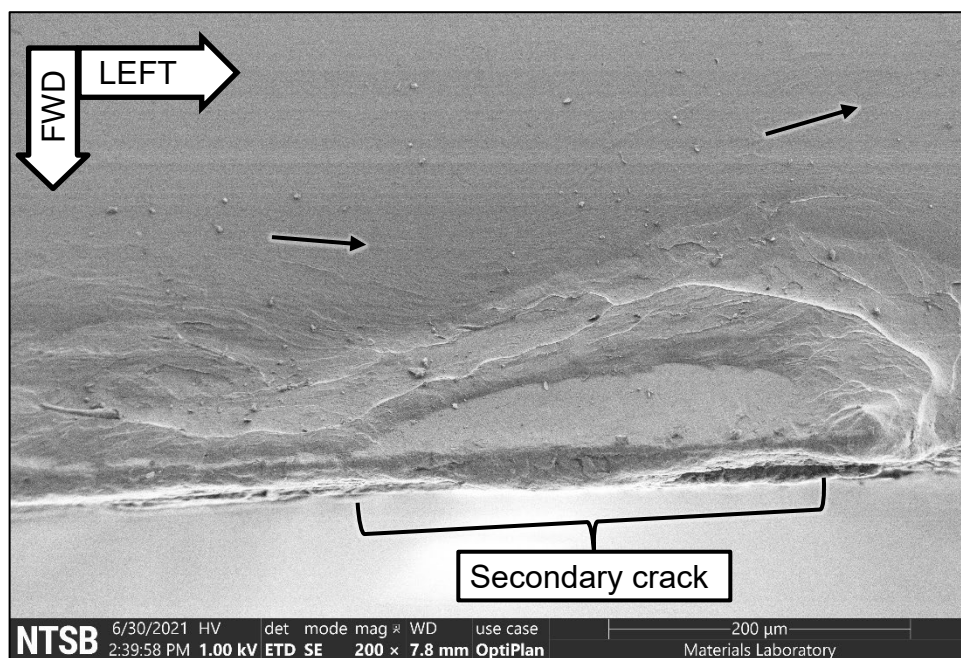
Figure 6. SEM image of the secondary crack to the left (airplane orientation) of the origin area. Arrows indicate propagation from the primary origin area.

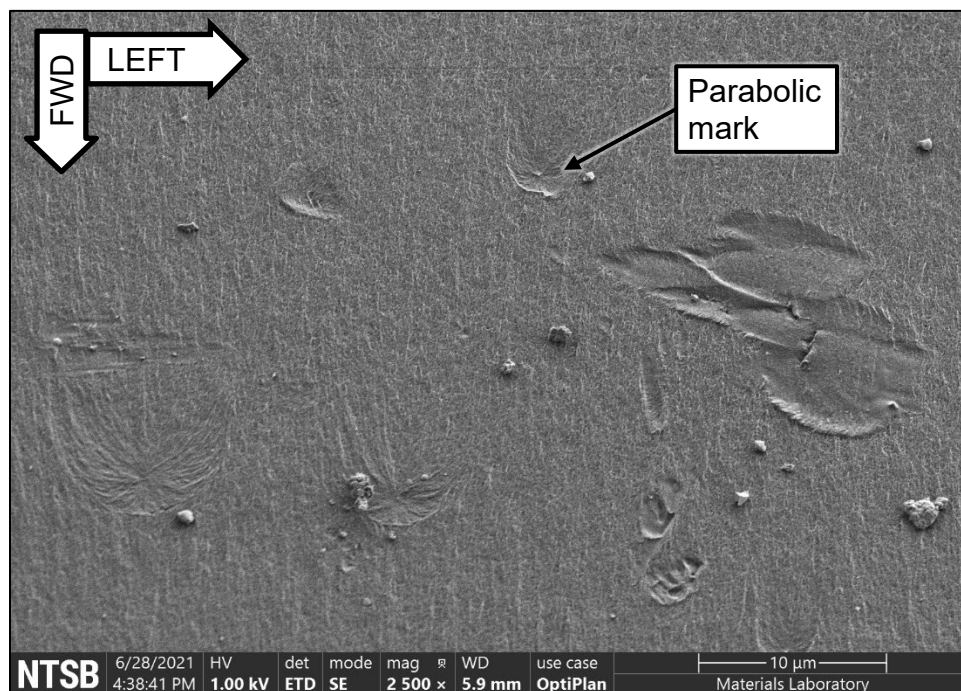
Figure 7. SEM image of typical fracture features near the origin inside the arrest line boundary showing isolated parabolic marks.

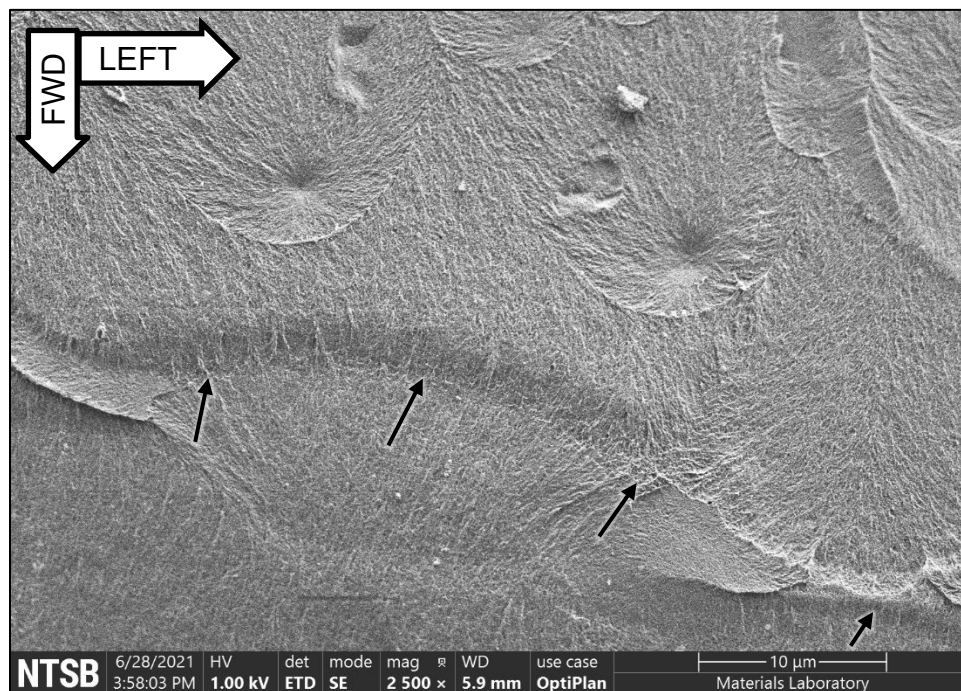
Figure 8. SEM image of fracture features at the arrest line boundary (boundary indicated with unlabeled arrows).

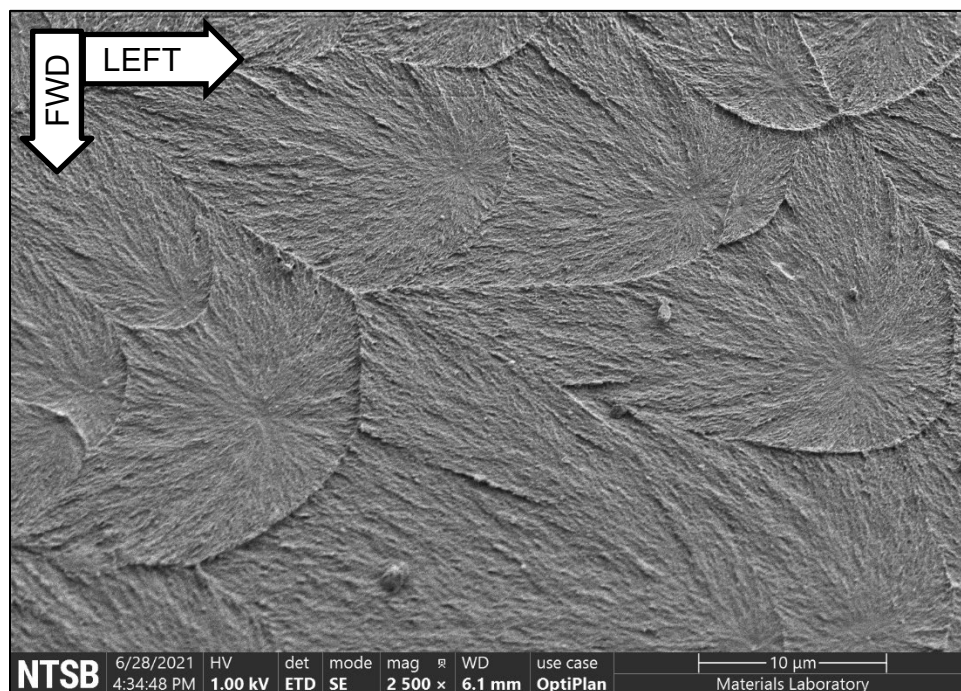
Figure 9. SEM image of fast fracture features beyond the arrest line showing intersecting parabolic marks.

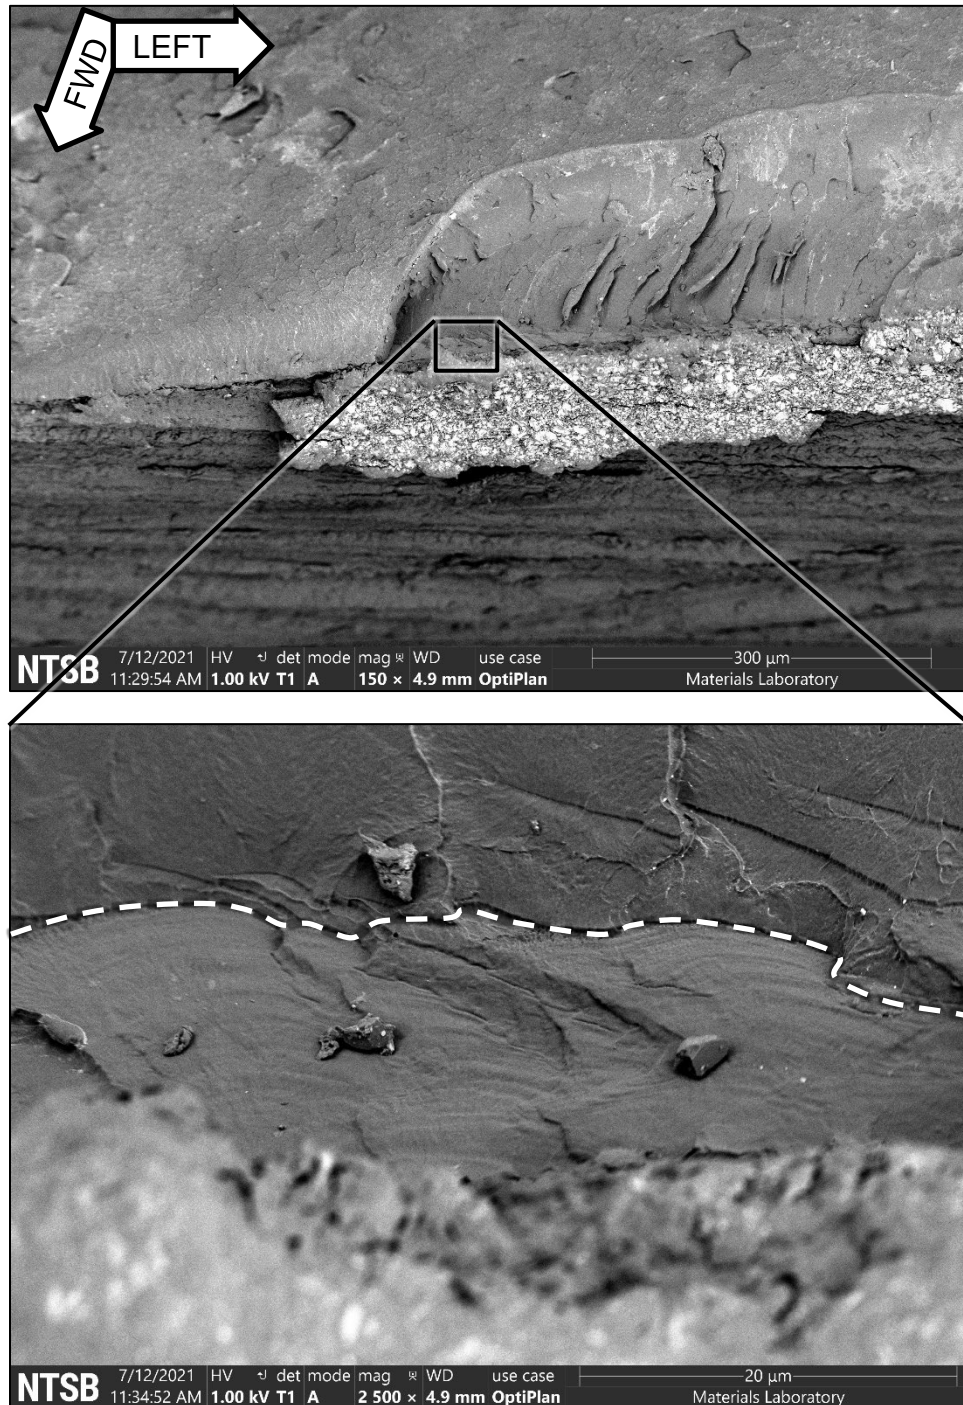
In addition to the secondary crack at the origin, the primary fracture intersected secondary cracks further from the origin area as shown in figure 10. The SEM images in figure 10 were taken where the fracture surface intersected the upper end of the bonded area, and paint is observed on the surface adjacent to the fracture. The boundary of the secondary cracks is indicated with a dashed line in the lower image and is associated with a distinct change in the fracture plane.

Figure 10. Region of secondary cracks intersecting the primary fracture surface to the left (as viewed looking forward) of the origin area. A dashed line in the lower image indicates the secondary crack boundary.

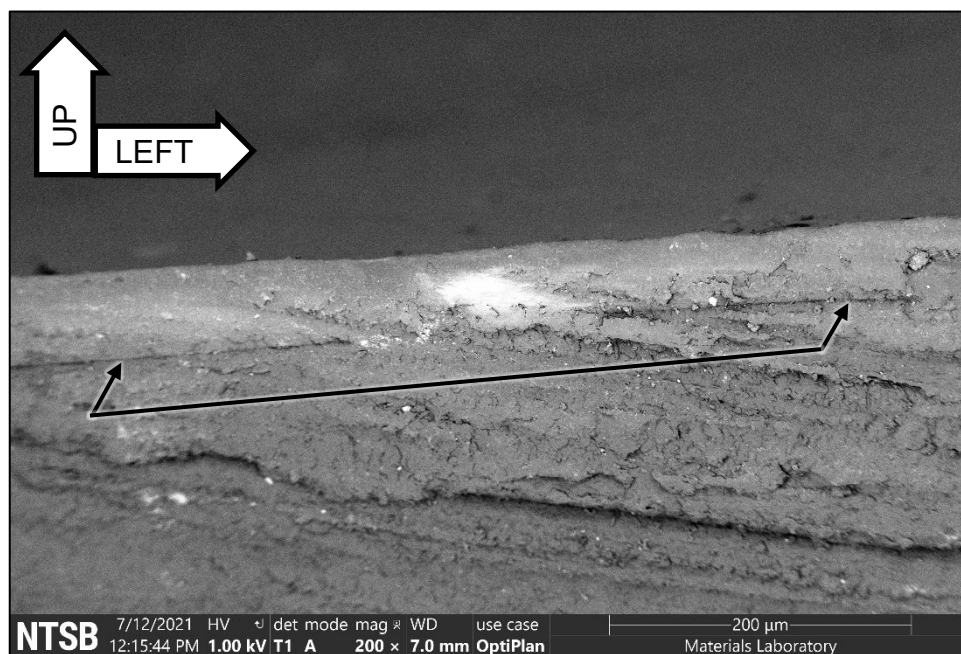
The exterior surface adjacent to the origin area is shown in figure 11, and an area of the exterior surface to the left of the origin area is shown in figure 12. The surface was mostly covered with parallel scratches oriented parallel to the bond edge. However, additional scratches oriented approximately parallel to the fracture plane were also observed as indicated with connected black arrows in figures 11 and 12. An apparent crack-like feature was observed at the base of some scratches including the horizontal scratch oriented parallel to the bond edge indicated with red arrows in figure 12.

Figure 11. SEM image of the exterior surface adjacent to the origin area. Connected arrows indicate a linear scratch nearly parallel to the fracture plane.

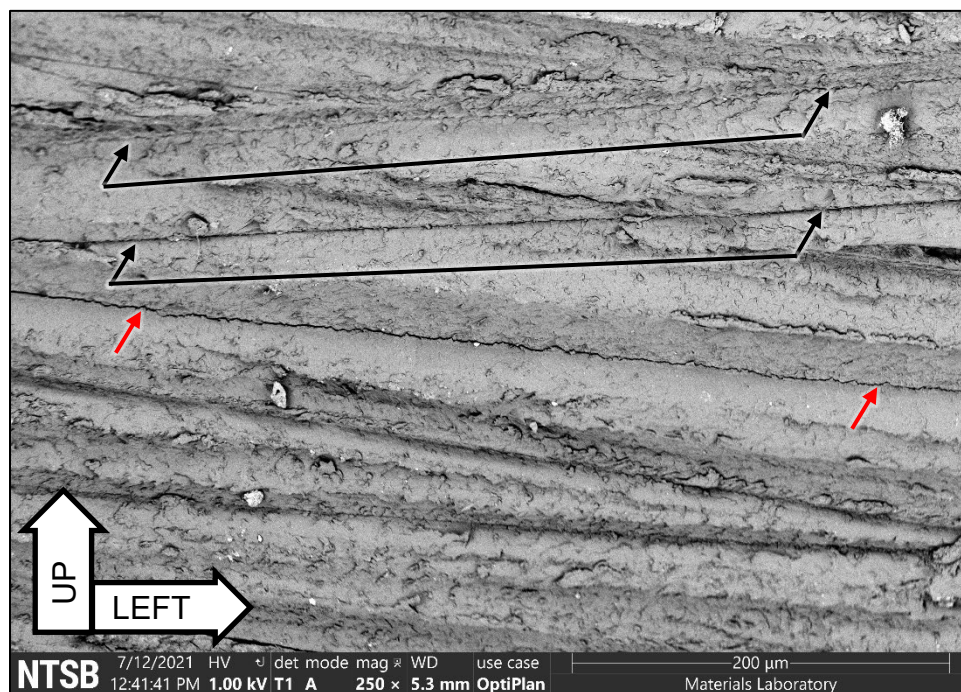
Figure 12. Exterior surface to the left of the origin area within the lighter region indicated with a bracket in figure 3. Connected black arrows point to scratches nearly parallel to the fracture plane, and red arrows point to a crack-like feature at the base of a horizontal scratch.

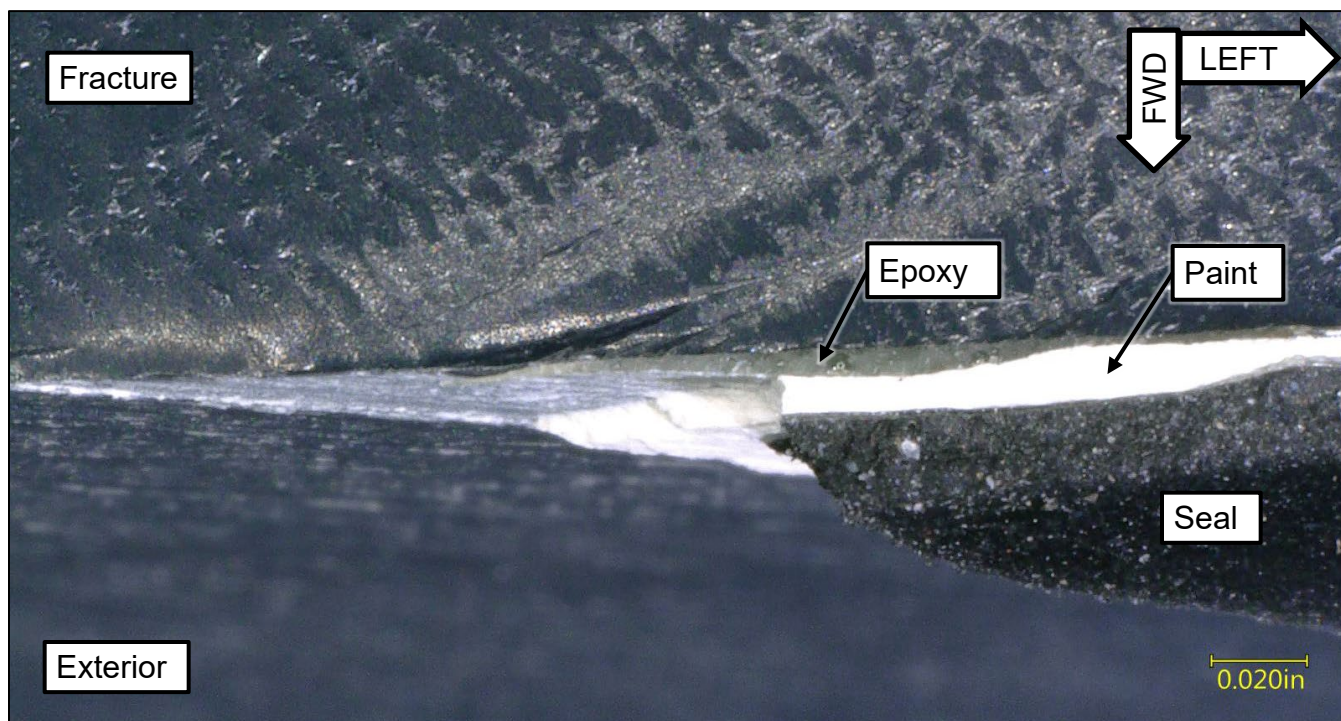
An optical image of the exterior edge of the primary fracture where the fracture intersected the upper edge of the bonded area is shown in figure 13. Layers of black sealant, white paint and/or primer, and translucent epoxy were observed as labeled in figure 13. The thickness of the epoxy appeared to be variable at this area, and paint and/or primer appeared to be adhered directly to the acrylic adjacent to the bond area. Another view of the layers on the acrylic at the upper end of the bond area are shown in figure 14 as viewed looking outward through the clear portion of the acrylic on piece 11. Material of varying colors were observed on the exterior surface of the acrylic as shown labeled in figure 14 including blue, yellow, white, and black materials. Samples of the blue, yellow, and white materials were analyzed using Varian IR600 Fourier-transform infrared (FTIR) spectrometer with a diamond attenuated total reflectance (ATR) accessory in accordance with ASTM E1252-98 (American Society for Testing Materials E1252-98: Standard Practice for General Techniques for Obtaining Infrared Spectra for Qualitative Analysis. Results showed a spectrum for the blue material consistent with Hysol epoxy. The spectrum for the yellow material had a spectrum that was similar to the Hysol epoxy but had a couple peaks that varied in height and width, often an indication of degradation. The surface of the white area in contact with the acrylic had a spectrum consistent with an epoxy paint.

Figure 13. Optical image of the exterior edge of the fracture surface to the left of the origin area showing layers of epoxy, paint, and an elastomer seal.

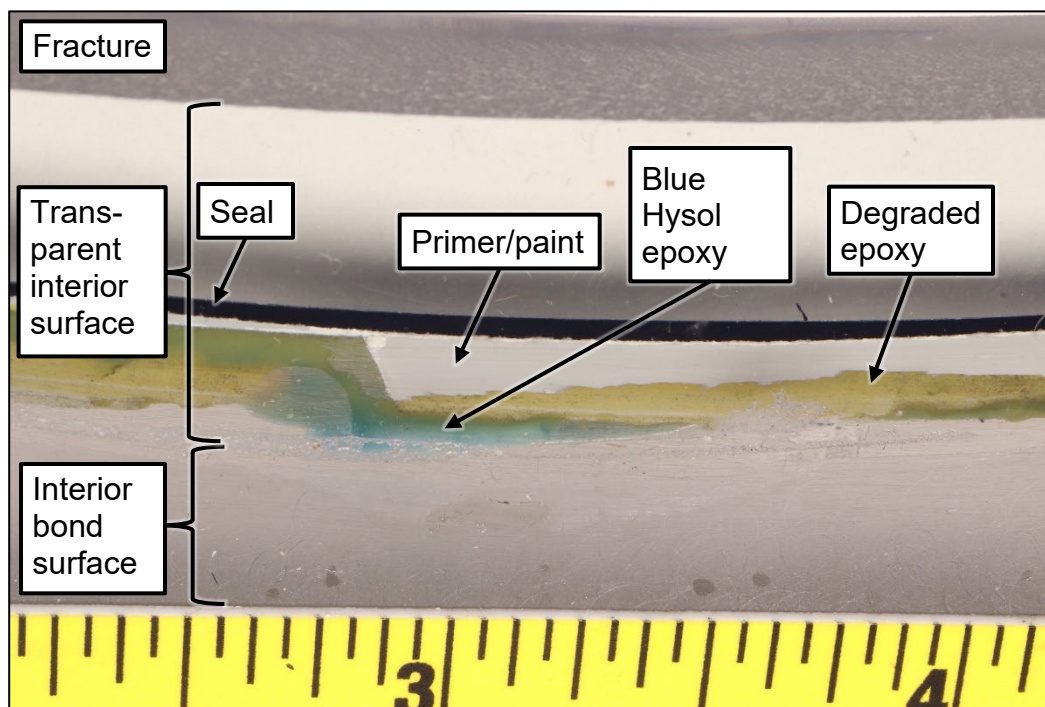
Figure 14. Upper end of the bond region on piece 11 as viewed looking through the windshield from the interior side showing areas where an elastomer seal, primer/paint, blue Hysol epoxy, and degraded epoxy contacted the exterior surface of the windshield.

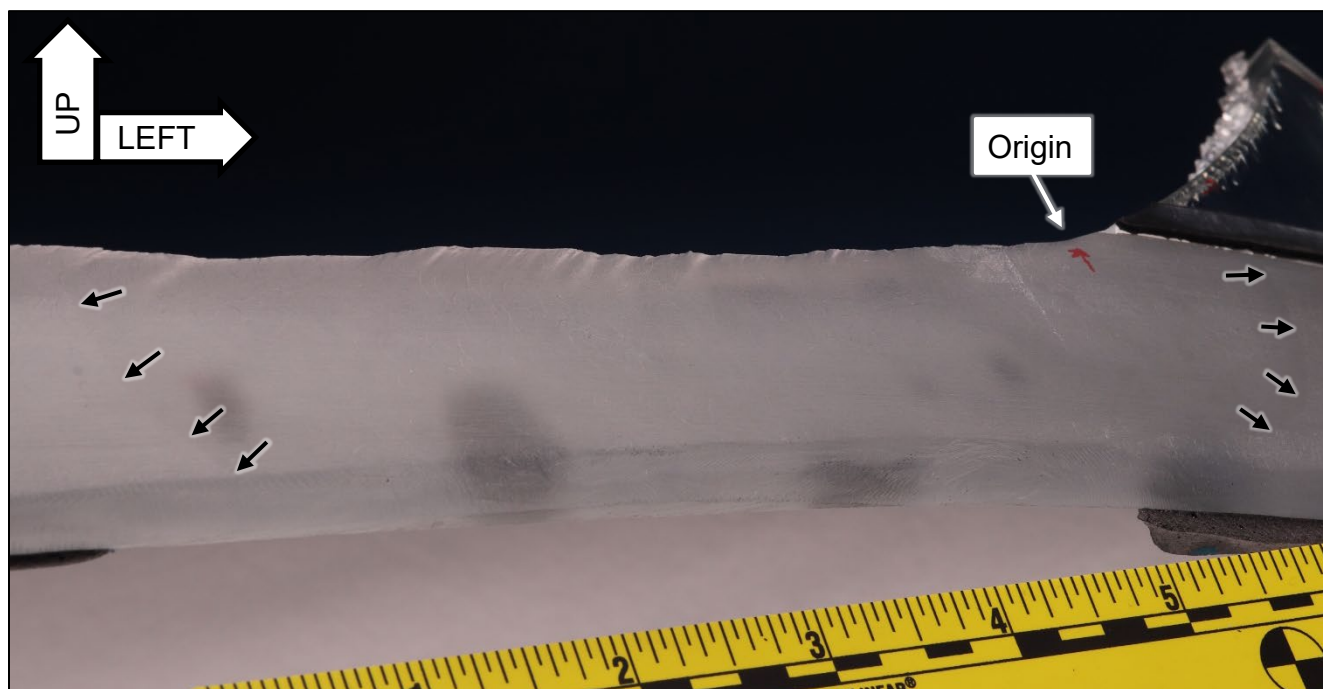
Oblique views of the exterior surface in the bond area on pieces 8 and 11 are shown in figures 15 and 16. Faint curving lines showing a slight change in color from darker to lighter were observed at locations indicated by unlabeled arrows. On piece 8, the origin was located between two curving lines as shown in figure 15. Arrows in figure 16 show several curving boundaries on piece 11. The number and locations of the curving lines appeared to coincide with locations where the sealant and paint were scraped and disturbed at the upper edge of the bond area.

Figure 15. Oblique view of the bond surface on piece 8. Unlabeled arrows indicated an optically visible curving boundary associated with a slight color change from darker to lighter in the direction of the arrows.

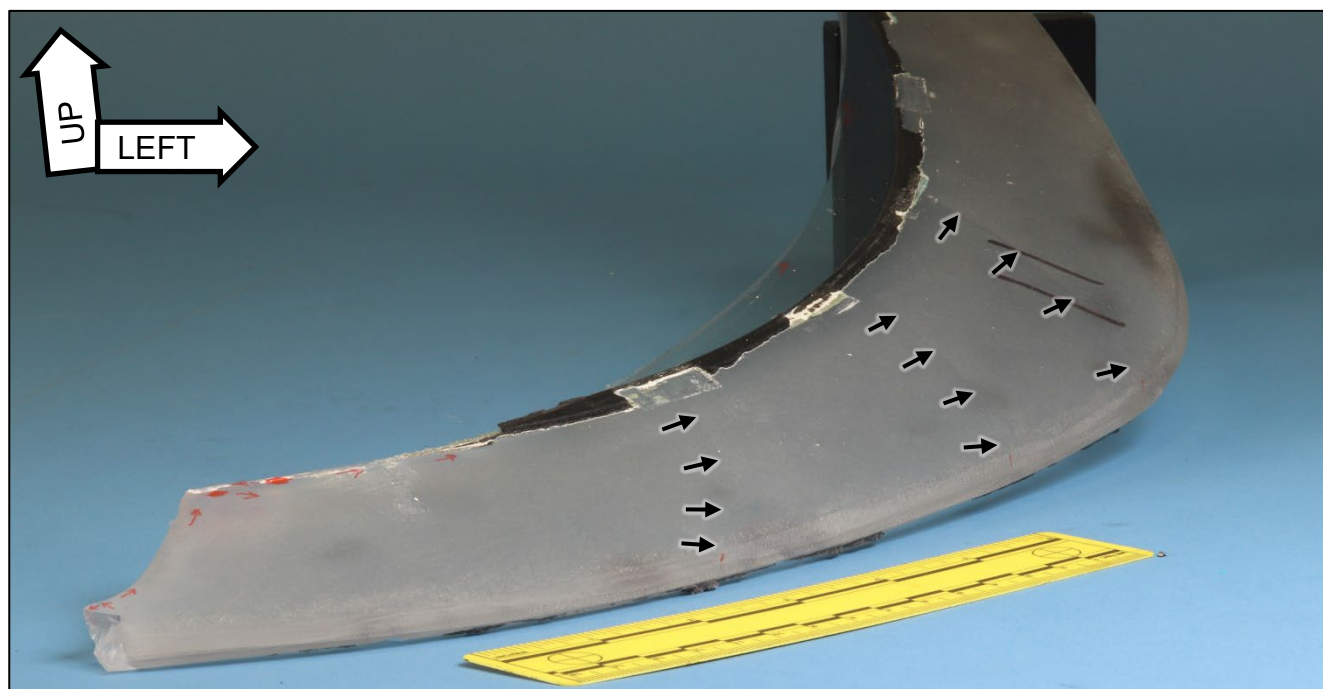
Figure 16. Oblique view of the bond surface on piece 11. Unlabeled arrows indicated an optically visible curving boundary associated with a slight color change from darker to lighter in the direction of the arrows.

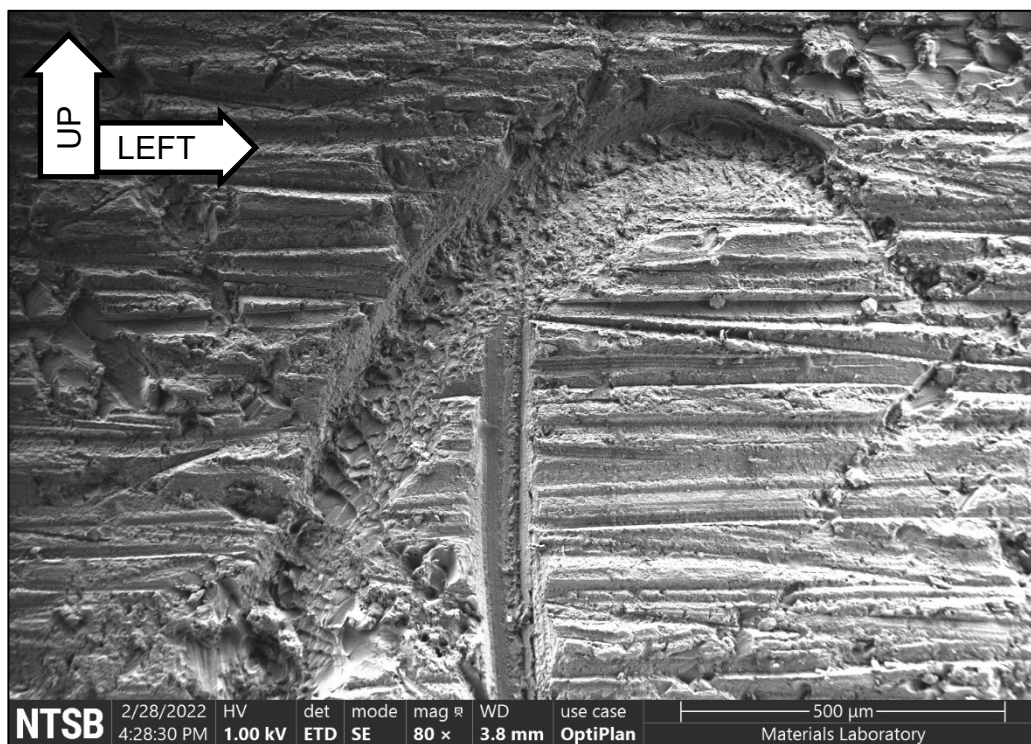
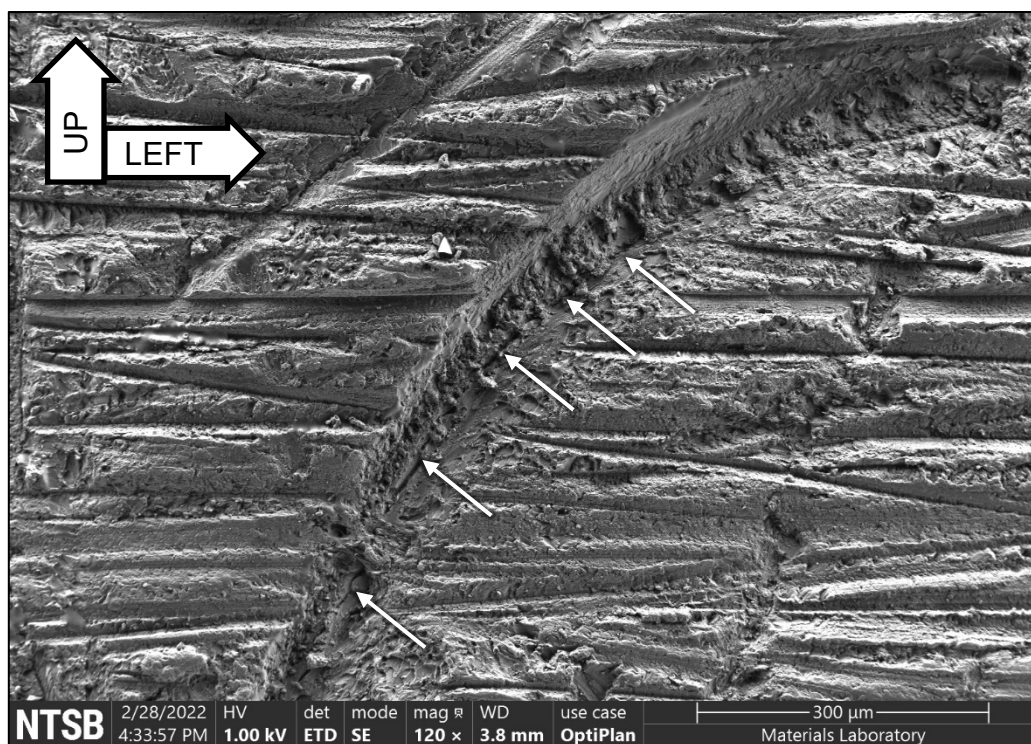
As indicated with unlabeled arrows in the upper image in figure 3, a grouping of elliptical grinding marks in the bond area to the right of the origin area appeared relatively deeper than the adjacent areas. SEM images of two of the relatively deep elliptical grinding marks are shown in figure 17. A crack-like feature was observed at the bottom of some of the scratches such as the scratch in the lower image in figure 17, where unlabeled arrows indicate the location of the crack-like feature.

Figure 17. SEM images of relatively deep elliptical scratches in the bond area to the right of the origin area. Unlabeled arrows in the lower image indicate a crack-like feature at the bottom of the relatively deep scratch.

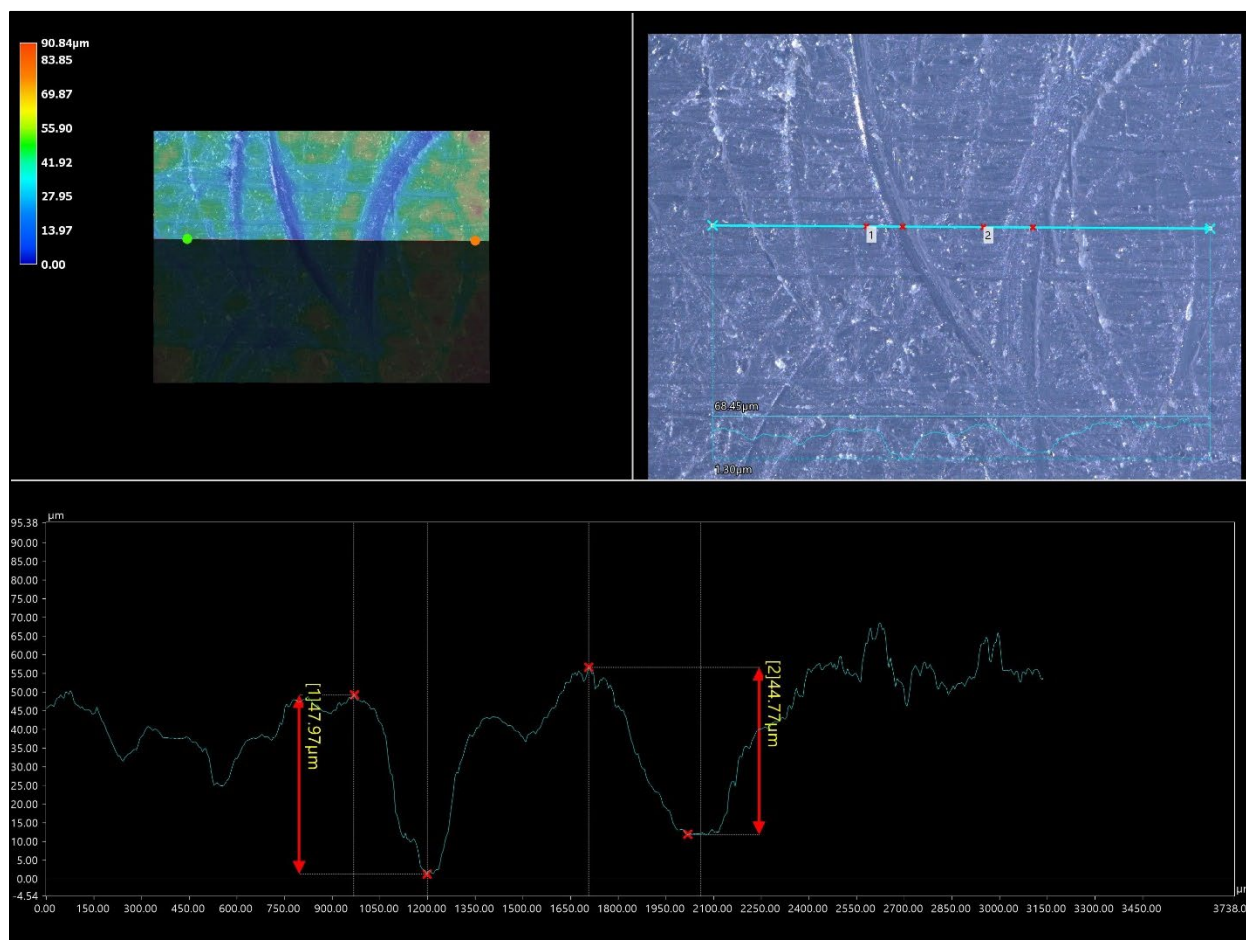
A 3D representation of the relatively deep elliptical grinding marks was obtained with a Keyence VHX-7000 microscope set at 80x magnification. A tilt correction was applied to the entire field of view, and a color-coded depth profile was obtained. Next a depth profile chart was obtained for a linear trace across the surface. The resulting image and profile measurements for an area with relatively deep elliptical grinding marks is shown in figure 18. The two deepest scratches in the field of view had measured peak-to-valley height differences of 0.0018 inch and 0.0019 inch (45 micrometers and 48 micrometers).

Figure 18. Color-coded 3D height map (upper left) of the bond surface area (upper right image) with relatively deep elliptical scratches near the origin and a chart showing relative height differences along the trace shown by the blue line in the upper right image.
