# NATIONAL TRANSPORTATION SAFETY BOARD

## MATERIALS LABORATORY FACTUAL REPORT

Report No. 22-008

Place : Saratoga, Wyoming  
Date : February 8, 2021  
Vehicle : Abbett Gerry Lancair Evolution, N7569A  
NTSB No. : WPR21LA108  
Investigator : Maja Smith, AS-WPR and Stephen Stein, AS-WPR

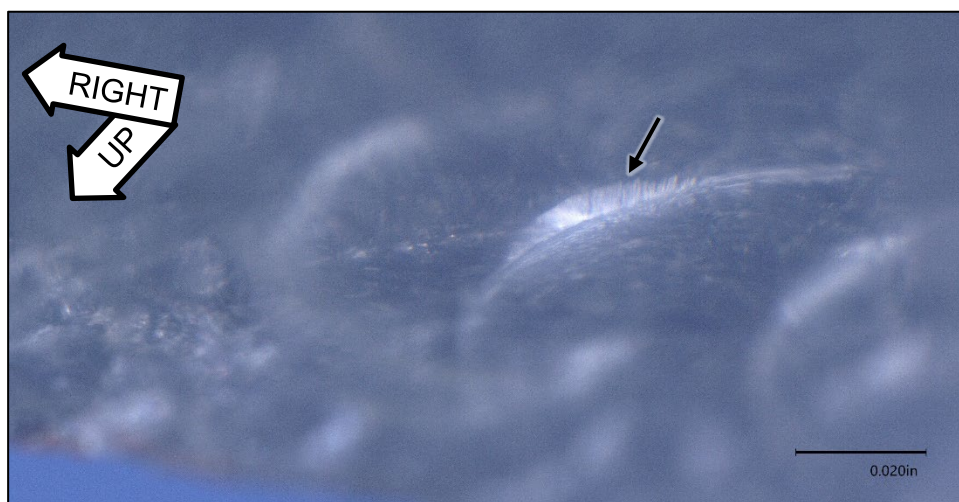
viewing conditions, small cracks were visible emanating from several of the relatively deeper elliptical cracks. One of these cracks is indicated in figure 19.

Figure 19. Crack emanating from an elliptical scratch on the exterior surface in the bond area near the origin.

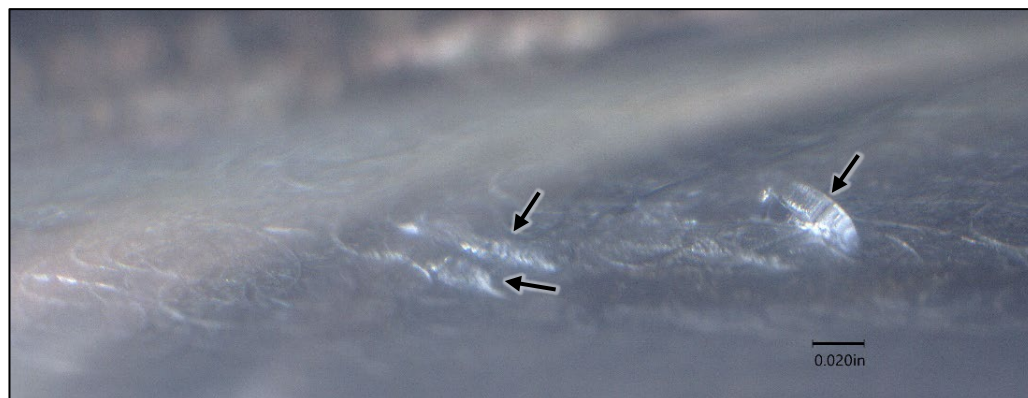
Relatively deep elliptical grinding marks were also observed on the interior bond surface of piece 5, and multiple cracks were detected in the area. Unlabeled arrows in figure 20 indicate multiple small cracks emanating from the interior bond surface in piece 5 that were illuminated using lighting and viewing conditions comparable to those used on piece 8.

Figure 20. Cracks emanating from elliptical scratches on the interior surface in the bond area of piece 5.

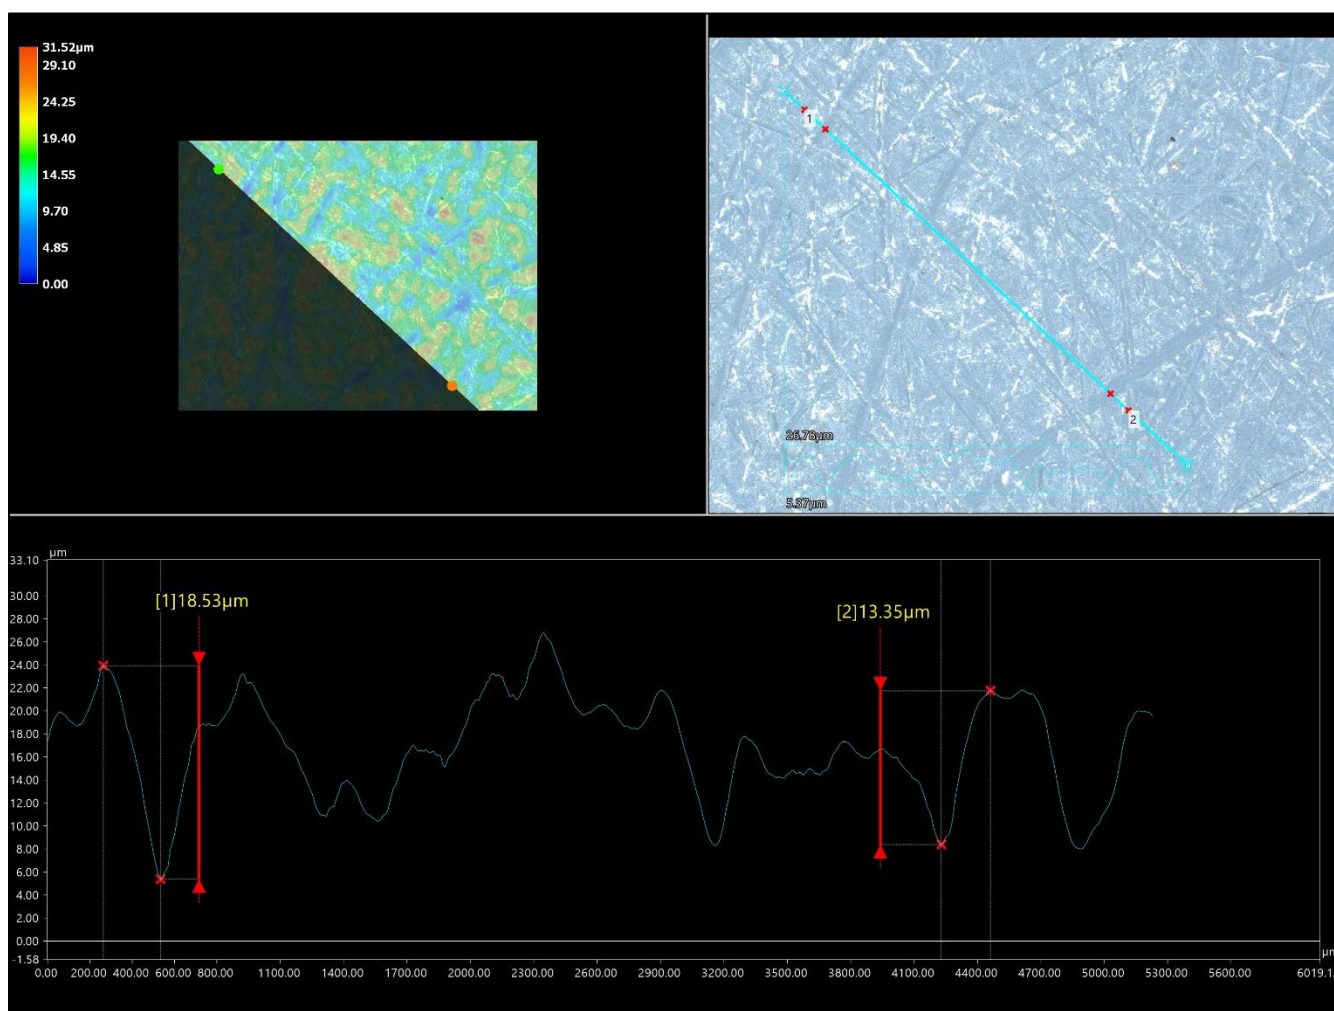
The exemplar scratched surface was examined using the Keyence VHX-7000 microscope, and the scratch profiles were analyzed using the same methods used for the data presented in figure 18 but with a 50x lens to cover a broader field of view. The resulting scratch profile for the exemplar scratched surface is shown in figure 21. The deepest scratches in the field of view had depths of 0.00053 inch and 0.00073 inch (13.35 micrometers and 18.53 micrometers).

Figure 21. Color-coded 3D height map (upper left) and optical image (upper right) of a surface scratched with a vibrating sander with 40-grit paper in area with scratches that appeared relatively deep. Relative height differences along the trace shown by the blue line in the upper right image are plotted in the chart below the images.

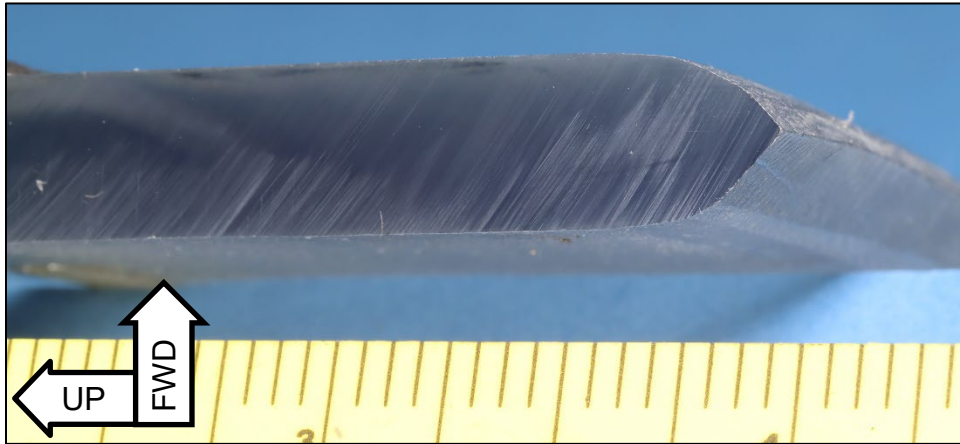
Around the circumference of the windshield, many areas of the edge had a flat angled chamfer with linear grinding marks on the flat portion. A view of the edge profile on piece 8 is shown in figure 22 where a flat chamfer was present on the interior side of the piece. Figure 23 shows relatively deep linear grinding marks at the edge of piece 8 on the flat chamfered edge. According to build instructions, the edge of the windshield should be ground with a DA grinder to a rounded (bullnose) edge profile.

Figure 22. Section through piece 8 showing the edge profile.

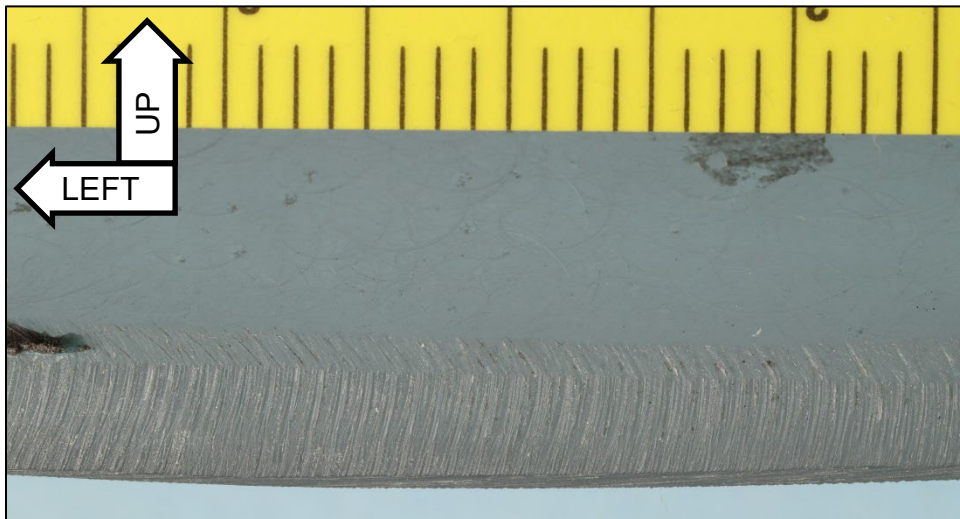
Figure 23. Linear grinding marks at the lower edge of piece 8 on the interior side of the windshield.
