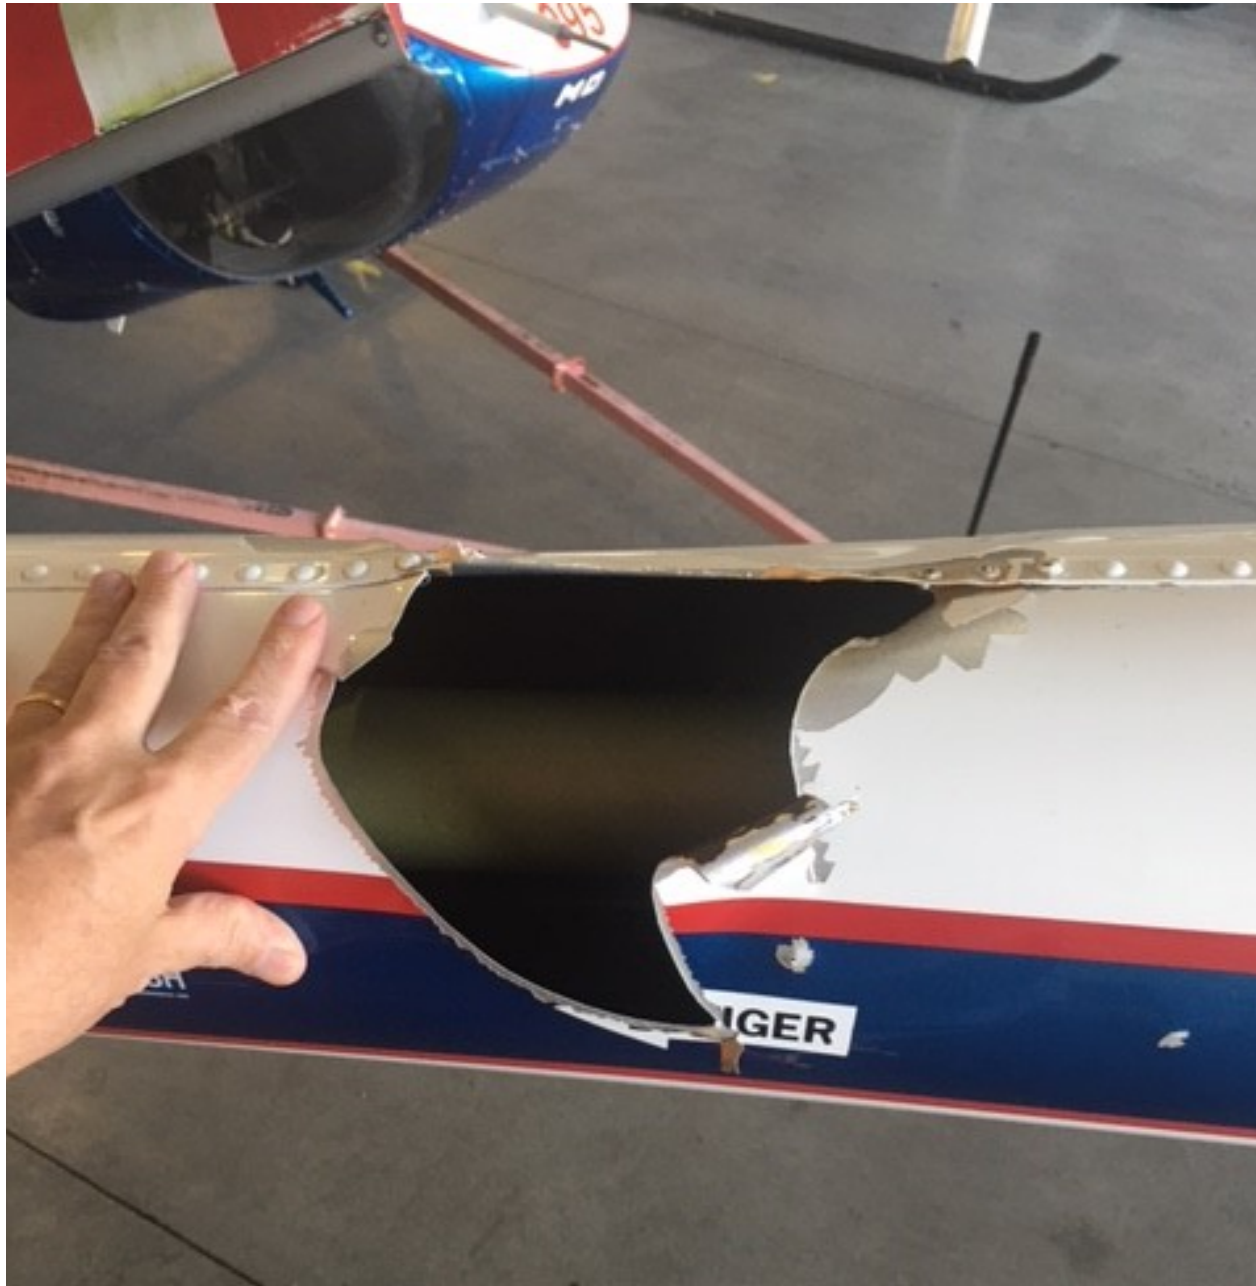
**Photo 1 – Top view, showing damage to the tail boom. Photo courtesy of the operator.**
