## **NATIONAL TRANSPORTATION SAFETY BOARD**

# **WRECKAGE EXAMINATION SUMMARY**

**WPR21LA111**

| Aircraft: | Piper PA46R-350T (Matrix), N40TS |

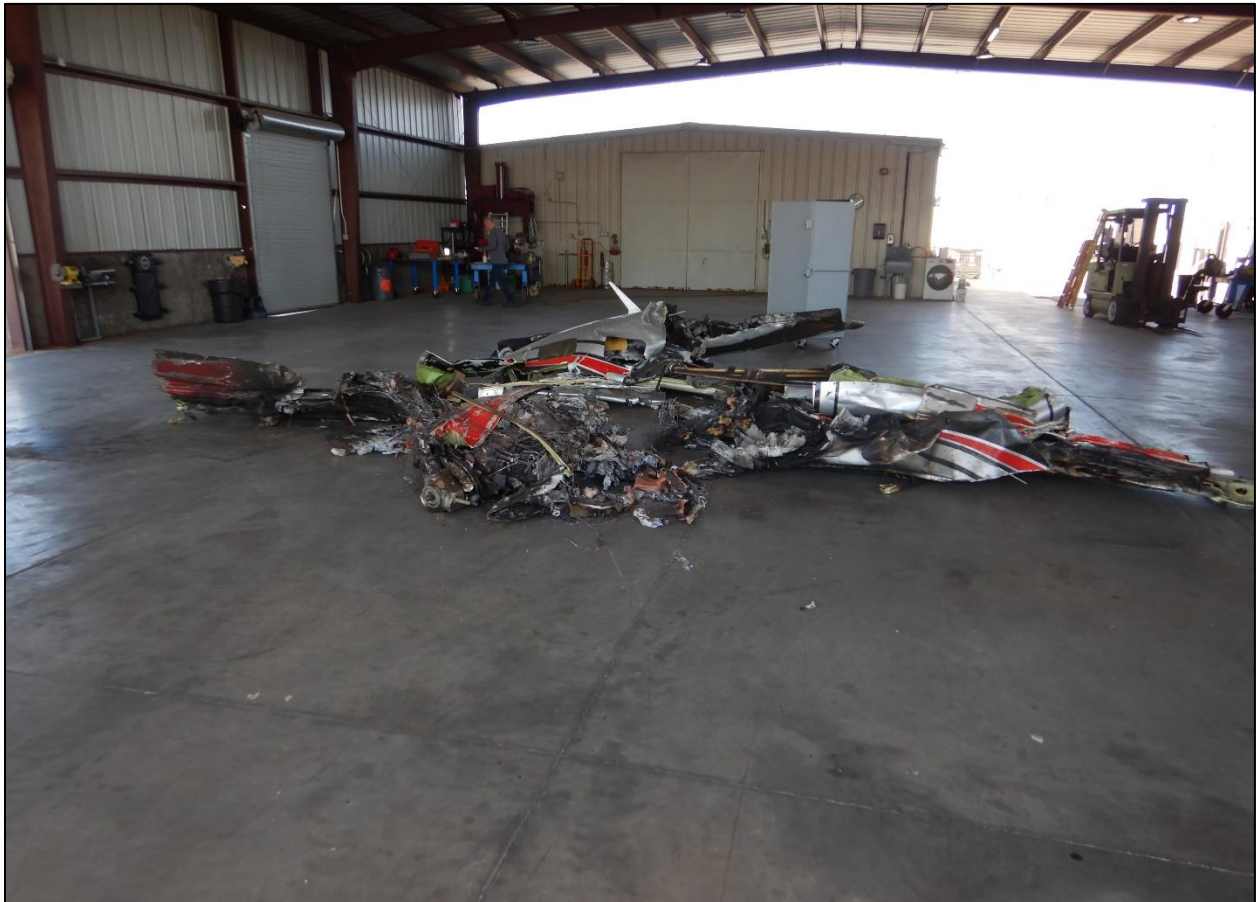
The wreckage was displayed on the ground and all flight control surfaces and airplane components were present with exception of the rudder. The rudder was identified in onsite photographs located near the vertical stabilizer. All of the recovered wreckage was found to have extensive crush damage and some had postaccident fire damage. The engine and its accessories had impact damage and remained partially attached to its mount. The engine mount was crushed and remained partially attached to the forward fuselage. The forward baggage door separated and was found in the debris field. The cabin area was destroyed, and no evidence of switch positions were available. The instruments were damaged, and non-volatile memory of the flight was no available.

**Figure 1-Main wreckage displayed on the floor.**

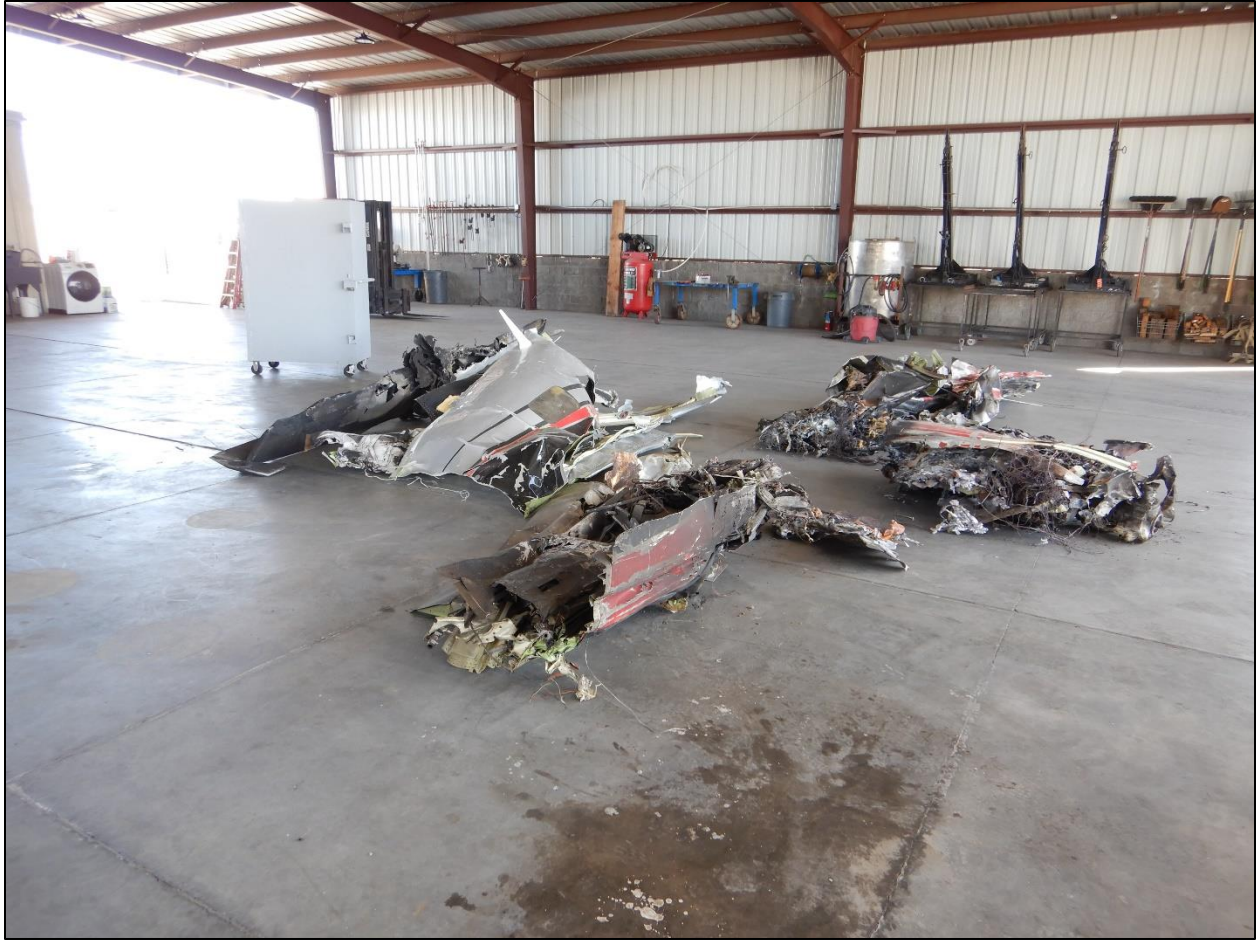
**Figure 2-Main wreckage displayed on the floor.**

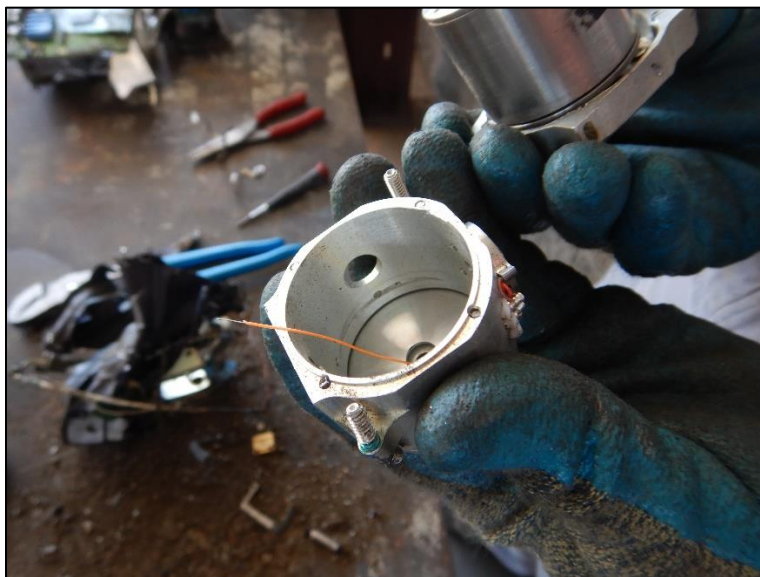
The attitude indicator instrument was disassembled, and the rotor and case were removed. The vacuum-powered rotor and case revealed rotational scoring damage.

**Figure 3-Attitude indicator case, interior rotational scoring.**

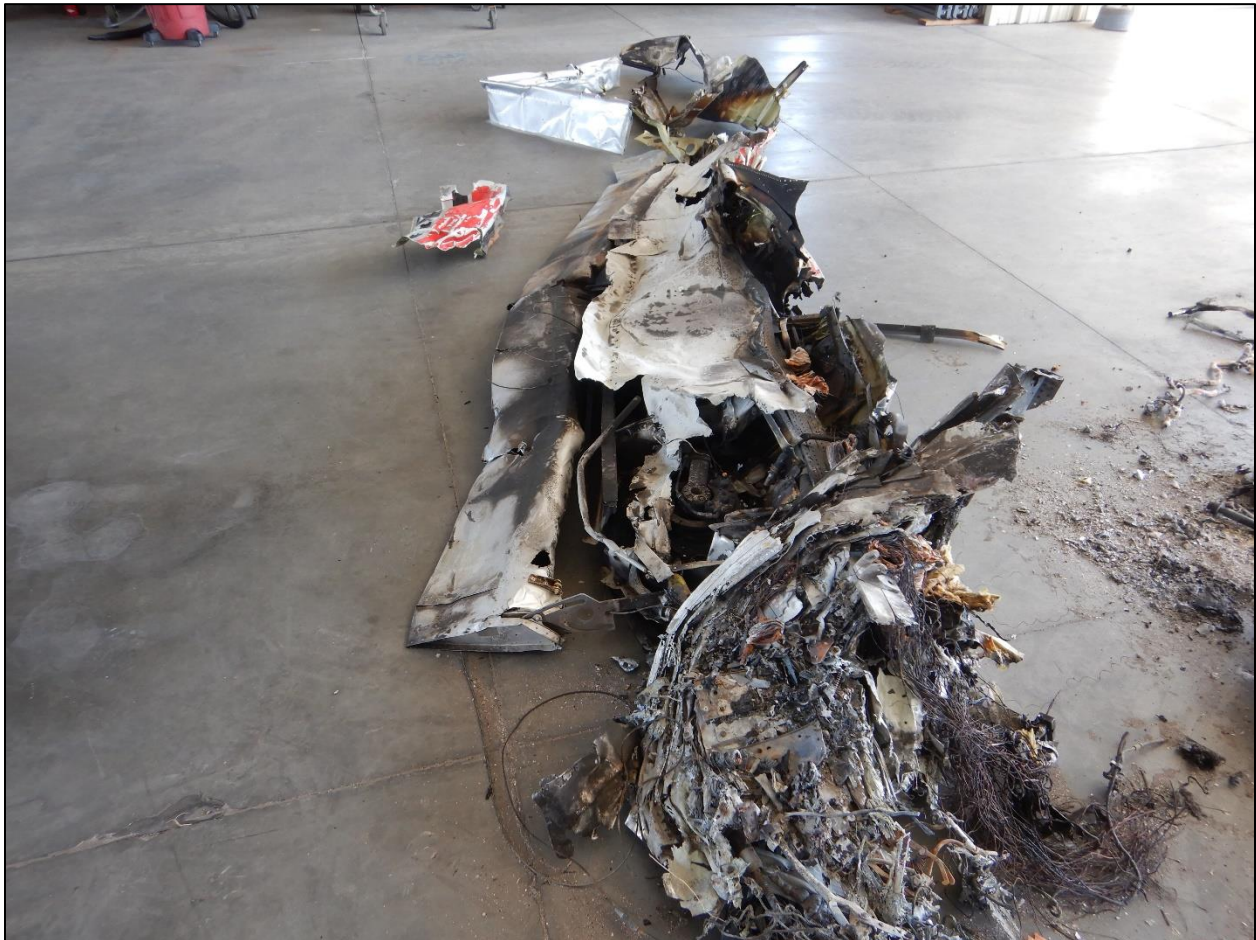
The wings had crush and thermal damage and were found in several sections. The main landing gear remained in the wings in the retracted position. Aileron cables were identified and were found in several sections.

**Figure 4-Left wing and cabin portion.**

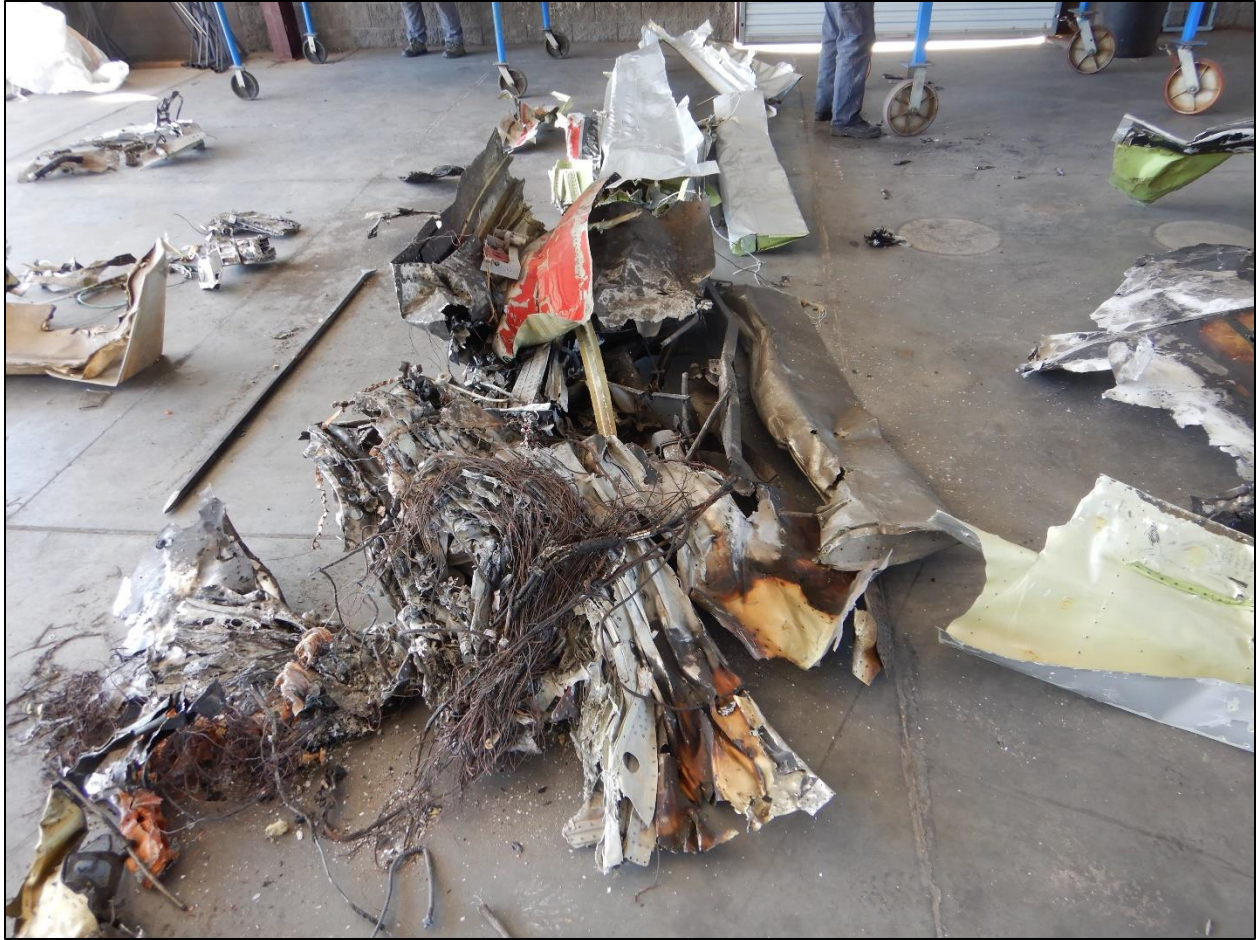
**Figure 5-Right wing and cabin portion.**

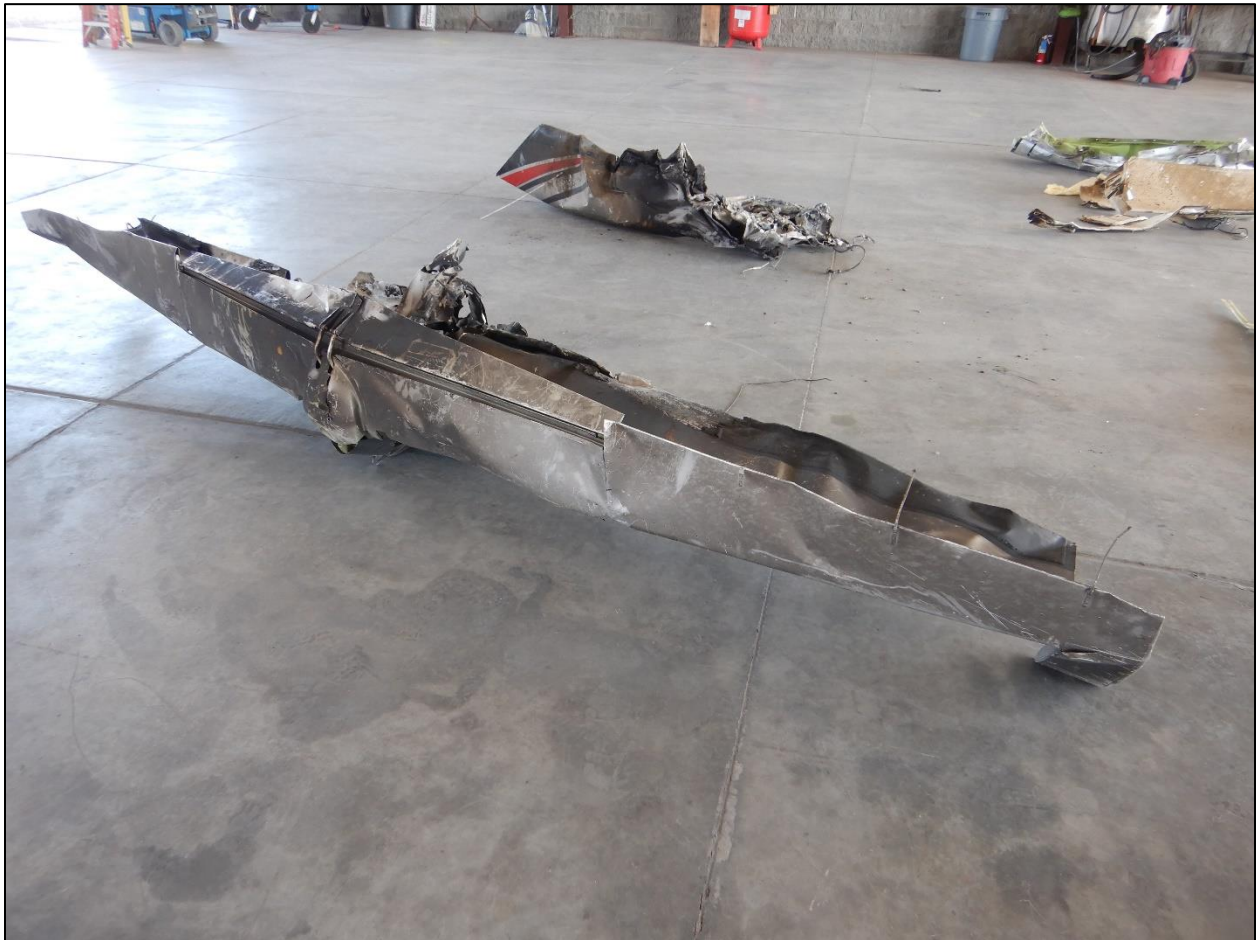
The horizontal stabilizer along with the elevator and trim tab had impact and thermal damage. The horizontal stabilizer remained attached to a small portion of the tailcone structure. The elevator trim barrel revealed that 15 threads of the trim screw was extended. According to airplane manufacturer this would relate to about a full-nose-up trim position. The vertical stabilizer remained attached to a portion of the tailcone structure and had impact and thermal damage. Both rudder control stops were separated. The rudder was not available at the examination but was identified in a photo that was taken of the accident site near the vertical stabilizer's location.

**Figure 6-Horizontal stab and elevator (vertical stabilizer in the background).**

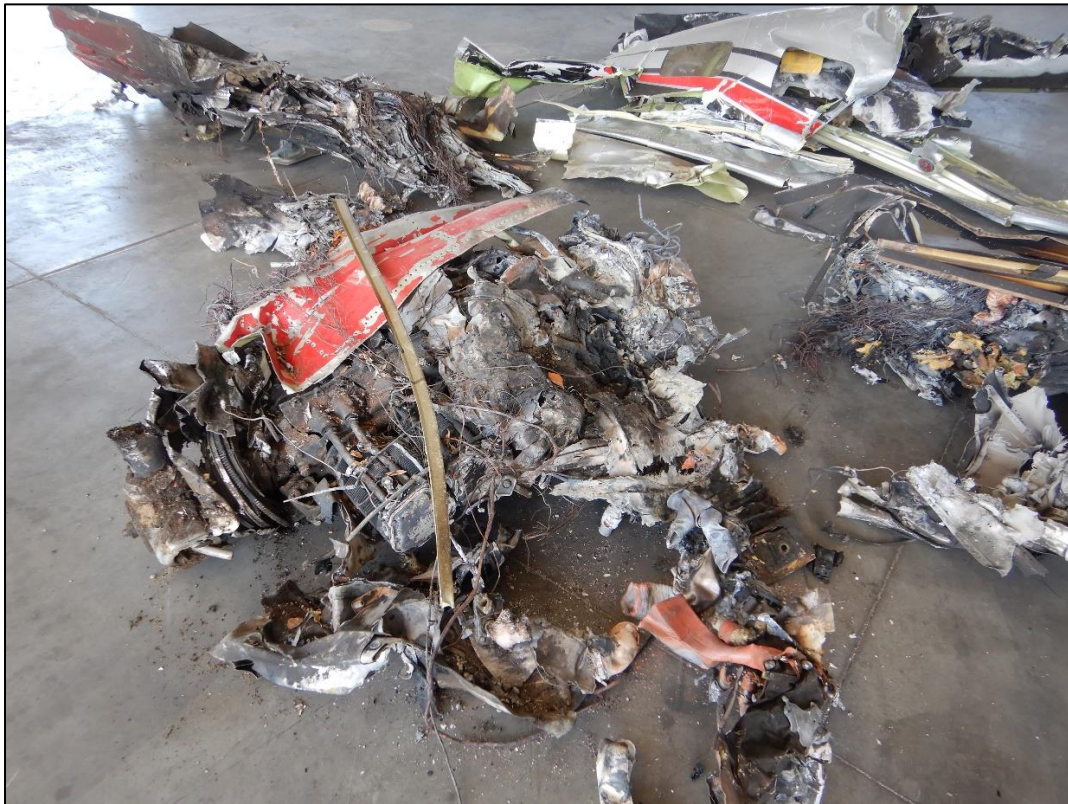
The engine was removed from the main wreckage and displayed excessive impact damage. The crankshaft would not rotate during the examination. The turbochargers were removed and disassembled. The compressor blades revealed blade tip contact to the scroll housing and curling at the blade tips.

**Figure 7-Engine and main wreckage.**

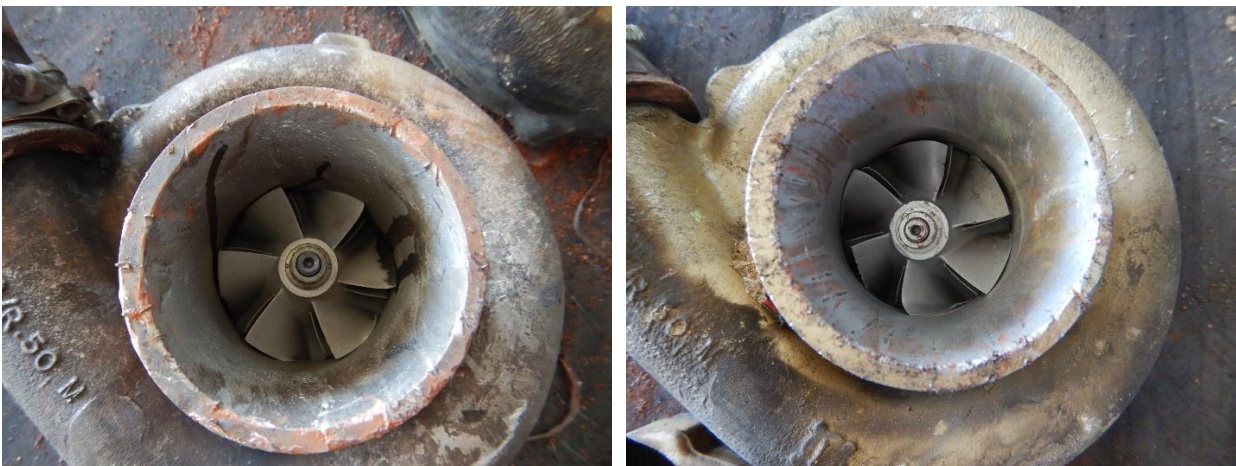
**Figure 8-Turbocharger compressor scrolls and blades.**

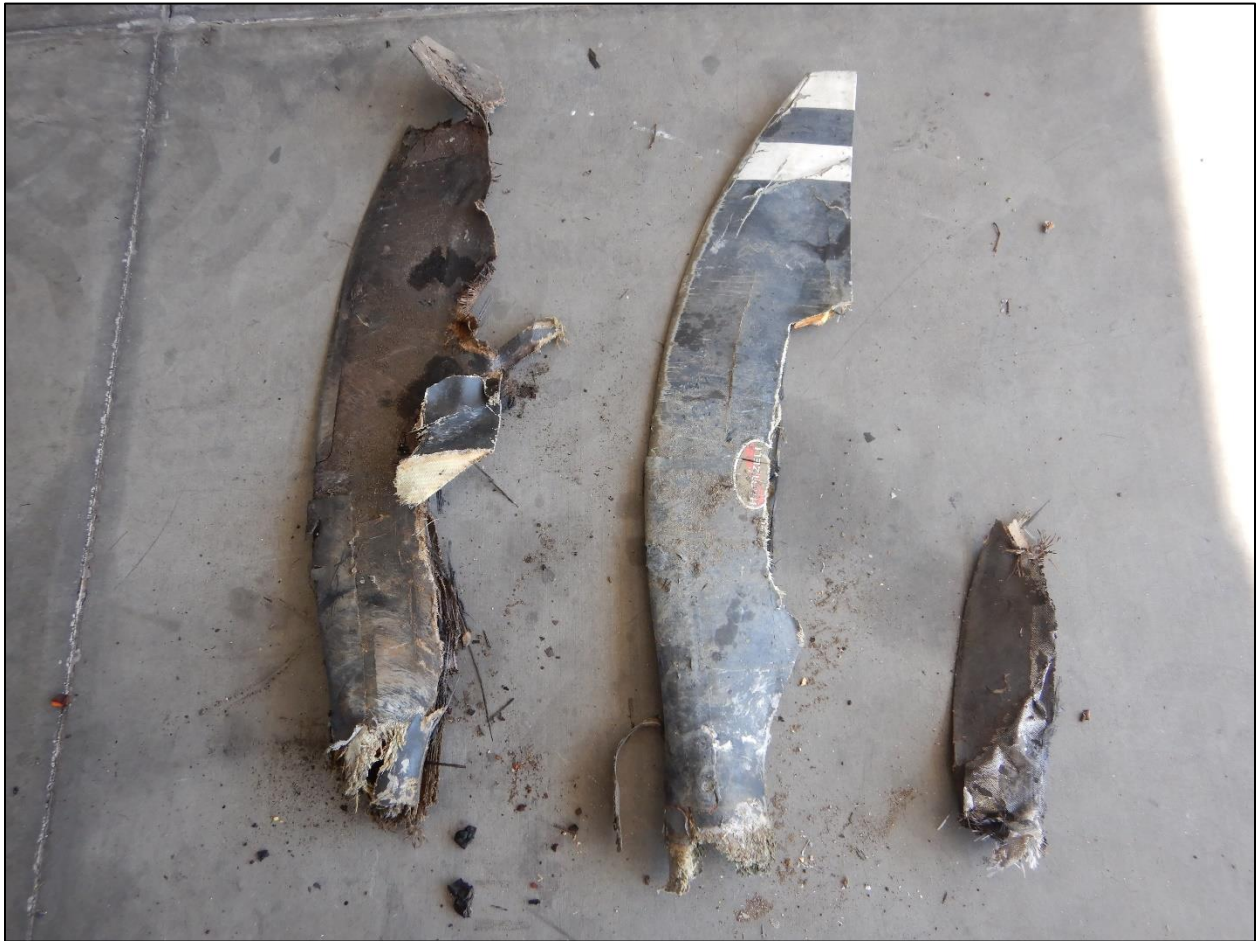
The composite propeller blades separated from the hub and had impact damage.

**Figure 9-Propeller blades.**
