# NATIONAL TRANSPORTATION SAFETY BOARD

## MATERIALS LABORATORY FACTUAL REPORT

Report No. 21-048

Place : Redmond, Oregon  
Date : February 7, 2021  
Vehicle : Piper PA-44-180, N125MG  
NTSB No. : WPR21LA117  
Investigator : Fabian Salazar, AS-WPR

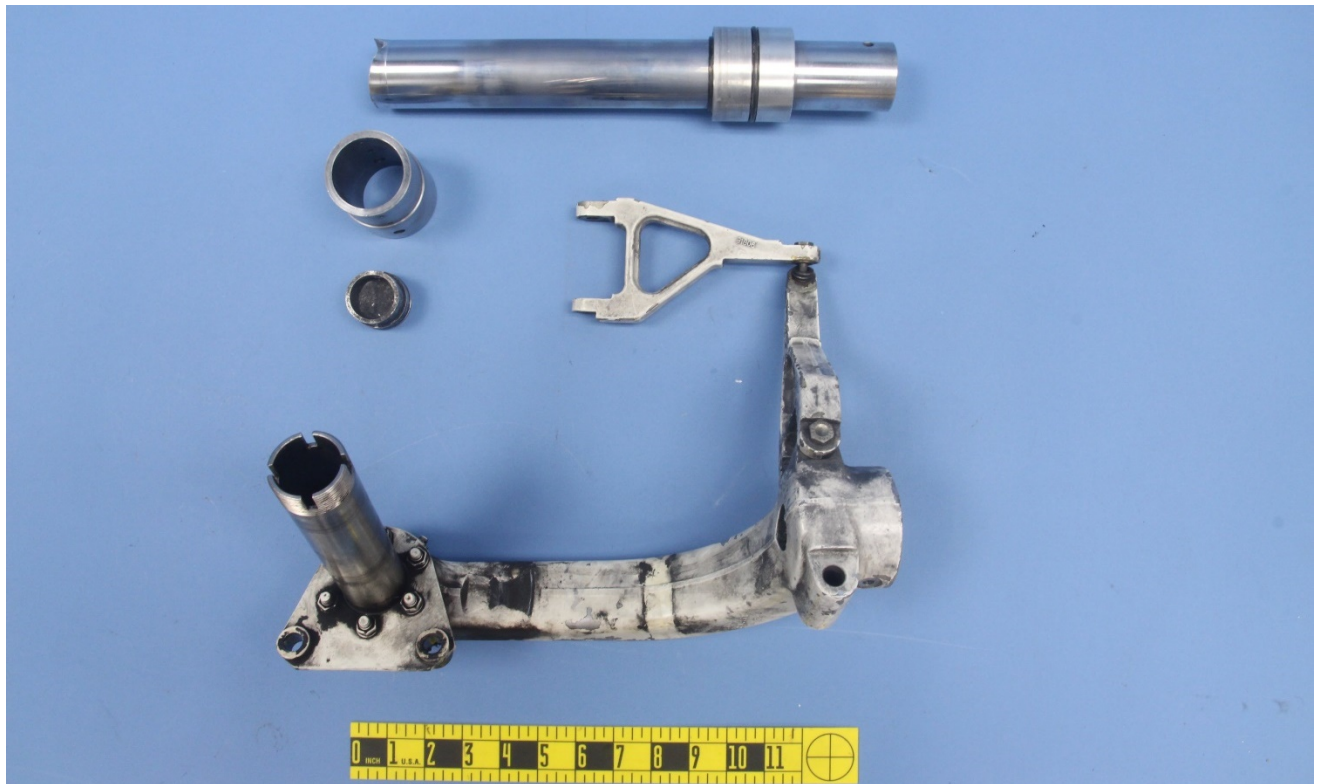
Figure 1 shows the components of the landing gear, as received. Figure 2 shows the location of the fractured strut piston. The fracture location of the piston was inside the cylinder bore within the wheel fork assembly. The fractured remnant of the strut piston and its fracture surface is shown in Figure 3.

Figure 1 – The landing gear components, as received.

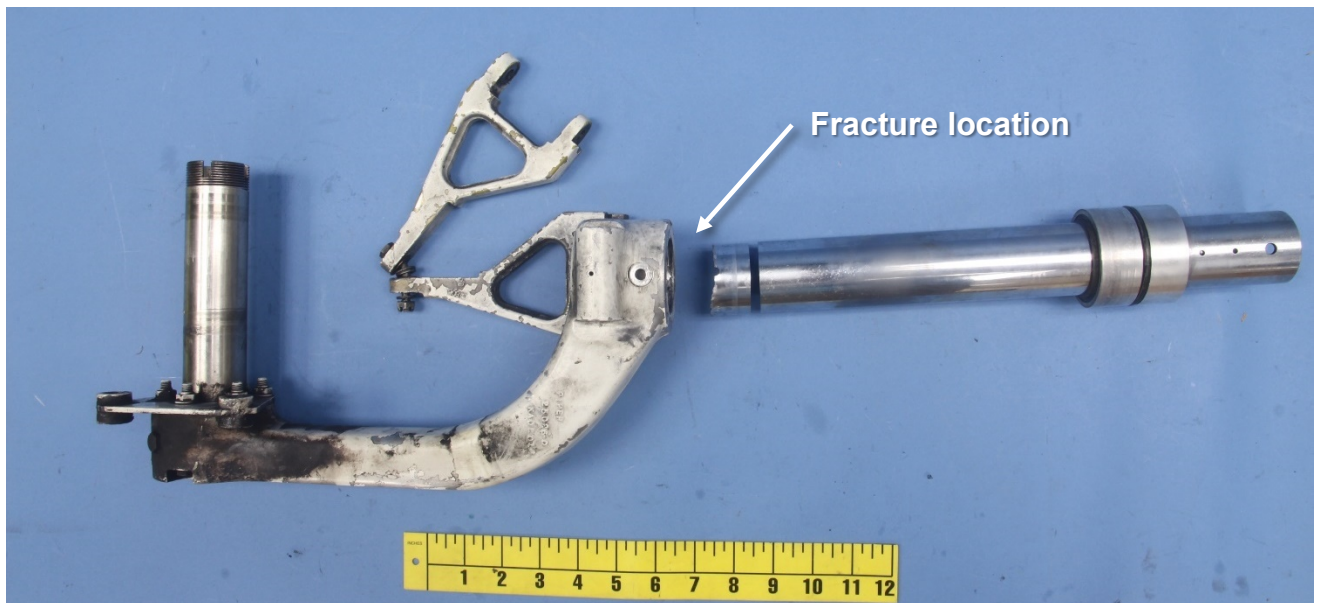
Figure 2 – Reconstruction of the landing gear strut piston as positioned prior to fracture.

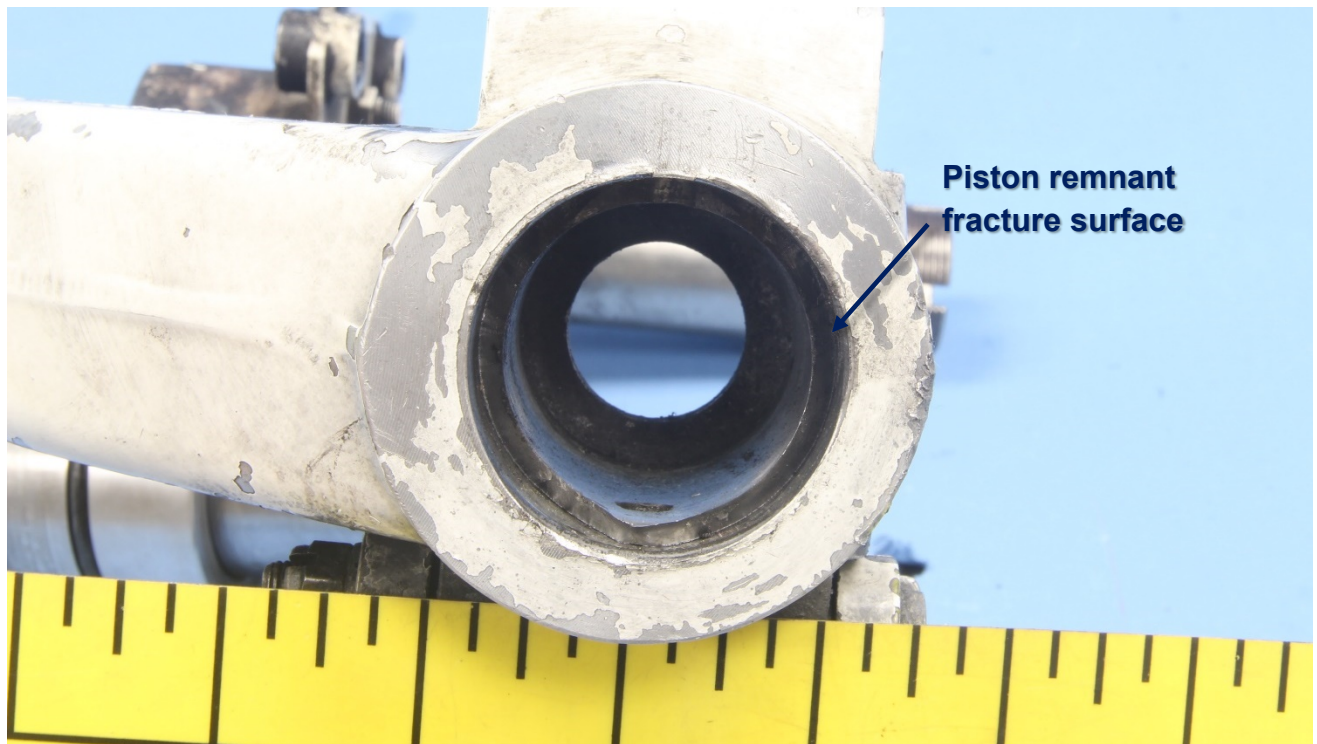
Figure 3 – View of the fracture surface of the piston fragment inside the cylinder bore.

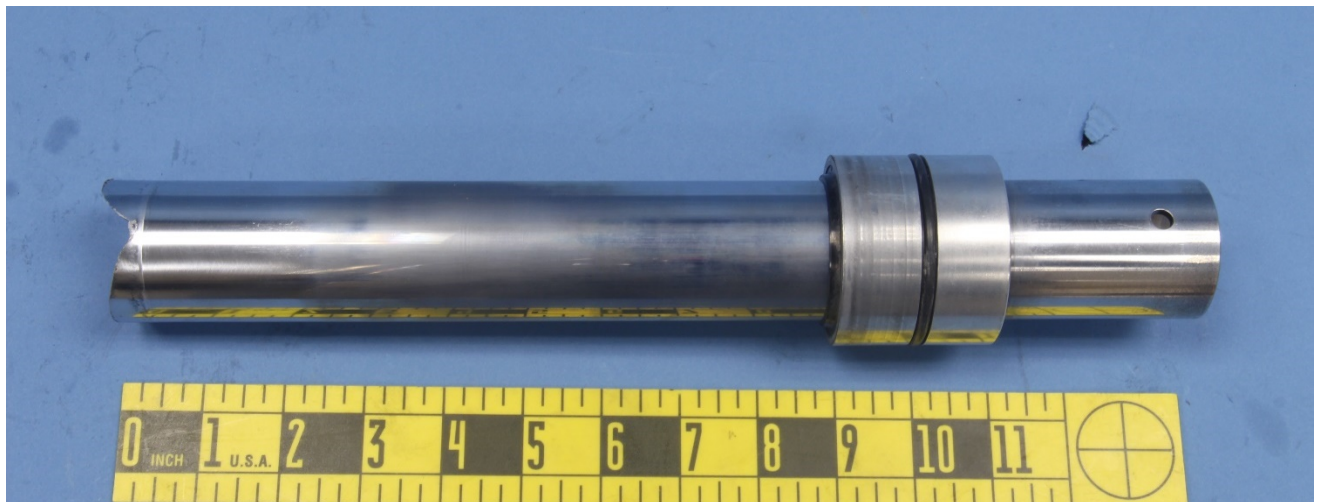
Figures 4 and 5 show the strut piston, as received from the side. The piston had fractured circumferentially mating with the fracture remnant inside the fork cylinder bore. The fractured end shown in Figure 5 demonstrates the location of the fracture through the bolt holes in the strut piston. There was also a dark circumferential line approximately 0.5 inches from the lowest end of the fracture surface, and 0.25 inches away from the holes, consistent with the outer face of the mating fork cylinder bore edges.

Figure 4 – Side view of the fractured landing gear strut piston, as received.

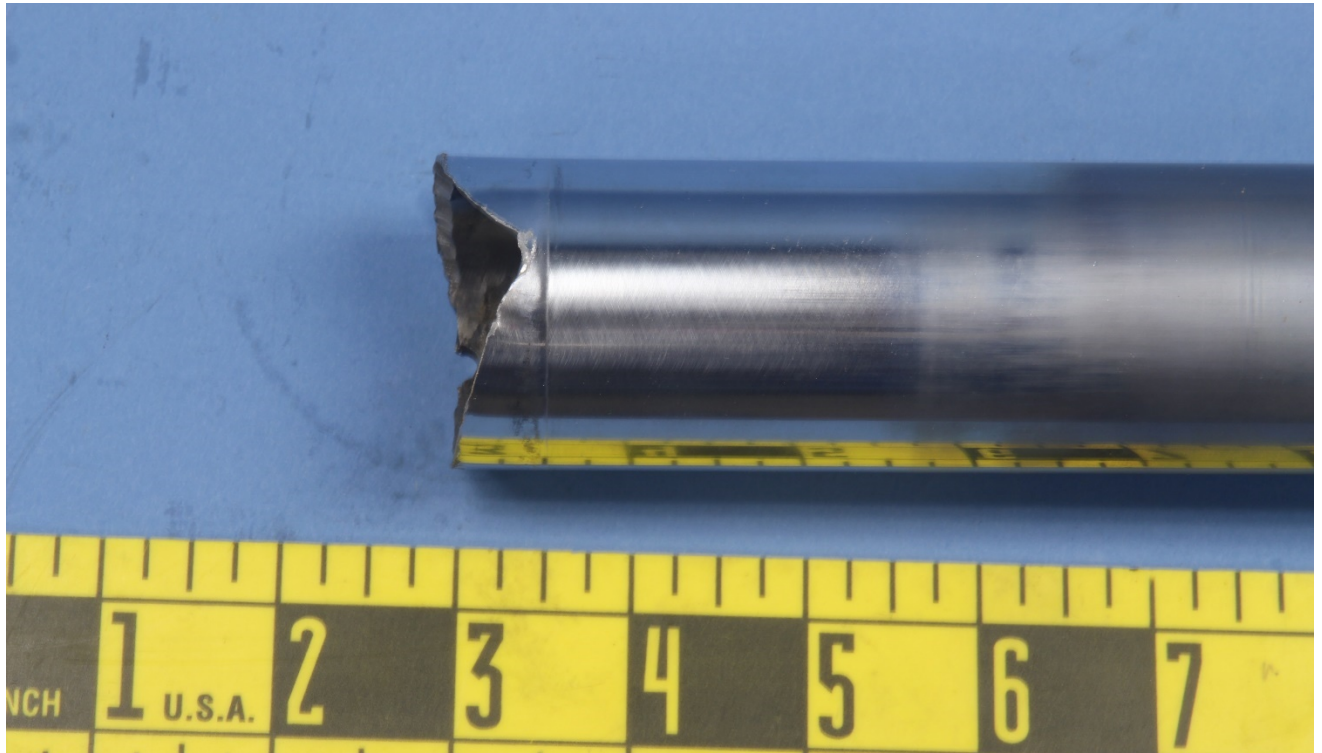
Figure 5 – Closer view of the fracture surface of the strut piston in Figure 4.

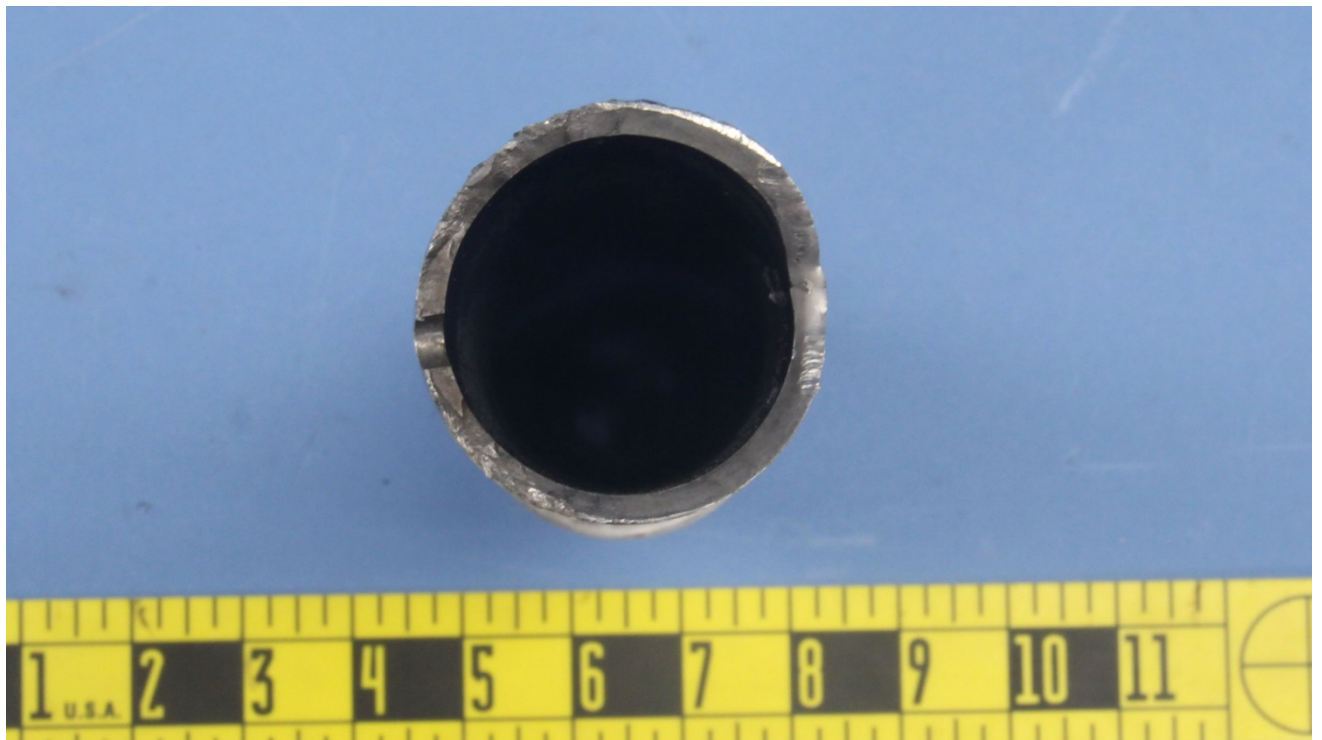
Figure 6 and Figure 7 show a planar and angled view of the piston fracture surface. For the most part, the fracture surface exhibited a slanted morphology, angled inward. The exceptions were the areas of the fracture surface near the attachment hole on the bottom of Figure 6 and Figure 7. These areas were generally flatter and more reflective, exhibiting characteristics consistent with thumbnail-shaped cracks.

Figure 6 – Planar view of the piston fracture surface.

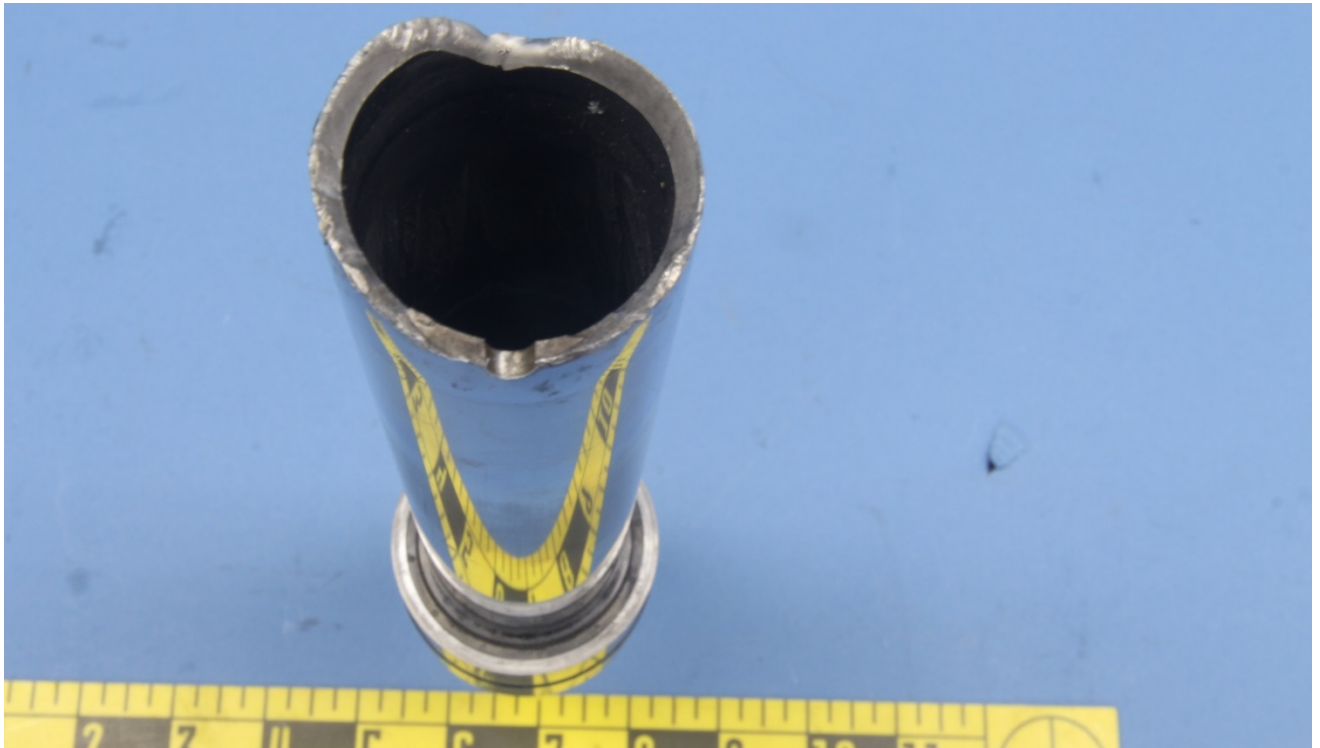
Figure 7 – Angled view of the piston fracture surface, showing two small thumbnail cracks near an attachment hole.

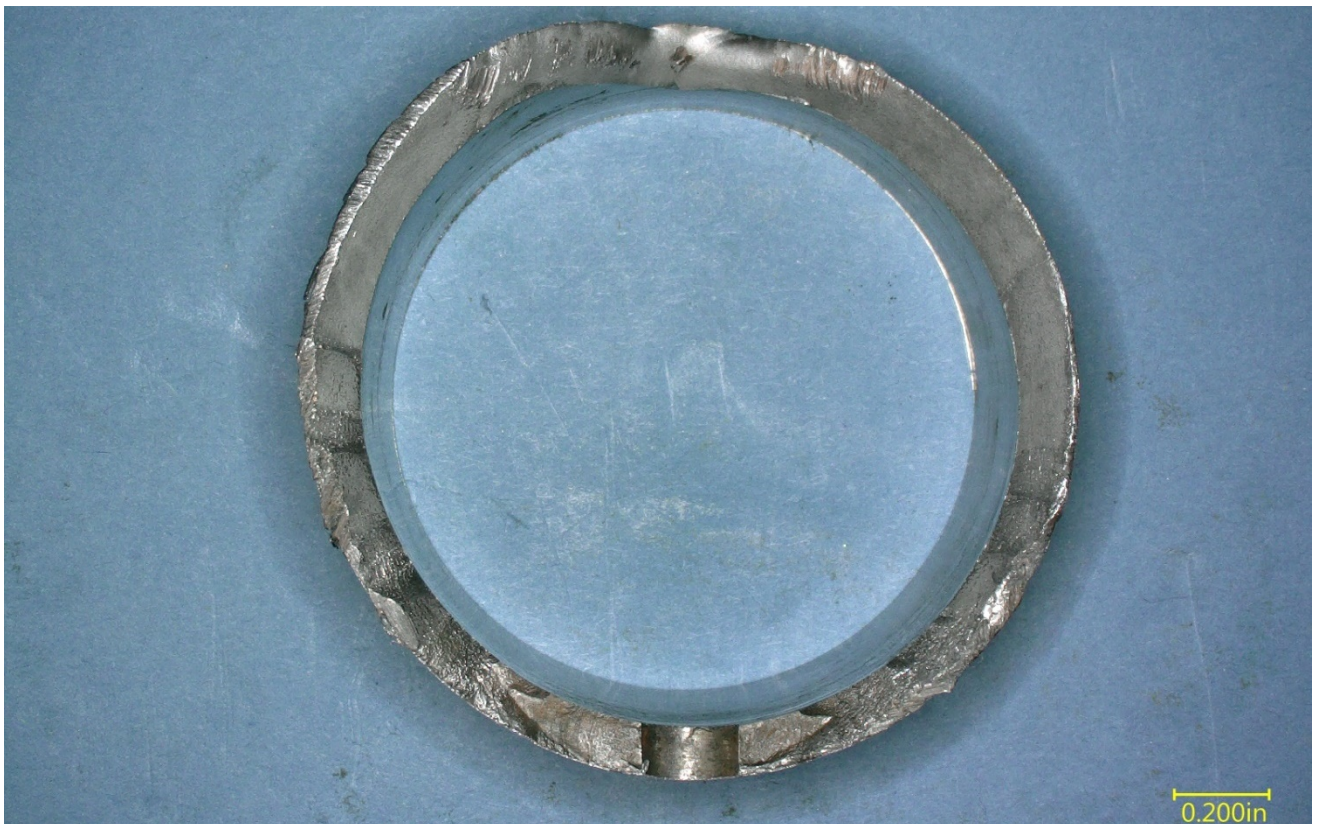
The fractured end of the upper strut piston fragment was sectioned and cleaned in an ultrasonic bath using acetone. Figure 8 shows the fracture surface after sectioning and cleaning. The two thumbnail cracks were present on the bottom of the figure adjacent to the attachment hole. These thumbnail cracks corresponded with the area of the fracture surface that was oriented perpendicular to the piston longitudinal direction, rather than oriented at an inward slant.

Figure 8 – Planar view of the piston fracture surface, after sectioning and cleaning.

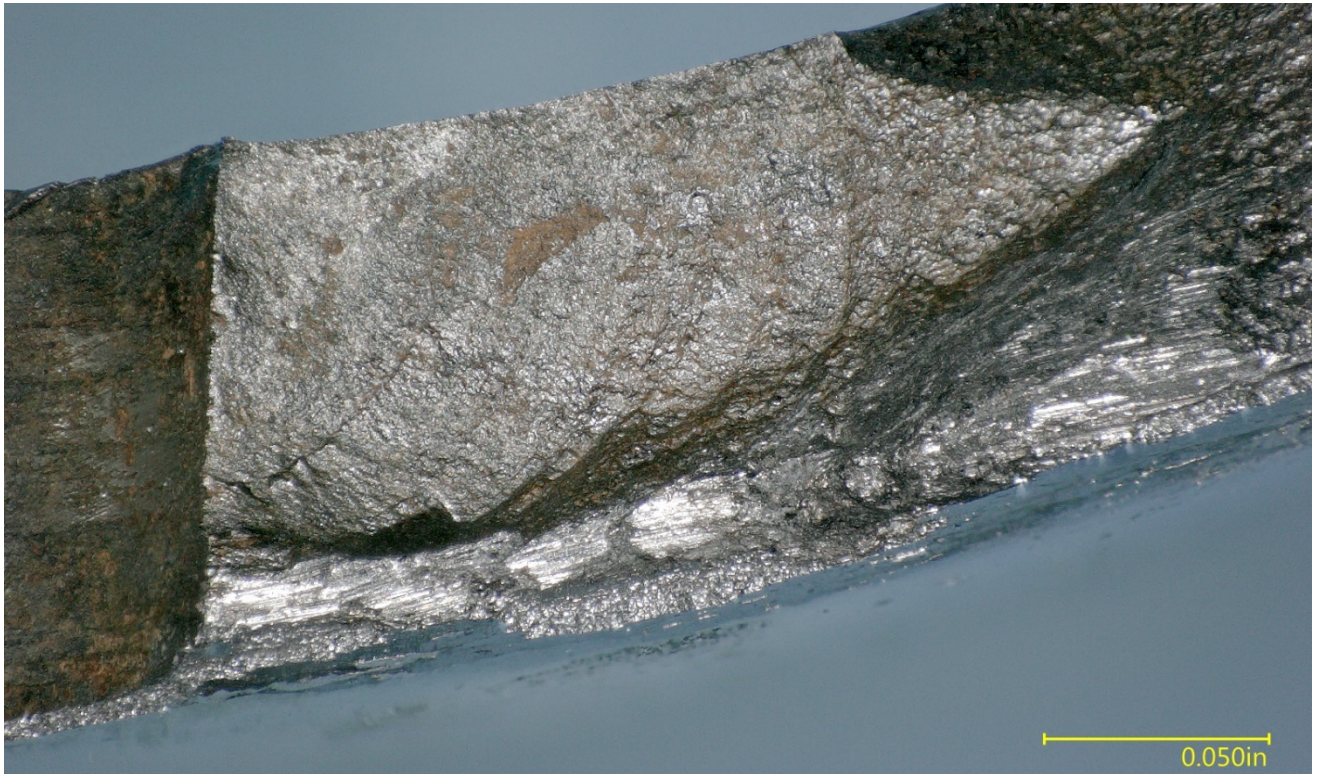
The thumbnail cracks to the right and to the left of the hole in Figure 8 are highlighted in Figure 9 and Figure 10, respectively. For the purposes of this report, these cracks will be referred to as the left and right cracks based on the positions in Figure 8 and 10. The fracture surfaces in both figures exhibited crack arrest, or beach, marks propagating circumferentially into the piston cross section emanating from the hole. The right crack was 0.21 inches in length, and the left crack was 0.33 in length, and both encompassed maximum widths equivalent to the piston wall thickness of 0.125 inches.

Figure 9 – View of the thumbnail crack on to the right of the hole in Figure 8.

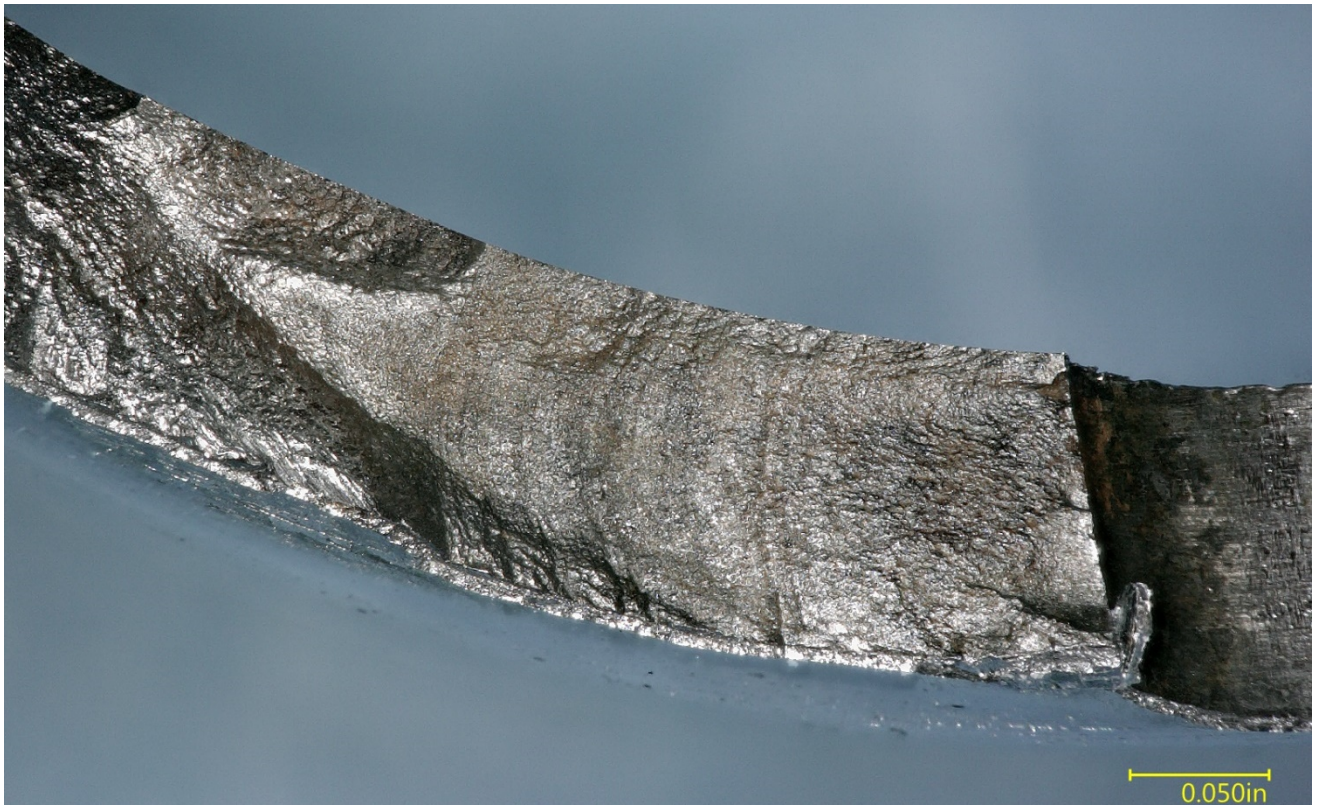
Figure 10 – View of the thumbnail crack on to the left of the hole in Figure 8.

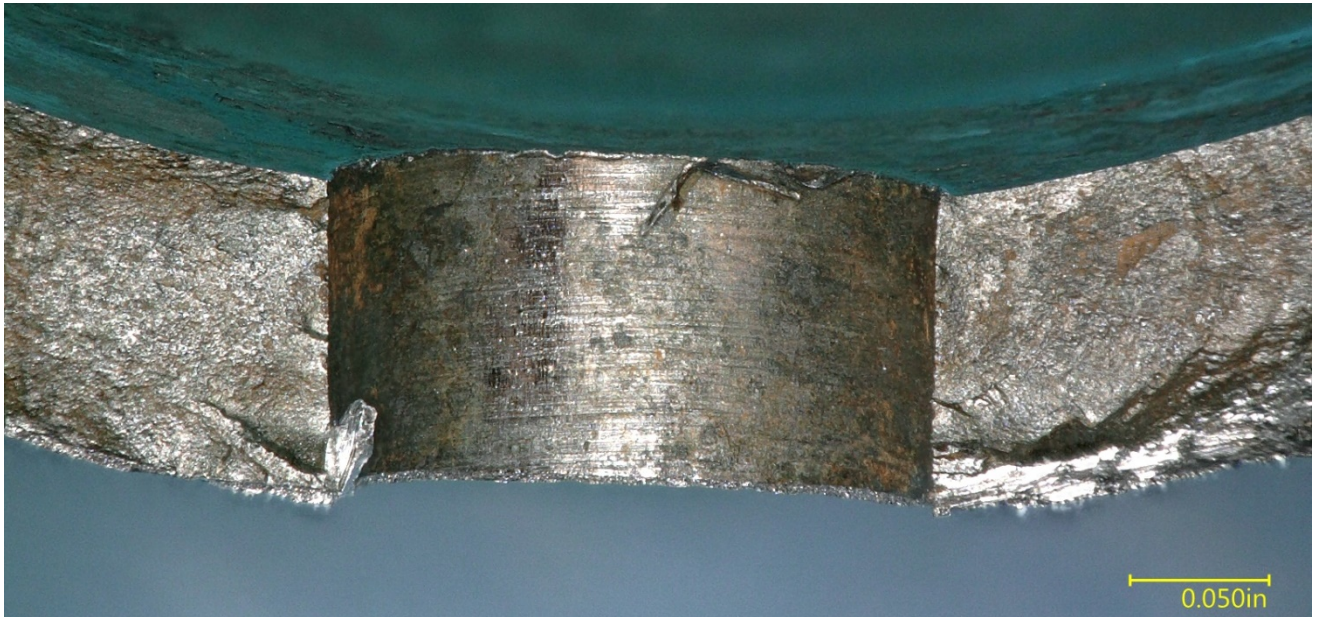
Figures 11 and 12 show closer views of the cross-drilled hole bore, which was used for the attachment bolt. The bore surface exhibited circumferential wear and machining marks. The inward-facing edge of the bore exhibited a protruding lip, consistent with plastic deformation inward. The radial edges of the bore, where the thumbnail cracks had initiated, exhibited circumferentially oriented linear features, consistent with ratchet marks. Ratchet marks were consistent with multiple crack initiation sites. Figure 13 shows a closer view of the bore, which highlights some of the wear marks present on the surface. Further, pits were found present along the surface of the bore.

Figure 11 – View of the hole of the piston fracture surface, showing initiation sites of the two thumbnail cracks.

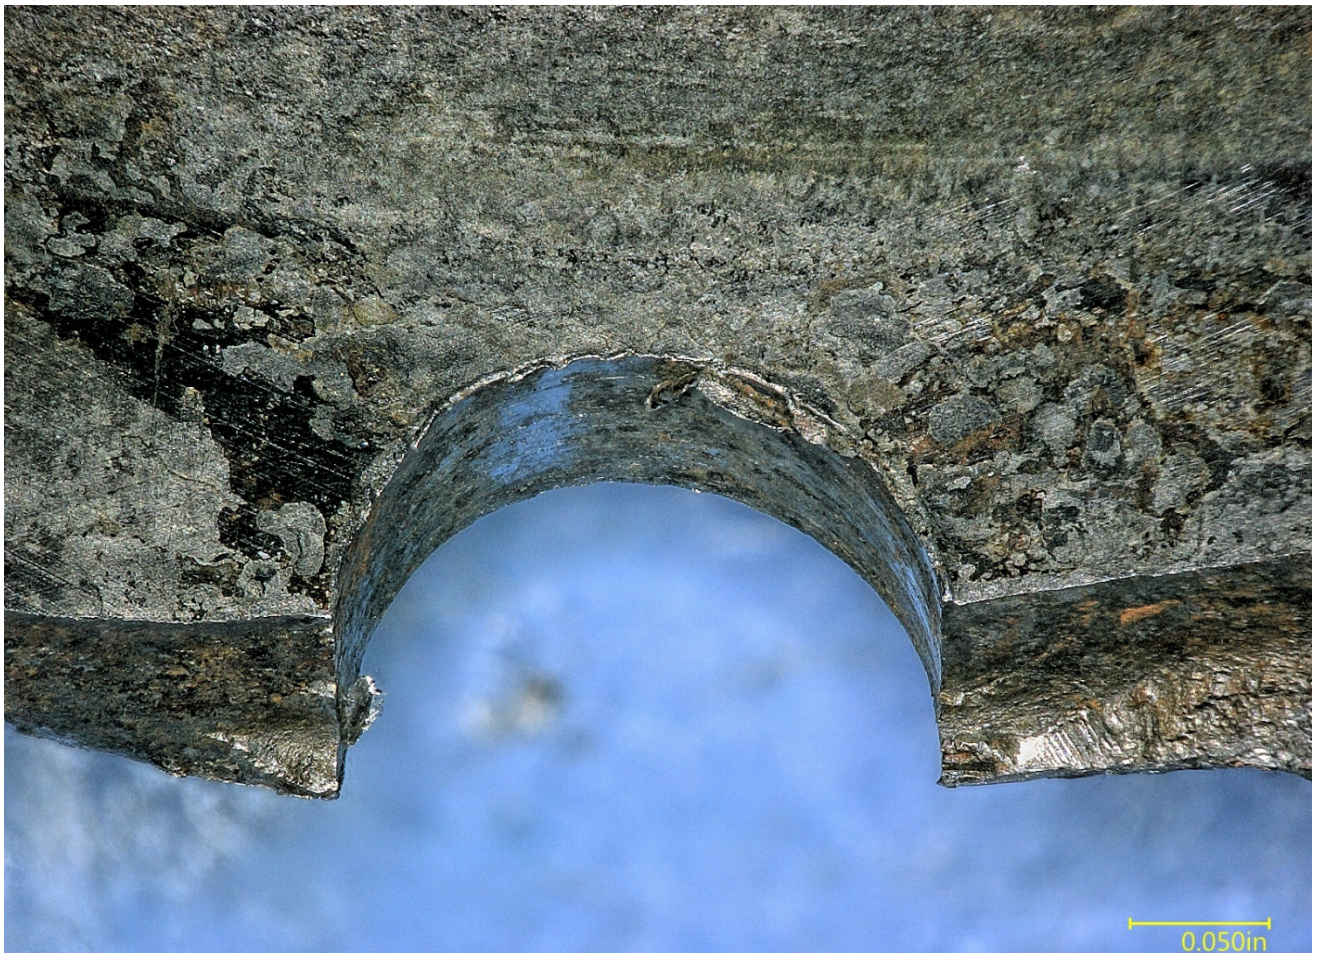
Figure 12 – Angled view showing the interior of the piston cylinder at the hole and cracks.

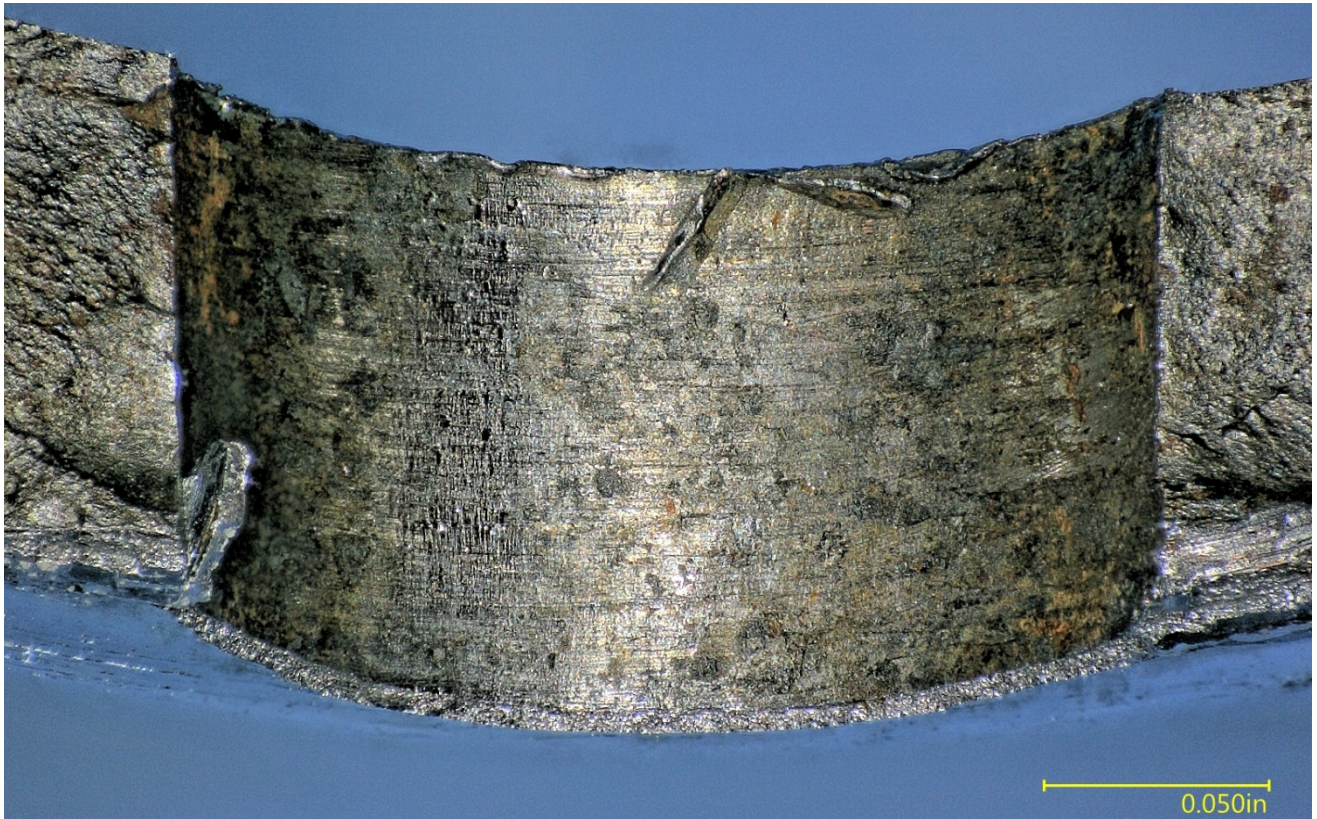
Figure 13 – Closer view of the hole surface, showing small pits and divots.

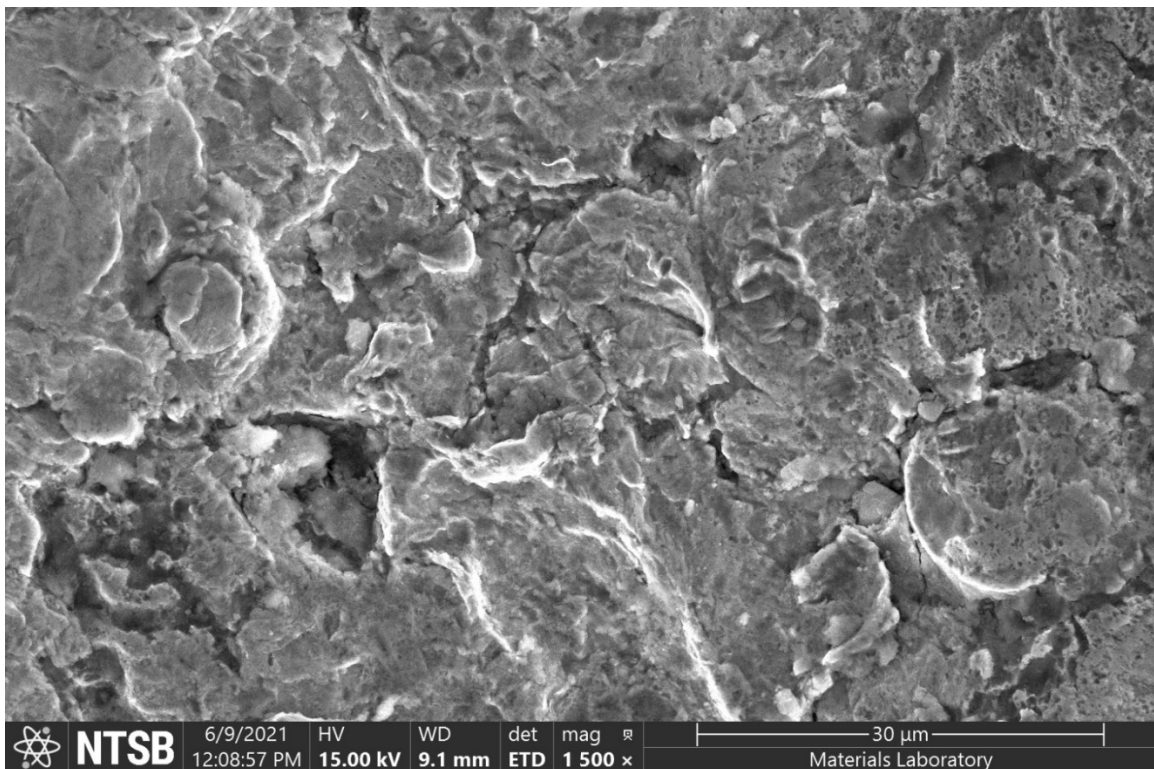
The sectioned fracture surface was examined using a scanning electron microscope (SEM). Typical areas of the thumbnail cracks exhibited striations, consistent with fatigue crack propagation (Figures 14 and 15). These fatigue features are typical of many high strength steels, where the striations are often fine or indistinct. Outside of the fatigue cracks, the fracture surface exhibited dimpled rupture, consistent with overstress fracture of ductile materials (see Figure 16 and Figure 17).

Figure 14 – Secondary electron (SE) of a typical area of the right thumbnail crack.

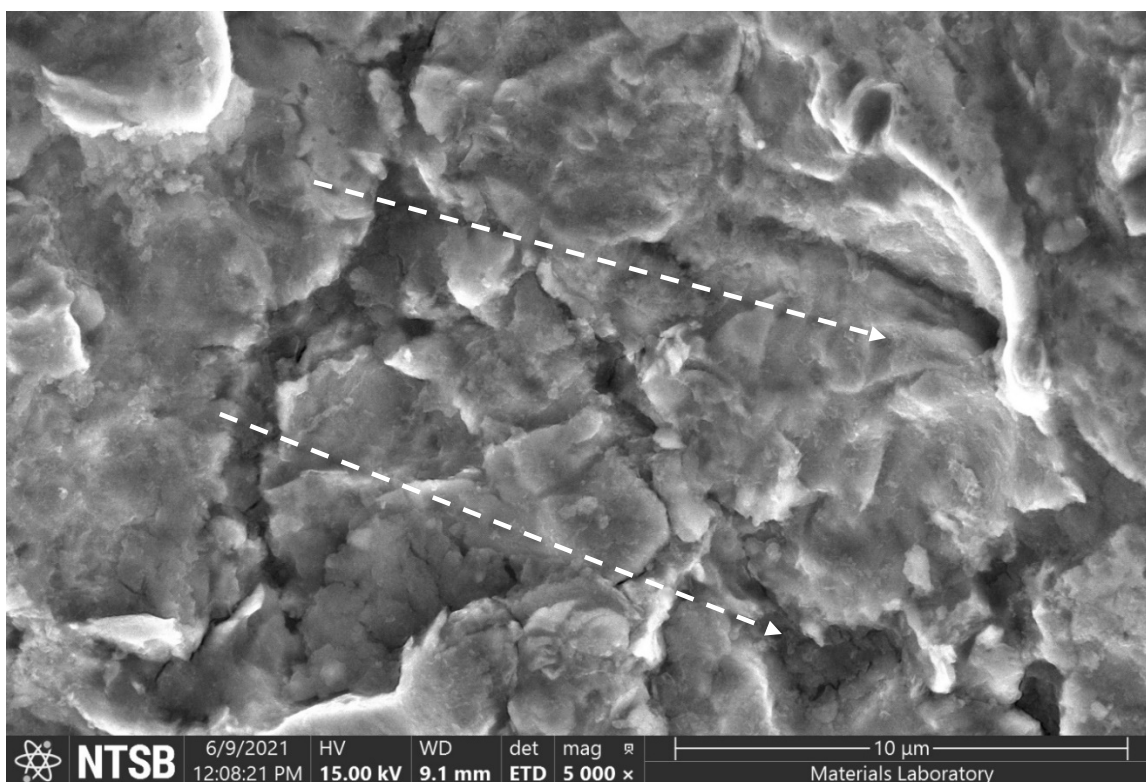
Figure 15 – SE micrograph of a closer view of an area in Figure 14, showing fatigue striations. The crack growth direction is annotated (dashed arrows).

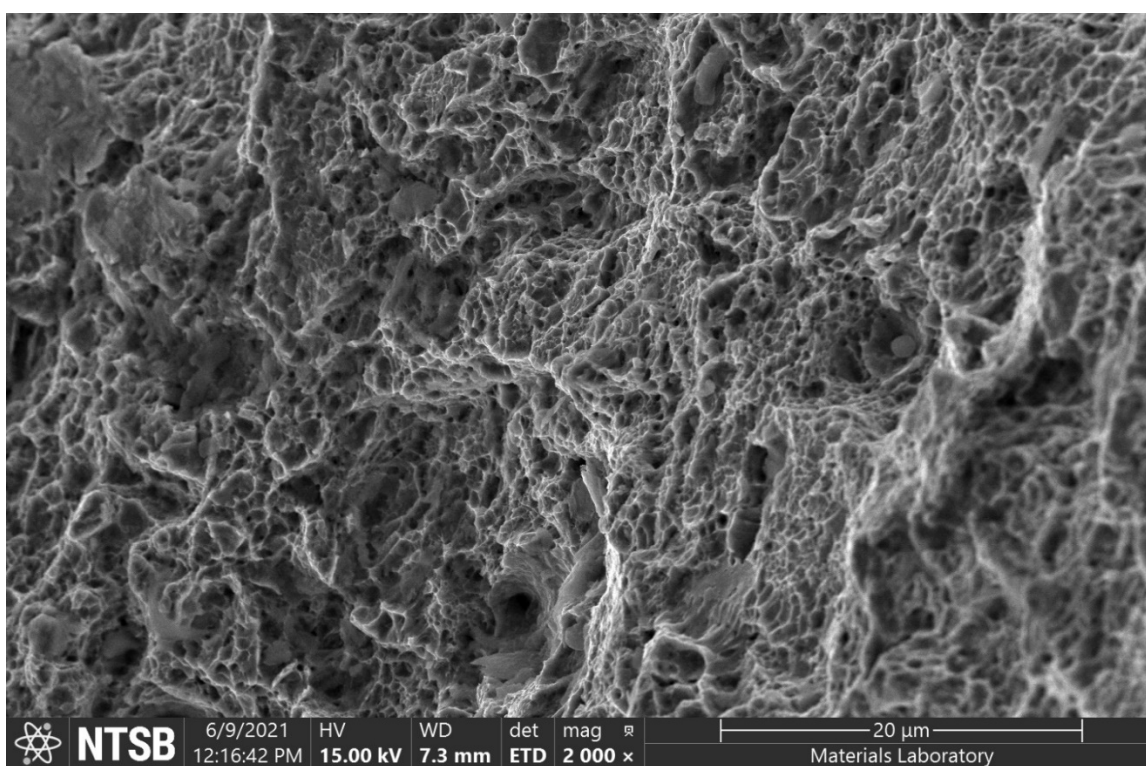
Figure 16 – SE micrograph of a typical area of the fracture surface outside the fatigue cracking.

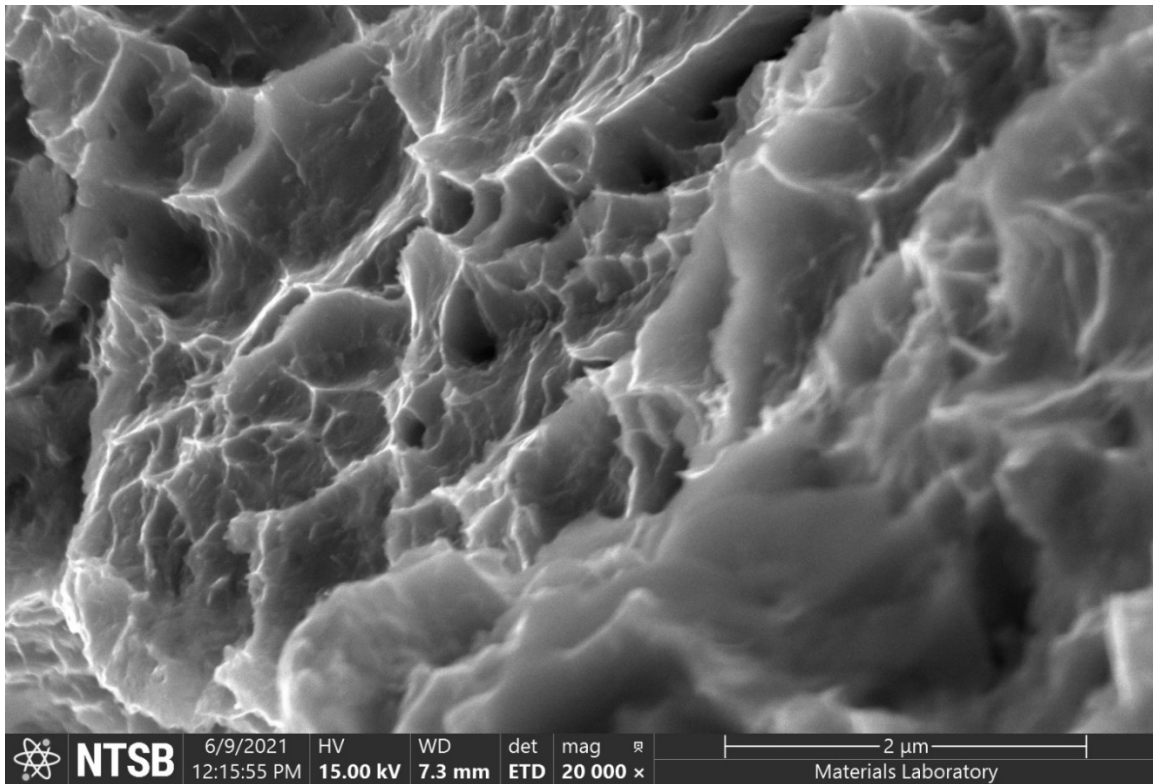
Figure 17 – SE micrograph of a closer of the dimpled rupture in Figure 16.

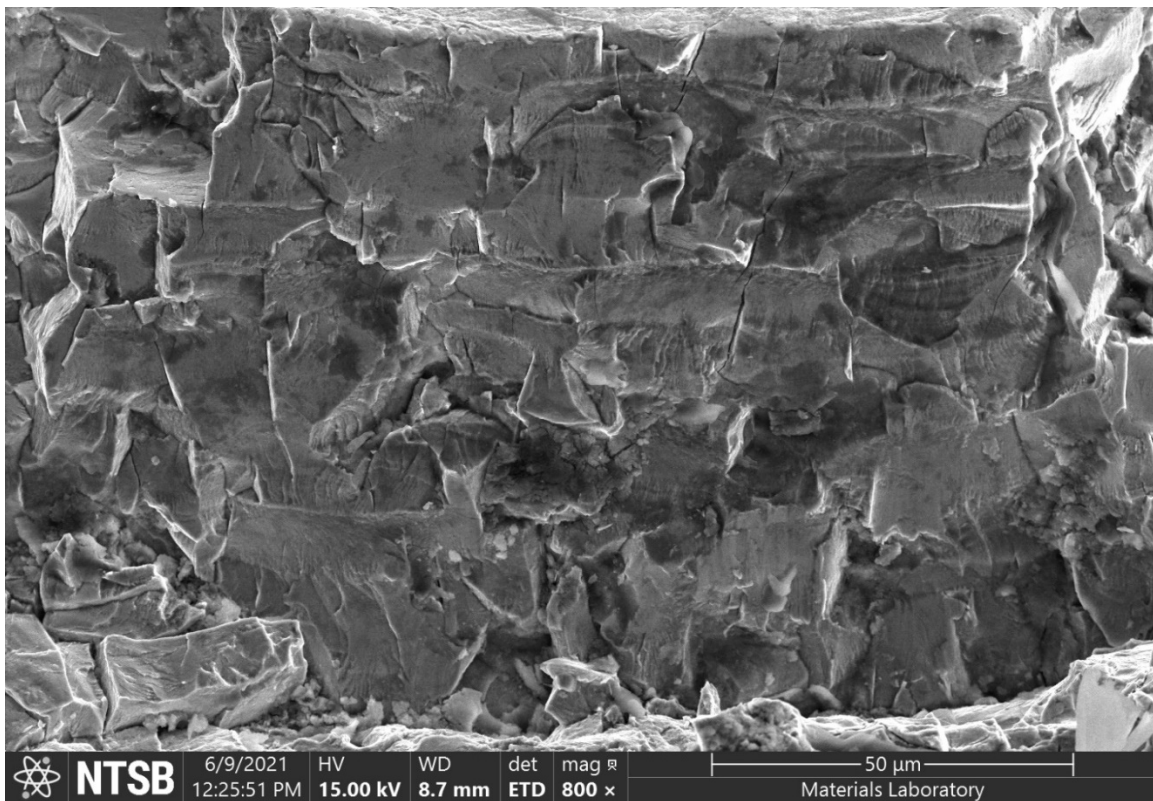
Disparate features were observed on the edge of the fracture surface at the outer surface, as shown in Figure 18.<sup>1</sup> This fracture region exhibited faceted features with cleavage fracture, typical of materials exhibiting limited ductility. Examination of this region by energy dispersive x-ray spectroscopy (EDS) found mostly chromium. These features and chemical composition were consistent with those of subsequent overstress fracture of a chromium electrodeposition layer, commonly applied to contact surfaces of landing gear struts.

Figure 18 – SE micrograph of the fractured remnant of a external chromium layer.

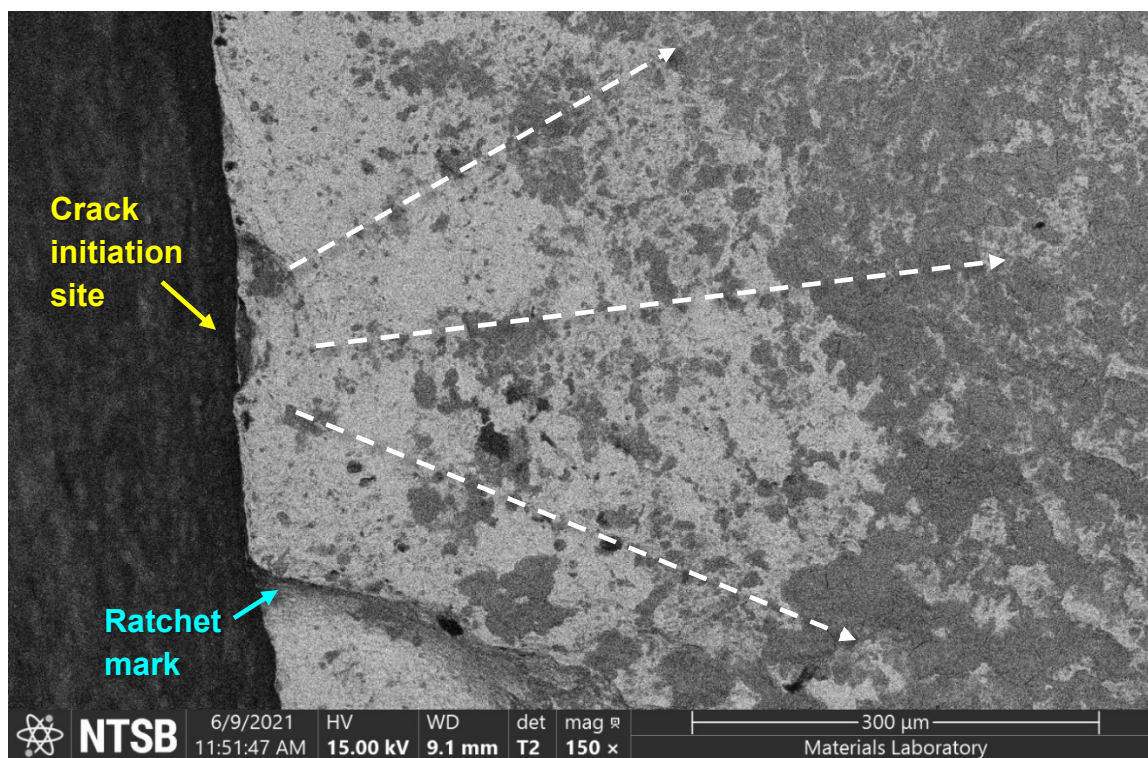
Figure 19 shows a closer view of the crack initiation site of the right side fatigue crack. The initiation region exhibited several ratchet marks, consistent with multiple crack initiation sites that coalesced during early propagation. The initiation site highlighted in

Figure 19 exhibited a small divot at the surface. A closer view of this site, shown in Figure 20, revealed the presence of non-metallic compounds, indicative of corrosion products.

Figure 19 – Backscattered electron (BE) micrograph of the crack initiation site of the right side fatigue crack.

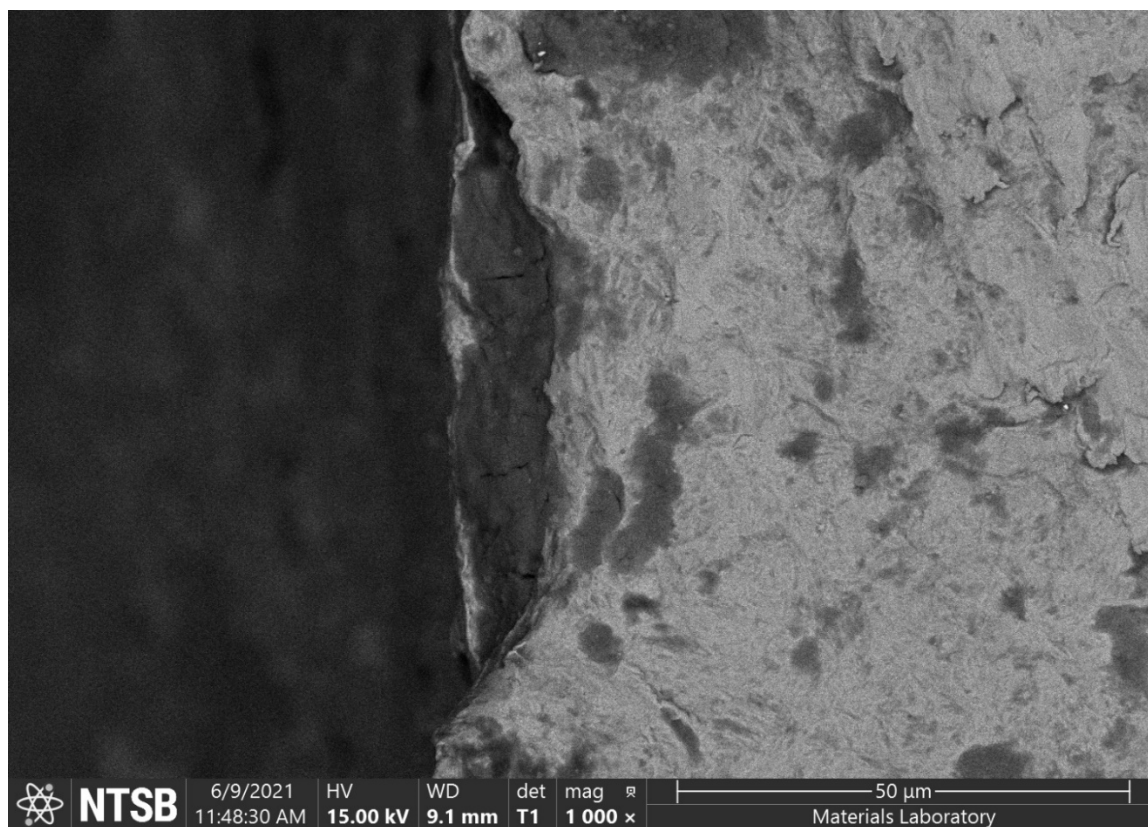
These features were consistent with corrosion pitting. Examination of the compounds within the pits using EDS found them to be consistent with iron oxides. The compounds also exhibited elements typical of salts, such as Na, K, and Cl. There was also cadmium present, consistent with a prior cadmium coating application.

Figure 20 – BE micrograph of a corrosion pit at the crack initiation site.

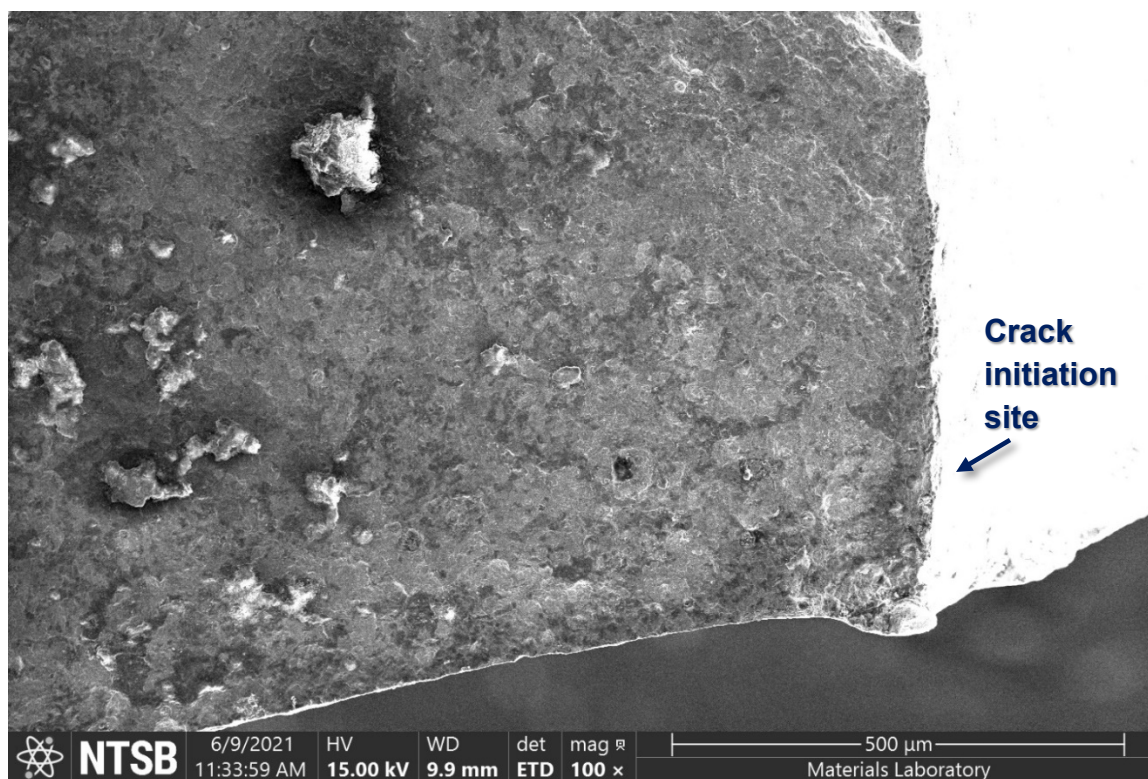
Figure 21 shows the crack initiation site on the opposite, or left facing, fatigue crack. While closer to the inner surface of the strut piston, the initiation site was also located along the bore. This initiation site exhibited a feature consistent with a corrosion pit at this crack initiation site. Similar to the right side thumbnail crack, the left side crack exhibited fatigue striations. This fatigue crack also exhibited secondary cracks, as shown in Figure 22, in addition to pit-like features on the fracture surface. These pits were consistent with post-cracking corrosion of the fatigue crack, which had been cleaned off prior to examination in the SEM.

Figure 21 – View of the outer edge corner of the left fatigue crack, showing a crack initiation site.

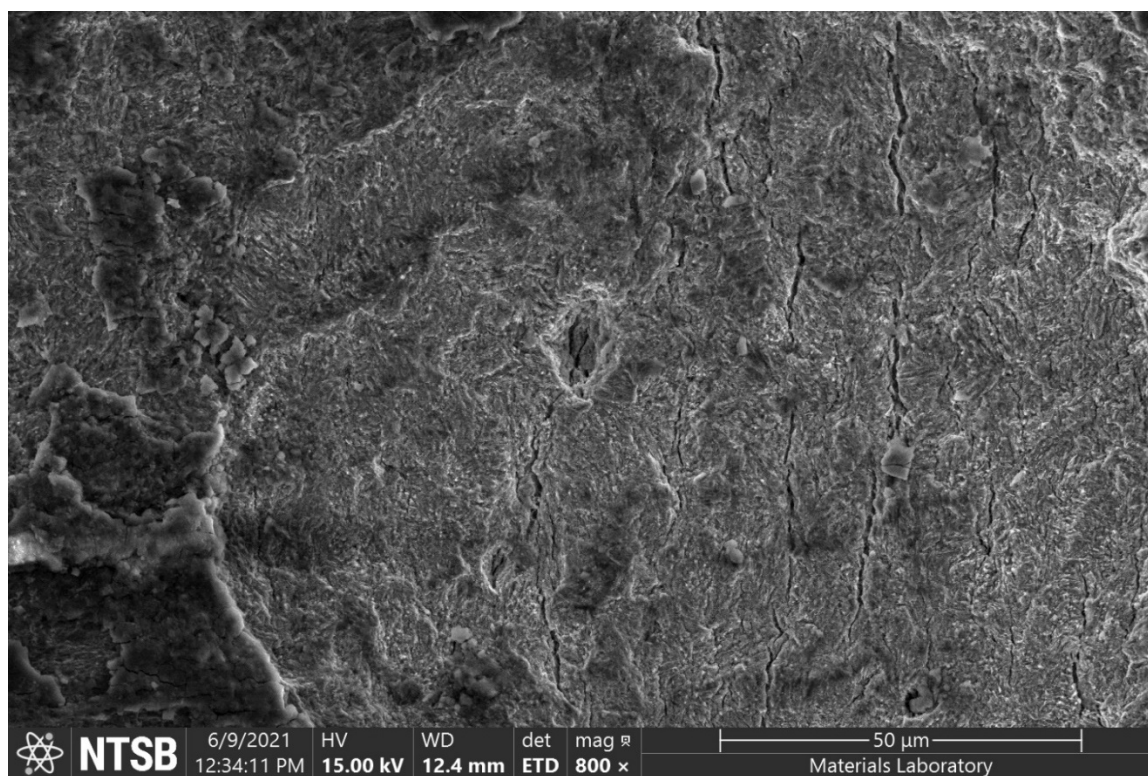
Figure 22 – View of a typical area of the left fatigue crack, showing secondary cracking and surface damage post-cleaning.
