# NATIONAL TRANSPORTATION SAFETY BOARD

## MATERIALS LABORATORY FACTUAL REPORT

Report No. 21-048

Place : Redmond, Oregon  
Date : February 7, 2021  
Vehicle : Piper PA-44-180, N125MG  
NTSB No. : WPR21LA117  
Investigator : Fabian Salazar, AS-WPR

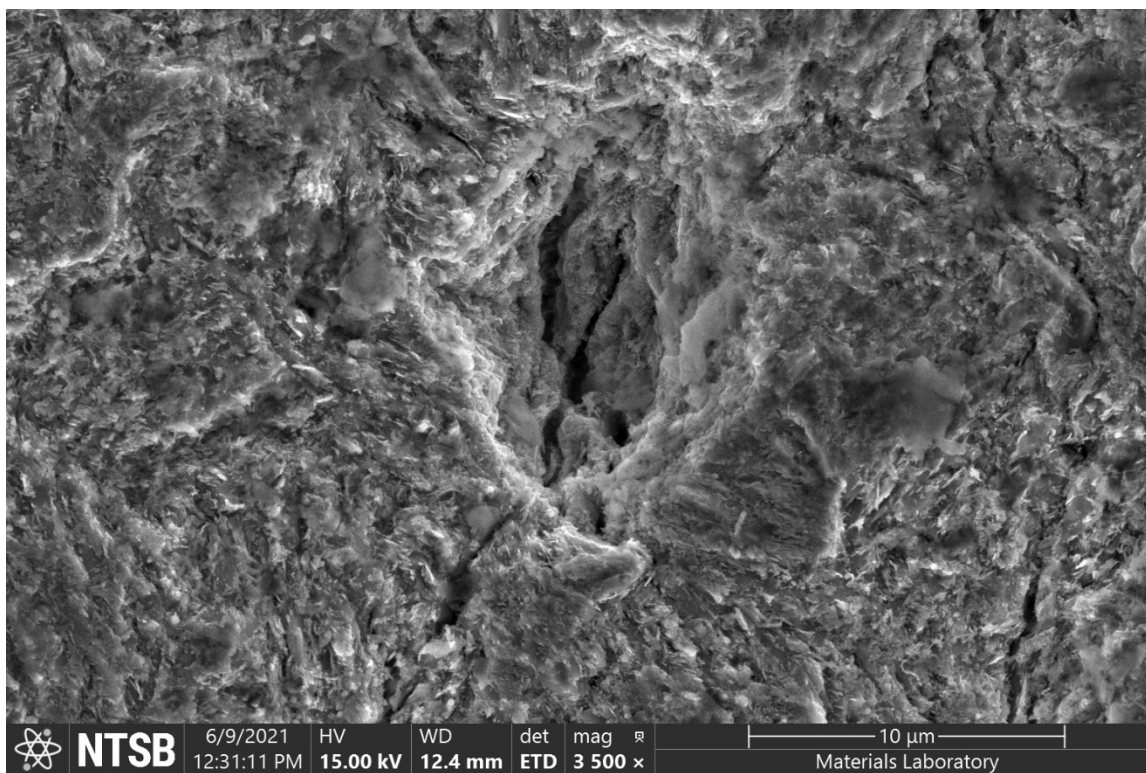
Figure 23 – SE micrograph of a closer view of the secondary crack and surface pit in Figure 22.

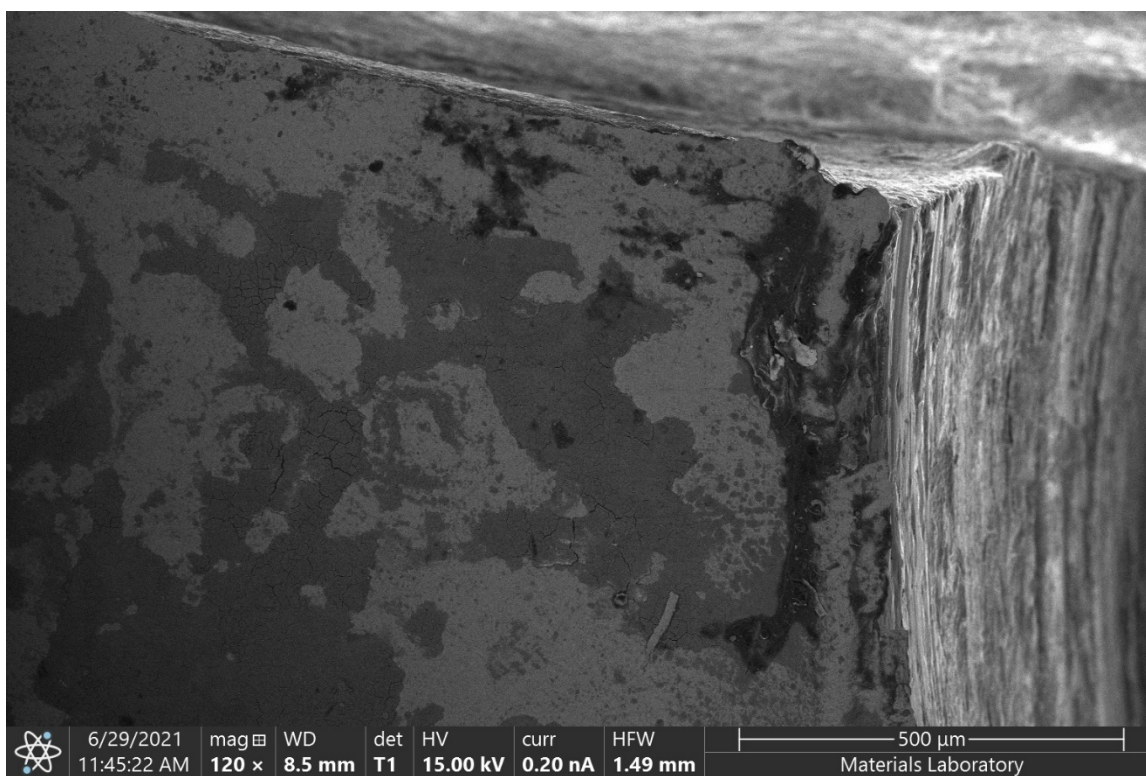
Examination of the inner surface of the piston found widespread areas of corrosion products, as illustrated in the darker gray and black areas in Figure 24. The inner surface showed alternating areas of bare steel and iron-based oxides, as demonstrated by the x-ray maps in Figure 25. The x-ray maps also discovered sporadic areas of cadmium remnants near the edge with the bore. A faint chromium response was observed in the bolt hole bore. The edges with corrosion pits were exemplified by areas of high Na and K.

Figure 24 – BE micrograph of the inner cylinder surface at the right fatigue crack edge corner.

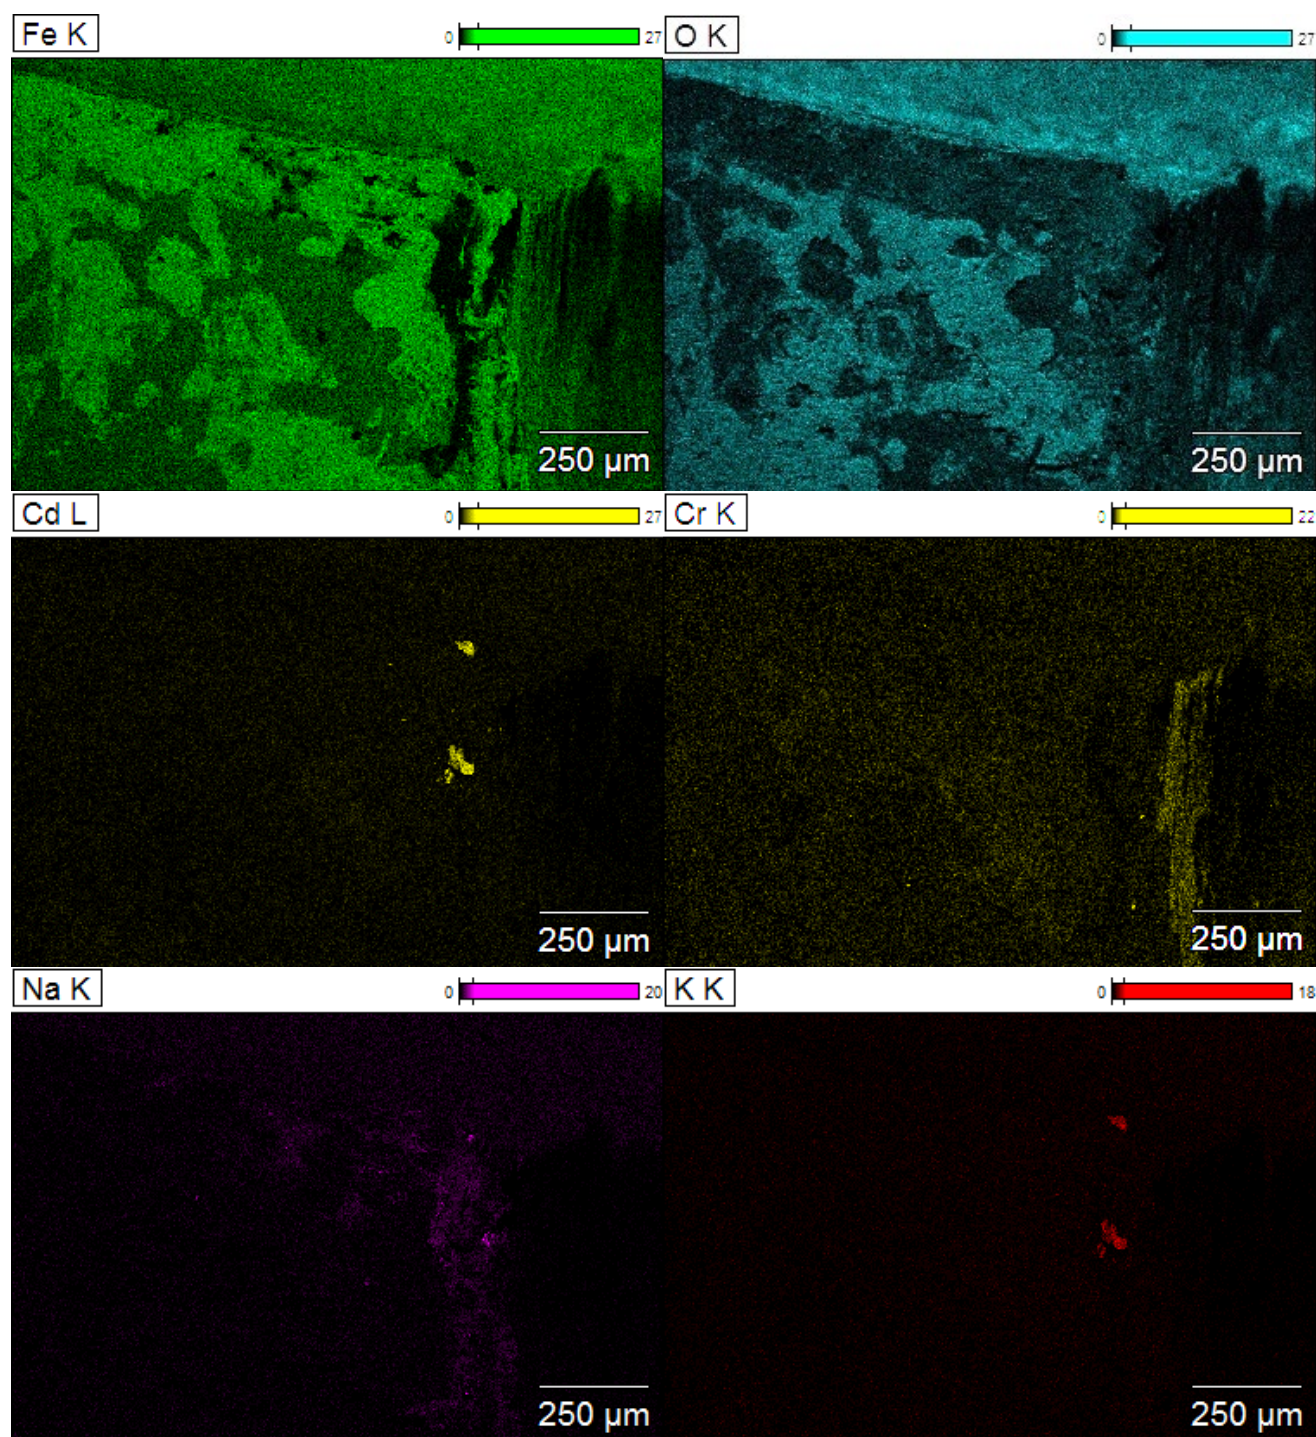
Figure 25 – X-ray maps from EDS scans of Figure 24, showing relative concentrations of Fe, O, Cd, Cr, Na, and K.

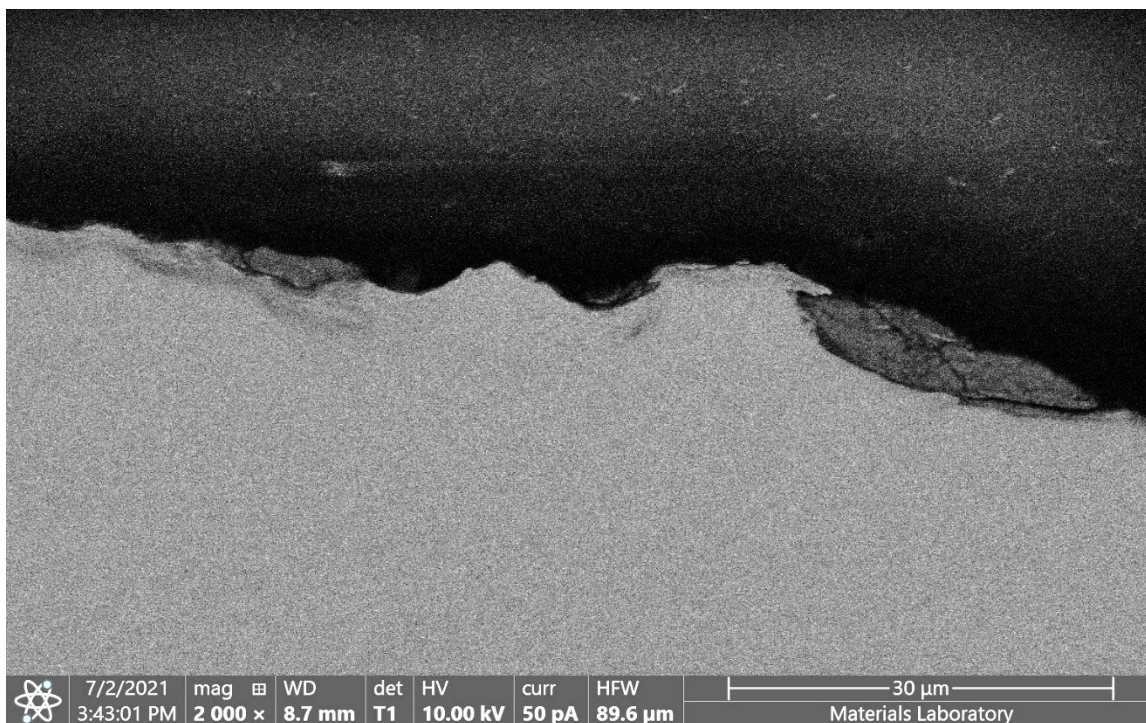
The piston bore was cross sectioned, mounted, and polished for metallographic examination. Several areas exhibited pits containing corrosion compounds, as typified in Figure 26. Examination of these compounds using EDS found compositions consistent with iron oxides, along with Na and K. Figure 27 also shows an area with some shallow cracking near the surface associated with a corrosion pit.

Figure 26 – BE micrograph of a cross section through a corrosion pit.

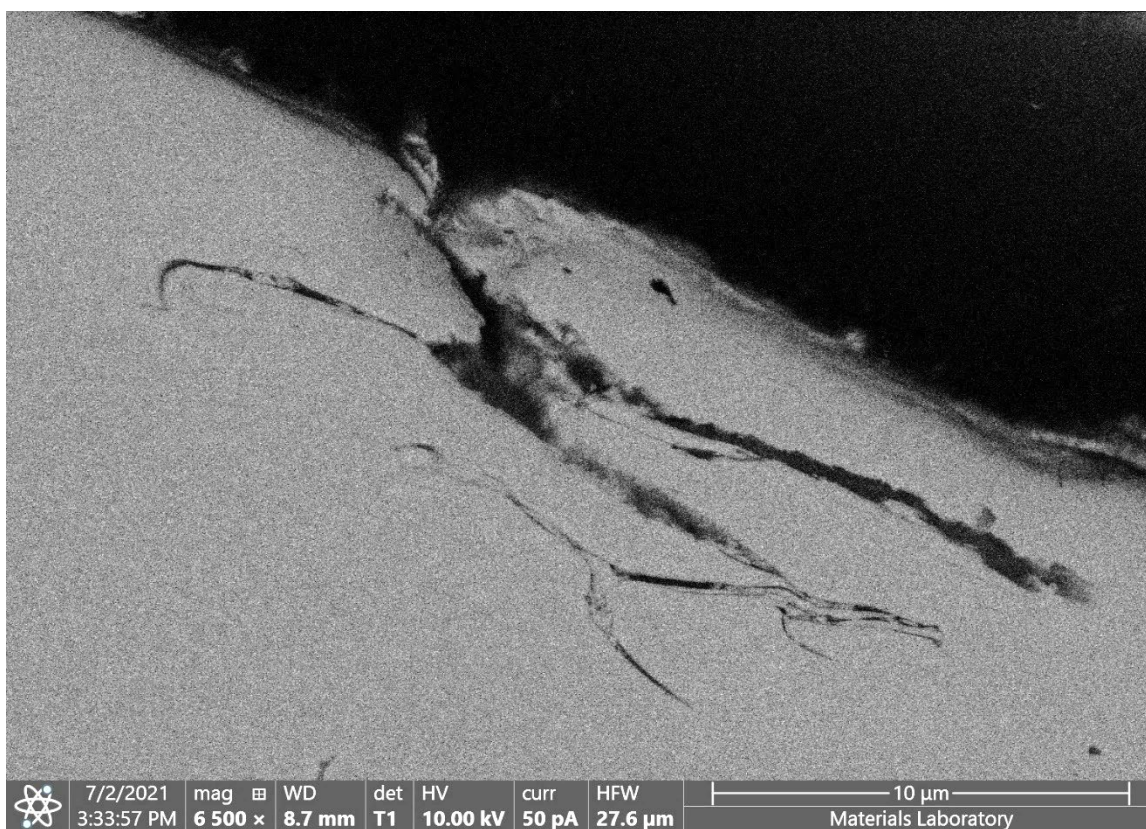
Figure 27 – BE micrograph of a cross section through a small surface crack.

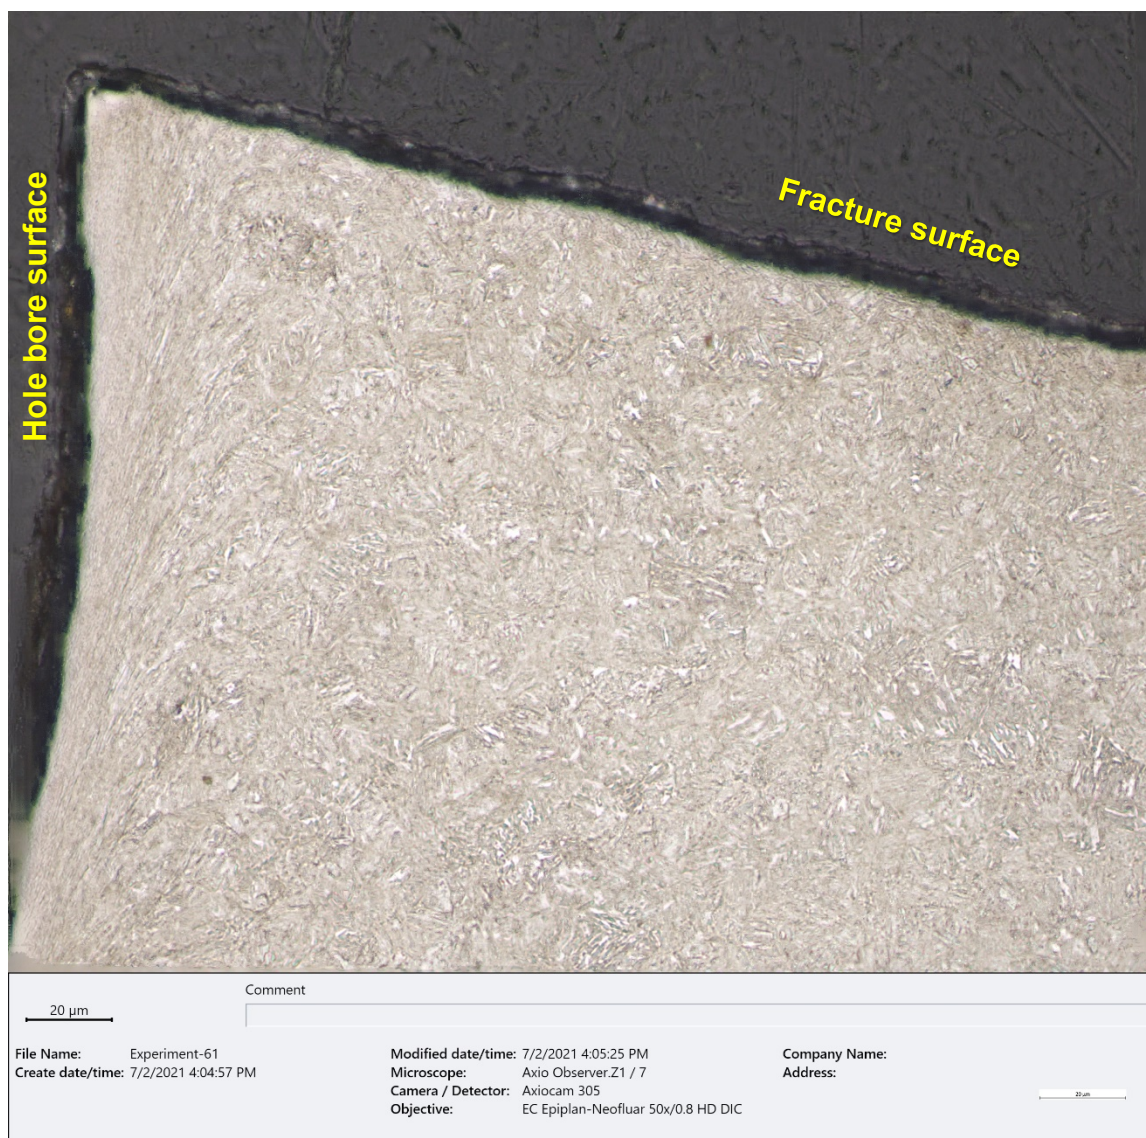
The polished cross section was etched using a 2% Nital solution, and the corner between the fracture surface and the bore is illustrated in Figure 28. The material adjacent to the bore surface exhibited grain deformation and flow parallel to the bore surface, consistent with the effects of machining of the hole. The microstructure exhibited a tempered martensite microstructure, typical of this composition.

Figure 28 – Bright-field optical micrograph of the corner of the fracture surface against the fastener hole bore (etched 2% Nital, ~200X).

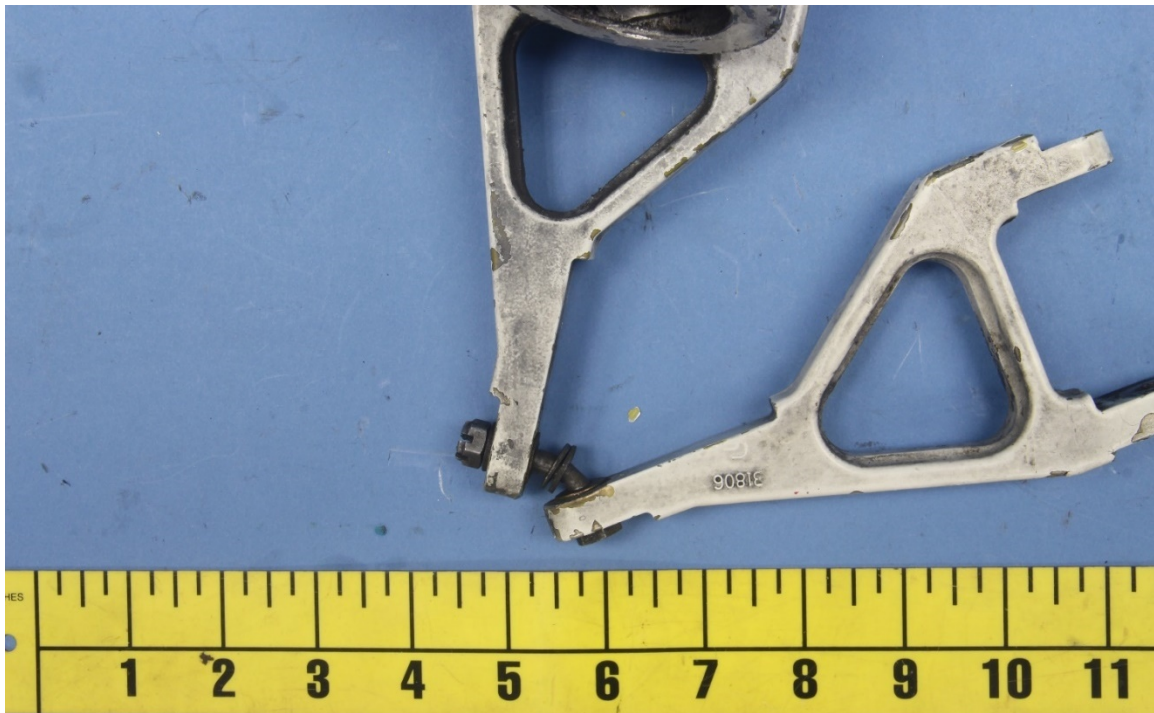
The only other component submitted that exhibited visible damage was the attachment bolt between the upper and lower torque links, pictured in Figure 29. These components attach to the forward side of the NLG assembly. The bolt was intact and still attached to the links. However, it was plastically deformed in bending, consistent with the excessive downward displacements typical of a landing gear collapse.

Figure 29 – View of a bent (but intact) attachment bolt connecting the two upper and lower torque links.
