# The Incident Statement

By Gamjae Han

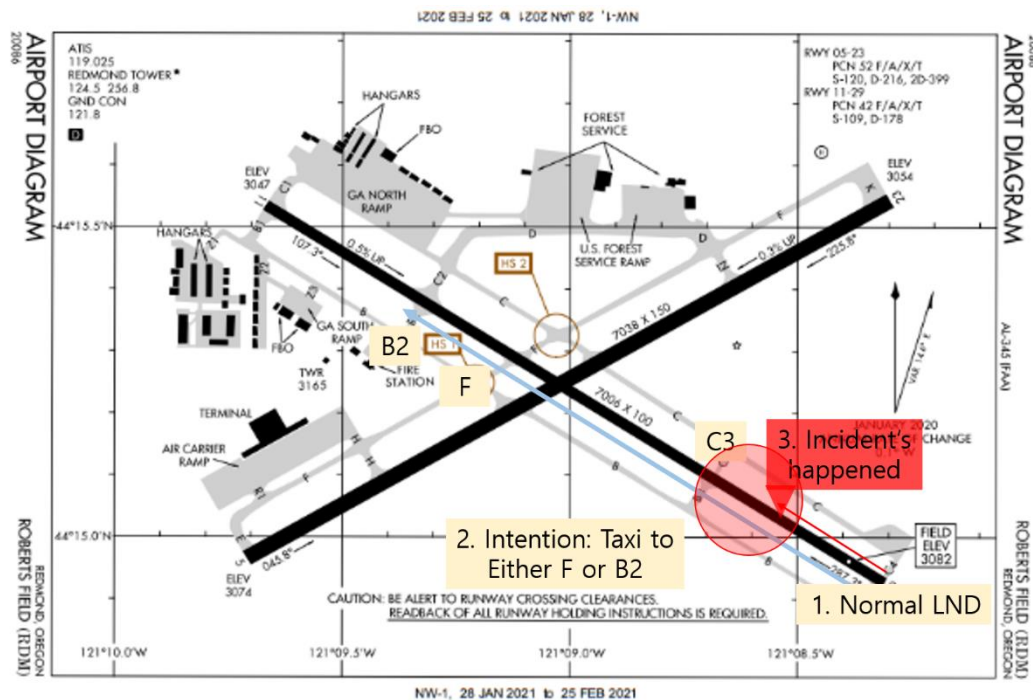
- (f) Normal LND, touch down near/on the thousand foot mark RWY 29 → Taxi → Feeling weirdness on the tire(drag); assuming flat tire → Experiencing yaw to the right side → Stopped between RWY 29 and Taxiway C3 → Contact the TWR to report flat tire and to inform the engine shut down → Check the right side and realized it was not due to flat tire

After local flight lesson, we were inbound to KRDM for full stop. The wind was 27013G17 at that moment and we had a clearance to land on RWY29. After touch down(no hard landing, no side landing), on the way to taxi expecting to turn either F or B2, we felt some drag at first and experienced yaw to the right side and then finally stopped between RWY29 and Taxiway C3. At first, we thought it was right side flat tire but after shutting down the engine we realized it was tilted to the right side and we had damage of the right side of prop and landing gear strut.
