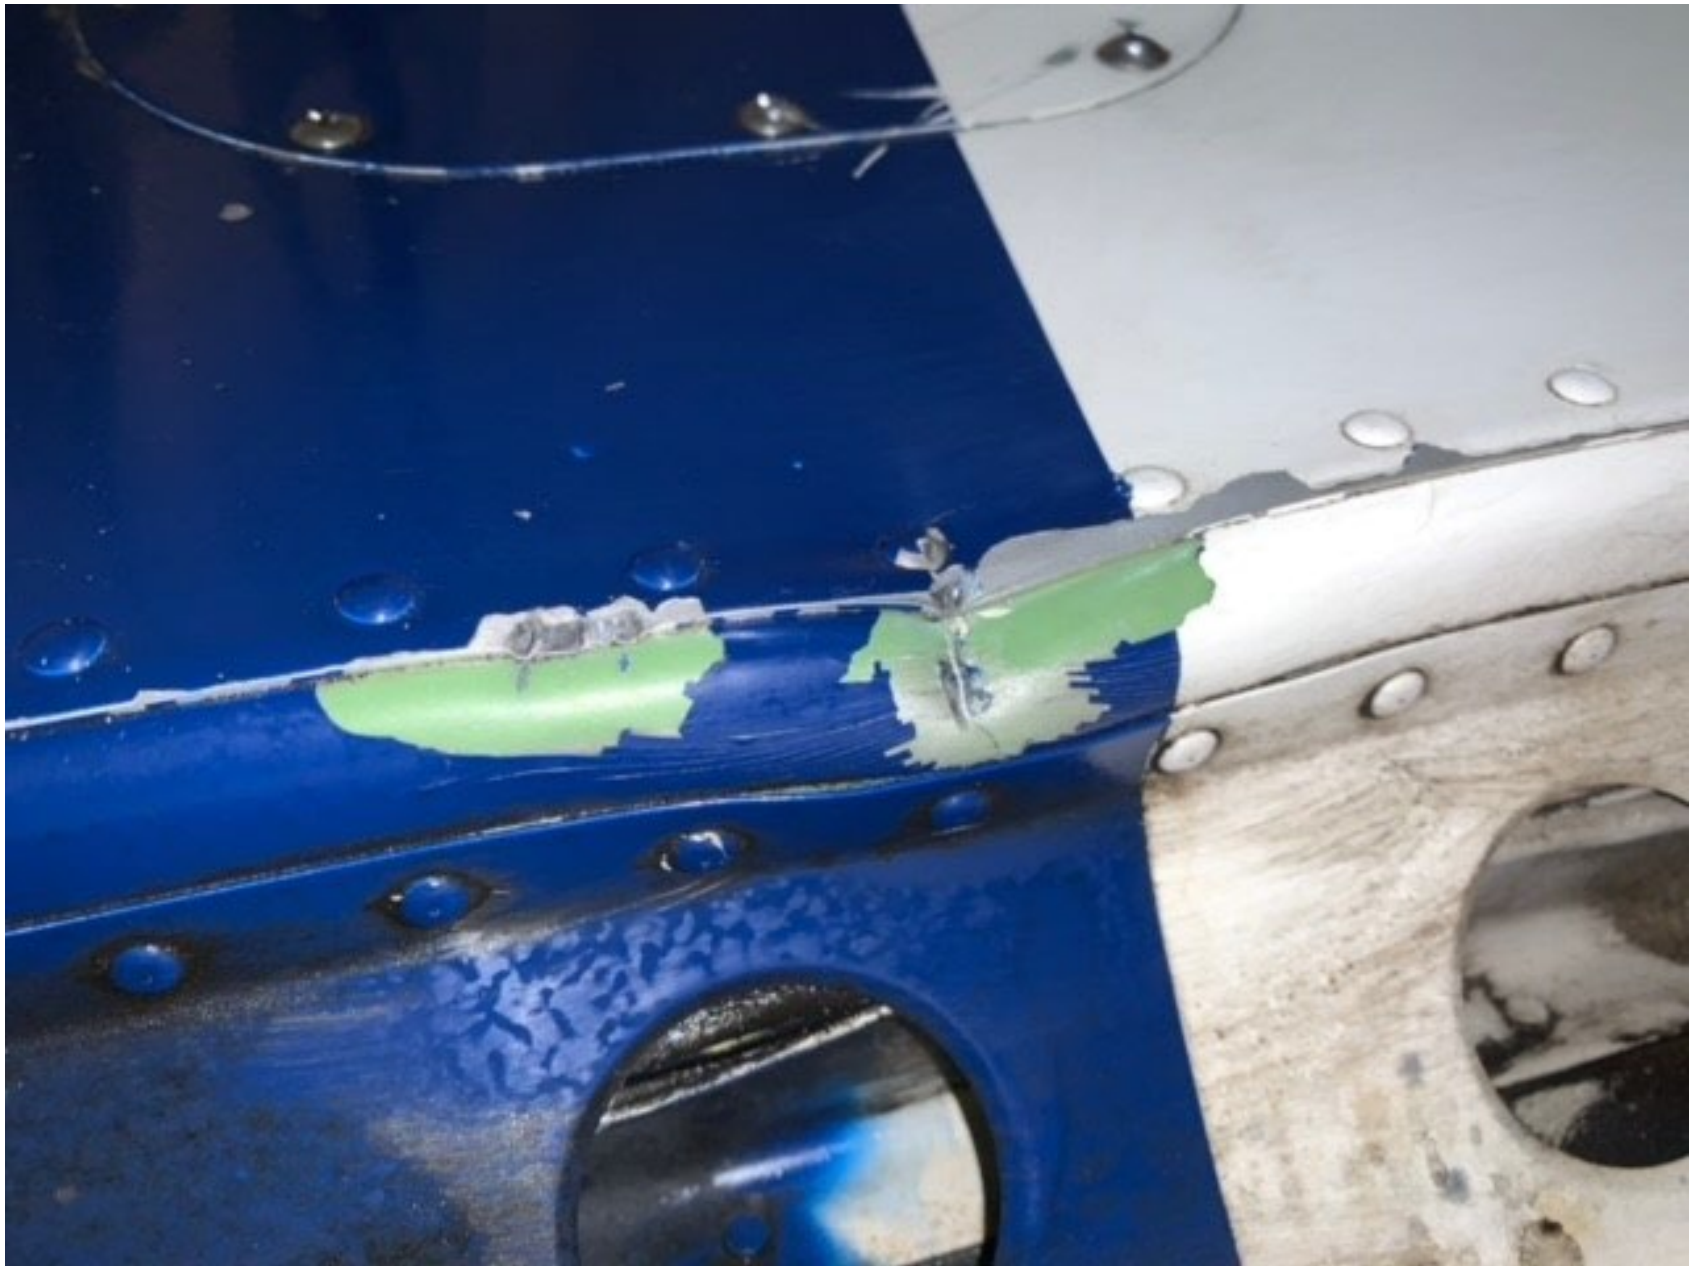
**Photo 1 – Underside view of the right wing showing substantial damage. Photo courtesy of the operator.**

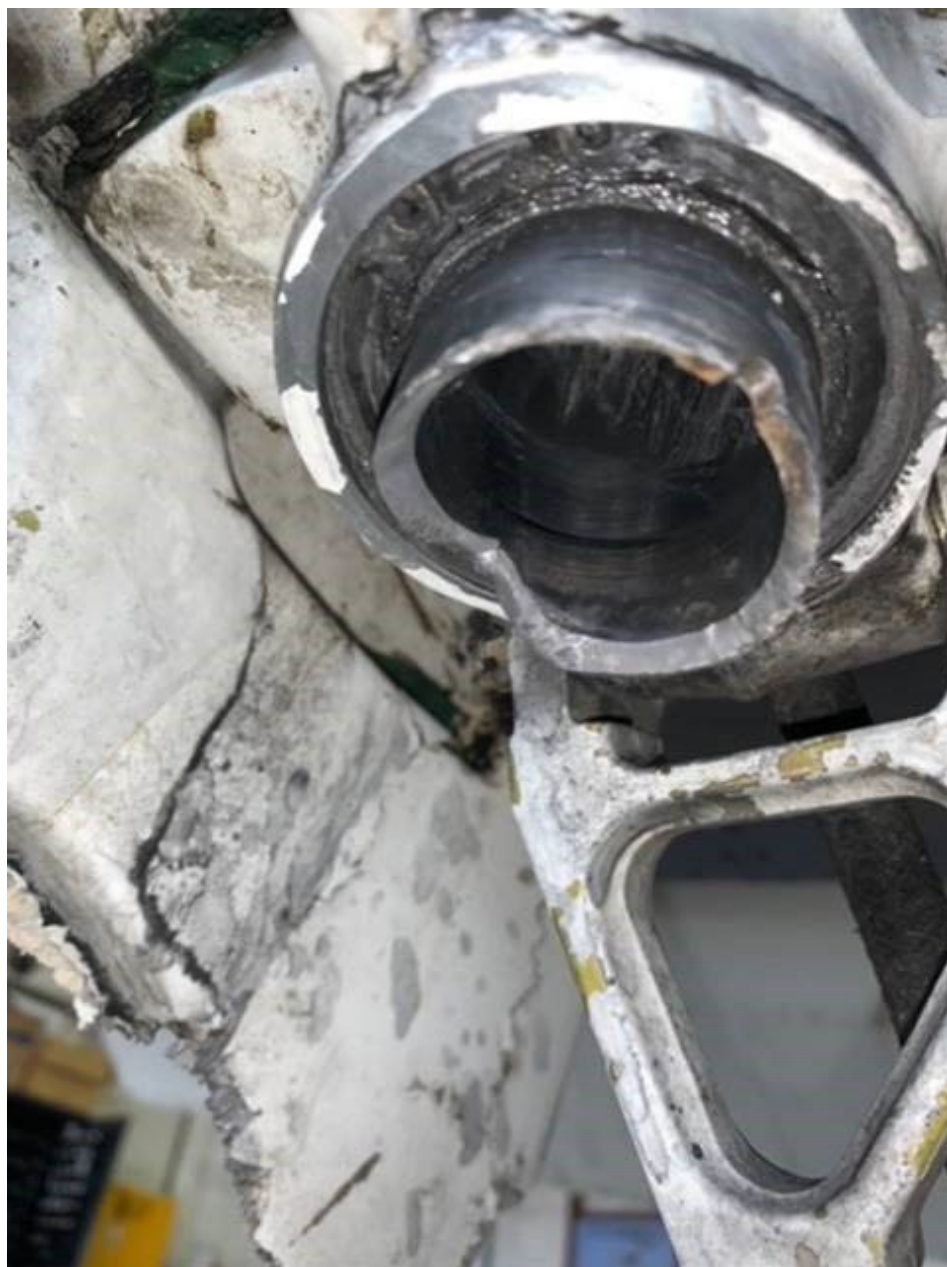
**Photo 2 – View of the failed landing gear strut. Photo courtesy of the operator**
