Piper Aircraft, Inc.  
2926 Piper Drive  
Vero Beach, FL, U.S.A. 32960

# SERVICE NO. 1263 LETTER

Date: December 23, 2020

**MAIN LANDING GEAR PISTON TUBE INSPECTION**

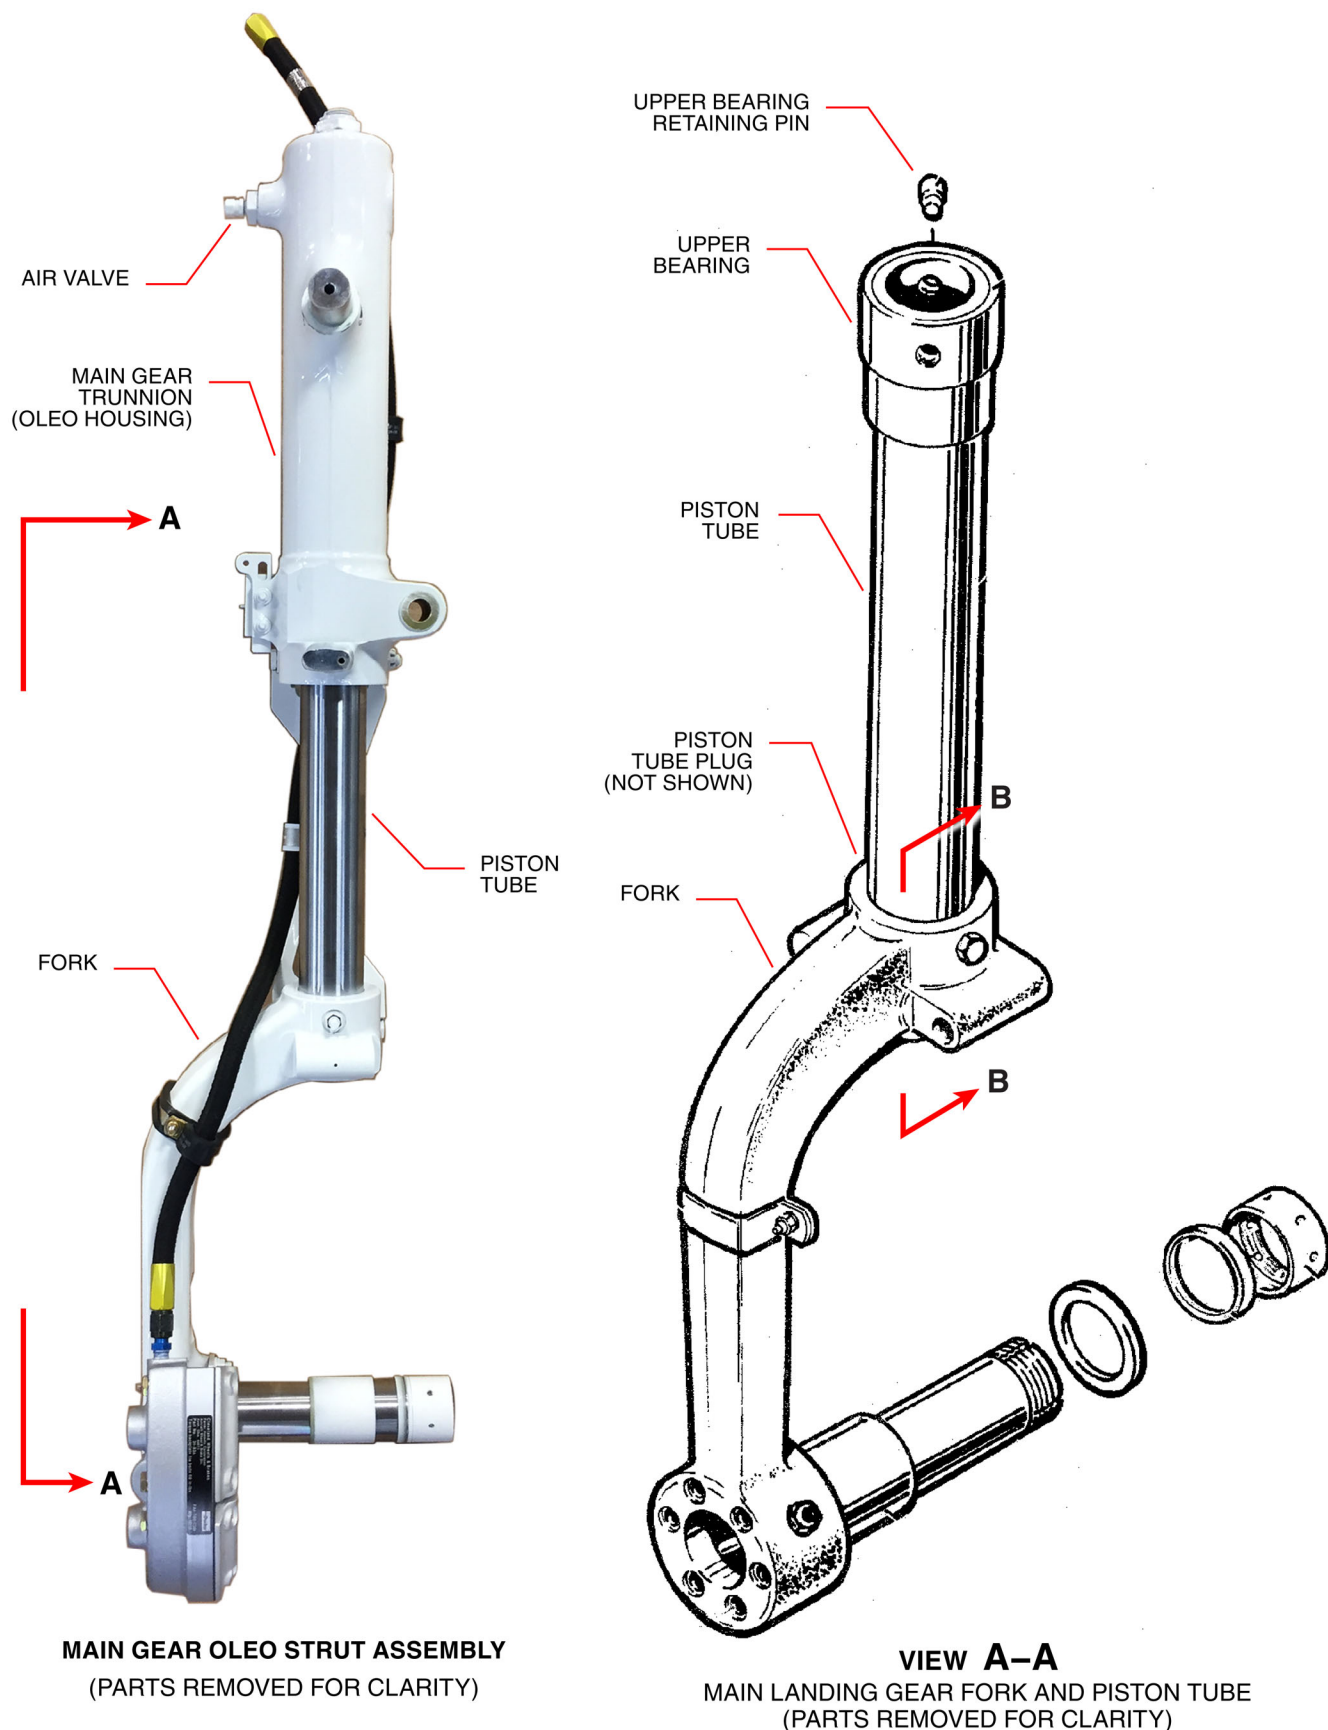
**Figure 1, Sheet 1 of 2**  
Main Landing Gear Strut Assembly

A review of service history reveals that fatigue cracks can develop in the main landing gear of the affected airplanes; specifically, at the bolt hole in the piston tube common to the fork. This service letter provides a schedule and instructions to inspect for cracks in the main landing gear.

- **If no cracks are found**, then proceed to Step 6.
  - **If any crack is found**, the main landing gear strut assembly must be replaced prior to next flight. Order and install a new Main Gear Strut Assembly, Piper part number (P/N) 67037-006. Upon completion, proceed to Step 7.
6. Reinstall the bolt that was removed in Step 4. Torque to 50–90 in-lb.
  7. Service the oleo strut with fluid and nitrogen per Chapter 12 of the applicable Piper AMM.
  8. Check main gear alignment and gear operation per Section 32-10-00 of the applicable Piper AMM. Confirm that the gear is down and locked.
  9. Remove the airplane from jacks.
  10. Make a logbook entry documenting compliance with this service letter.

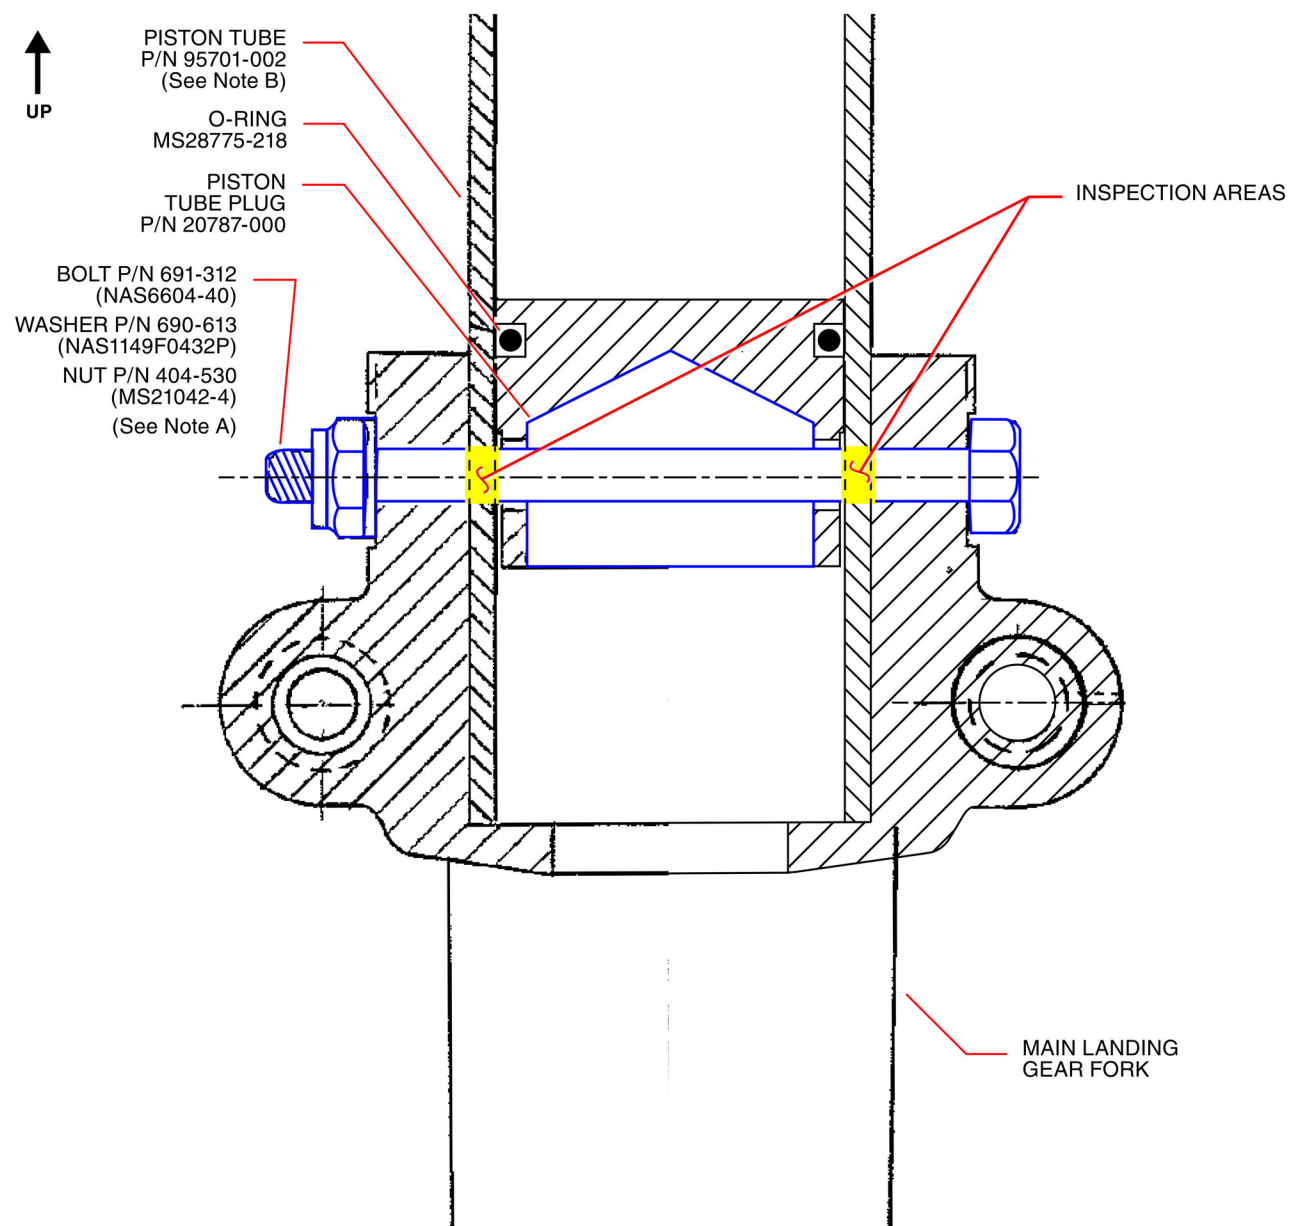
**Figure 1, Sheet 2 of 2**  
Main Landing Gear Strut Assembly

**VIEW B-B**  
FORK ASSEMBLY

**NOTE A:** Remove for inspection. For reinstallation, torque the nut to 50–90 in-lb.
