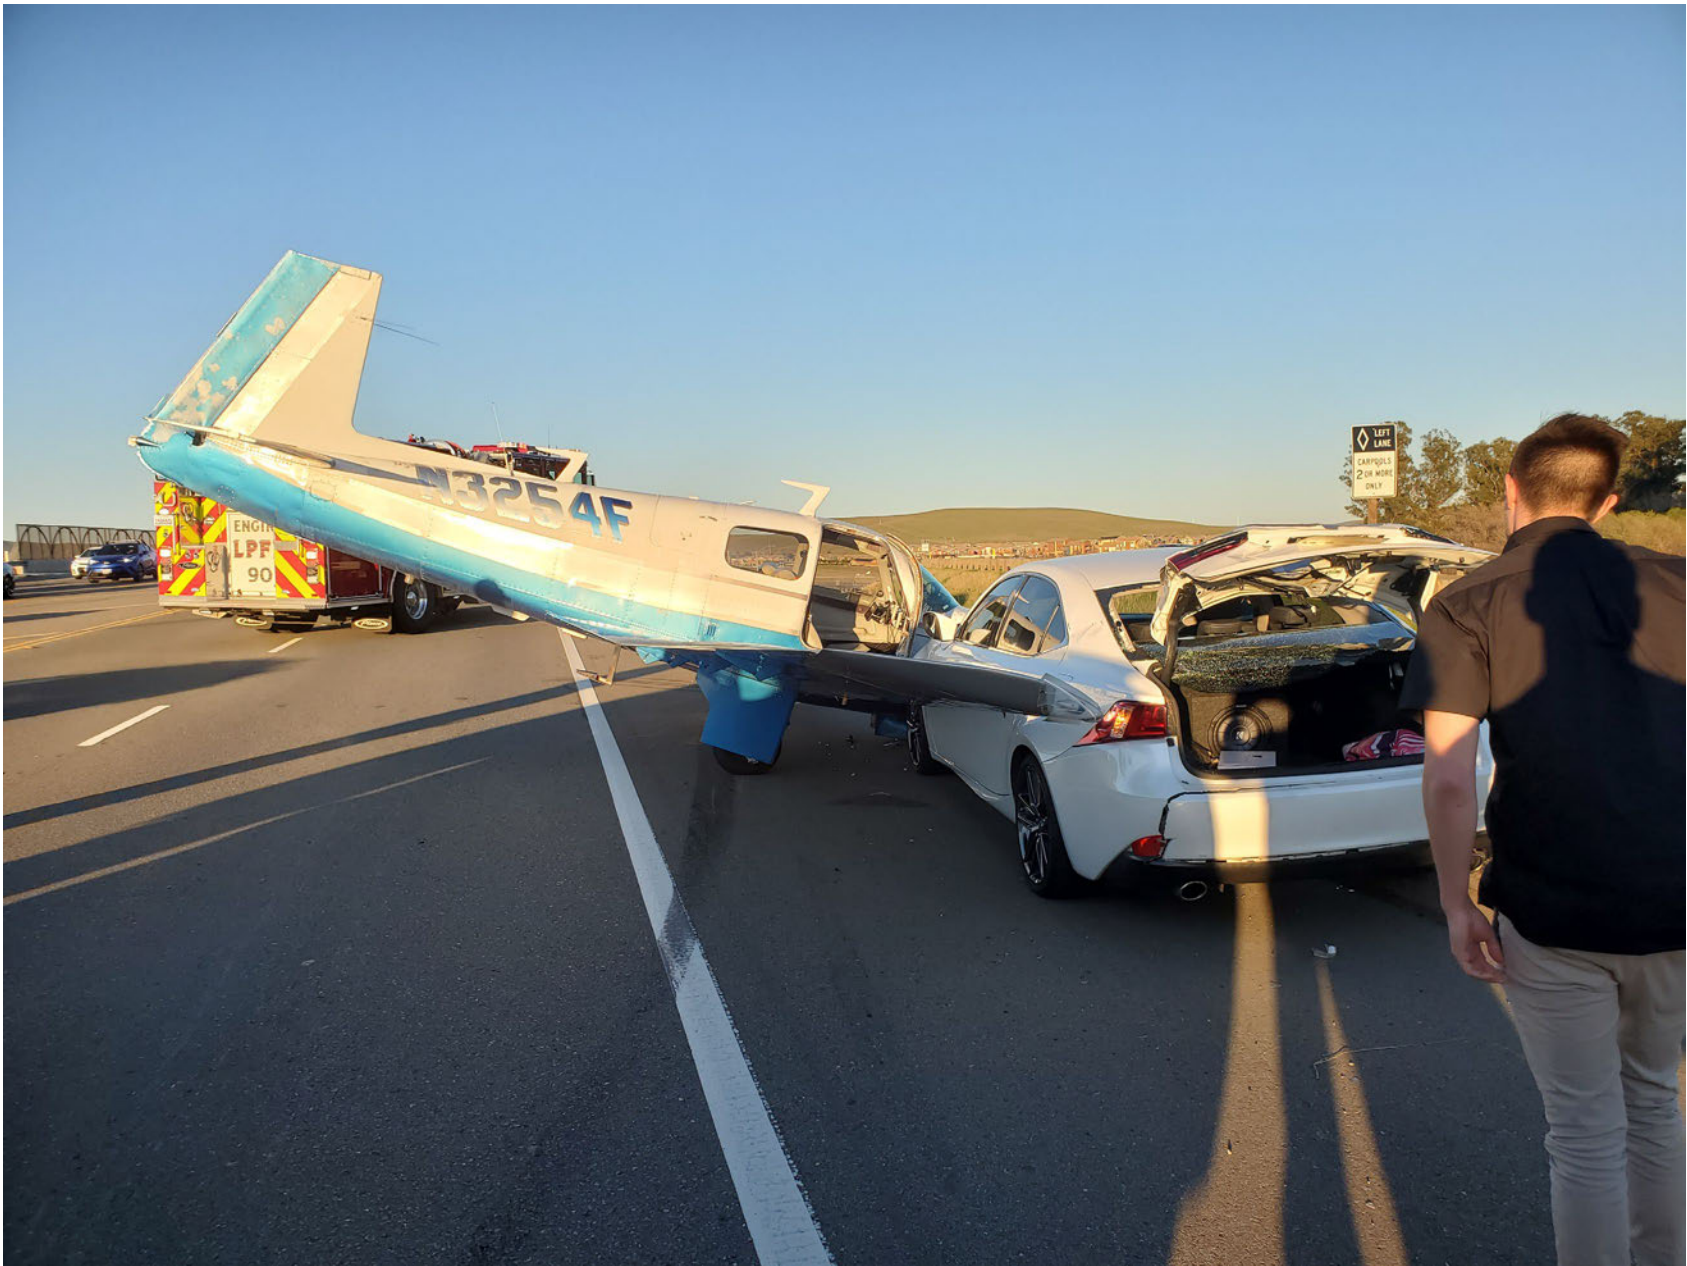
**Photo 1 – Accident site shows the right side of the airplane with the car against it. (Photo Courtesy of Livermore Airport Operations)**

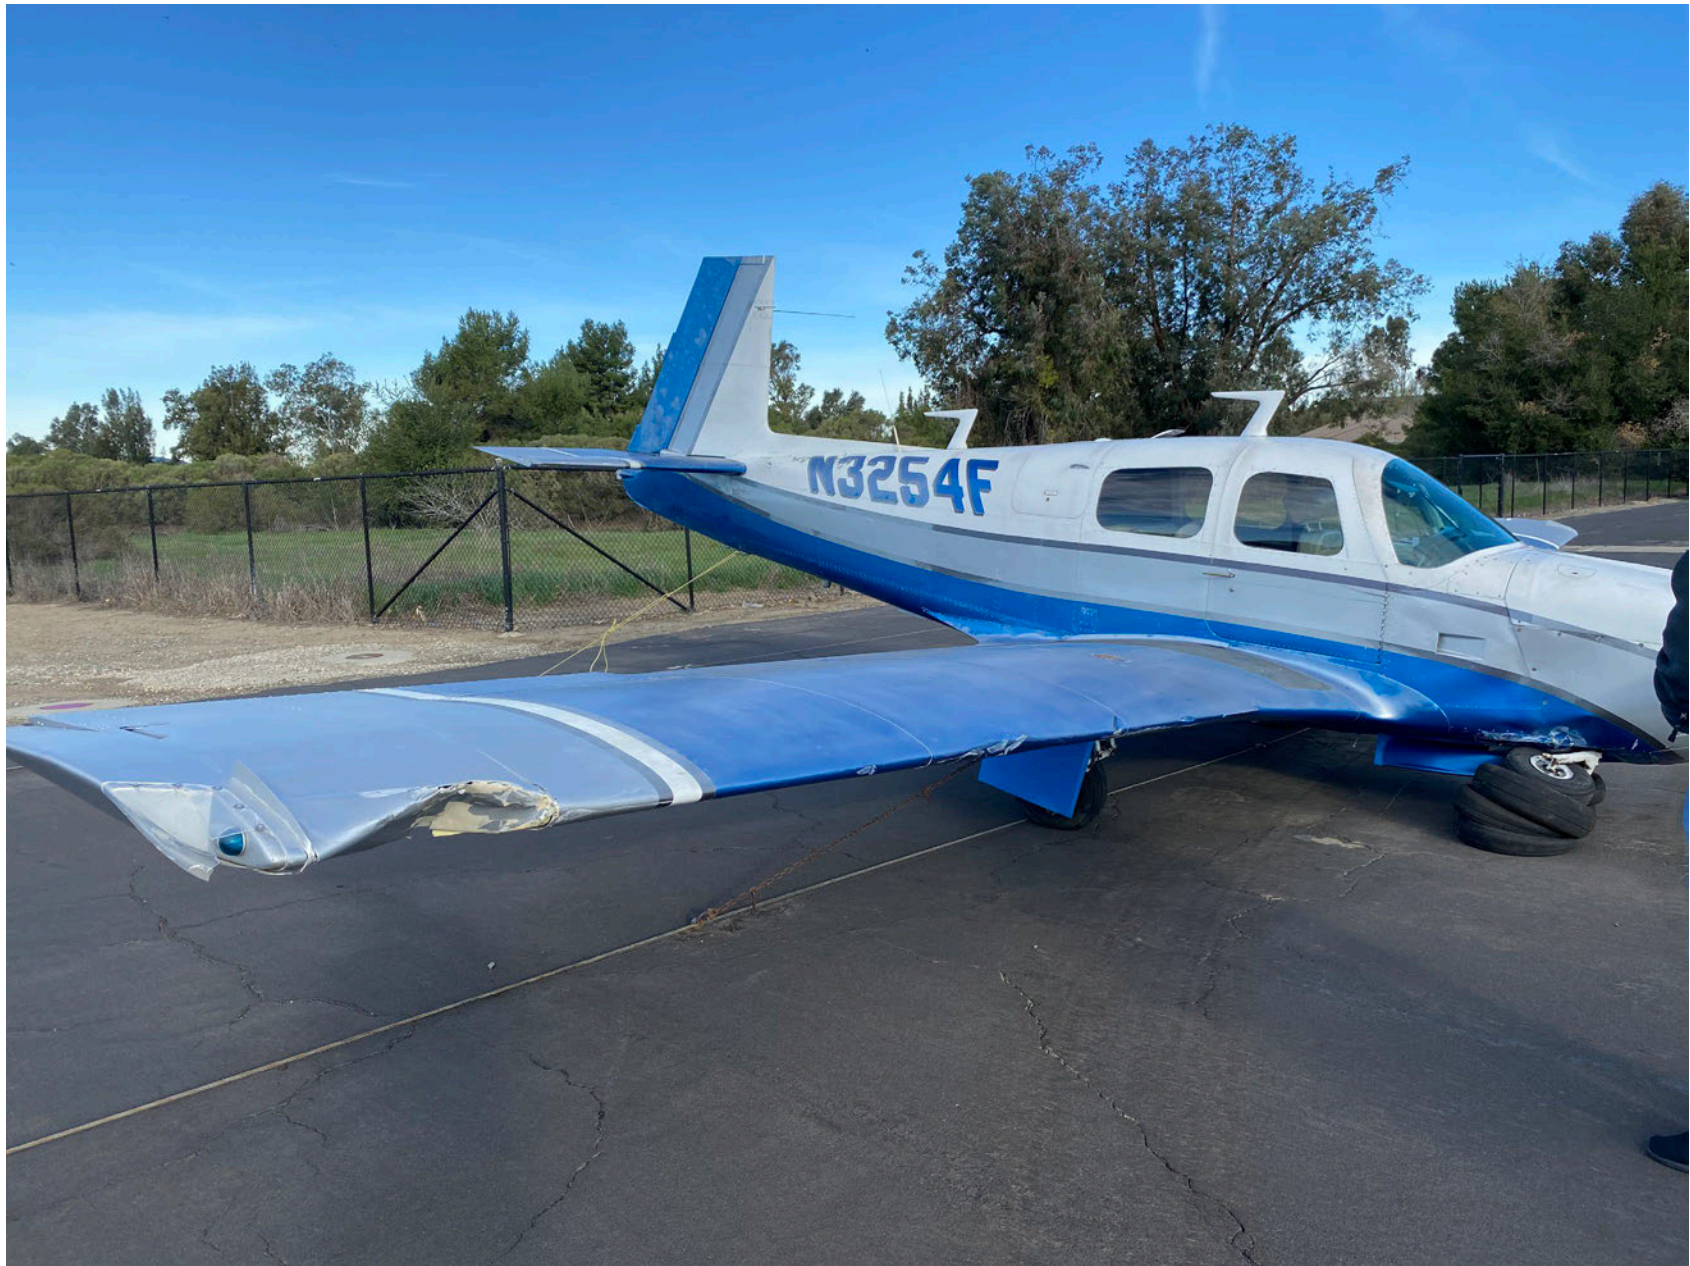
**Photo 2 - Right Side of Airplane with damage to the wing tip and length of the wing. (Photo Courtesy of FAA)**
