## **NATIONAL TRANSPORTATION SAFETY BOARD**

### **FUEL SERVO EXAMINATION**

**WPR21LA119**

| Aircraft: | Mooney, M20E, N3254F |

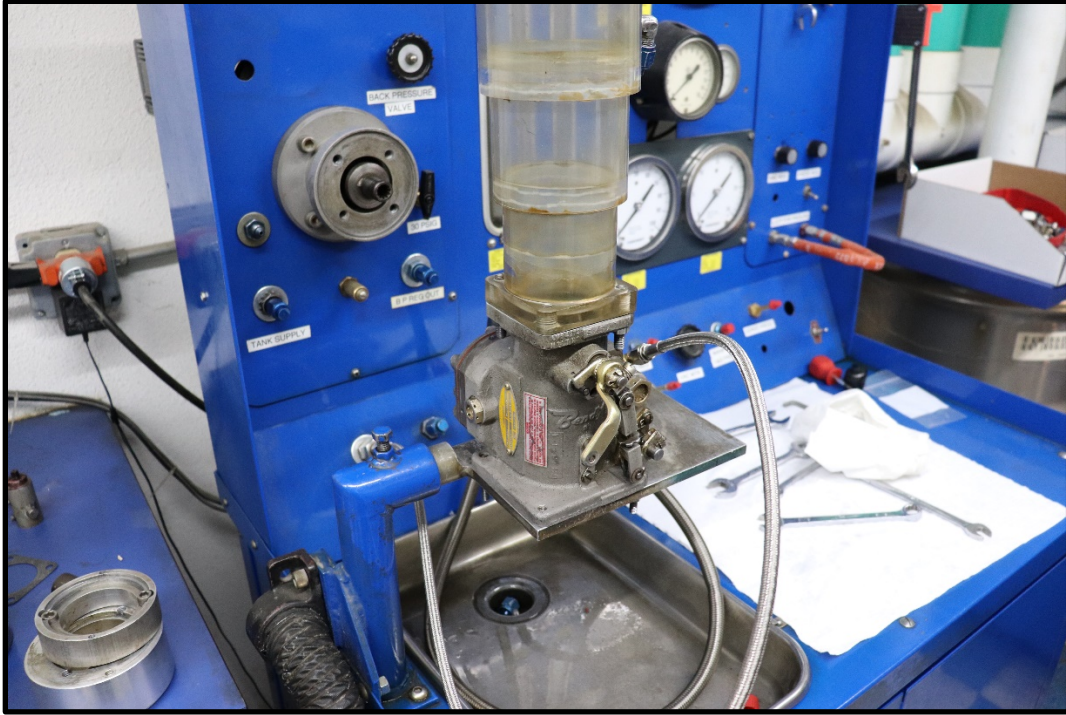
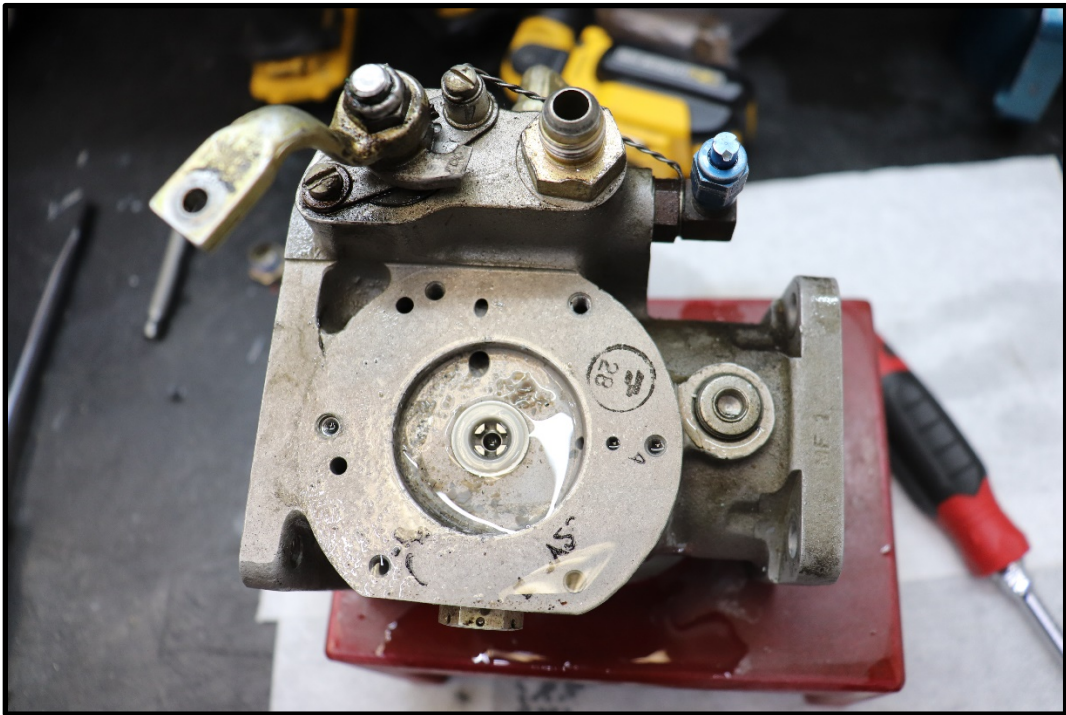
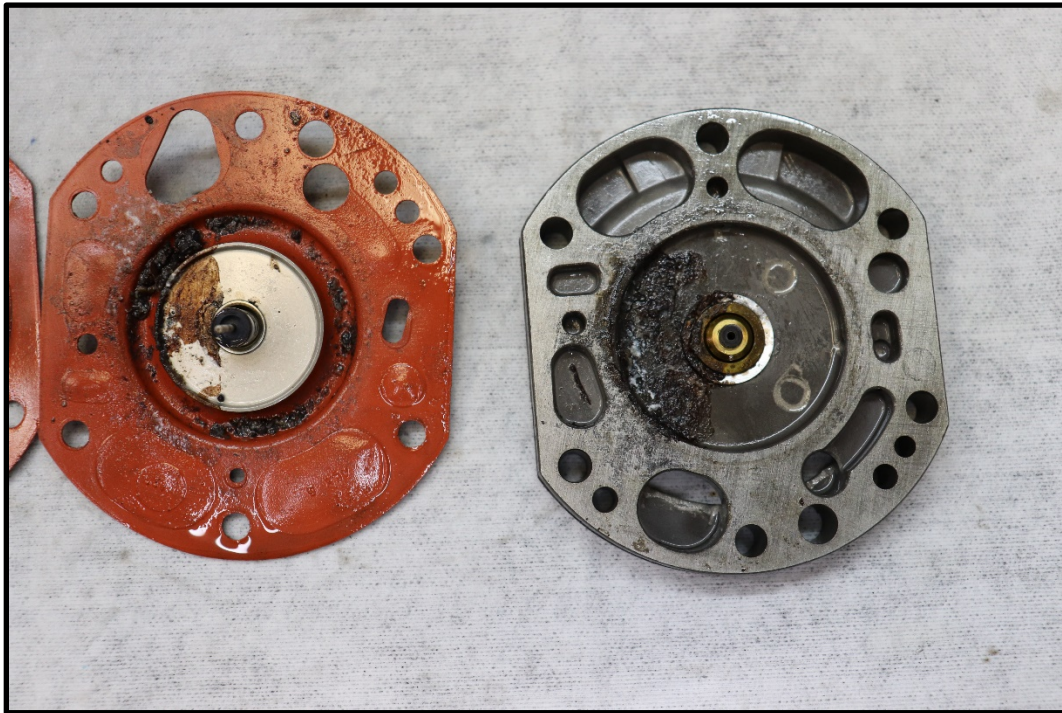
The fuel servo was connected to a test stand, and a functional test was attempted; however, no fuel flowed through the servo during the flow test. The fuel servo was removed from the test stand and disassembled. Extensive corrosion and debris were observed in the regulator center body and diaphragm assembly, which prevented normal operation. As a result of the corrosion in the regulator center body further functional tests were not possible.
