# NATIONAL TRANSPORTATION SAFETY BOARD

## MATERIALS LABORATORY FACTUAL REPORT

Report No. 22-018

Place : Lodi, California  
Date : March 3, 2021  
Vehicle : Cessna 150J  
NTSB No. : WPR21LA121  
Investigator : Stephen Stein

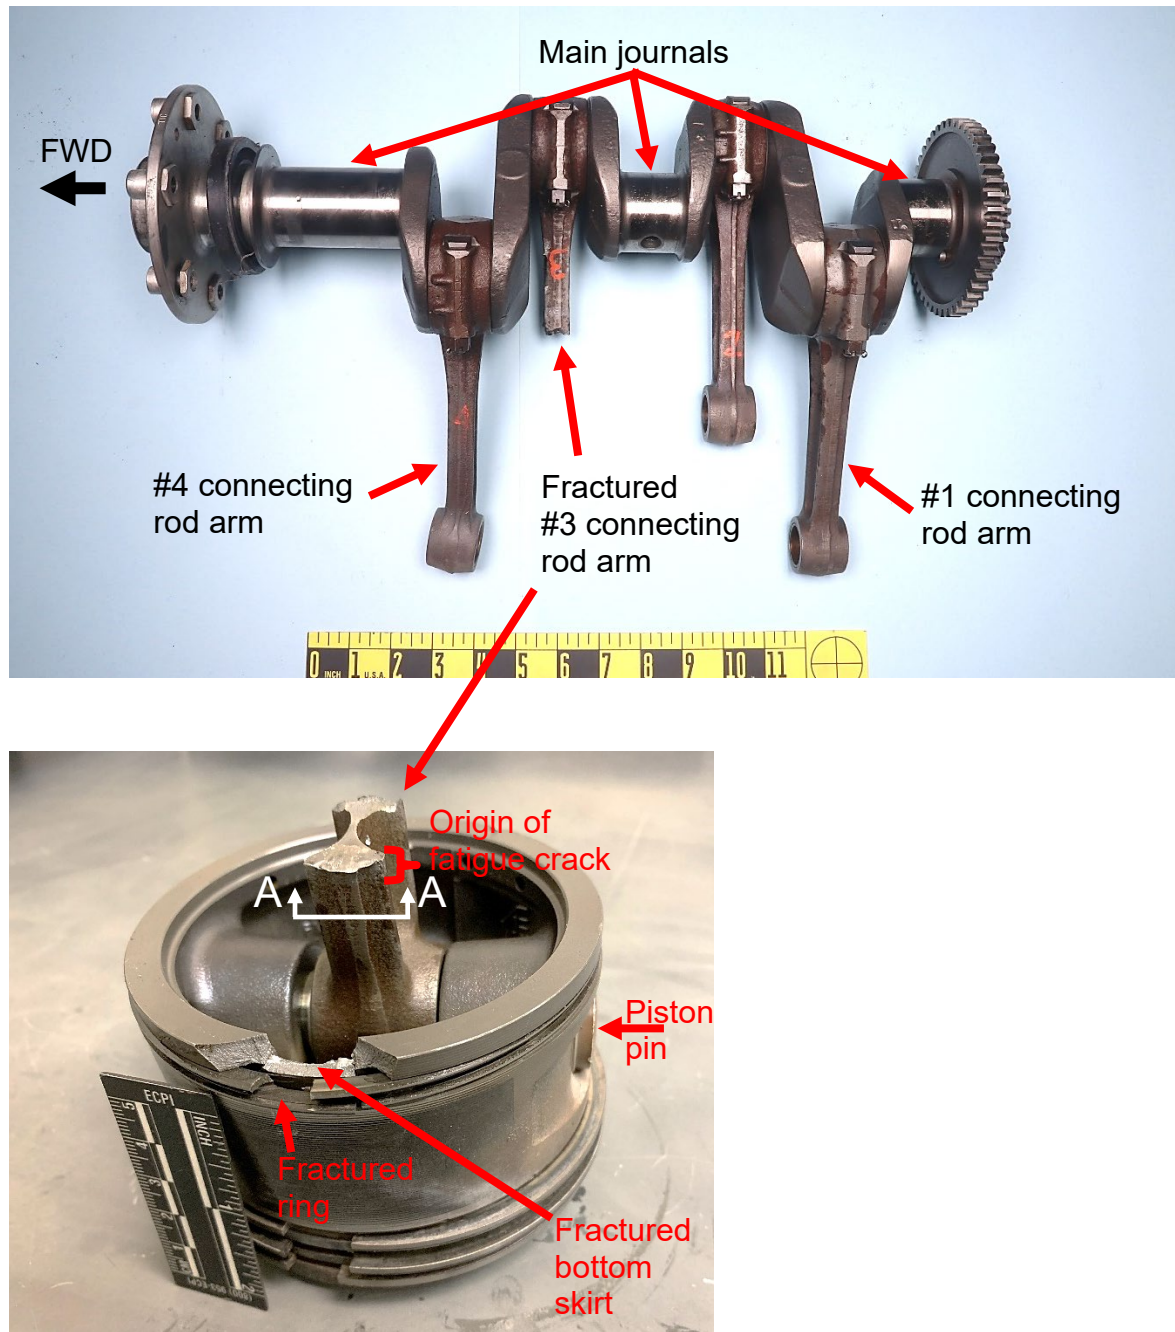
Bench binocular microscope examination of the #3 connecting rod arm revealed the fracture face exhibited crack arrest marks typical of fatigue cracking that emanated from one corner of the arm in the area indicated by a bracket in figures 1, 6, and 7.<sup>2</sup> A large portion the fatigue crack region contained mechanical damage that obliterated major portions of the fatigue crack features. The origin of the fatigue crack exhibited no evidence of mechanical damage, such as a gouge. The surface texture of the arm appeared to be consistent with a shot peened surface. The fatigue crack extended through approximately 40 percent of the arm cross section and terminated in the area indicated by a dashed line in figure 6. The area outside of the fatigue region and the fractures from the remaining parts exhibited coarse texture fracture features on a slant plane consistent with overstress separation.

A cross section was made through the #3 connecting rod arm in the area indicated by section line "A-A" in figure 1. The prepared cross section was etched with 2% Nital reagent. Examination of the section revealed the arm contained a microstructure of tempered martensite with no evidence of a decarburizing layer at the surface.

Figure 1. As-received crankshaft with fractured #3 connecting rod arm (top of page); and mating fracture of the #3 connecting rod arm (bottom of page). The #3 connecting rod arm fractured approximately 1 inch from the piston pin boss area.

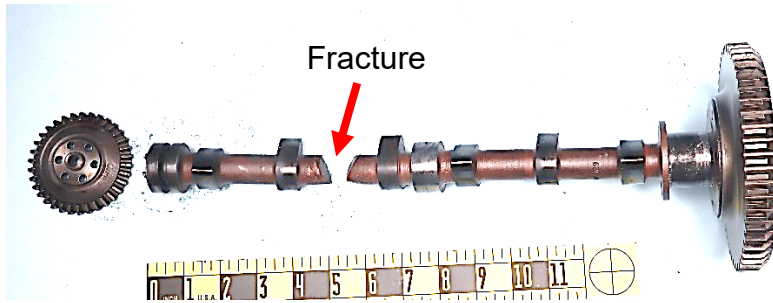
Figure 2. As-received fractured camshaft.

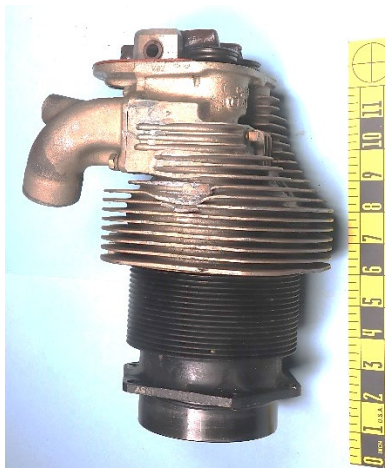
Figure 3. As-received #3 cylinder. Push rods are in the background and are not visible.

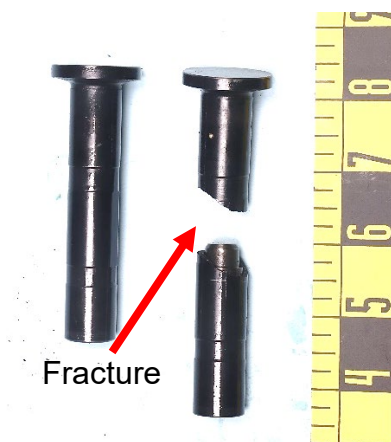
Figure 4. As-received tappets for the #3 cylinder. One of the tappets fractured at the shank portion.

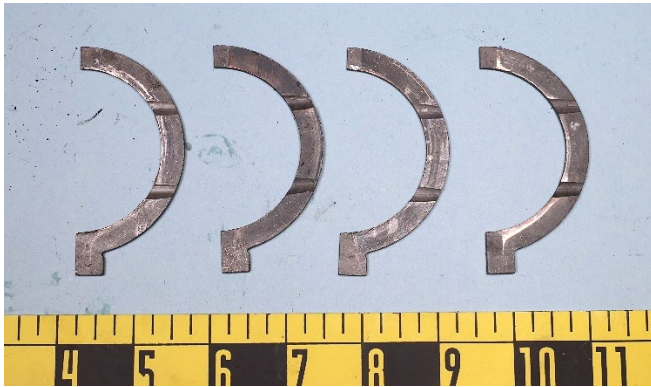
Figure 5. As-received thrush washer halves.

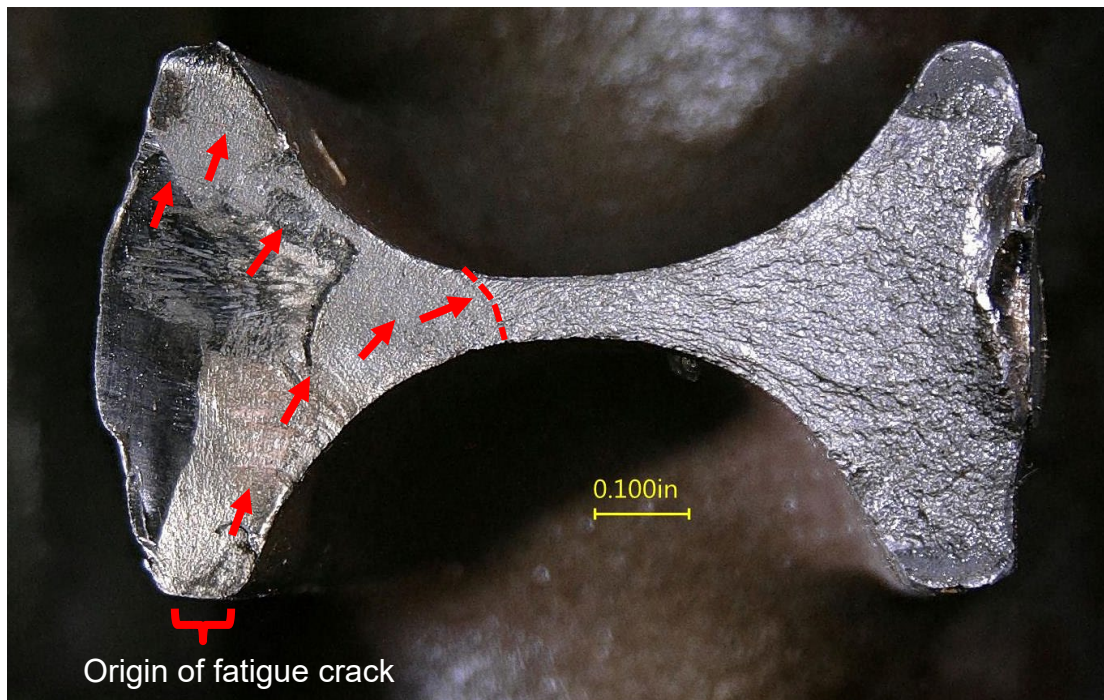
Figure 6. Fracture face from the #3 connecting rod arm (view looking at the piston side of the fracture face). A fatigue crack emanated from the bottom left corner. Fatigue propagation was in the general direction indicated by arrows and terminated in the area indicated by a dashed line. The dark-luster region on the left of the photograph is post-fracture impact damage.

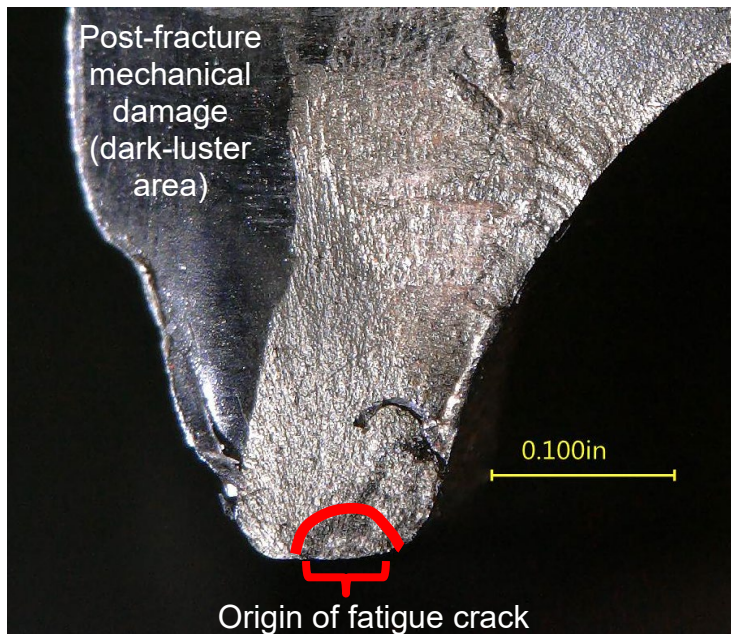
Figure 7. Close-up photograph of the fatigue crack origin area. A semi-spherical dark tinted band is located outside of the origin in the general area indicated by a solid line.

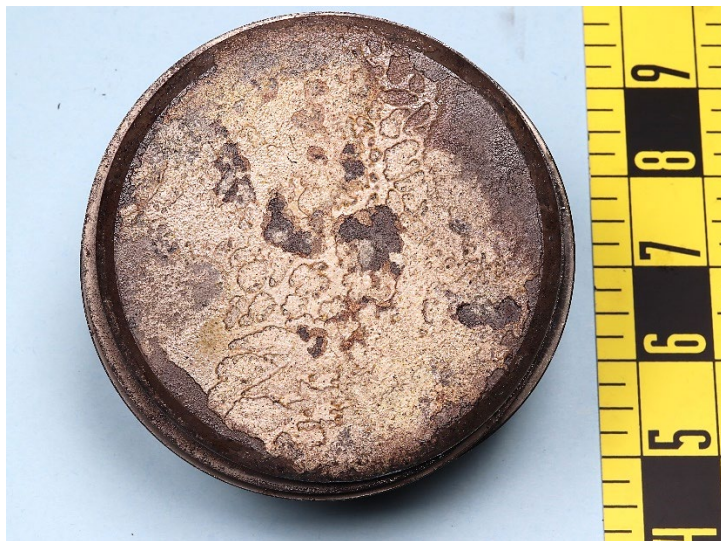
Visual examination of the #3 piston revealed the outer crown portion contained evidence of heavy combustion deposits (see figure 8) and the internal surface of the corresponding cylinder in the general area of the spark plugs, intake and exhaust valves exhibited similar heavy combustion deposits (figure 9).

Figure 8. Photograph of the #3 piston showing heavy combustion deposits on the outer surface of the crown portion.

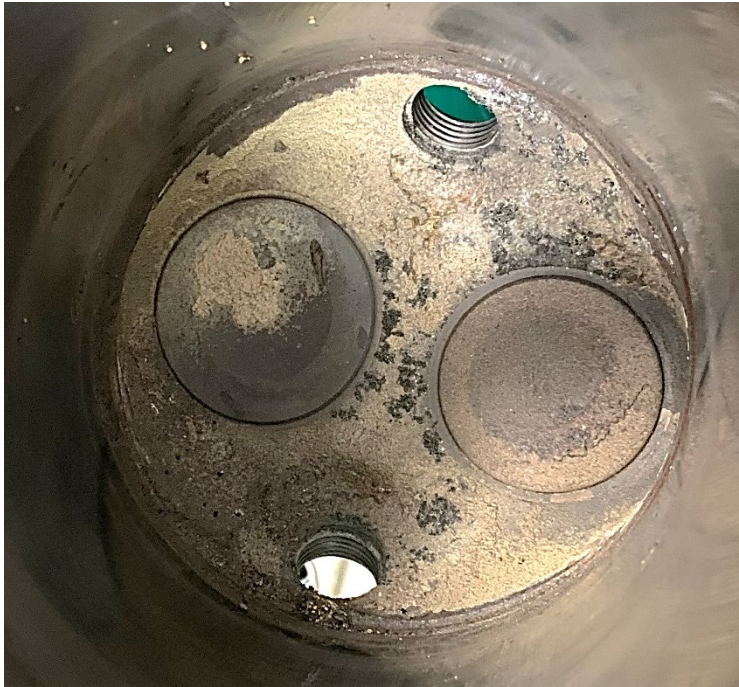
Figure 9. Photograph of the #3 cylinder inner surface showing heavy combustion deposits in the general between the spark plugs, intake and exhaust valves.
