**NATIONAL TRANSPORTATION SAFETY BOARD**

**AIRFRAME AND ENGINE EXAMINATION**

**WPR21LA121**

Aircraft: Piper Cessna 150J

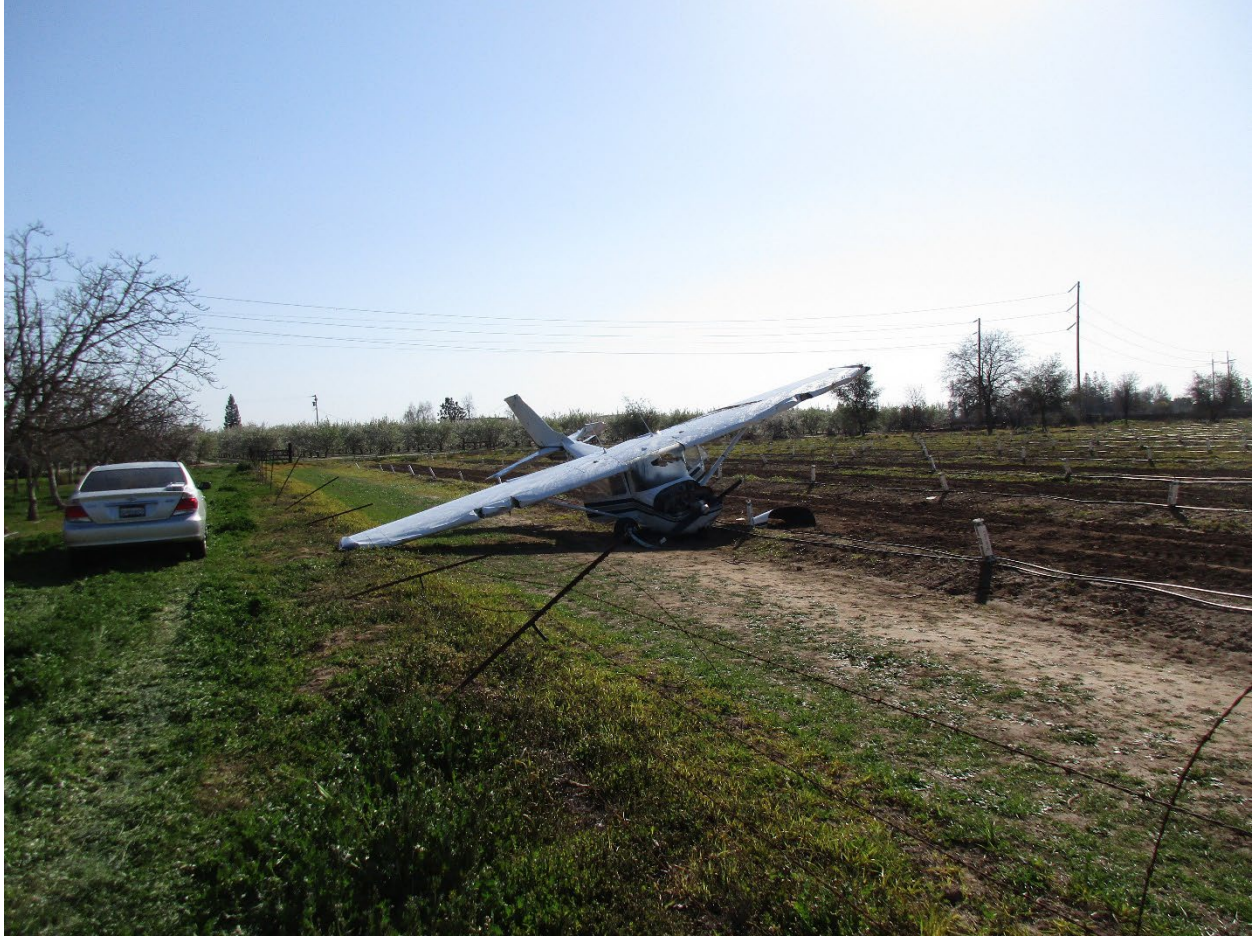
Photograph 1: Airplane at Accident Site (Courtesy of Federal Aviation Administration)

The wreckage was examined at a secure facility in Rancho Cordova, California on April 15, 2021 by the NTSB IIC. The wreckage was intact and both wings had been previously removed by recovery personnel. The empennage was partially separated near the aft fuselage and both the right and left horizontal stabilizer were substantially damaged. Both wings were mostly intact except for the left wing leading edge, which exhibited a large depression about midspan.

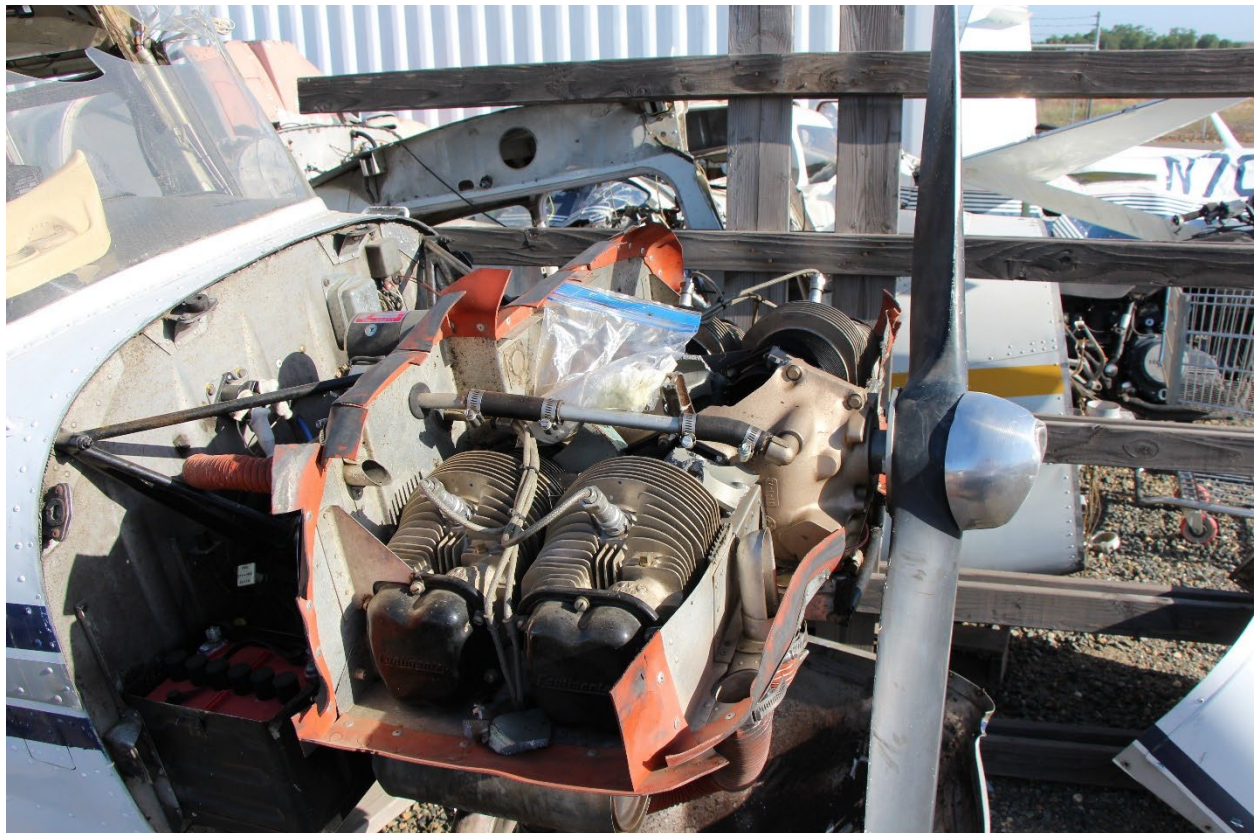
The engine was attached to the airplane; the upper engine mounts were secured from the firewall to the engine while the lower mounts had been fractured at the nose landing gear attachment truss. The top of the engine case was fractured with a hole that extended across about 7" in diameter. Additionally, the lower case had fractured around the circumference of cylinder 4. None of the other cylinders displayed were fractured.

Photograph 2: Engine Prior to Examination

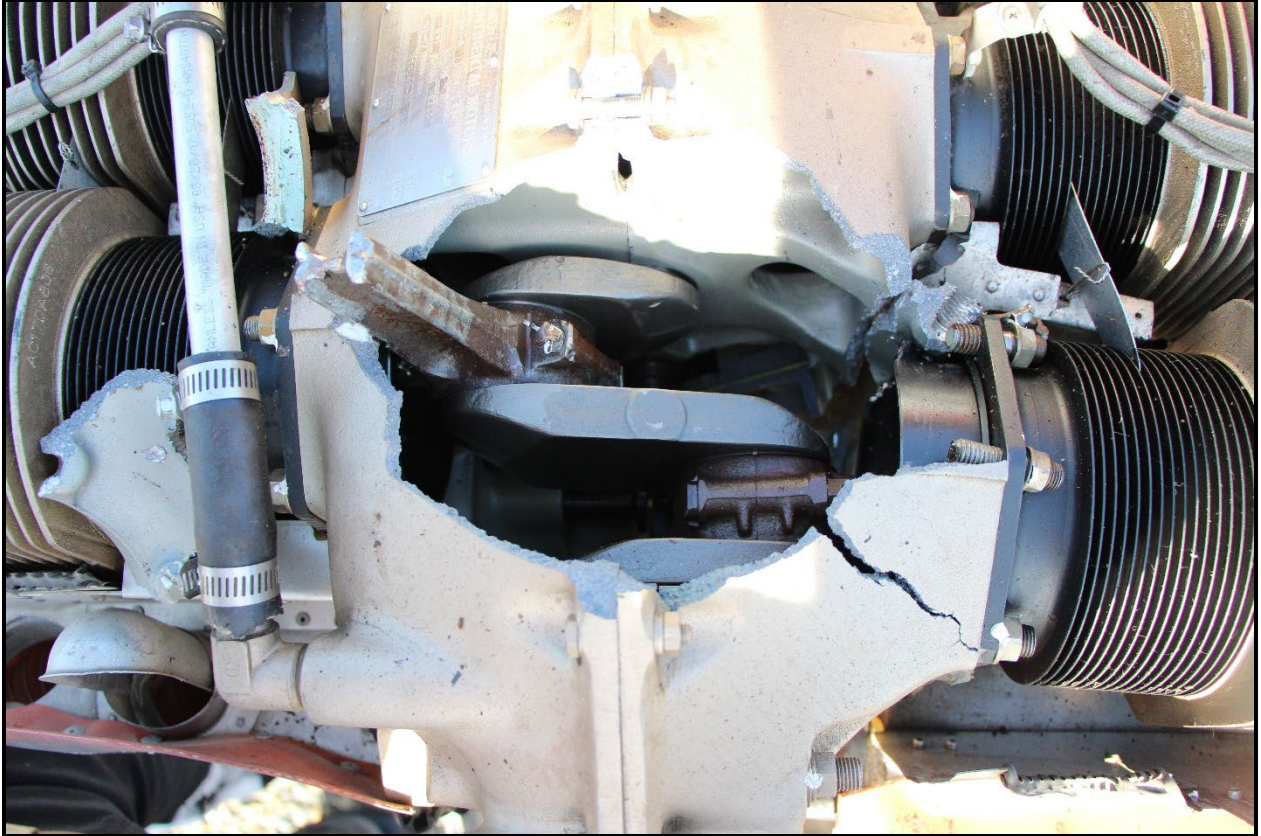
The cylinder 3 connecting rod was fractured at the connecting rod shank and was mechanically damaged. The cylinder 4 barrel rim was bent outboard towards the crankcase. The camshaft had separated at the cylinder 4 intake lifter and at the crankshaft attachment where it displayed a slight bend. Both the cylinder 3 and 4 connecting rods remained attached to the crankshaft and they cylinder 3 connecting rod movement was smooth and unrestrictive. No evidence of a bearing failure was observed at the cylinder 3 and 4 connecting rod bearings at the crankshaft. The cylinder 1 and 2 connecting rod bearings at the crankshaft were not observed at this time.

Photograph 3: Hole in Crankcase at Cylinder 3/4 and Exposed Cylinder 3 Connecting Rod Shank

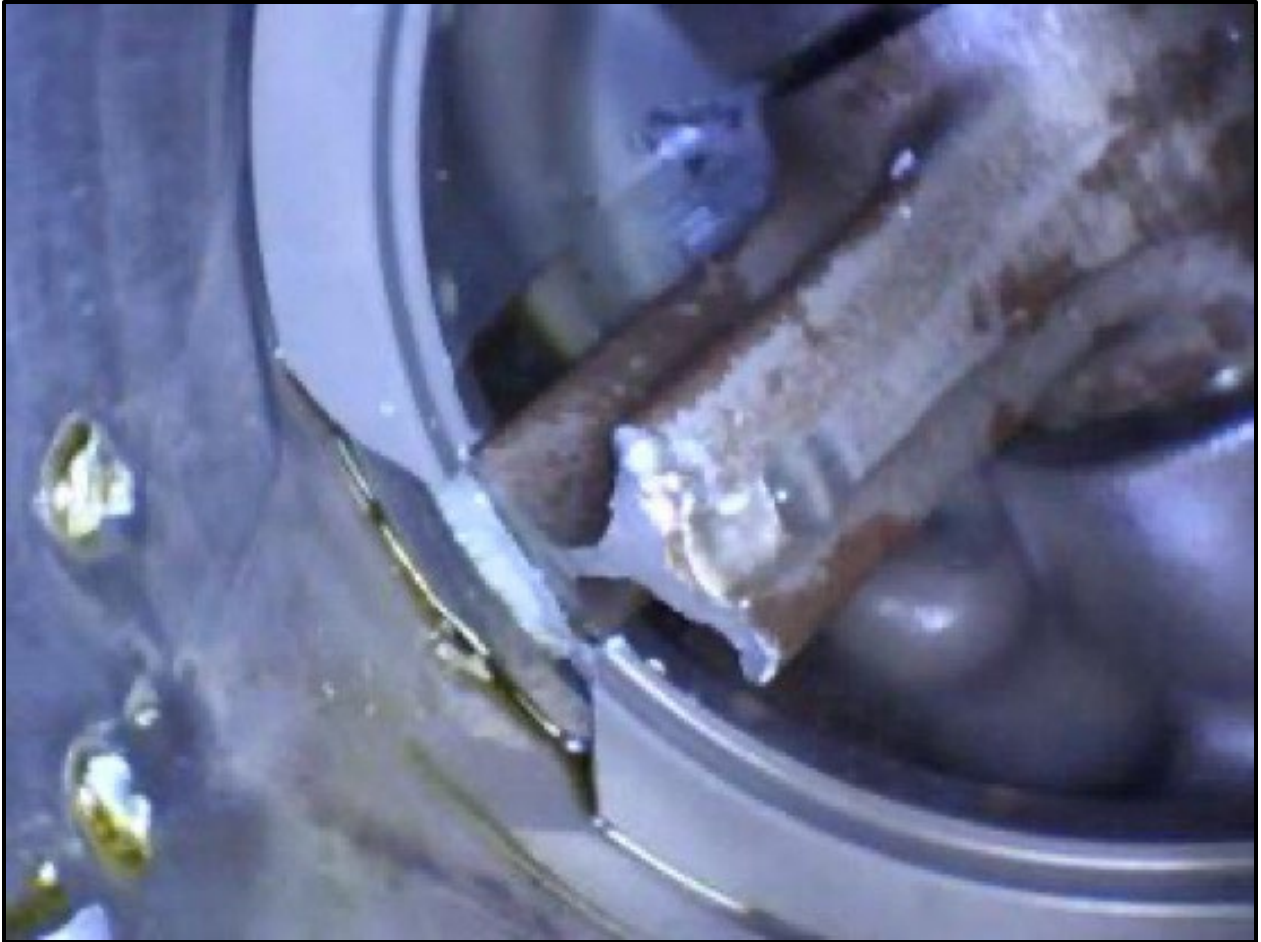
A borescope inspection was performed on each cylinder. The inspection of cylinder 3 revealed that the connecting rod bushing end was still attached to the piston pin. The piston ring seal was fractured and part of a piston ring was exposed. Additionally, there was some debris along the cylinder wall. The cylinder 4 connecting rod remained attached to the piston pin. Some oil stained fragments were observed at the cylinder wall. The connecting rods to cylinders 1 and 2 remained attached to their piston pins. The limited movement of the propeller and inspection holes precluded further inspection of these cylinders.

Photograph 4: Cylinder 3 Piston Ring Seal and Piston Ring

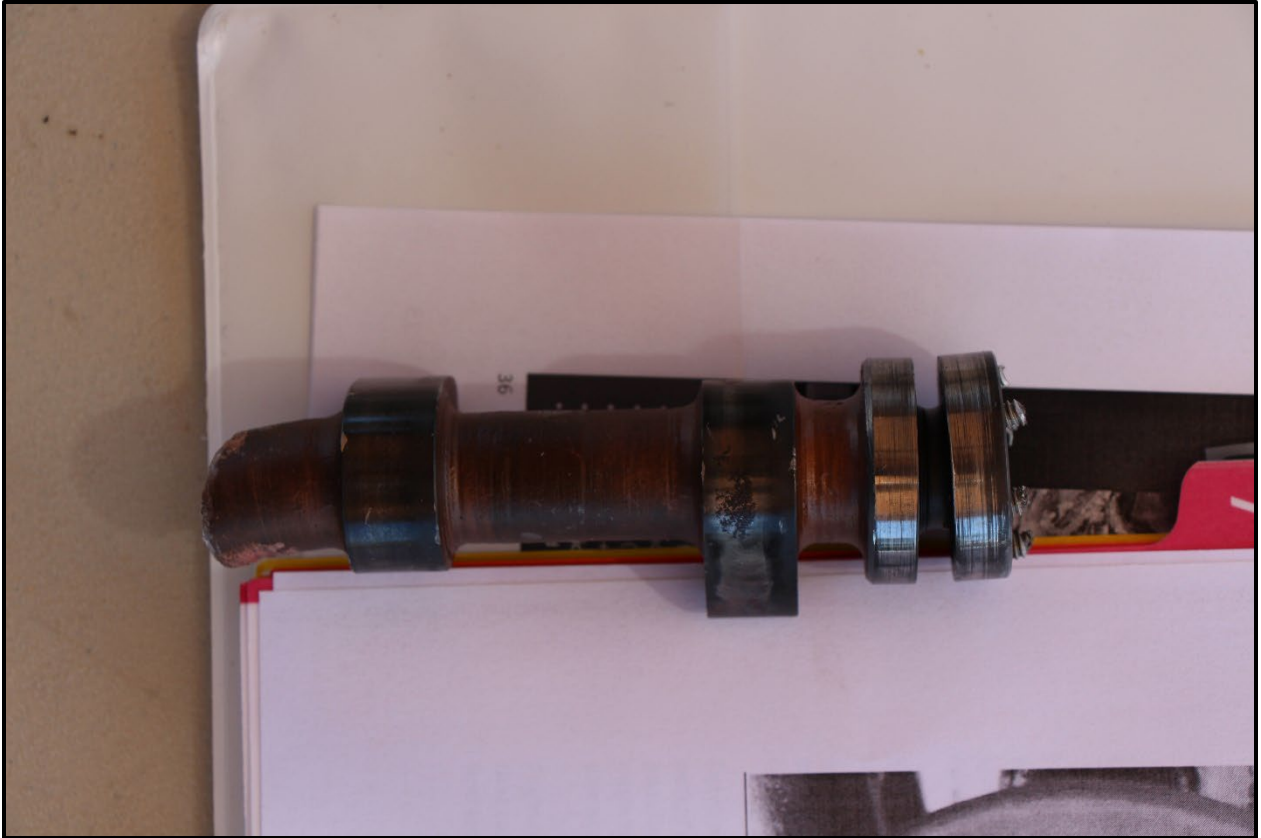
Photograph 5: Fractured Camshaft Section

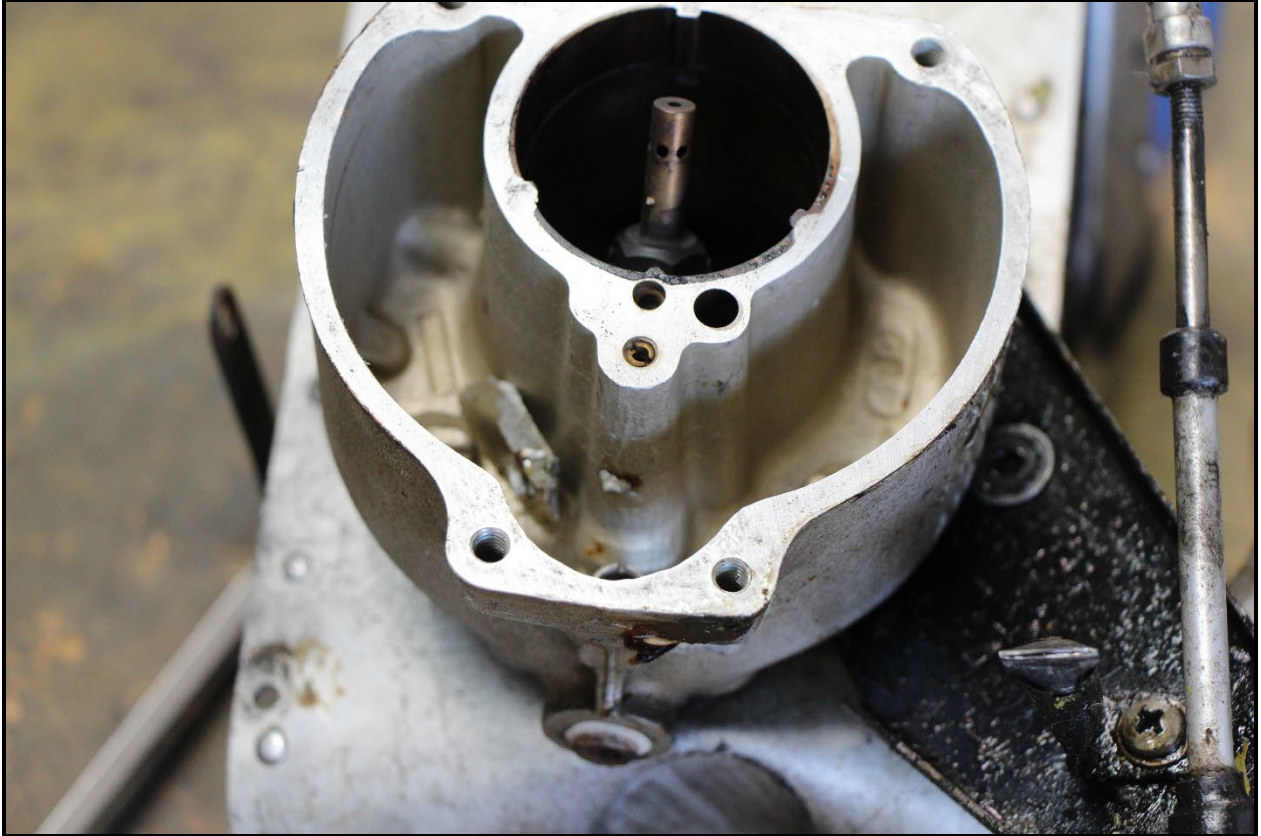
Photograph 6: Carburetor Fuel Bowl
