**NATIONAL TRANSPORTATION SAFETY BOARD  
OFFICE OF AVIATION SAFETY  
WASHINGTON, D.C. 20594**

**POWERPLANT EXAMINATION REPORT**

**NTSB ID No.: WPR21LA121**

Location: Lodi, California  
Date: March 3, 2021  
Time: 1500 Pacific daylight time  
Aircraft: Cessna 150, Registration: N60290

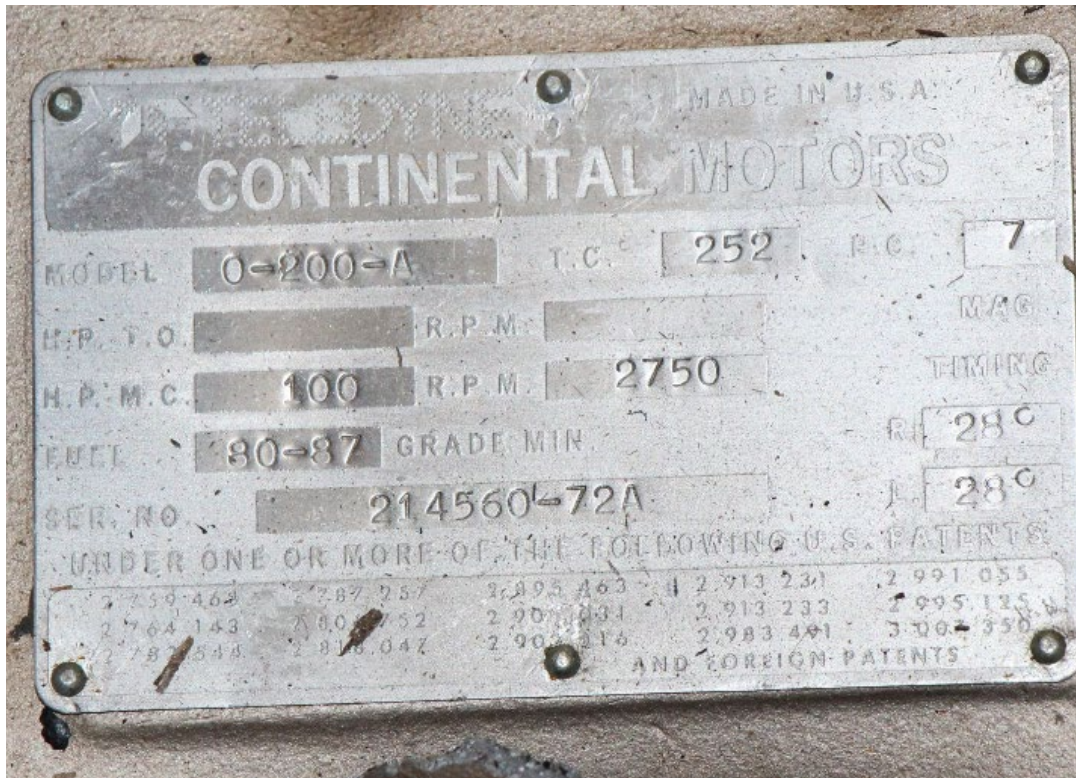
The engine was a Continental O-200-A engine, a 100 horsepower, horizontally opposed, air cooled, reciprocating engine.

**Photograph 1: Engine Data Plate**

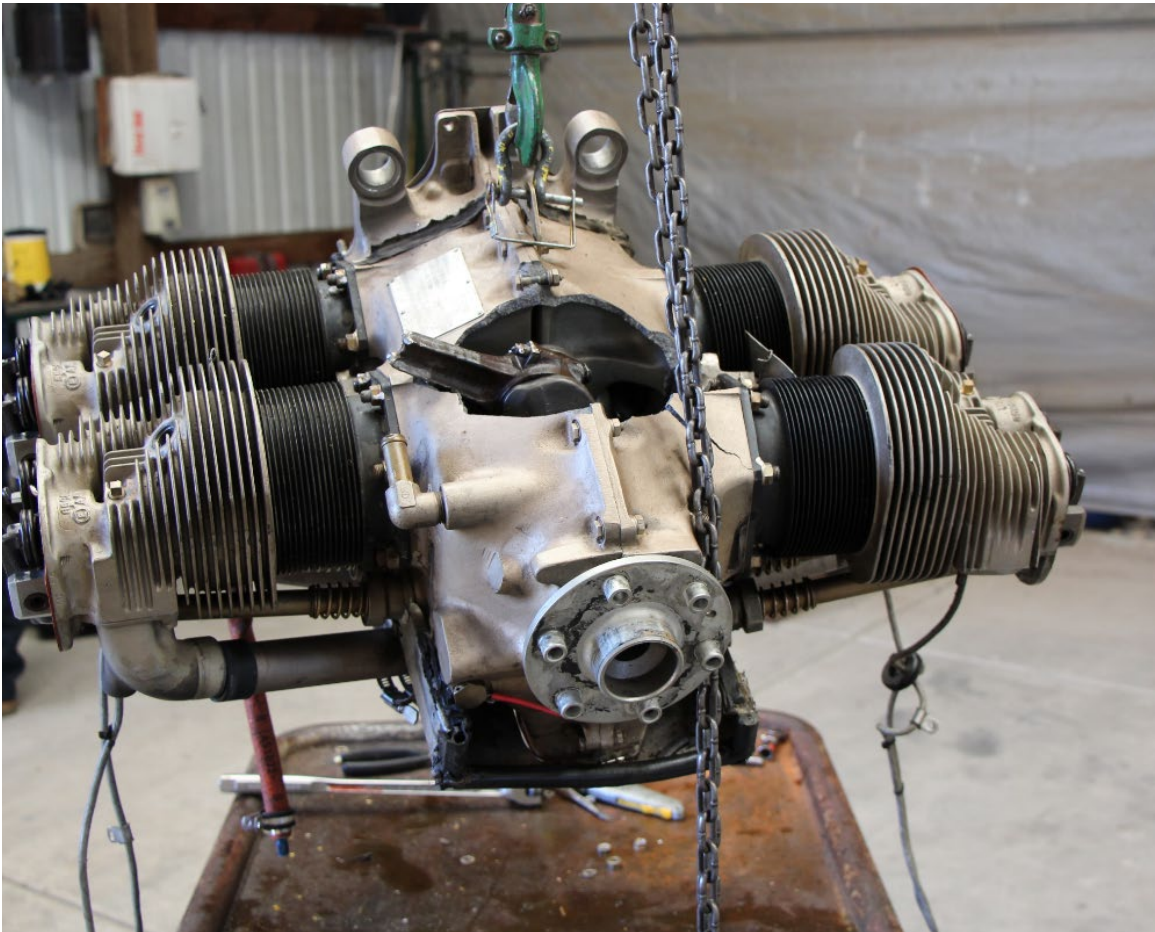
The engine remained attached to the airframe through its mounts; however, the lower mounts were fractured at the nose landing gear attachment truss. The top of the engine case was fractured with a hole that extended across about 7" in diameter. Additionally, the lower case had fractured around the circumference of cylinder 4. None of the other cylinders displayed were fractured.

The cylinder 4 intake tube shaft was displaced at the cylinder joint. Most of the scat tubing remained secured from the exhaust manifolds to each exhaust port with exception of the cylinder 3 and 4 exhaust tubes, which were partially crushed. Additionally, the cylinder 4 exhaust scat tube was partially crushed at the carburetor.

The oil sump case was damaged.

**Photograph 2: Engine with Baffling, Rocker Covers, and Accessory Case Removed**

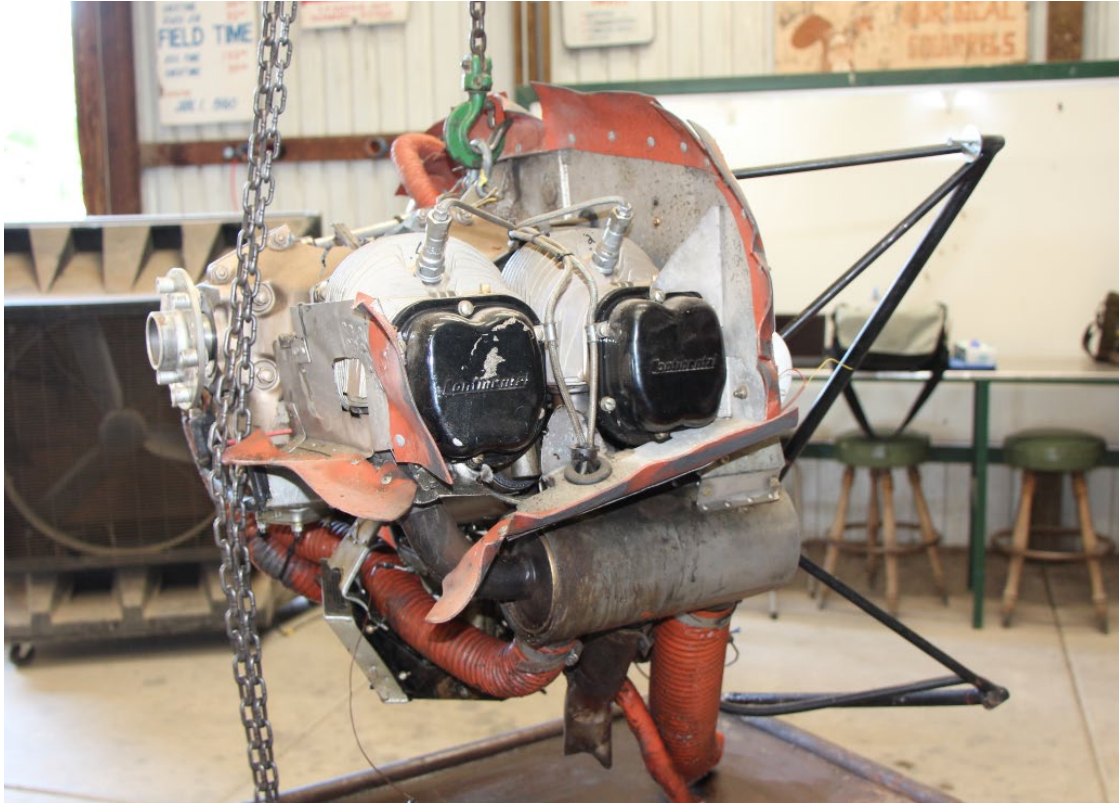
**Photograph 3: Engine Prior to Teardown**

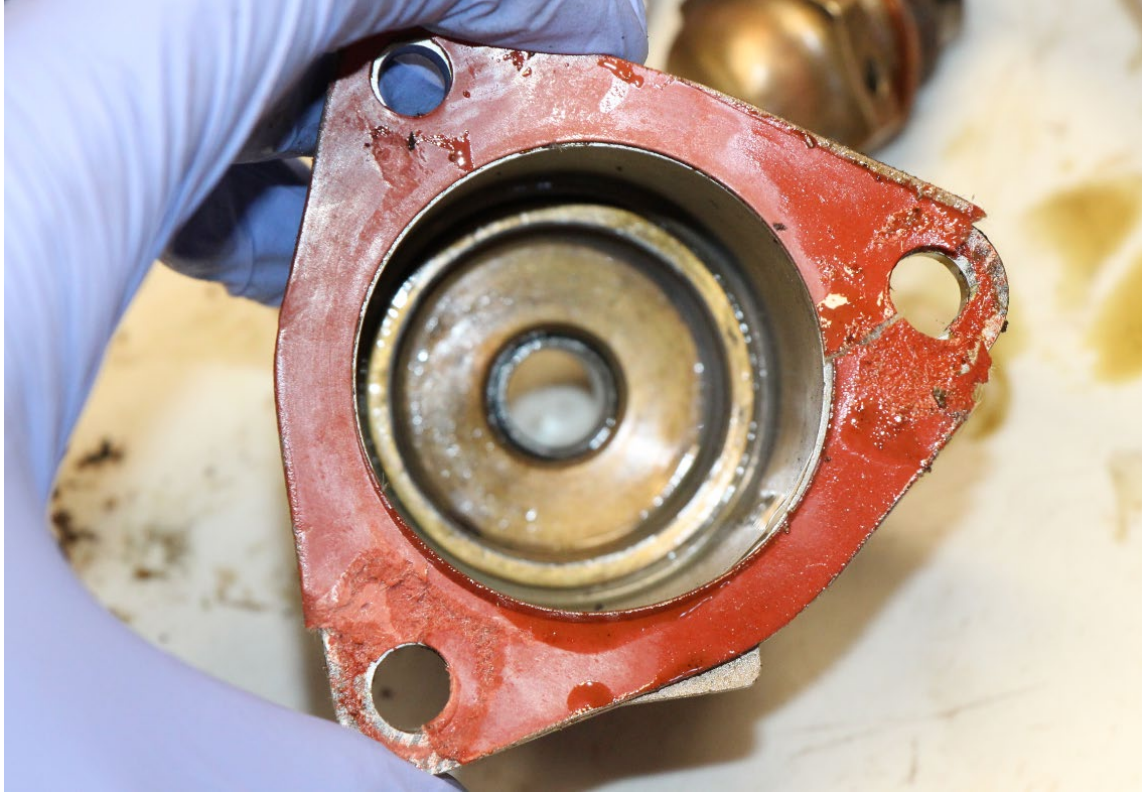
The engine was equipped with an oil pump driven impeller shaft collocated with the tachometer drive shaft at the center of the accessory case. Both impellers were unremarkable and displayed a light film of fresh oil. An oil screen is normally contained with a housing at the lower section of the accessory case. However, the oil screen was missing from its housing, which was secured to the case and did not exhibit any damage or metallic fragments. According to the overhaul facility, the fuel screen had been removed before the engine arrived for the overhaul.

**Photograph 4: Oil Screen Housing with Screen Absent**

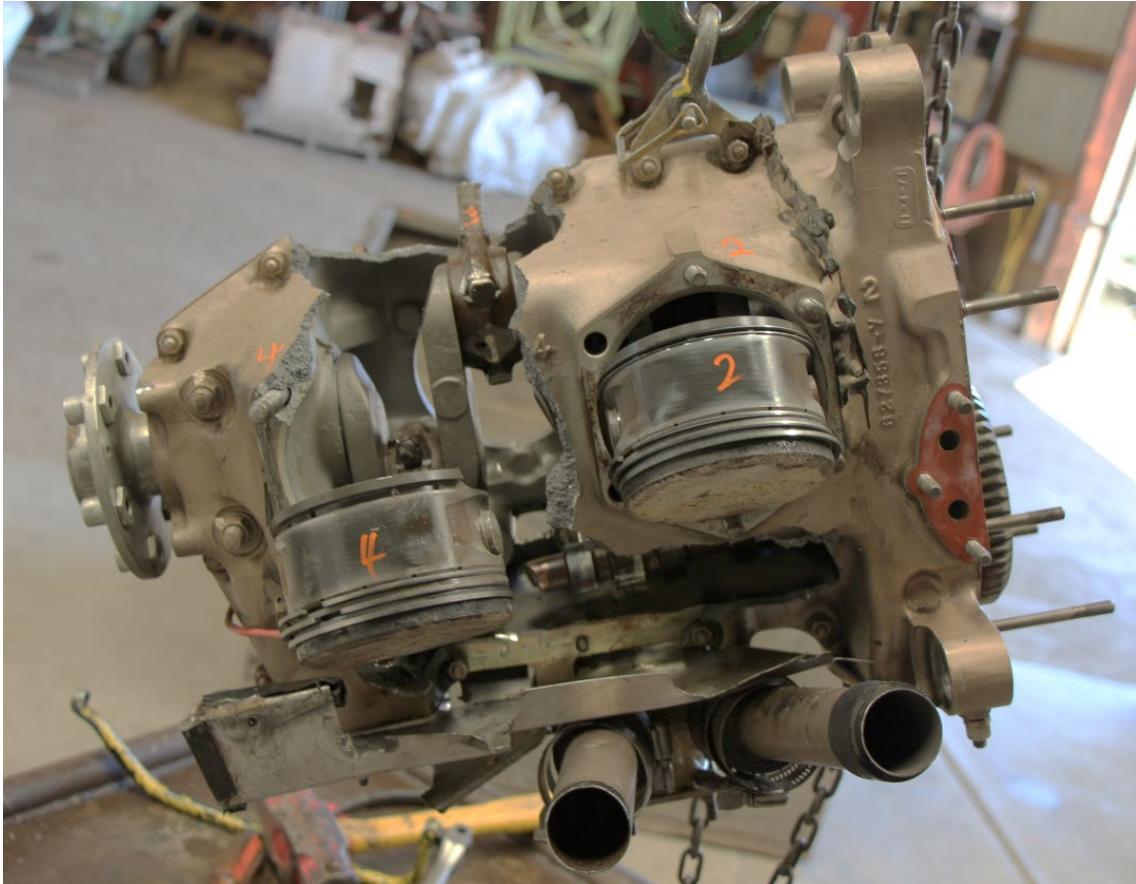
Most of the damage to the engine case was localized to Cylinder no. 4 as the case was fractured around the cylinder. Further, the case displayed was split longitudinally below cylinders 2 and 4.

**Photograph 5: Engine case from the left side with cylinders 2 and 4 removed**

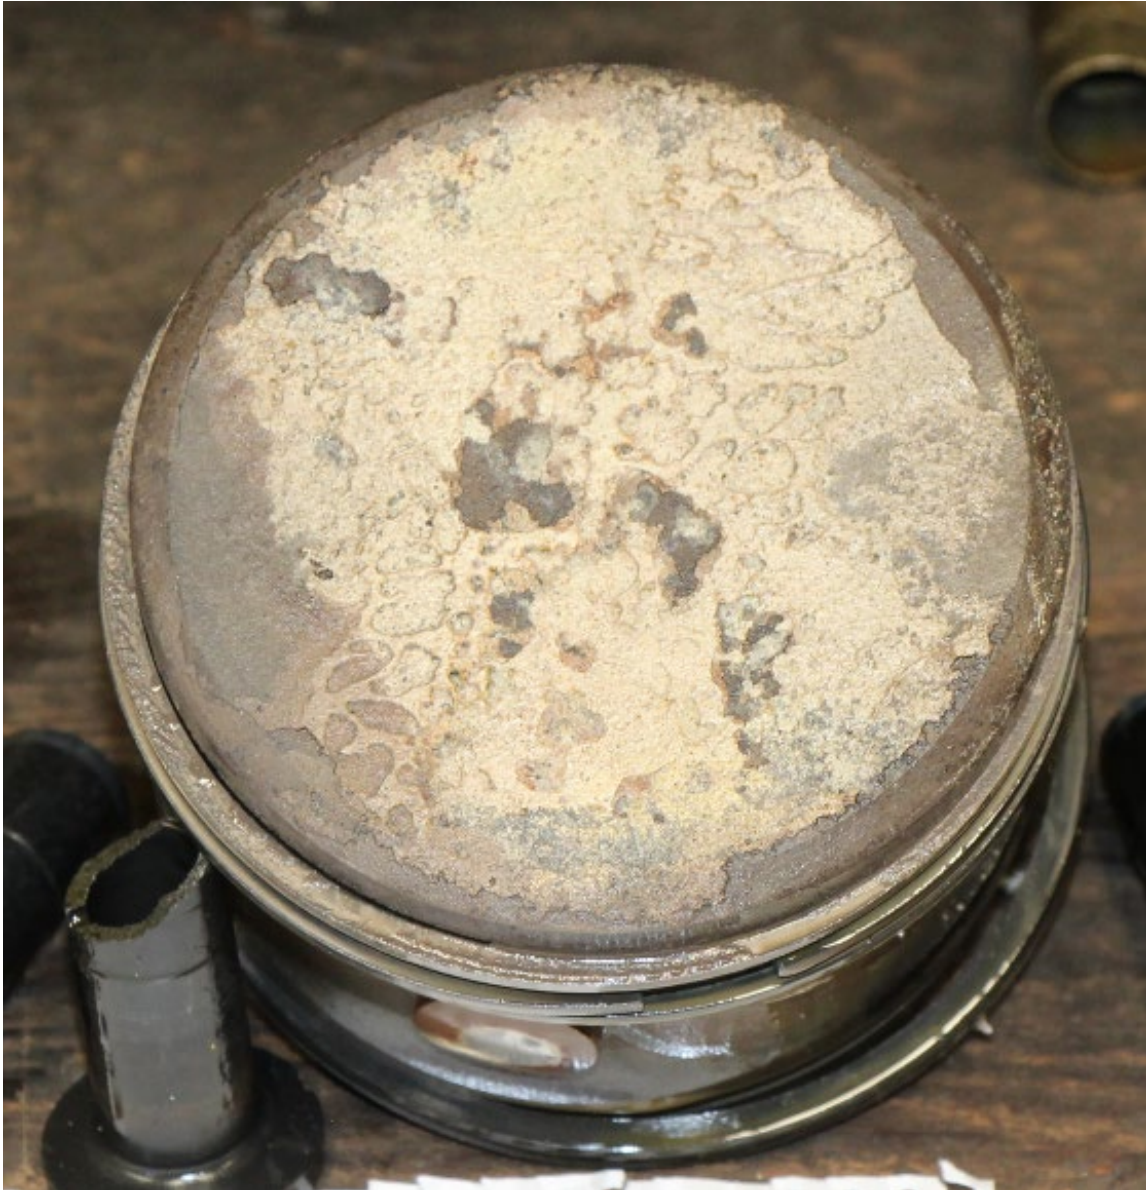
The cylinders were mostly unremarkable in appearance and did not exhibit any unusual wear with exception of cylinder no. 3, which contained a broken piston ring seal. The piston rings were attached to each piston and were unremarkable. Each of the four piston faces displayed signatures consistent with normal wear. The hydraulic valve lifters to cylinders 1 and 3 were remained within the lifters housings; however, one cylinder 3 lifter had fractured at the lifter body. The cylinder 2 and 4 lifter housings had separated

**Photograph 6: Piston Face, Cylinder No. 3**

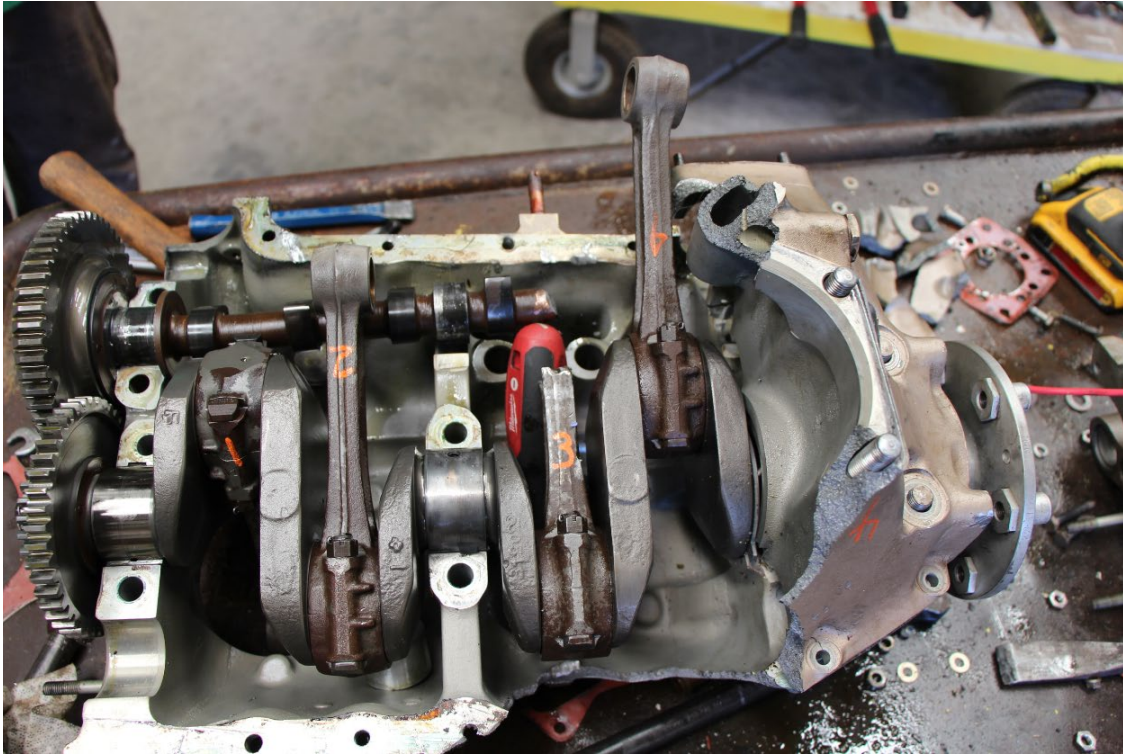
The crankshaft was secured within the engine case and each connecting rod was attached to the crankshaft and rotated normally without resistance. The cylinder 3 connecting rod was fractured at the shank about midspan. Additionally, a castellated nut was missing from the cylinder 3 connecting rod at the crankshaft; however, the safety wire was in place at the bolt bore. The crankshaft bearings and thrust washers were in place and unremarkable. The camshaft was fractured in the plane of rotation of the cylinder 3

connecting rod. The engine case, crankshaft and connecting rods did not display any evidence of thermal damage.

**Photograph 7: Disassembled engine case with crankshaft and camshaft**

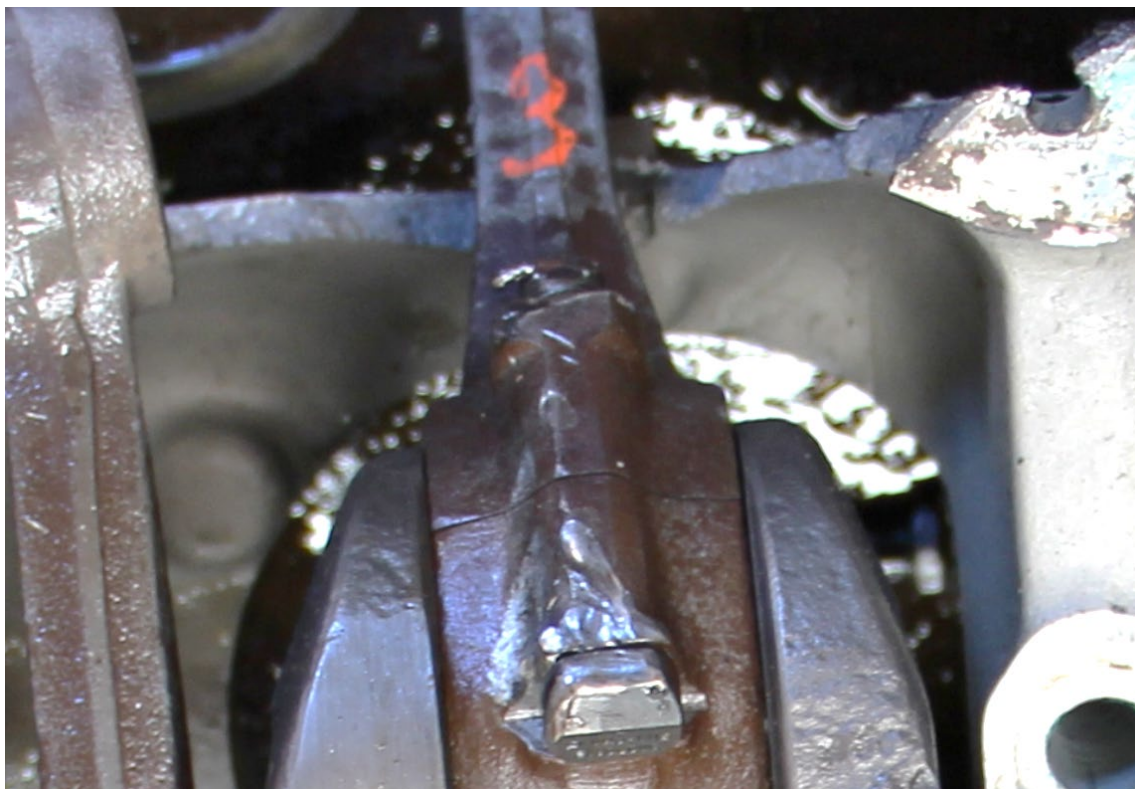
**Photograph 8: Cylinder 3 connecting rod with missing castellated nut**
