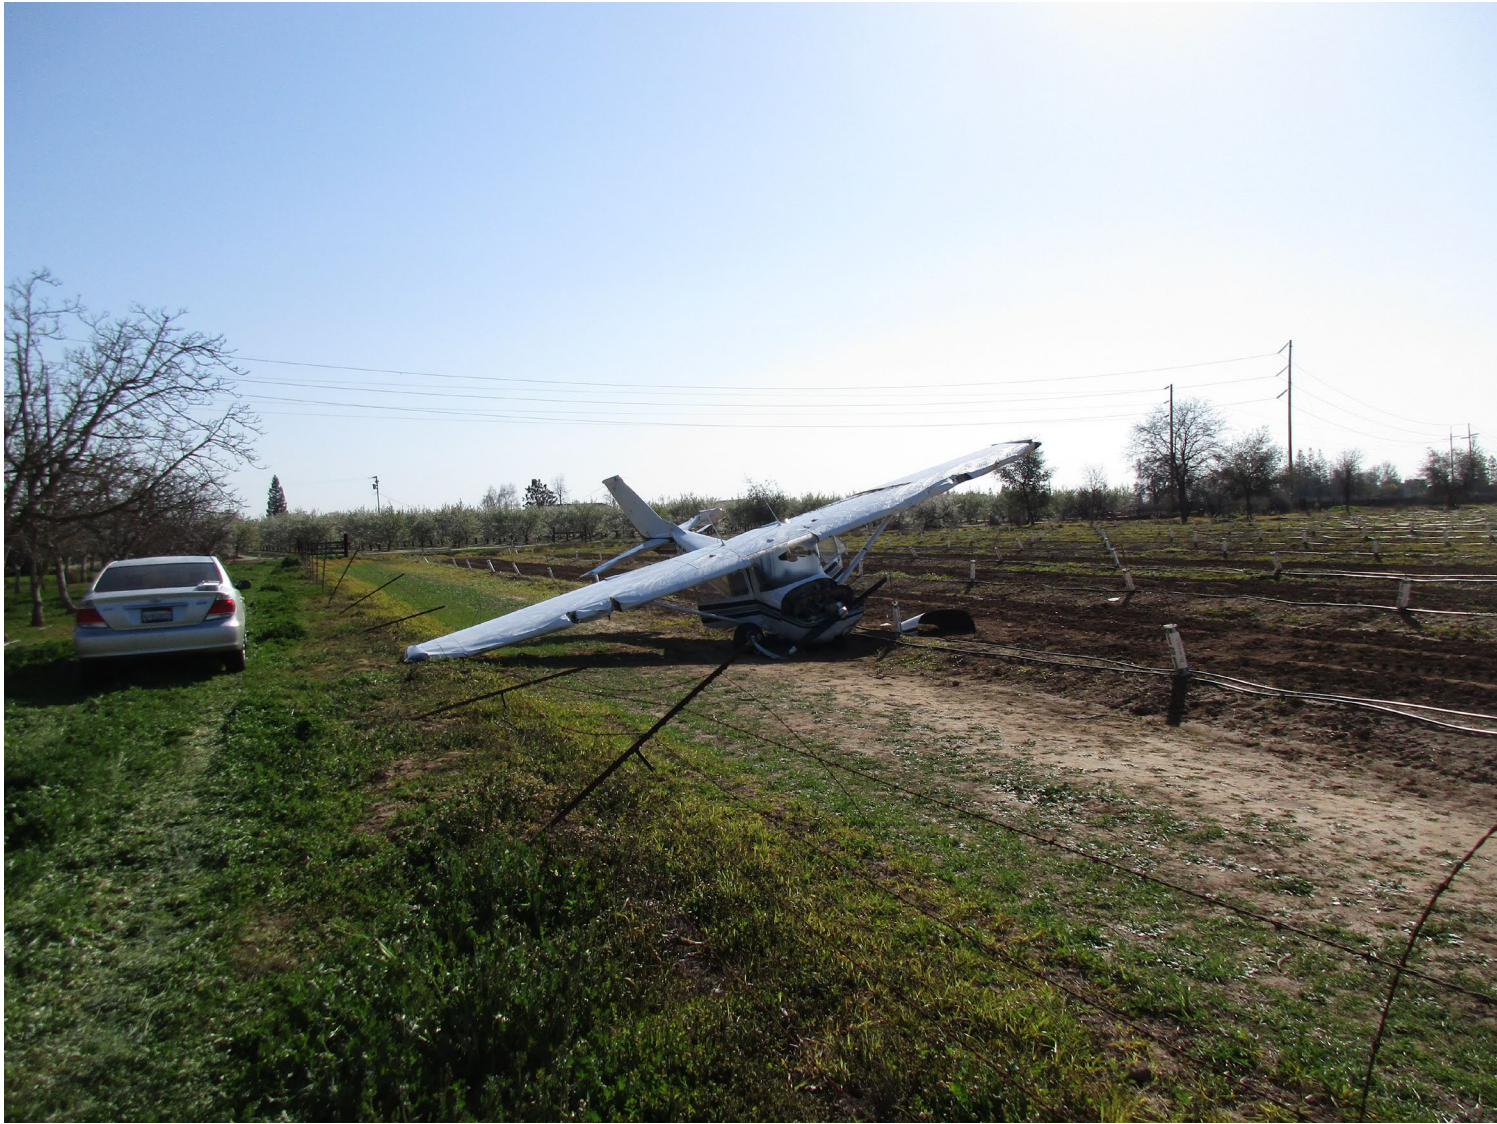
**Photo 1 – Quartering view of accident airplane (Courtesy of Federal Aviation Administration)**

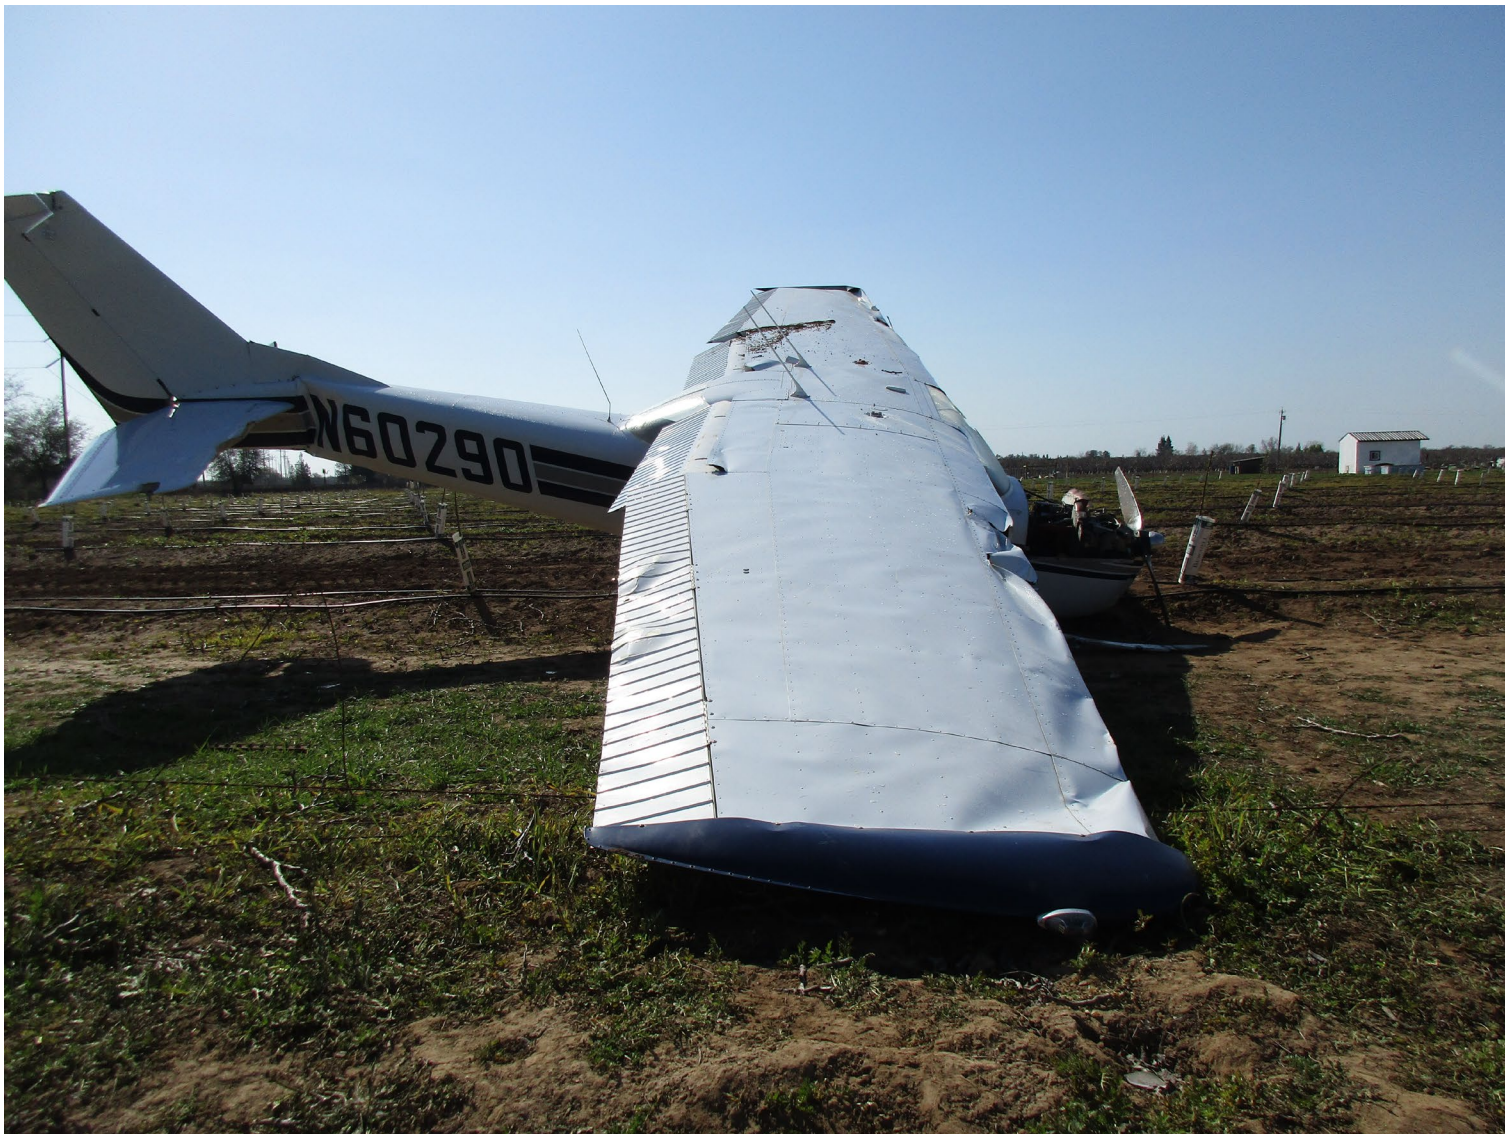
**Photo 2 – View from right wing (Courtesy of Federal Aviation Administration)**

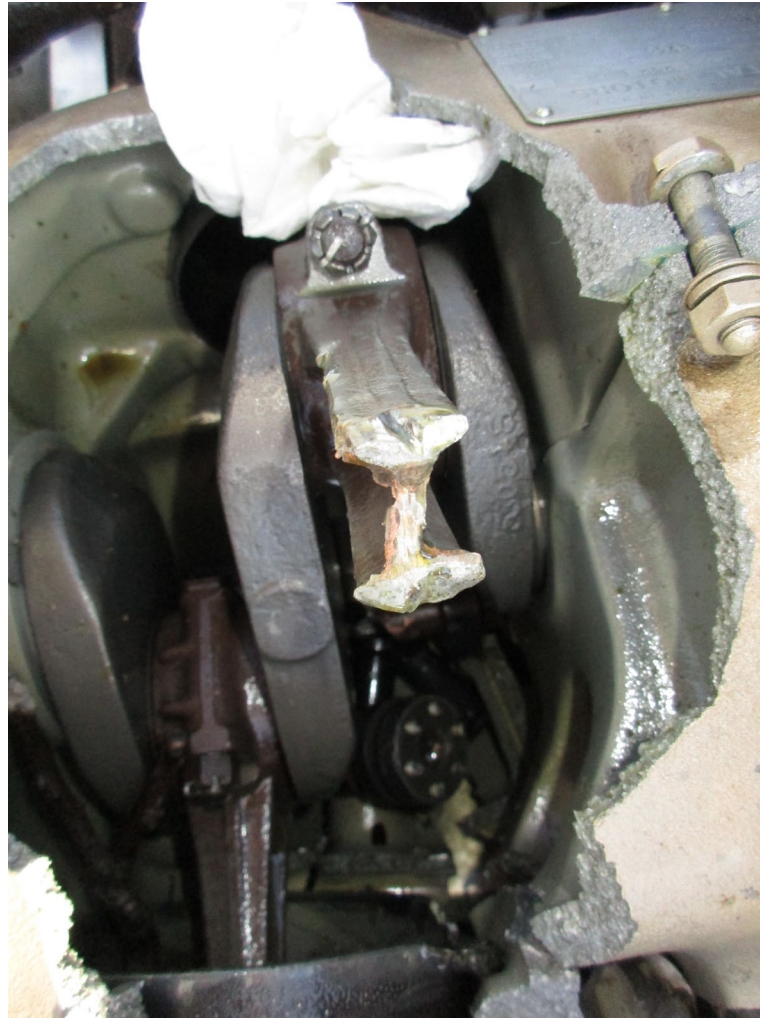
**Photo 3 – Cylinder no. 3 connecting rod shaft fracture at accident site (Courtesy of Federal Aviation Administration)**
