## Engine and Airframe Exam Summary

WPR21LA122

C172 Sisters Oregon.

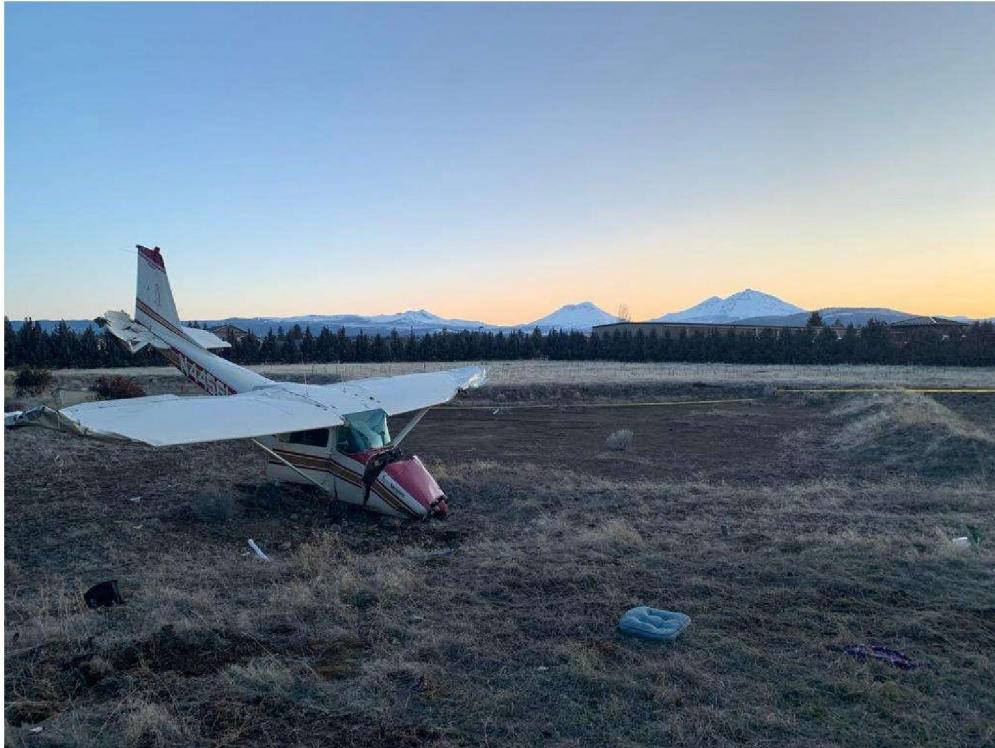
*Figure 1-Accident Site, courtesy law enforcement*

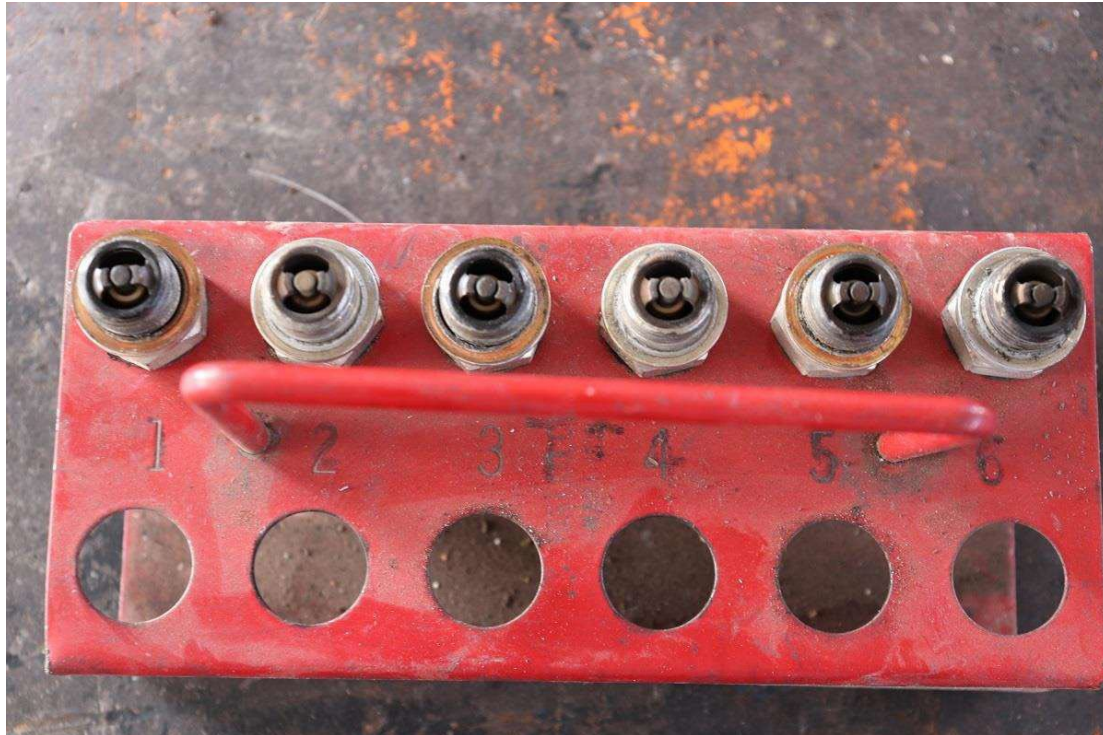
Top six spark plugs were removed and visually inspected. All plugs were evenly gapped with minimal corrosion. No FOD present. Electrodes showed wear but no abnormal shape or distortion. Plugs 1,3,5, and 6 were lightly coated with oil. Plug 6 was grey. Rocker box covers were removed. Rocker assemblies push rod tubes, and valve springs were normal and lightly coated with oil. All components had a consistent tan color with no signs of heat stress. Cylinders 1,3, and 5.

*Figure 3-Top 6 spark plugs*

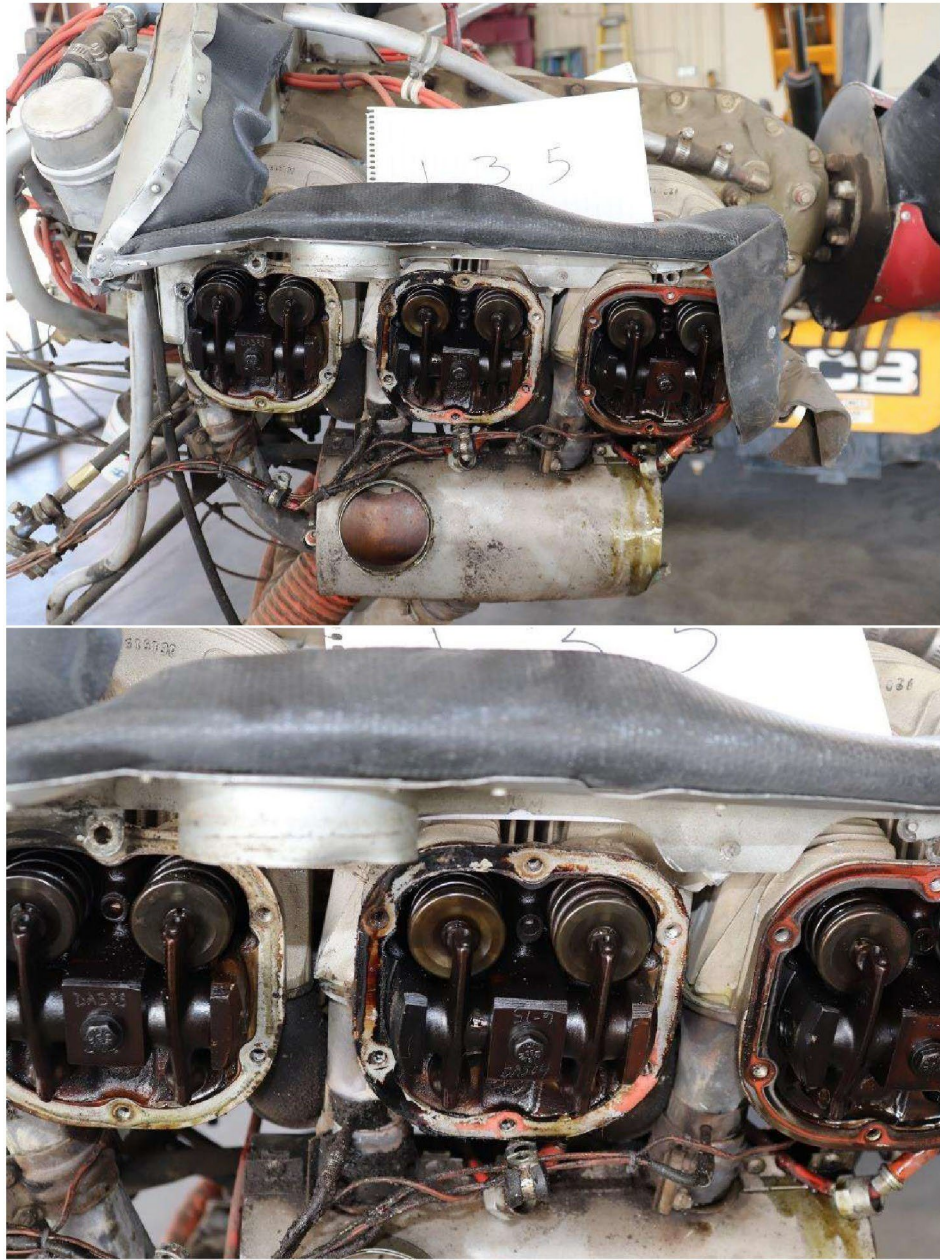
After removing the top spark plugs and all leads, mechanical continuity was checked by manually rotating the prop. There was no evidence of resistance or grinding during rotation. The sound of the magneto impulse coupling could be heard. Thumb compression was checked on all 6 cylinders via the top spark plug holes. While the prop was rotated by hand, compression and suction was verified on each cylinder. Additionally, each exhaust and intake valve spring and rocker arm moved correctly.

Figure 4-Rocker and Valve Assemblies, cylinders 1,3,5.

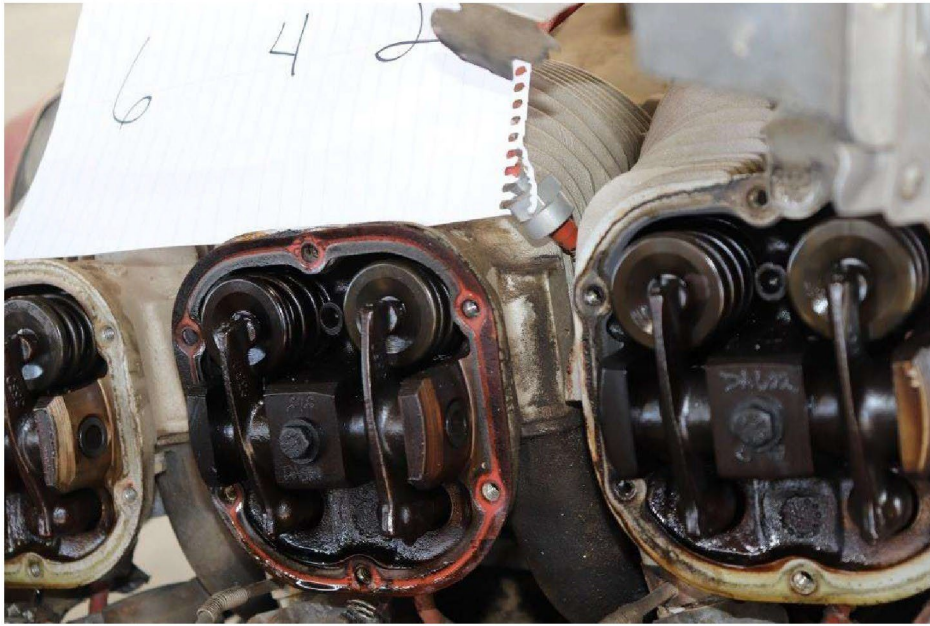
*Figure 5-Rocker and Valve Assemblies, cylinders 2,4,6.*

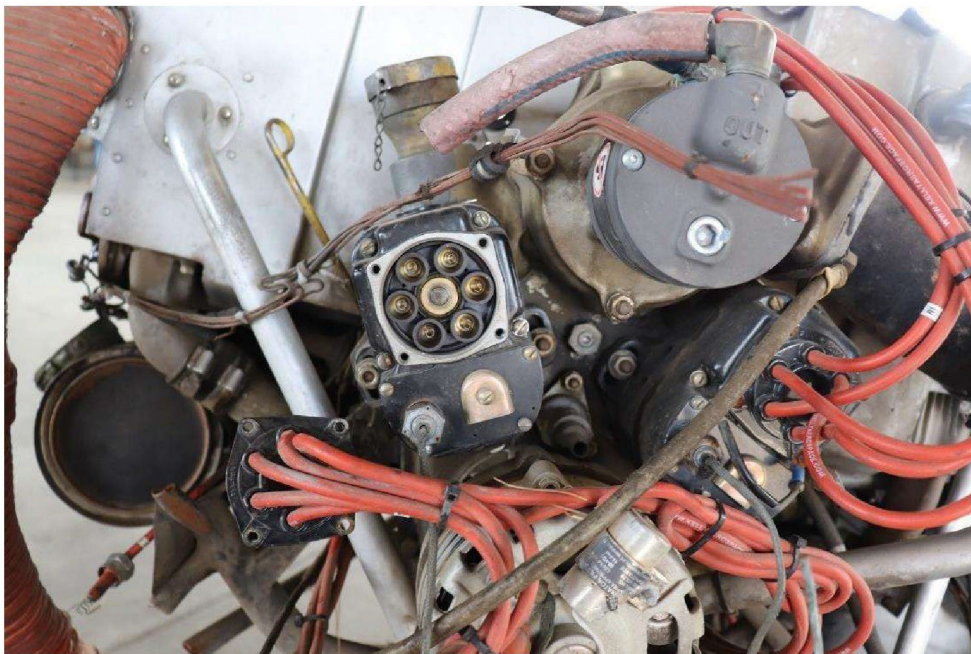
Magnetos remained on the engine to be visually inspected and tested. No signs of external damage to magneto body existed. By rotating the propellor, the right mag produced spark but the left one did not produce spark by rotating the propellor. The left magneto was then removed to be tested further. Subsequent rotation on the right magneto produced normal spark.

*Figure 6-Magnetos*

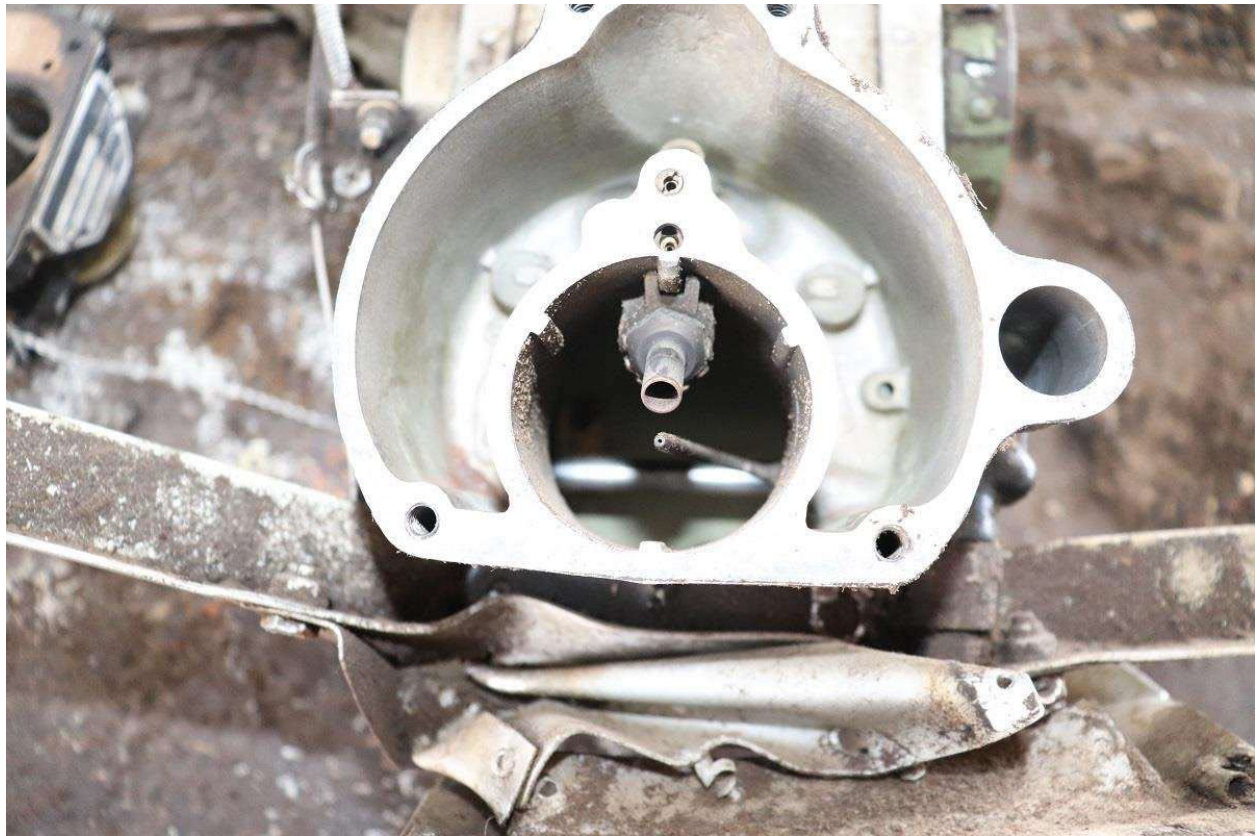
Carburetor. The carb mounting flange was partially torn away from the carb body. The throttle was exposed. All linkages were tested by pushing the linkage in each direction. Throttle and mixture linkage travel was tested favorably from stop to stop. Cables linkages were intact. Finger screen was inspected and free of debris or contaminants. Carburetor heat valve was closed, carb heat off. Carburetor main assembly was examined and found to be intact and free of debris. The main port was blown through with unpressurized air and was free of blockage. The metal floats were intact without deformation and the spring actuated normally. The venturi was normal and clear of any debris.

*Figure 7-Carburetor*

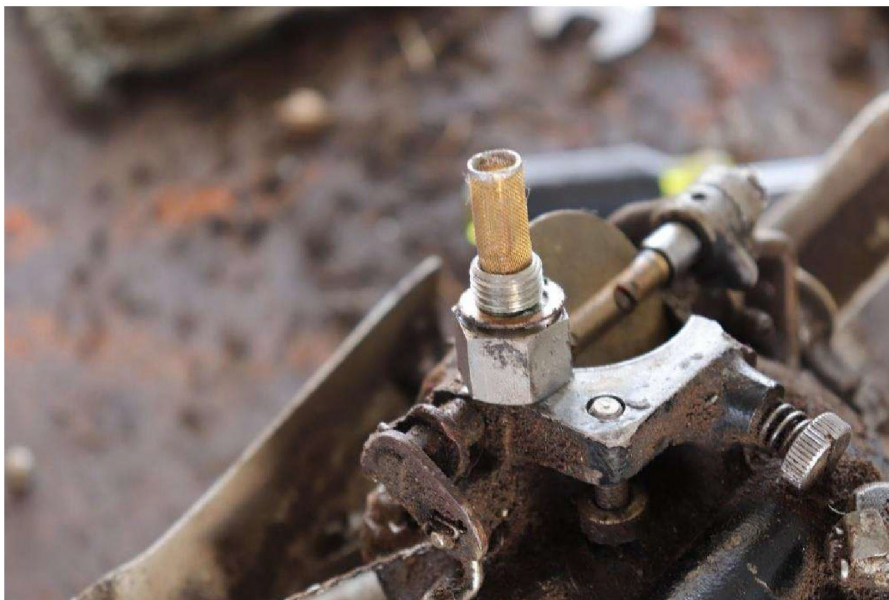
Fuel was present and tested with SARGEL with no signs of water. The fuel had the appearance and smell of automotive unleaded gas. Finger screen was clear and free of debris.

Figure 8-Carb Finger Screen

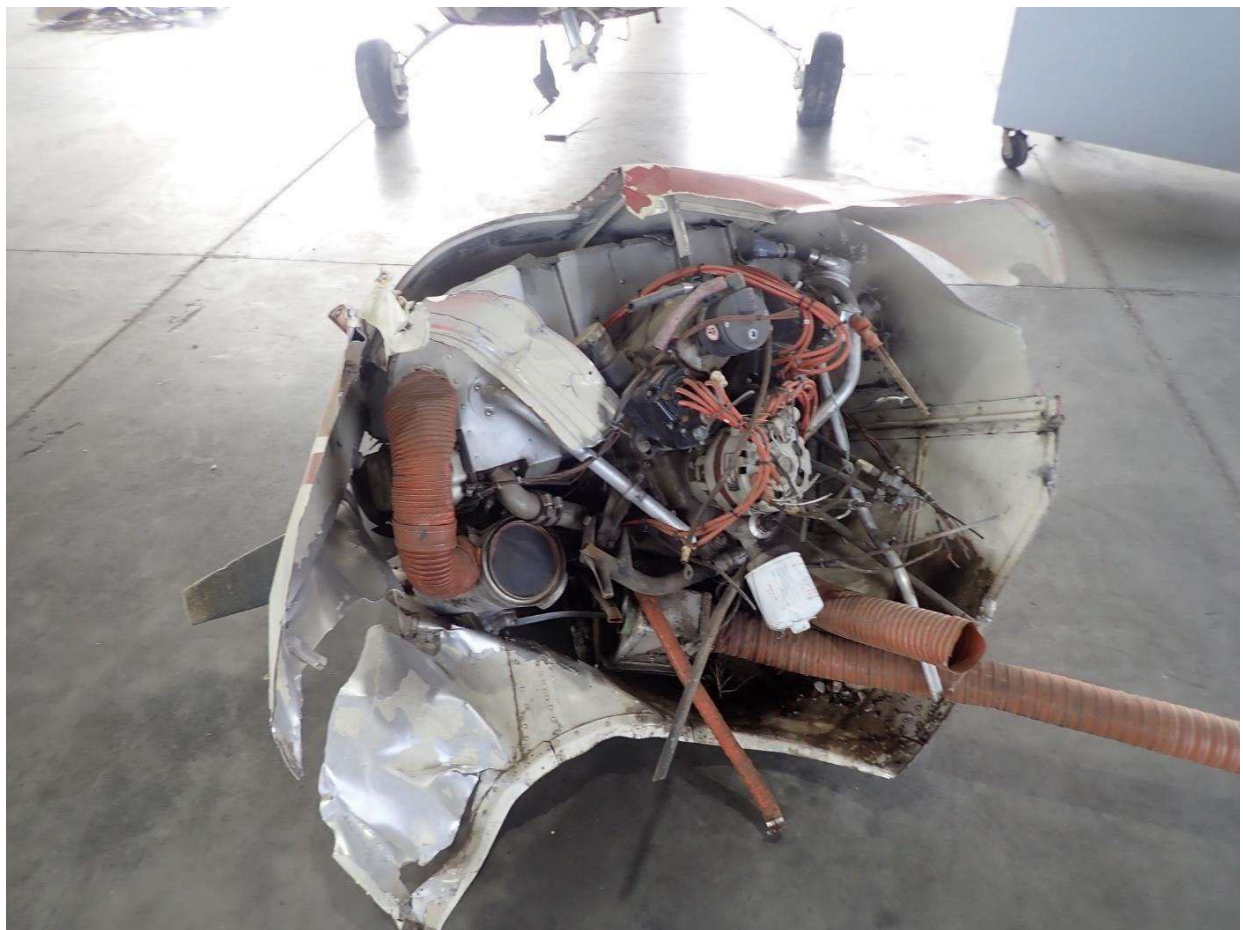
Engine compartment. The entire nose section including the engine and propellor was separated from the fuselage. The recovery company reported it separated at the crash site except for one metal tube which remained attached. The recovery crew cut the tube for transport. The propellor remained intact to the crankshaft flange. Starter solenoid wires were cut about 6 inches from the solenoid. Alternator, starter, and oil filter were undamaged. Spark plug leads from magnetos remained intact.

*Figure 9-Engine Compartment, courtesy Textron*

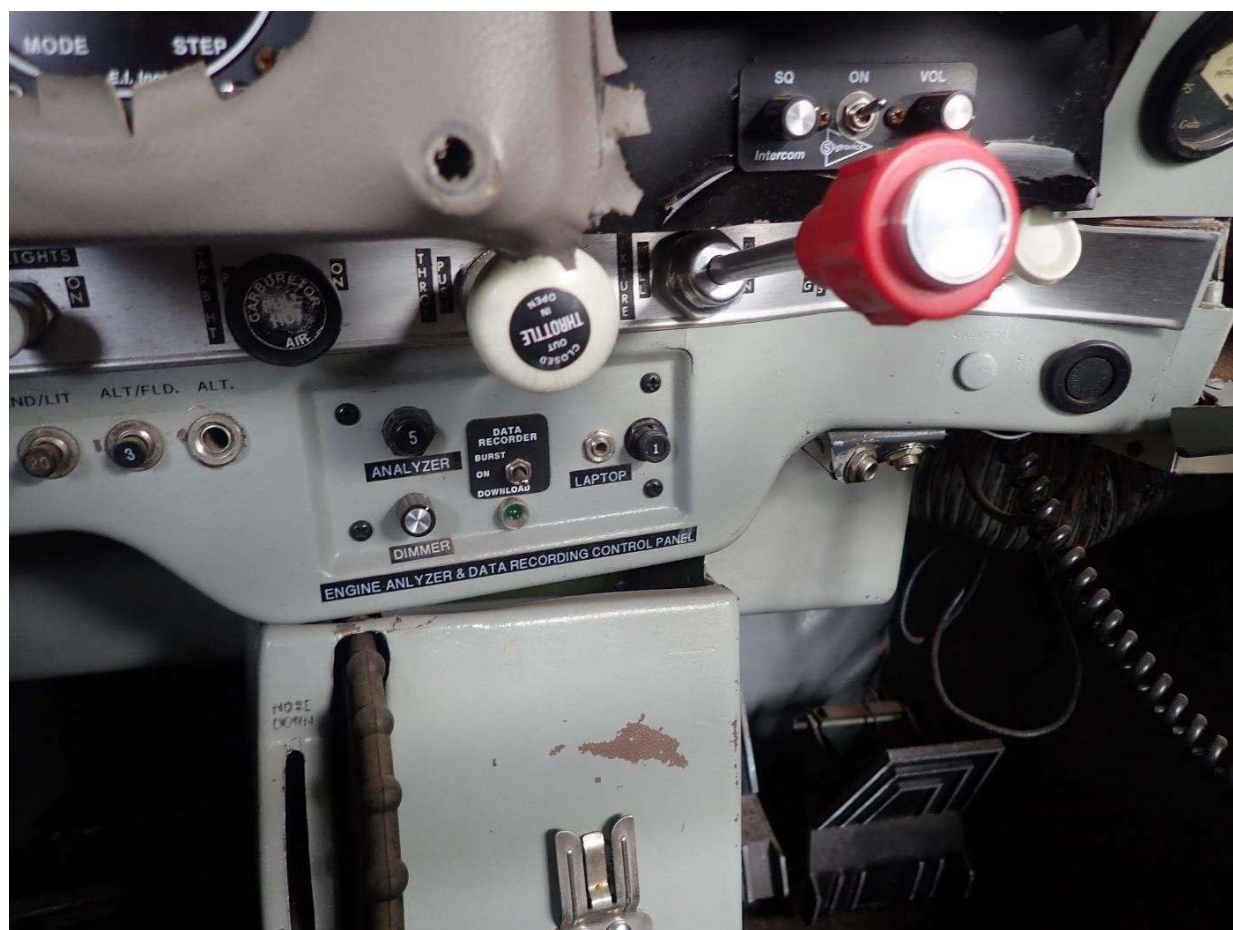
Seat tracks were normal with no anomalies. All instruments were installed. Attitude indicator showed right 20 degree bank. Throttle handle was set to full in and mixture handle was extended all the way back in the full lean position. Carb heat handle was pushed in (off). The panel had an engine analyzer with a control panel and circuit breaker. The fuel selector switch was in the off position. It was placarded with "switch to single tank operation immediately upon reaching cruise altitude above 5000 feet."

Figure 10-Throttle, mixture, and carburetor heat controls, courtesy Textron

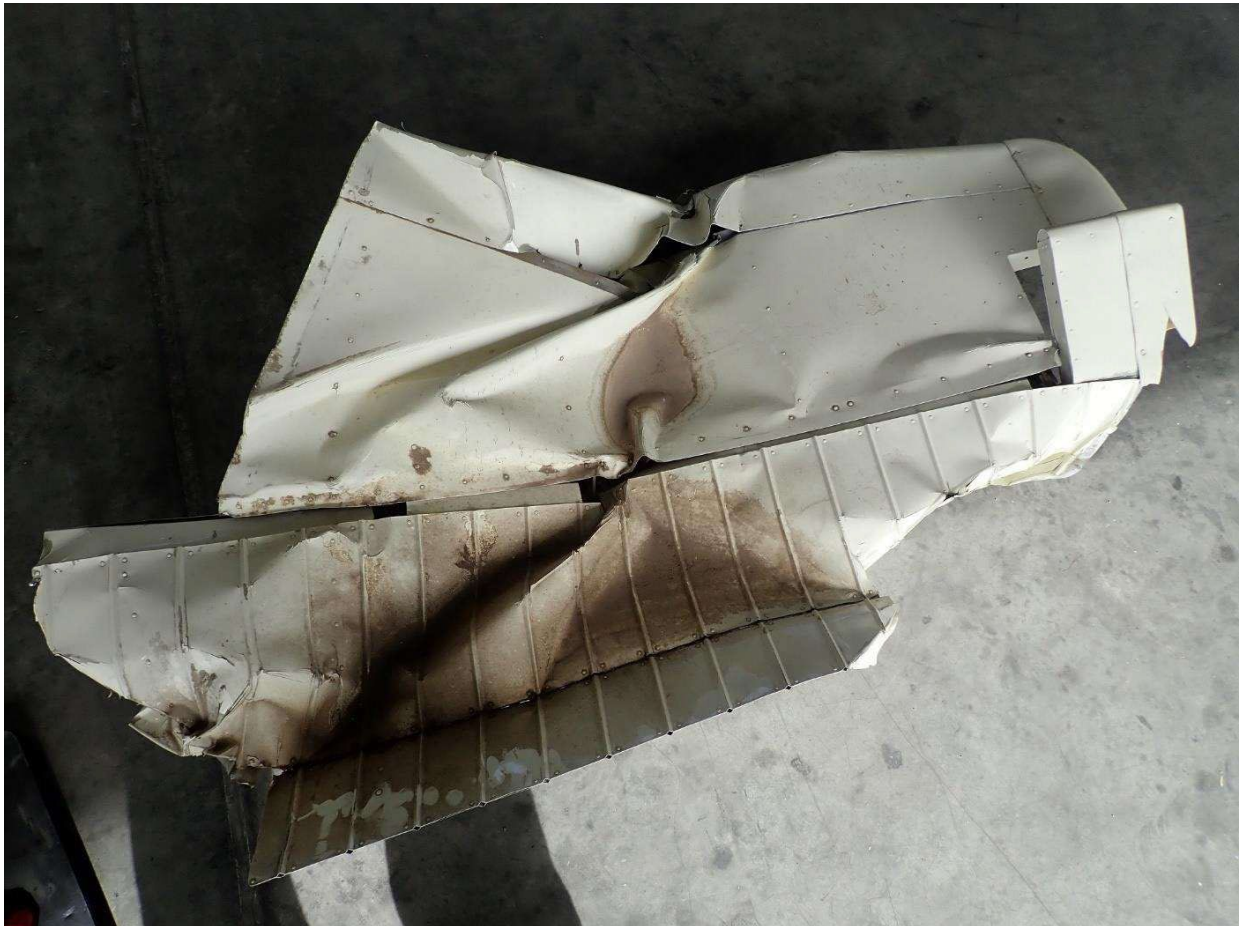
Horizontal Stabilizer. The left horizontal stabilizer and elevator remained intact and undamaged. The right was cut and removed by the recovery company but showed bending and crushing on the leading edge of the horizontal stabilizer and crushing damage to the elevator.

*Figure 11-Right Horizontal Stabilizer and Elevator, courtesy NTSB*

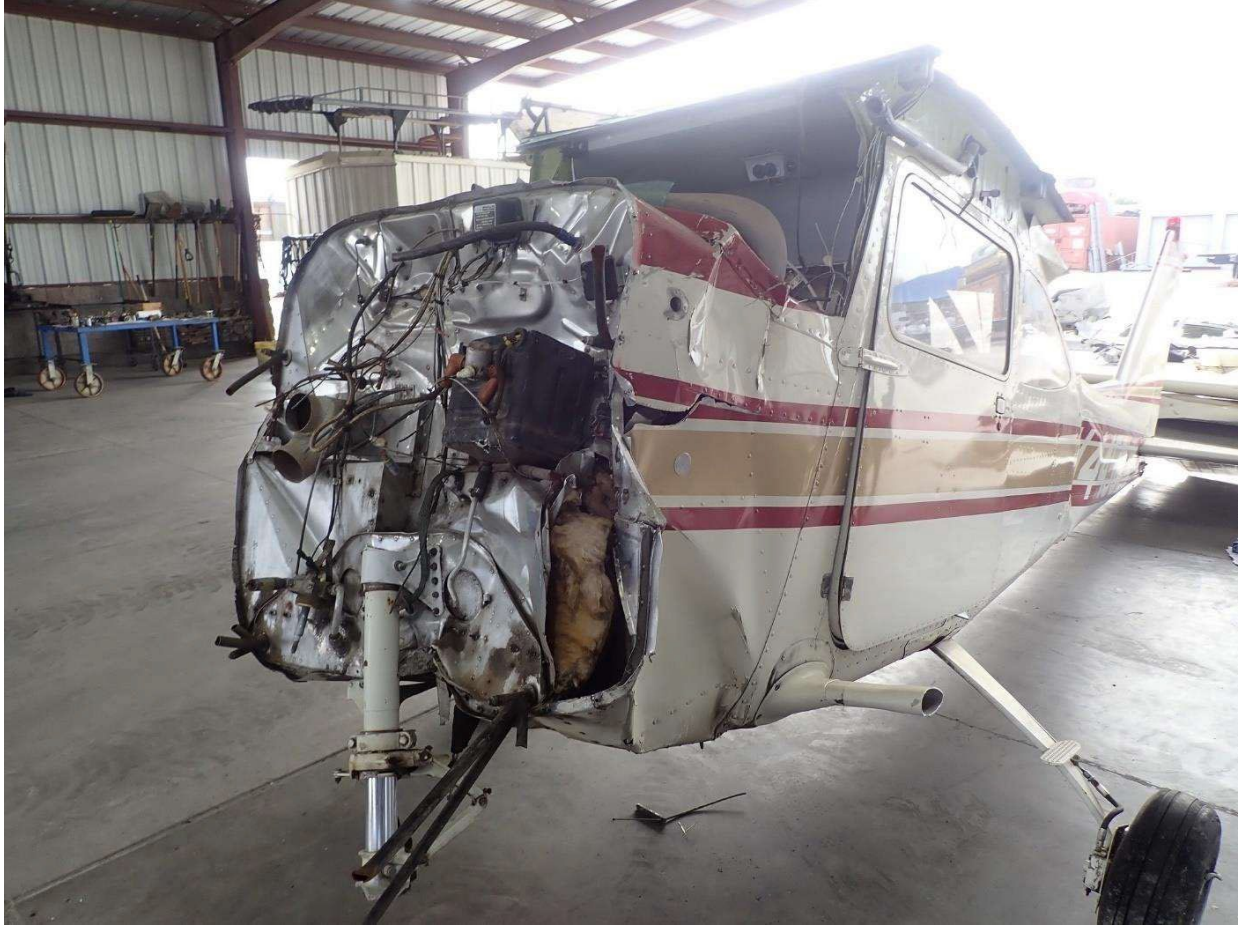
Landing gear. Nose wheel was broken off at the bottom of the strut. Despite the front tire and wheel being dislocated from the wheel support structure, the strut remained attached to the firewall slightly bent to the left.

*Figure 12-Damage to engine compartment and front wheel, courtesy Textron*

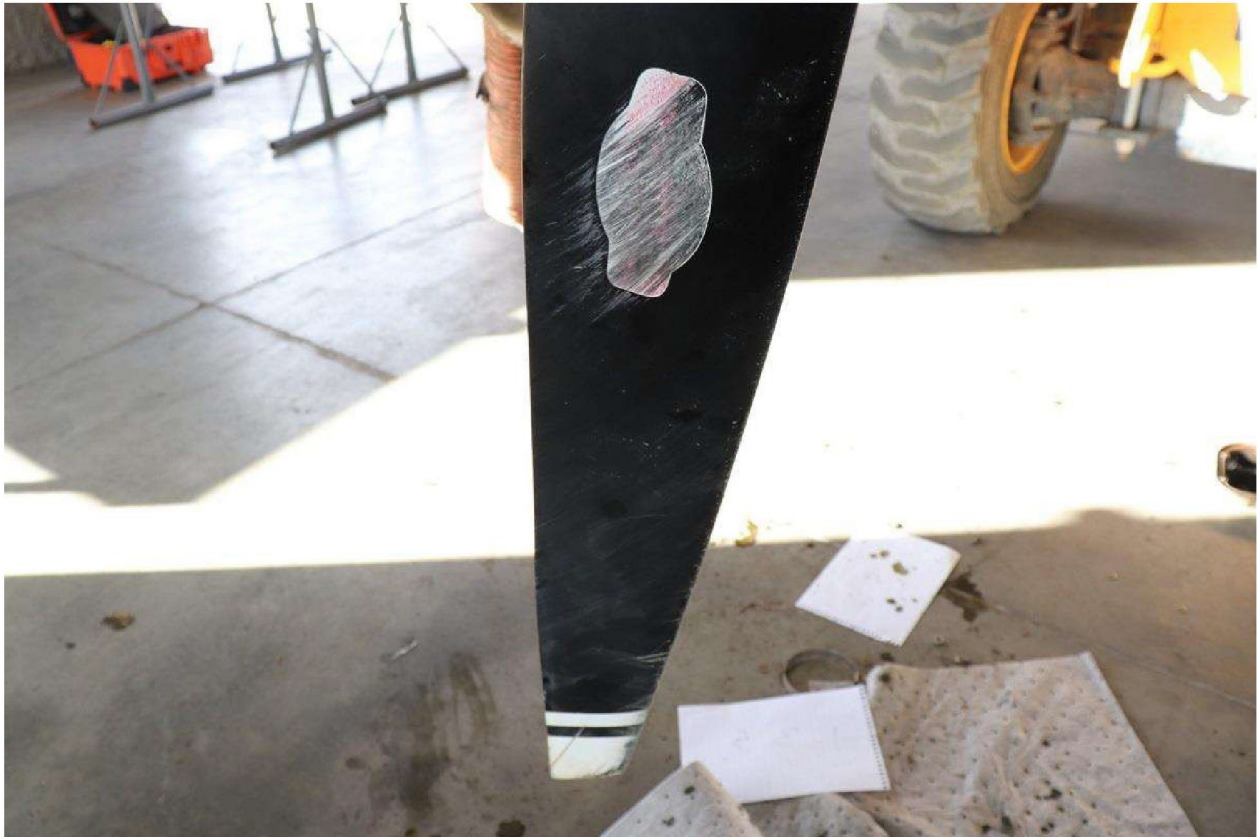
Blade A had a slight aft bend 18 in from the hub. Some light scratches were found on the camber side. The scratches were diagonal to the leading edge but began on the trailing edge of the blade. With the blade at the 12 o'clock position the scratches were from the 2 o'clock to the 7 o'clock direction. The tip was intact without damage except for light scratching from the 11 o'clock to the 5 o'clock direction.

*Figure 13-Propel/or Scratches, courtesy NTSB*

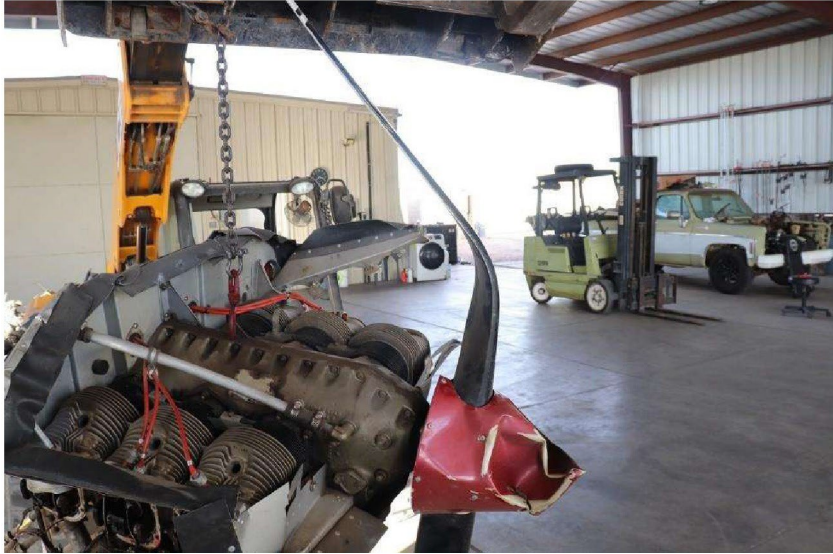
Blade B had a more prominent bend than A. About 10 inches from the hub, the blade was bent about 45 degrees to the rear. The leading edge had a  $\frac{1}{4}$  inch wide dent by one inch located 5 inches from the blade tip.

*Figure 14-Propellor with bend, courtesy NTSB*

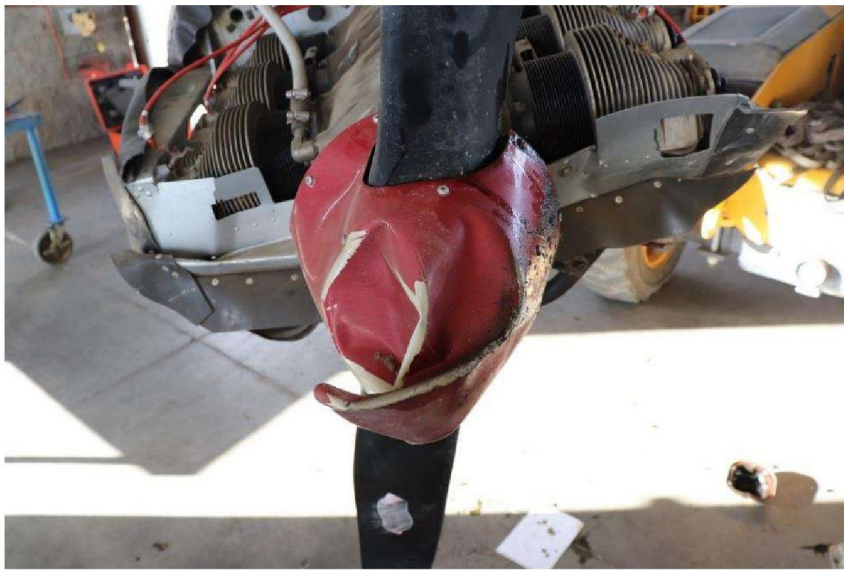
The spinner tip was crushed but remained on the airplane. All mounting hardware was intact.

*Figure 15-Spinner*
