## **NATIONAL TRANSPORTATION SAFETY BOARD**

### **ENGINE EXAMINATION NOTES**

**WPR21LA127**

Location: Marana, AZ  
Date: February 27, 2021  
Aircraft: N6135T, Cessna 150E  
NTSB IIC: Albert Nixon

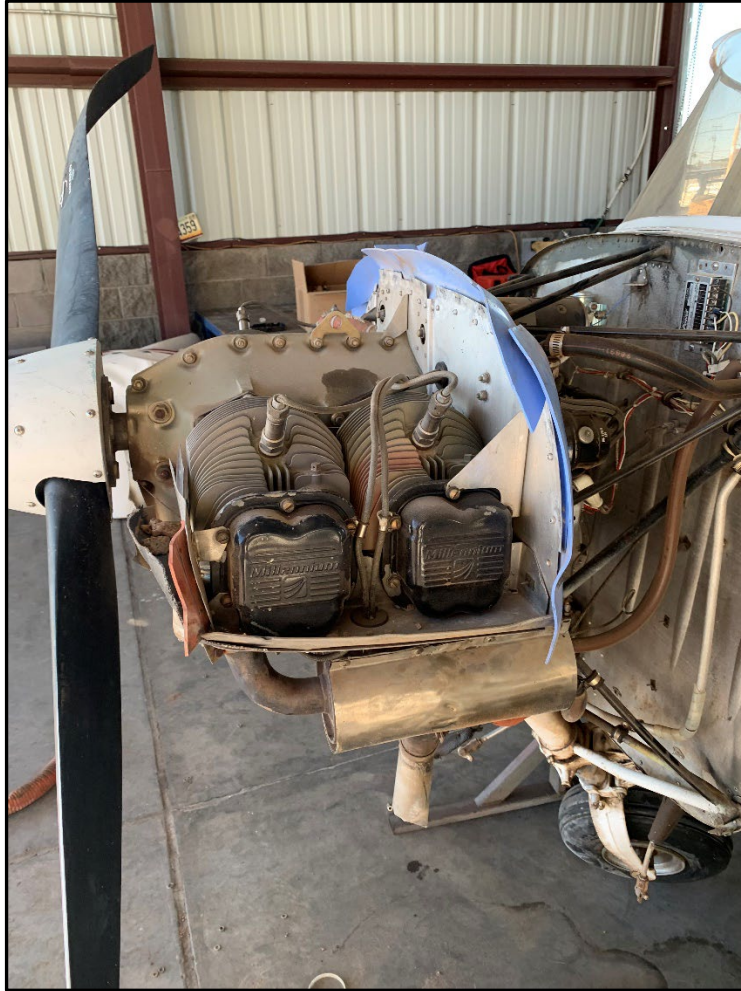
The engine was partially attached to the front of the fuselage. The bottom portion of the engine was observed to sustain impact damage. All engine accessories appeared to be attached and intact.

**Figure 1: Engine as viewed from the left side.**
