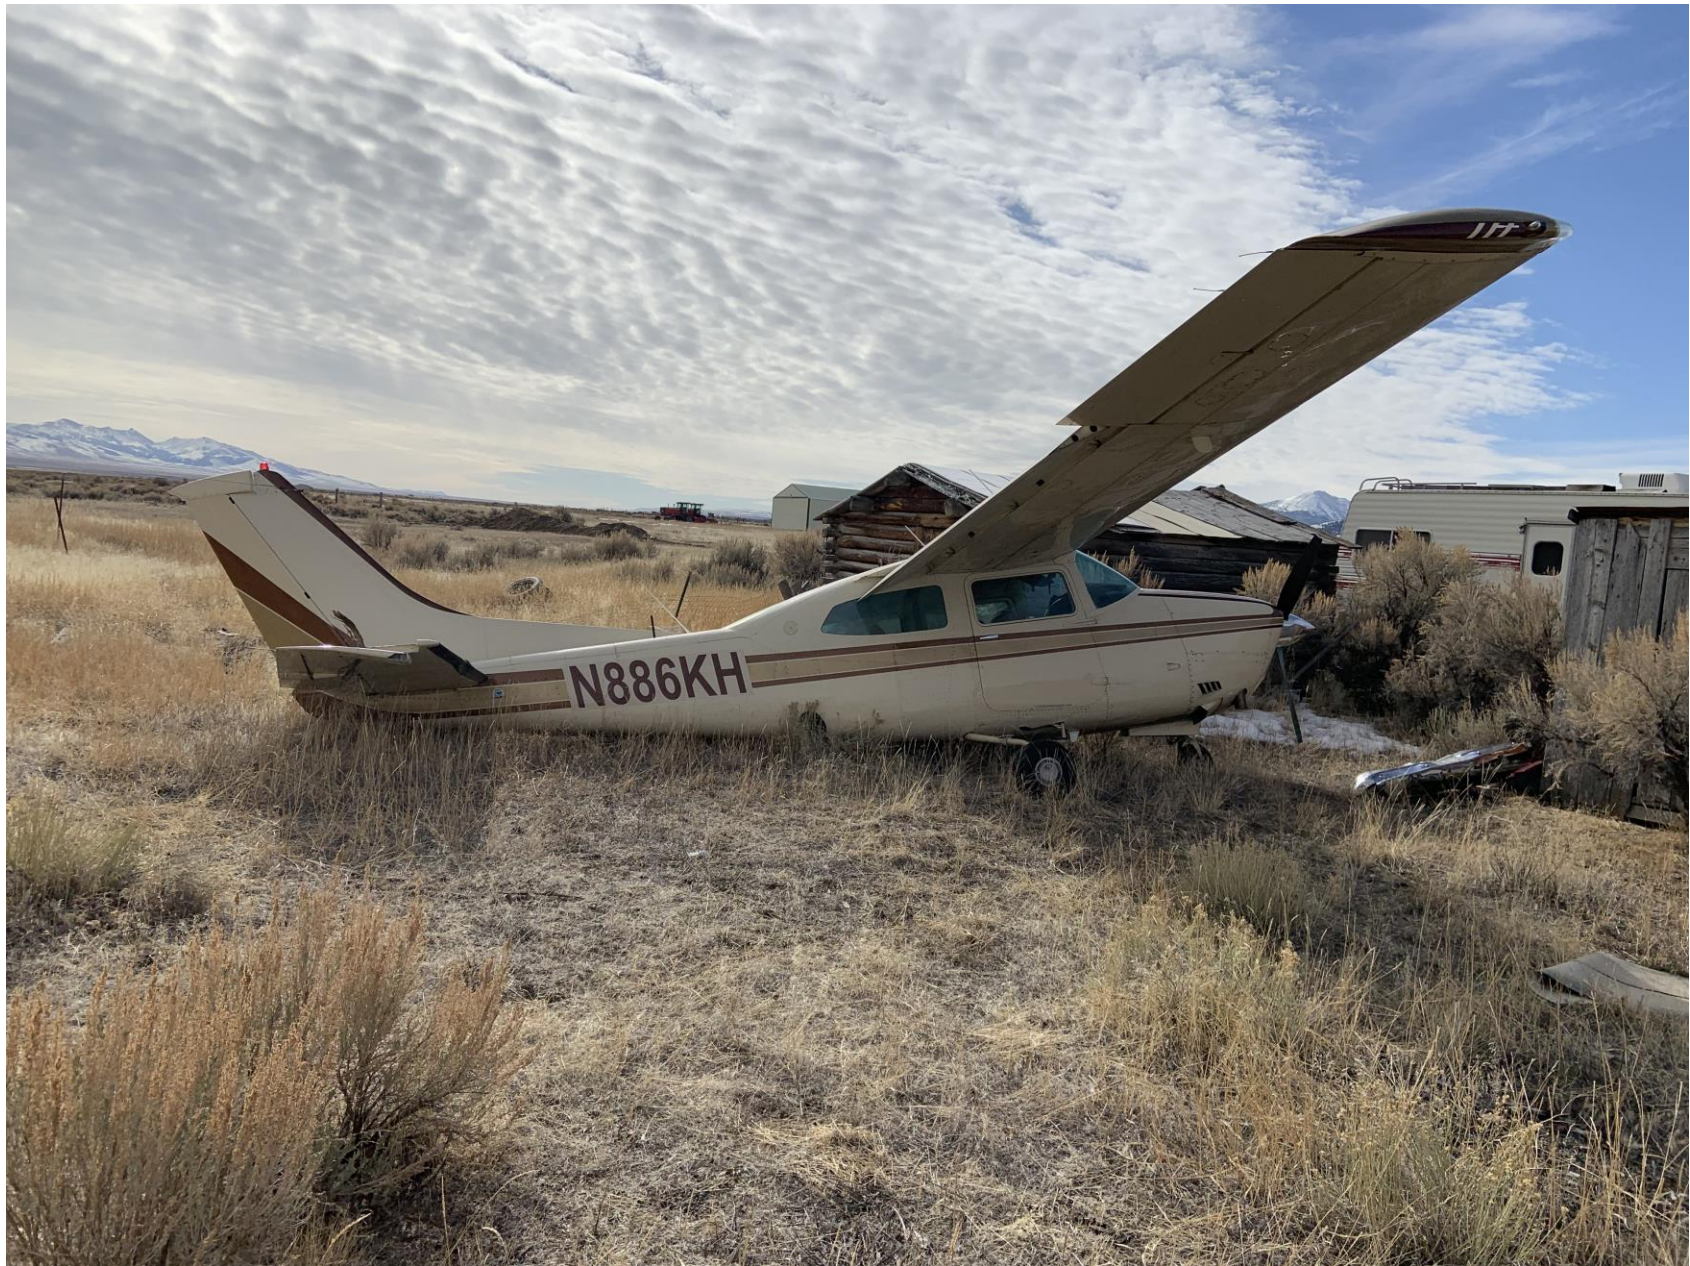
**Photo 1 – Accident site, southeast view of the main wreckage. (Courtesy of the Lemhi County Sheriff's Office)**

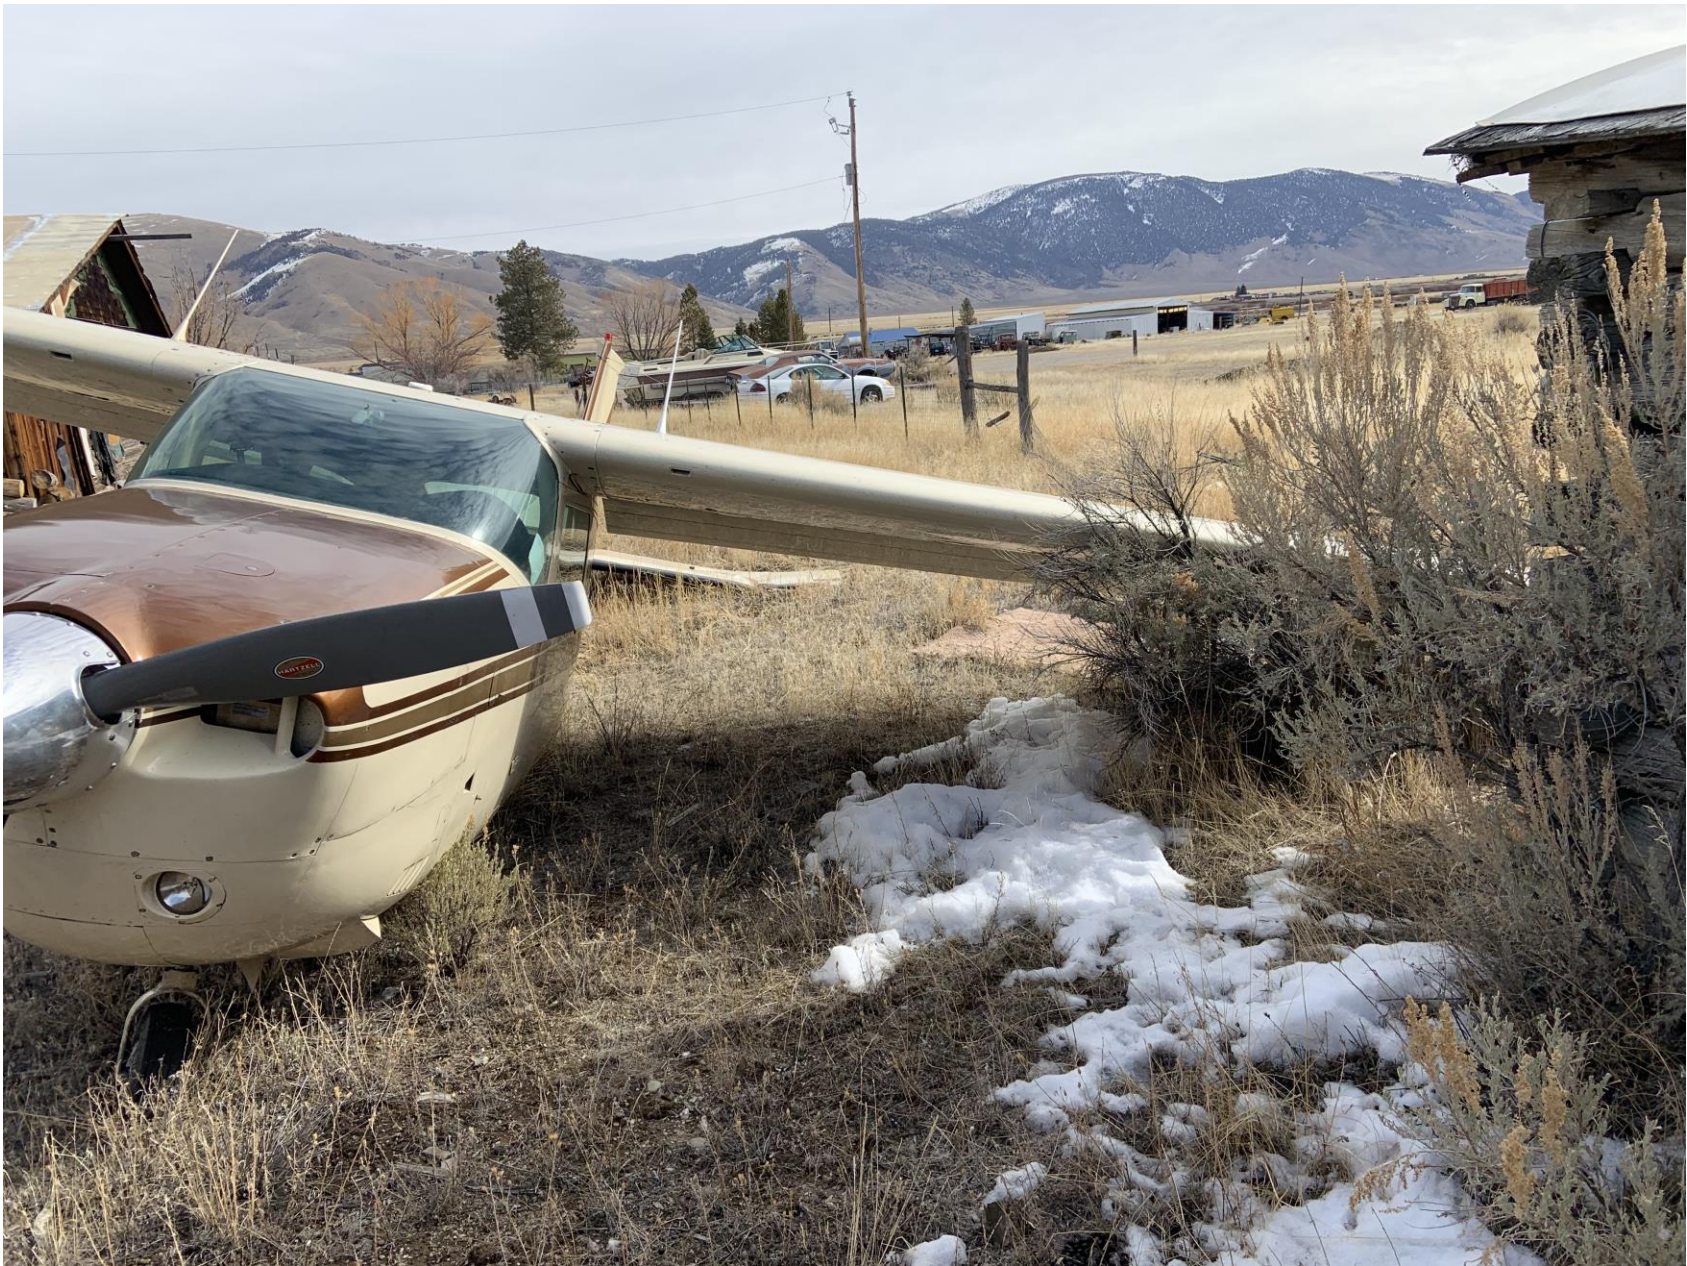
**Photo 2 – Accident site, east view of the main wreckage. (Courtesy of the Lemhi County Sheriff's Office)**

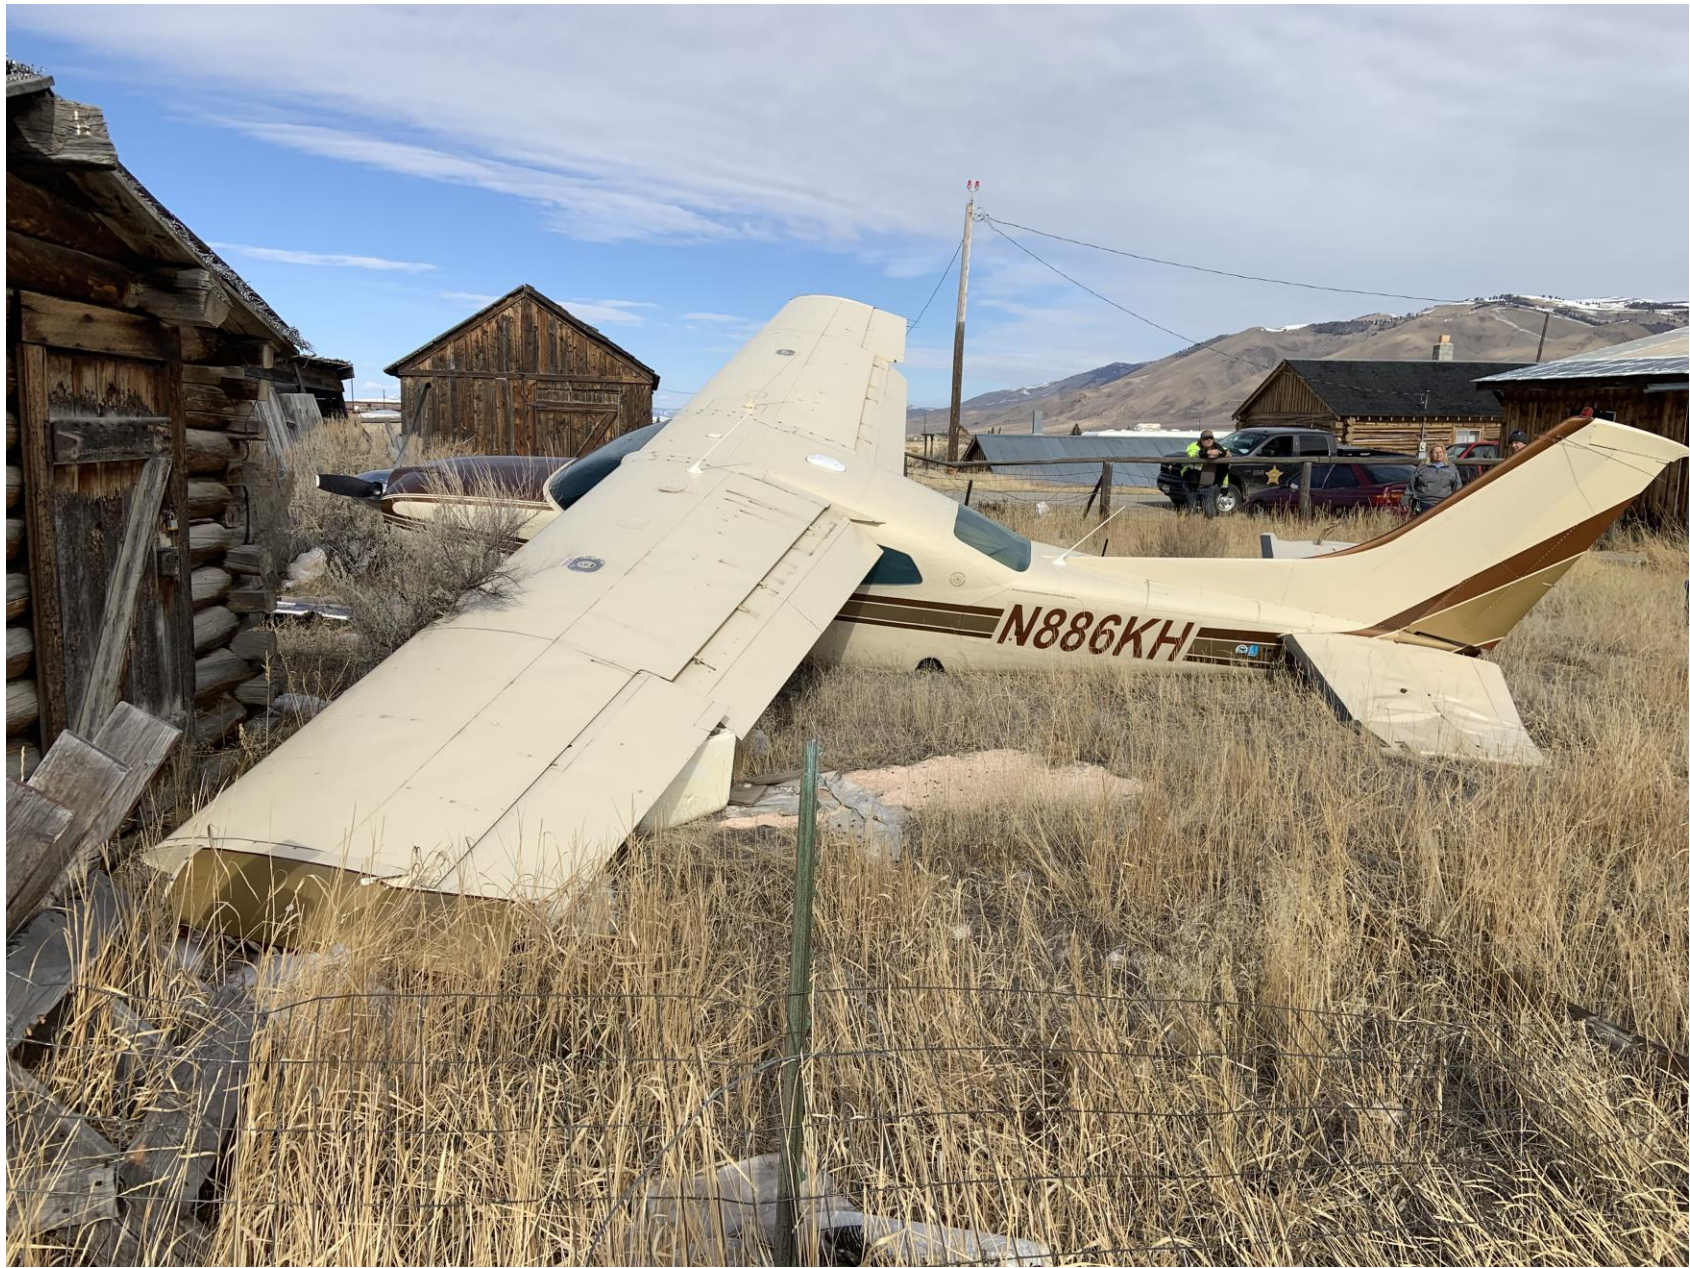
**Photo 3 – Accident site, northeast view of the main wreckage. (Courtesy of the Lemhi County Sheriff's Office)**

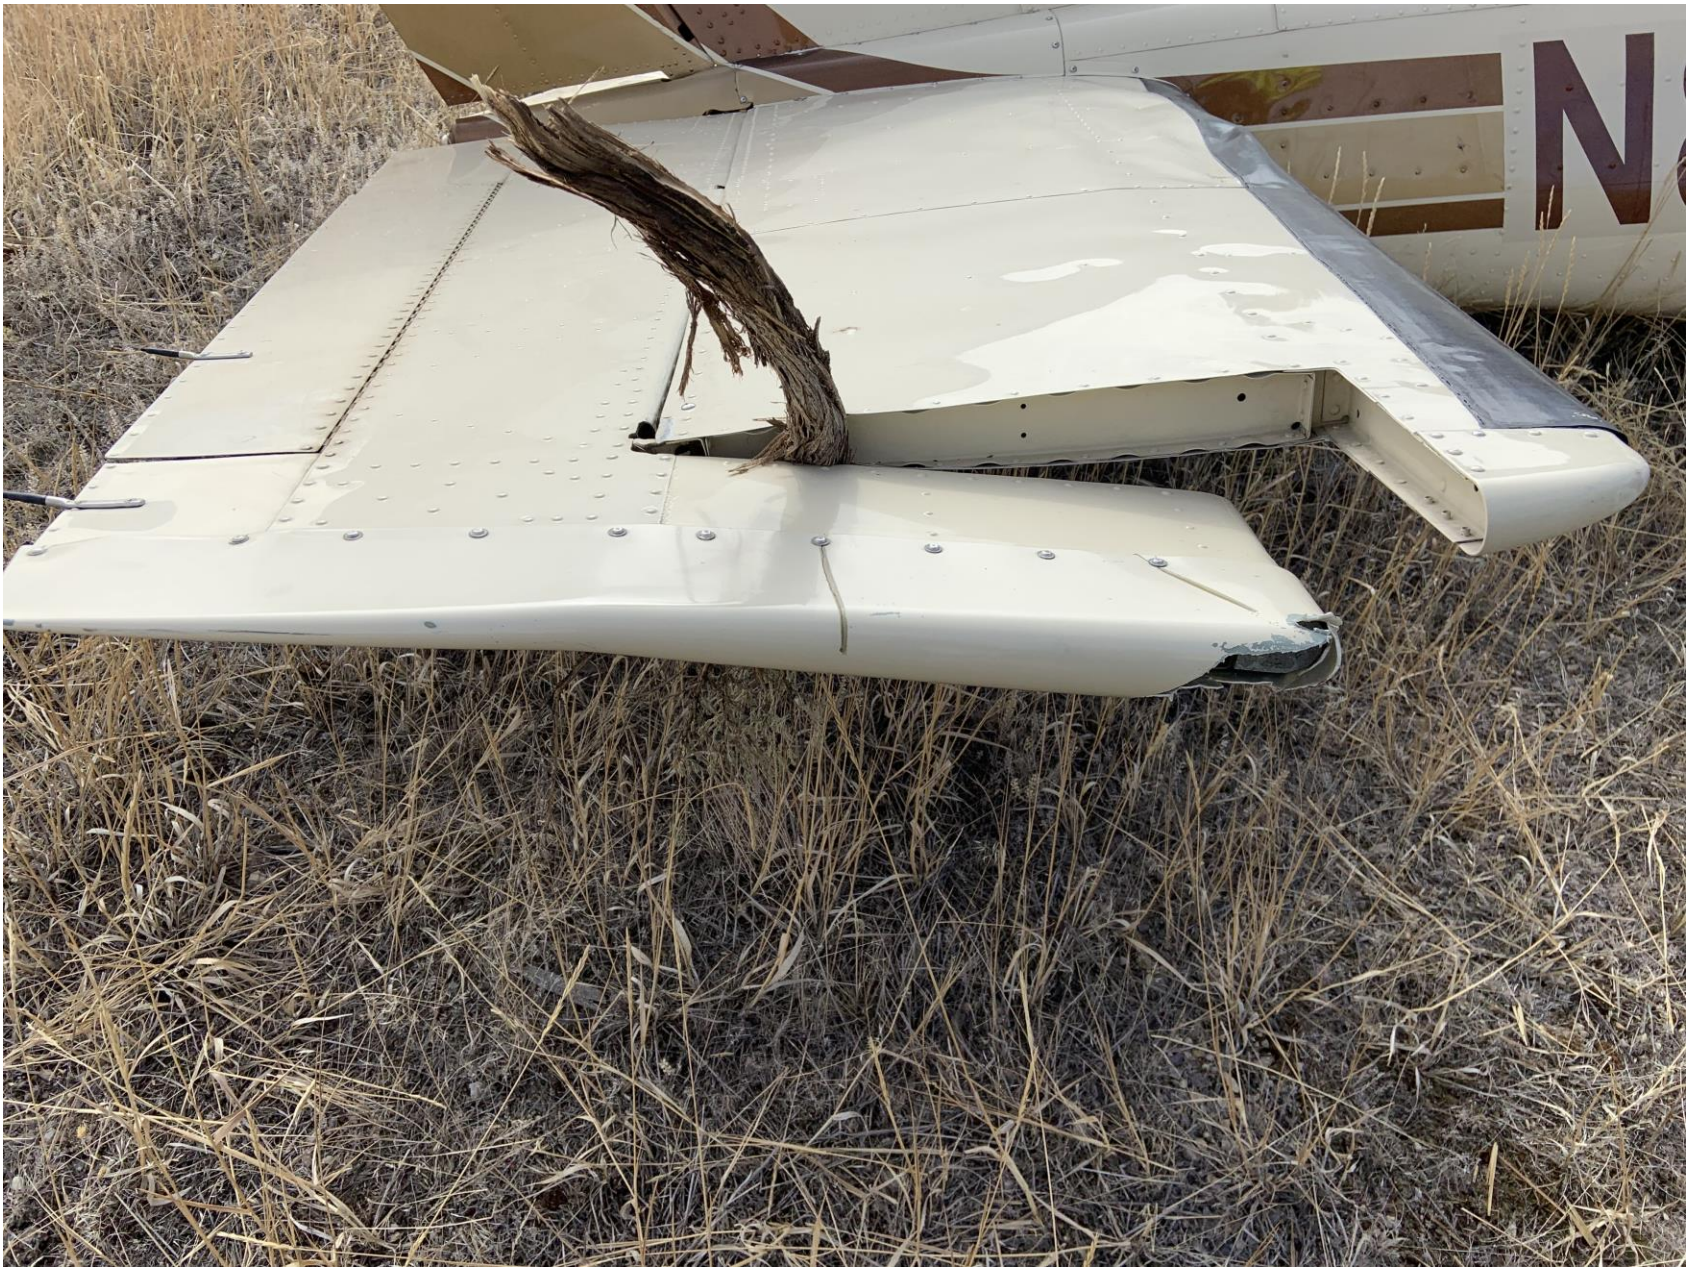
**Photo 4 – Accident site, right horizontal stabilizer and elevator. (Courtesy of the Lemhi County Sheriff's Office)**

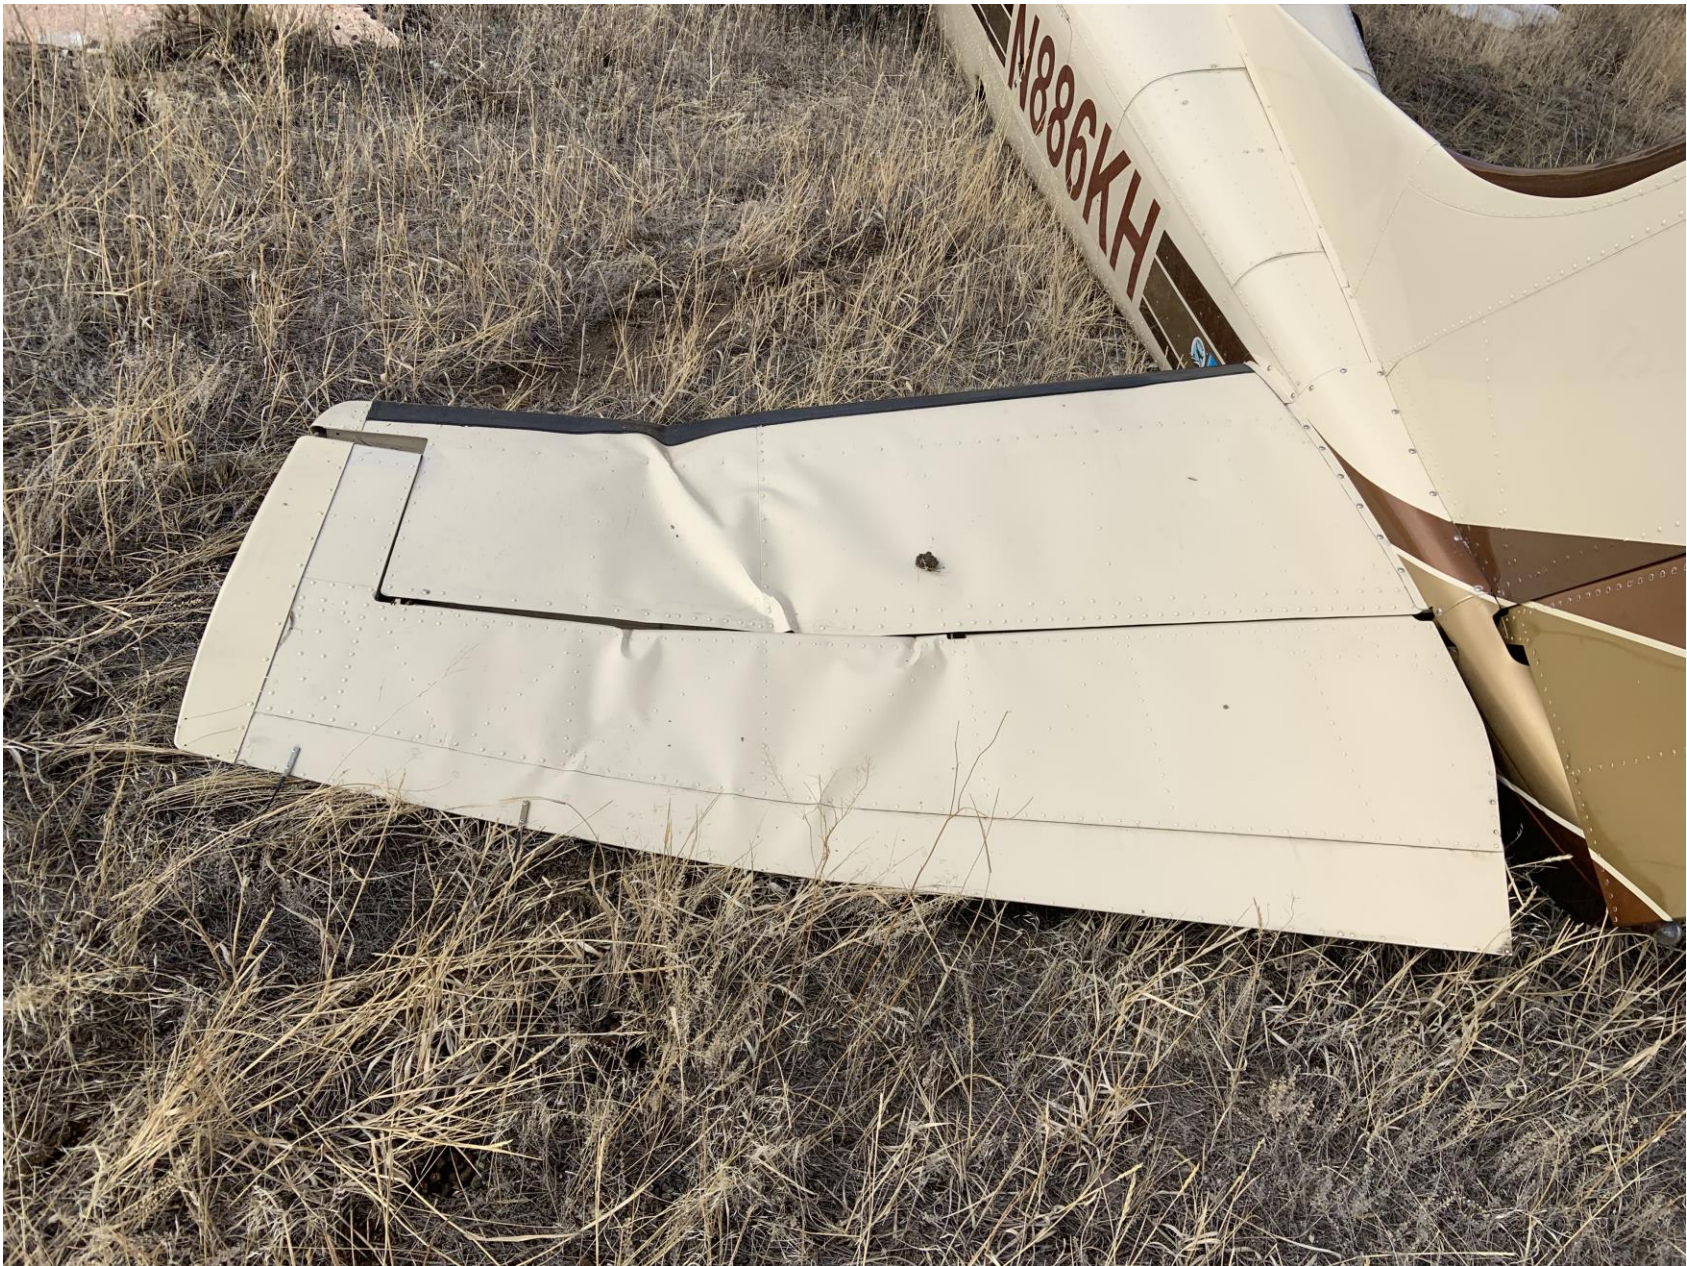
**Photo 5 – Accident site, left horizontal stabilizer and elevator. (Courtesy of the Lemhi County Sheriff's Office)**

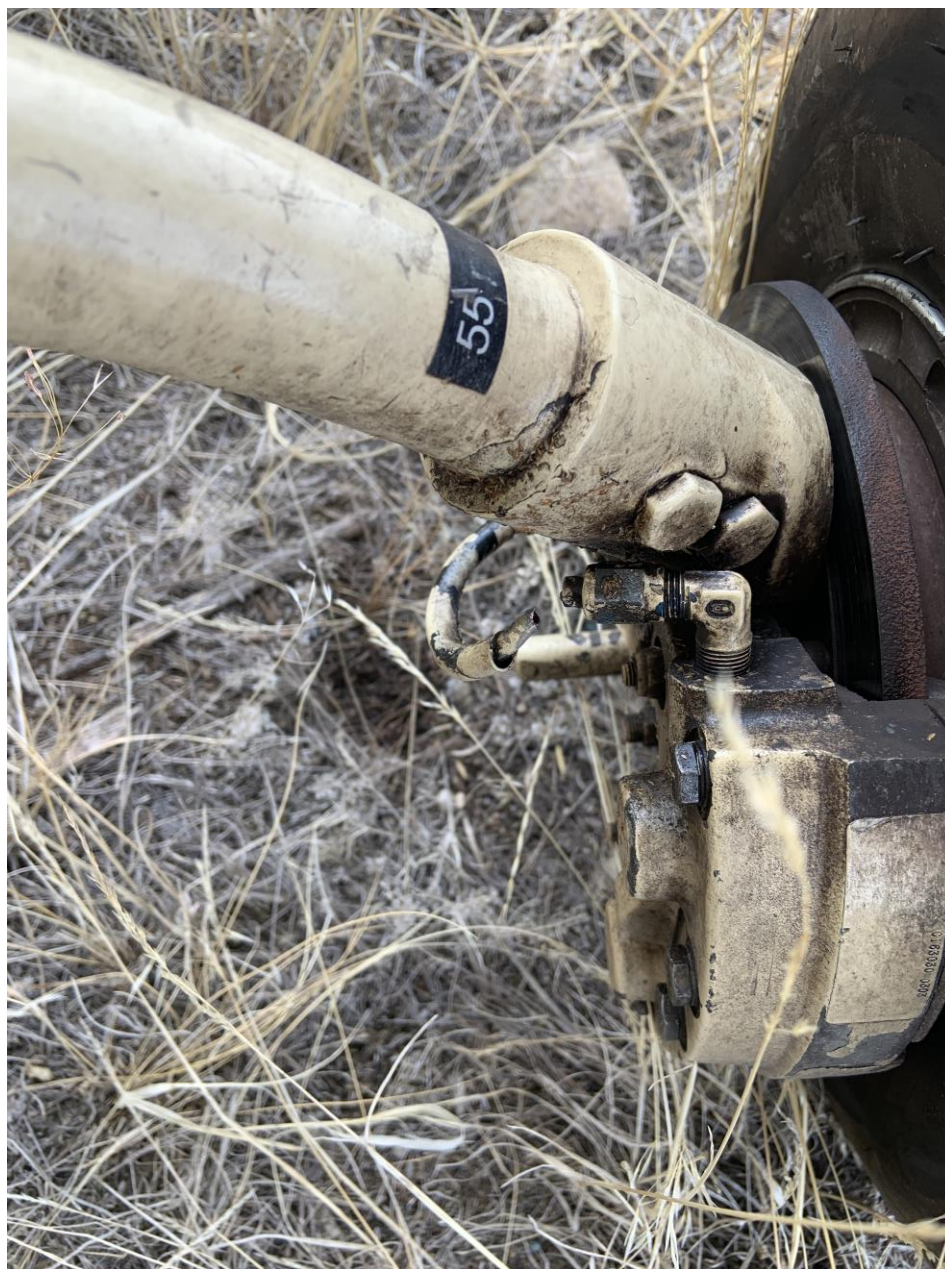
**Photo 6 – Accident site, left main landing gear brake assembly. (Courtesy of the Lemhi County Sheriff's Office)**

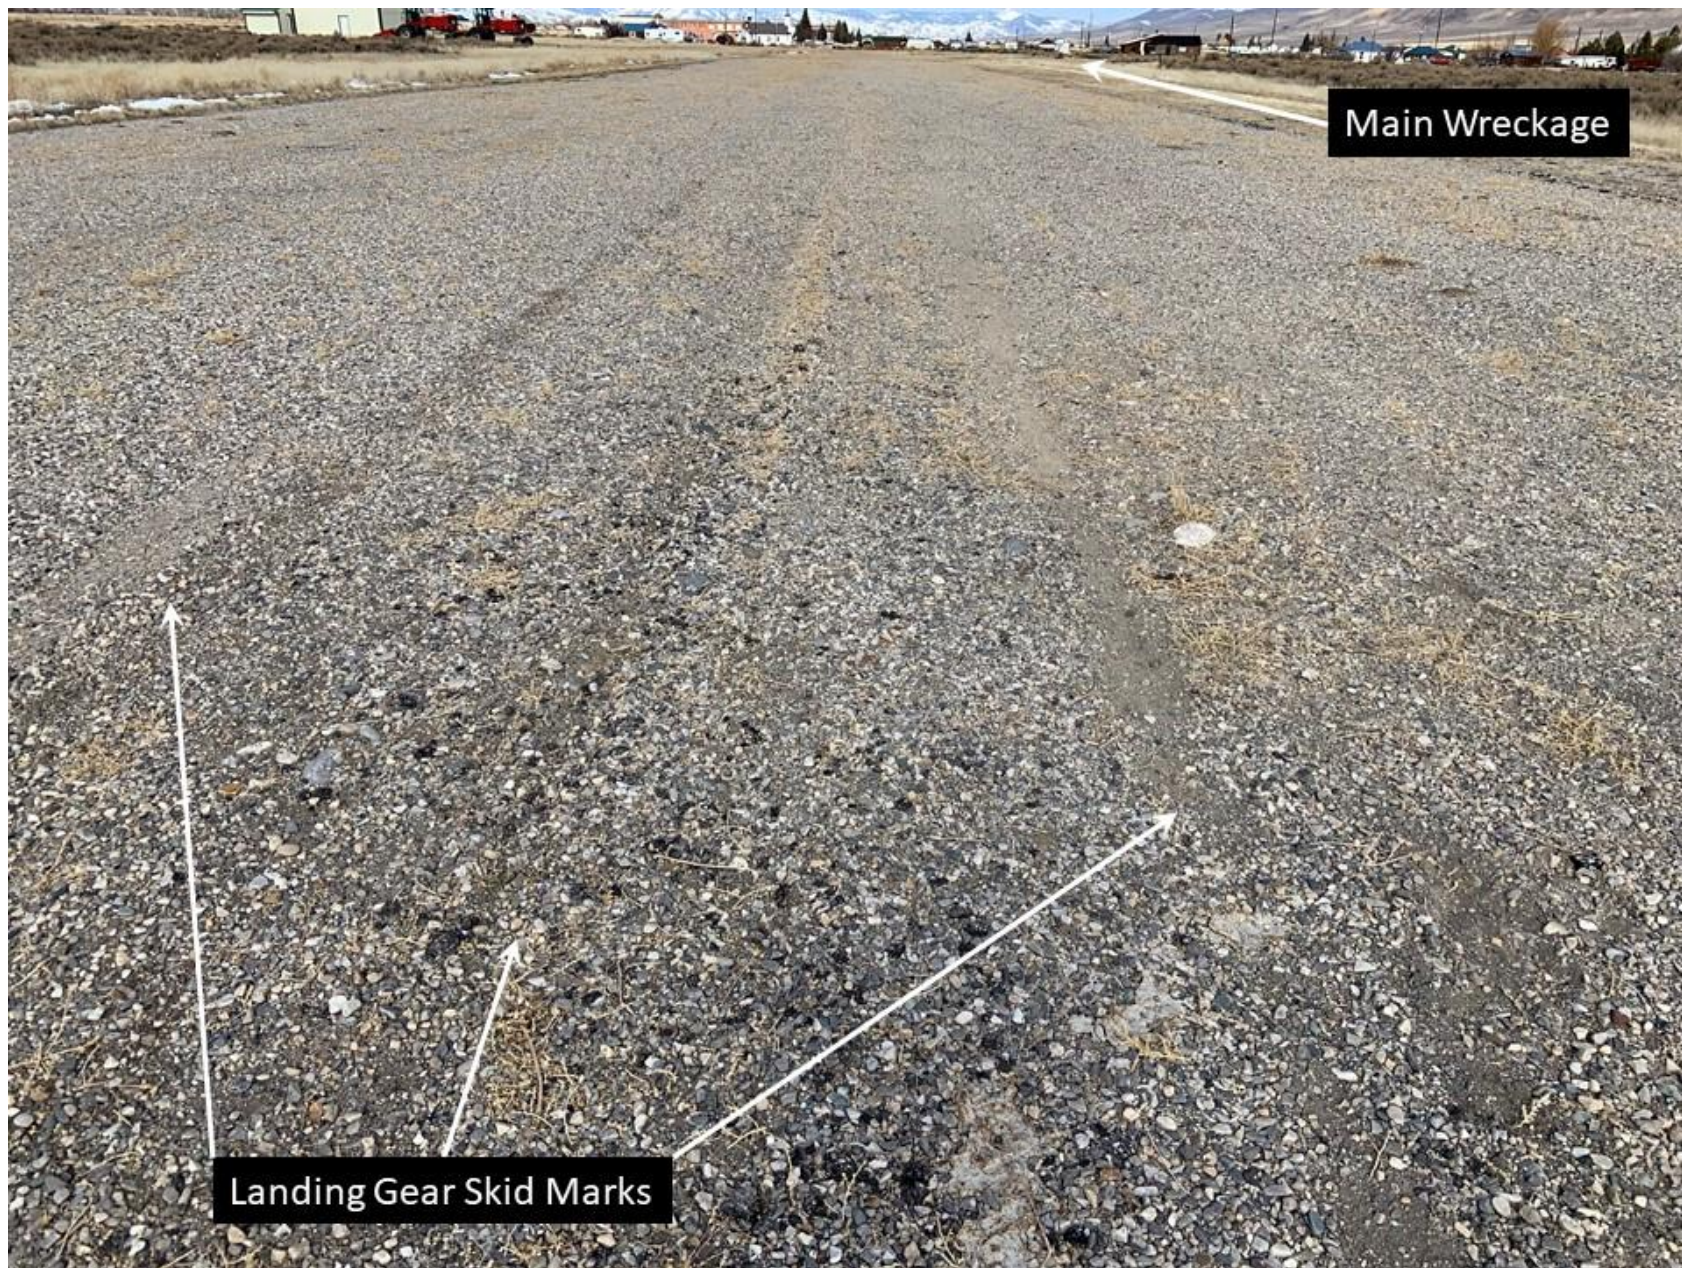
**Photo 7 – Accident site, first identified contact with the runway. (Courtesy of the Lemhi County Sheriff's Office)**
