## **NATIONAL TRANSPORTATION SAFETY BOARD**

# **AIRFRAME AND ENGINE EXAMINATION**

**WPR21LA140**

Location: Everett, Washington  
Date: March 23, 2021  
Aircraft: Cessna, 172S, N2164Z  
NTSB Investigator-in-Charge: Maja Smith

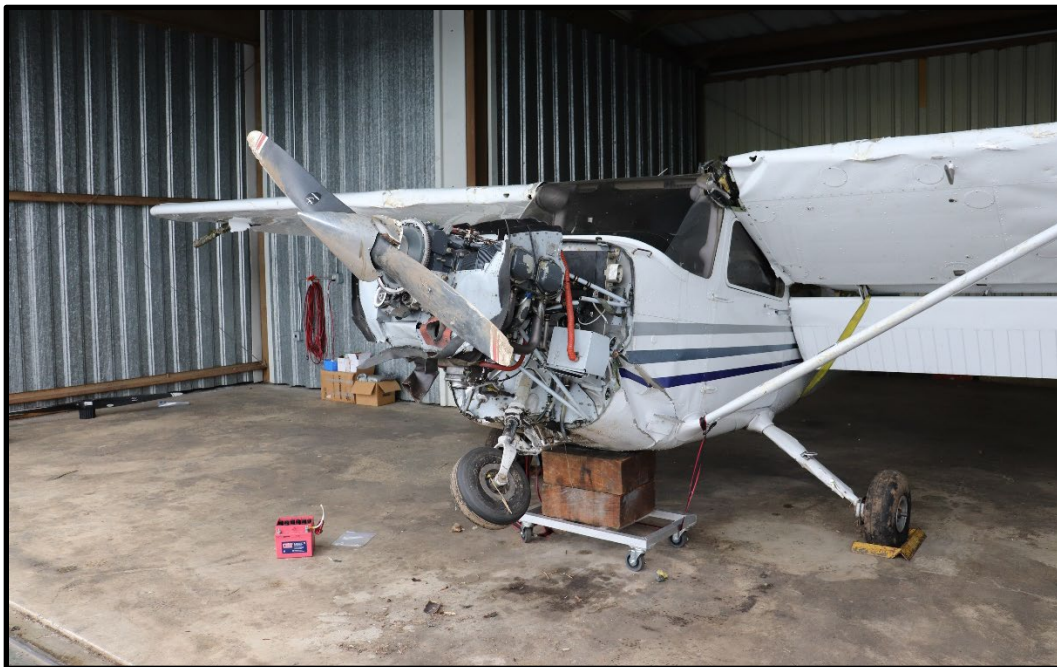
Examination of the recovered wreckage revealed that the nose landing gear had impact damage, the top section, at the firewall attachments were bent forward. The firewall exhibited crushing and bending aft. The left-wing fuel line was crimped closed near the wing root by recovery personnel to stop a fuel leak.

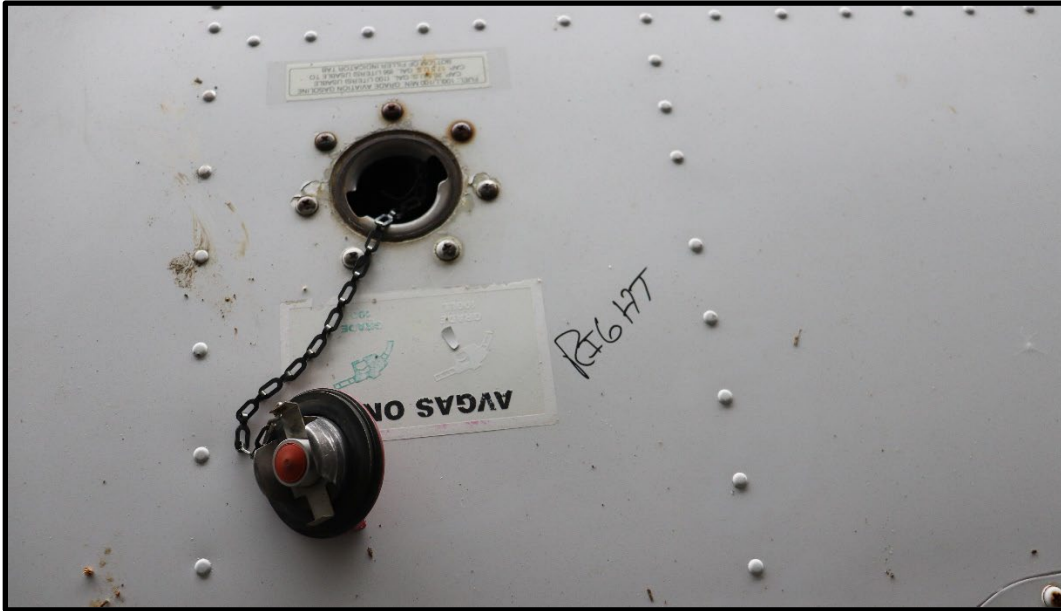
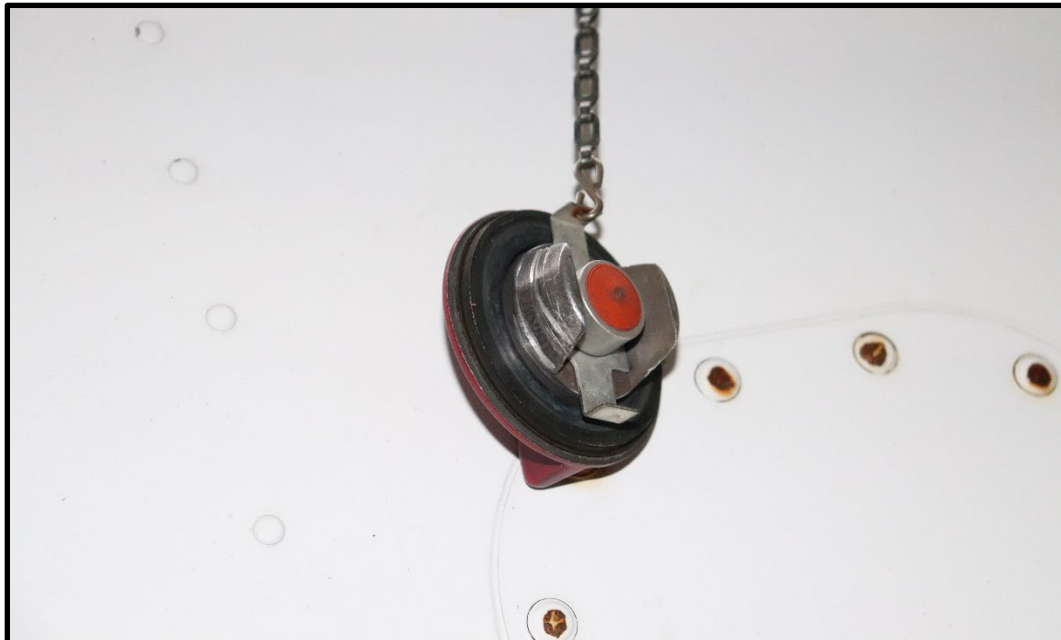
The left and right wings remained attached to the airframe and exhibited buckling throughout. The left wing was partially separated, the aft wing spar was fracture separated near the wing root. Visual inspection of the left and right fuel caps revealed that both fuel caps rubber seals appeared worn. The observed tachometer time was 4477.9 hours and the HOBBS meter indicated 6090.2 hours.

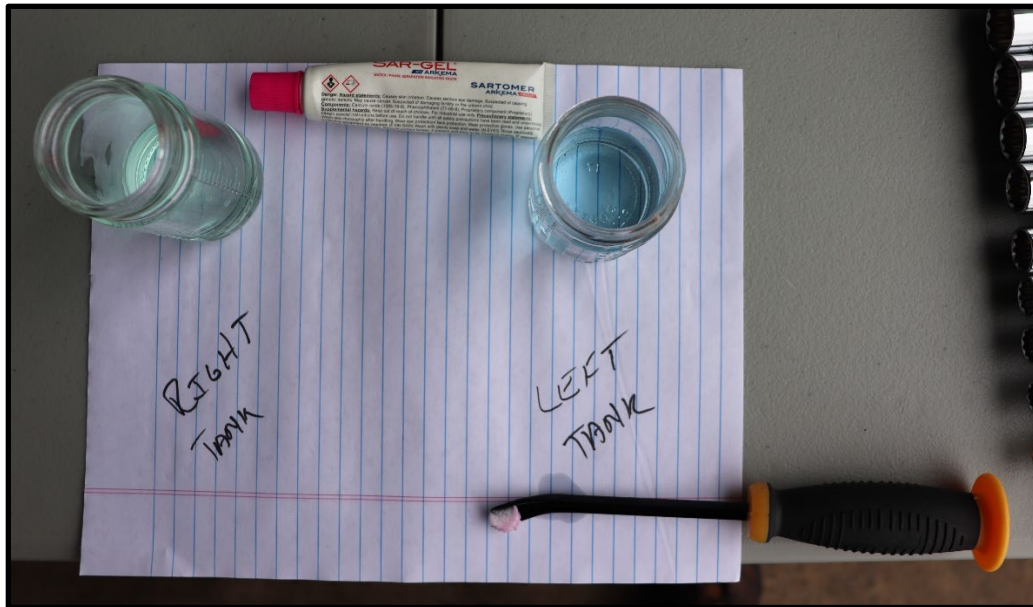
A visual inspection was conducted of the fuel system. Continuity was established from the main fuel tanks throughout the system to the gascolator fuel fitting at the firewall. When the airframe electric fuel pump was turned on, fuel expelled from the fuel fitting at the firewall. Visual inspection of the gascolator fuel and minor debris.. The fuel was tested for water using SAR-GEL water finding paste, with negative results.

Figure 4: View of SAR-GEL water finding paste (photo courtesy of the NTSB)

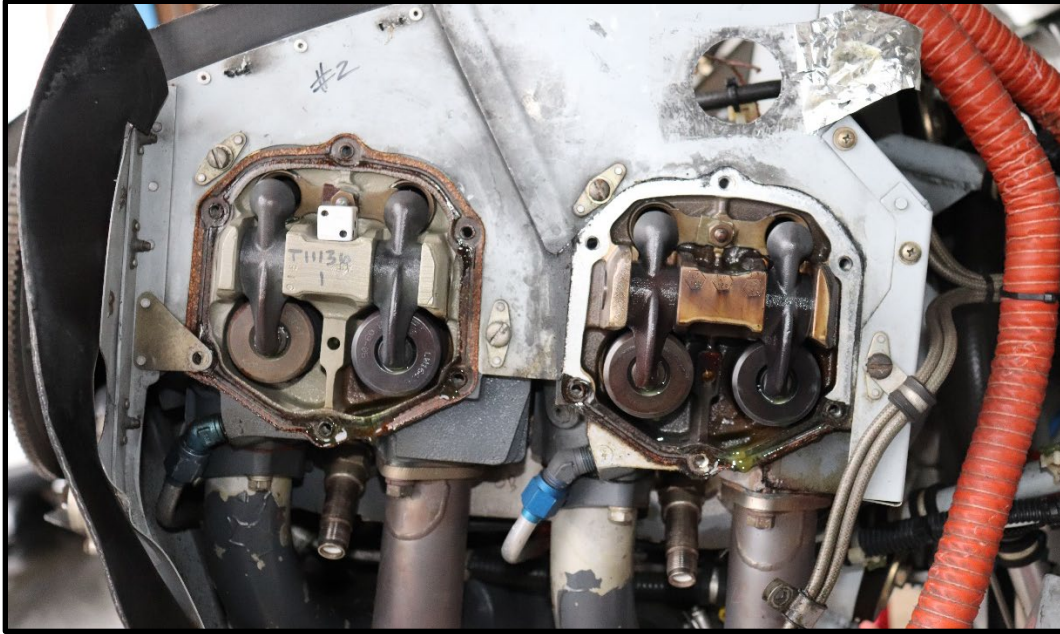
Examination of the recovered engine revealed that it remained attached to the engine mounts. All four cylinders and all engine accessories remained attached. All fuel and oil lines appeared attached to their respective fittings and were tight. No evidence of any mechanical damage was observed to the engine crankcase.

Figure 5: View of left side of the engine (photo courtesy of the NTSB)

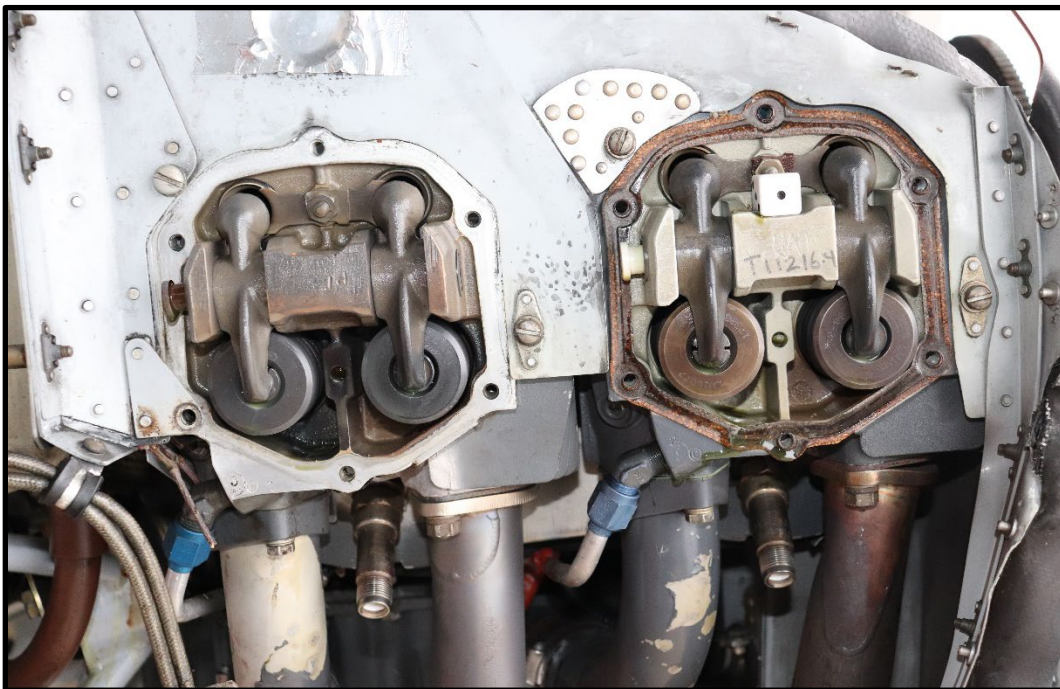
Figure 6: View of right side of the engine (photo courtesy of the NTSB)

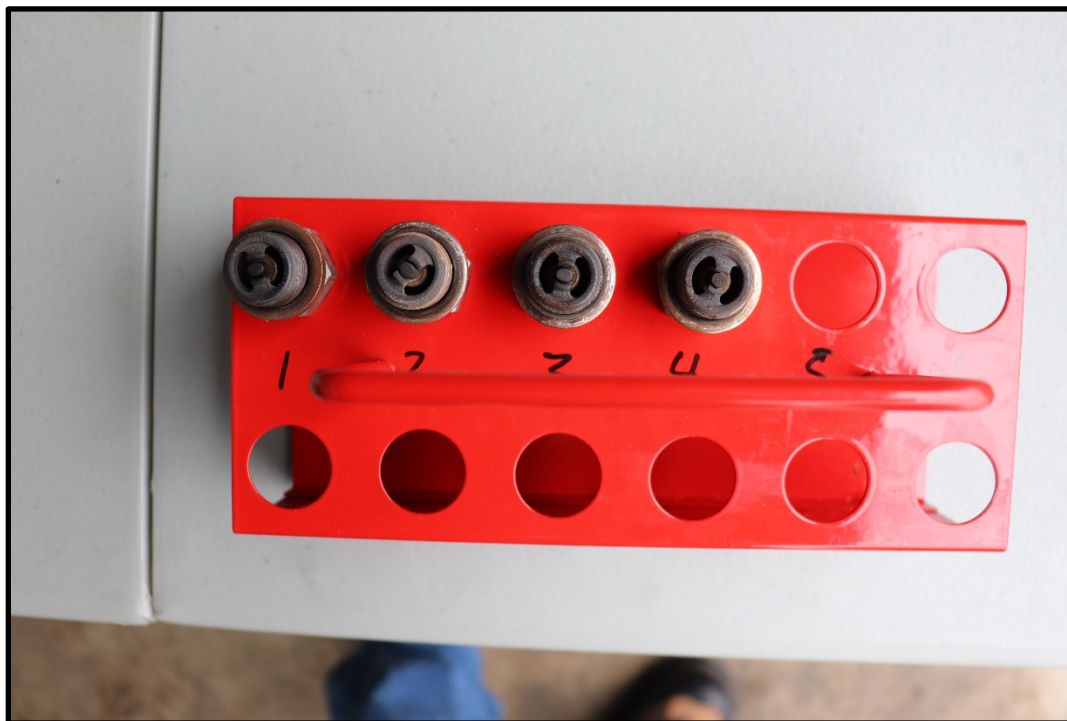
The top spark plugs were removed from the engine. Dark gray coloration within the electrode areas was observed. When compared to the Champion Check-A-Plug chart, the sparkplugs exhibited NORMAL use signatures.

Figure 7: View of top spark plugs (photo courtesy of the NTSB)

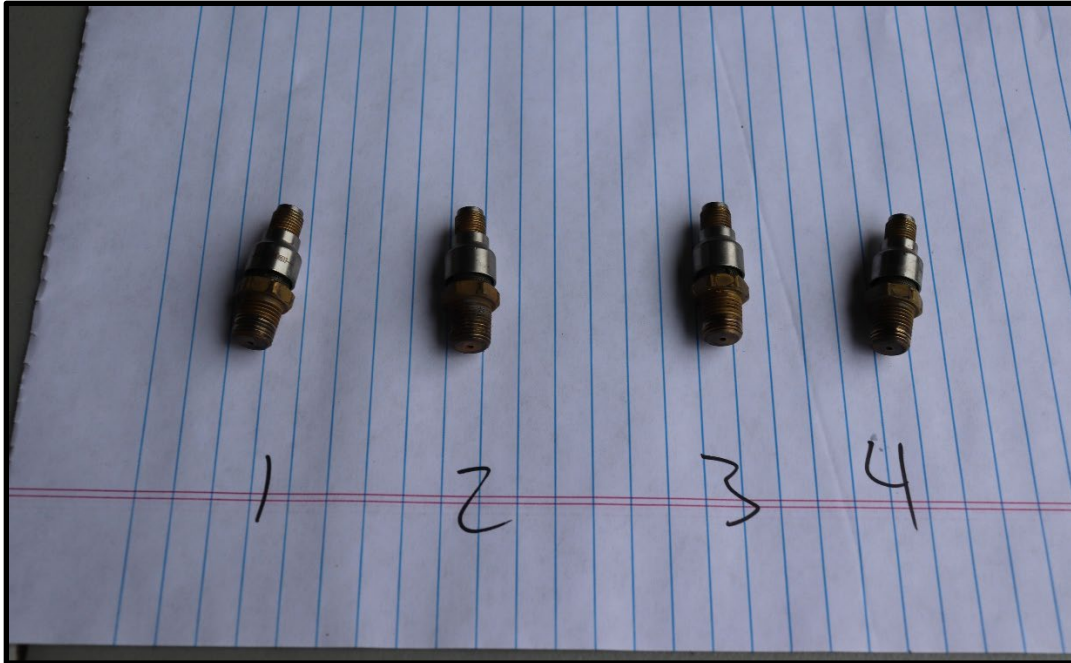
All four fuel injector nozzles were removed from the cylinders and found to be free of debris or restrictions.

Figure 8: View of fuel injector nozzles (photo courtesy of the NTSB)
