## **NATIONAL TRANSPORTATION SAFETY BOARD**

### **FUEL SYSTEM COMPONENTS EXAMINATION**

**WPR21LA140**

| Aircraft: | Cessna, 172, N2164Z |

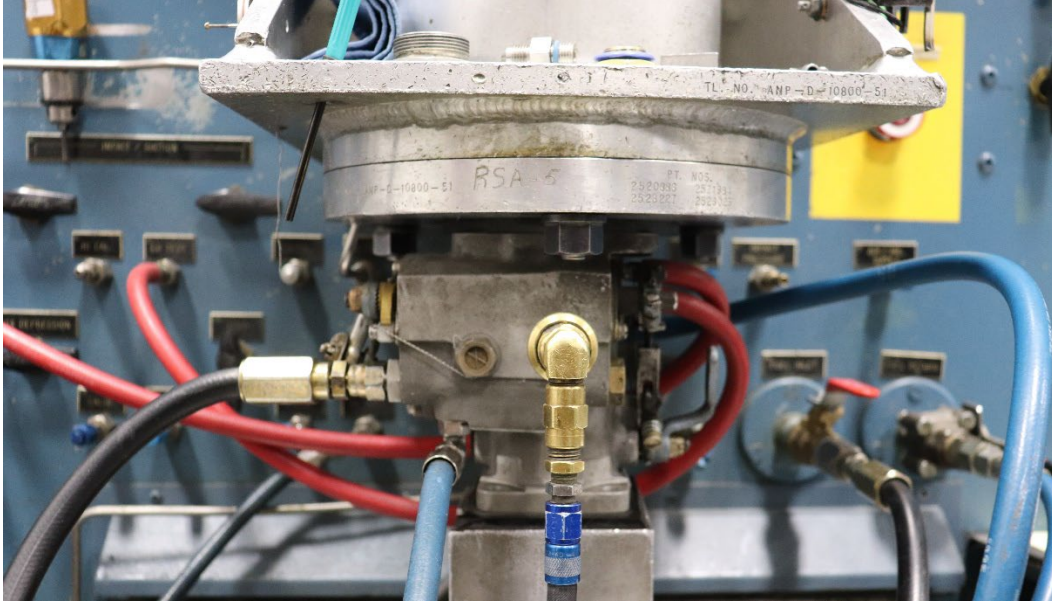
Examination of the servo revealed that the throttle lever was intact and moved freely from stop to stop. The mixture control lever remained attached to the throttle body was damaged but moved freely from stop to stop. The fuel inlet screen was removed, and no debris was observed. The servo was connected to a test stand and performed within manufacturers specifications.

Figure 1: View of fuel servo on test stand (photo courtesy of the NTSB)

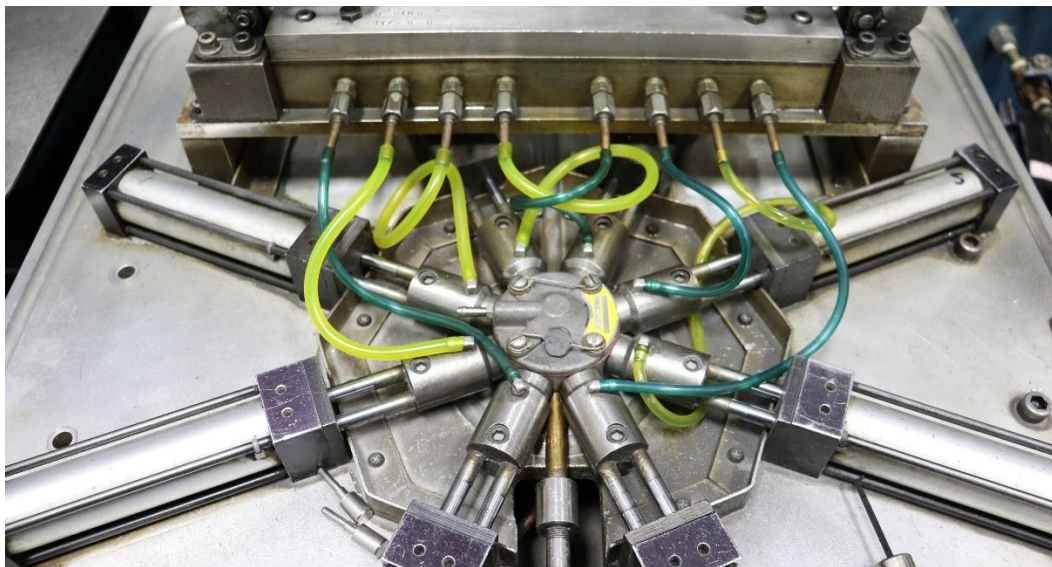
Examination of the fuel flow divider revealed it remained intact and undamaged. The fuel flow manifold valve was connected to a test stand and performed within manufacturers specifications when tested at low flow. When tested at a medium flow, one port was 6 pounds lower than the manufacturers specifications; however, the other 3 ports tested within manufacturers specifications at a medium flow. Per the manufacturer, the port that had the 6 lbs lower fuel flow output would not have an adverse effect on the engine ability to produce power.

Figure 2: View of fuel flow divider on test stand (photo courtesy of the NTSB)
