## **NATIONAL TRANSPORTATION SAFETY BOARD**

### **FUEL PUMP EXAMINATION**

**WPR21LA140**

| Aircraft: | Cessna, 172, N2164Z |

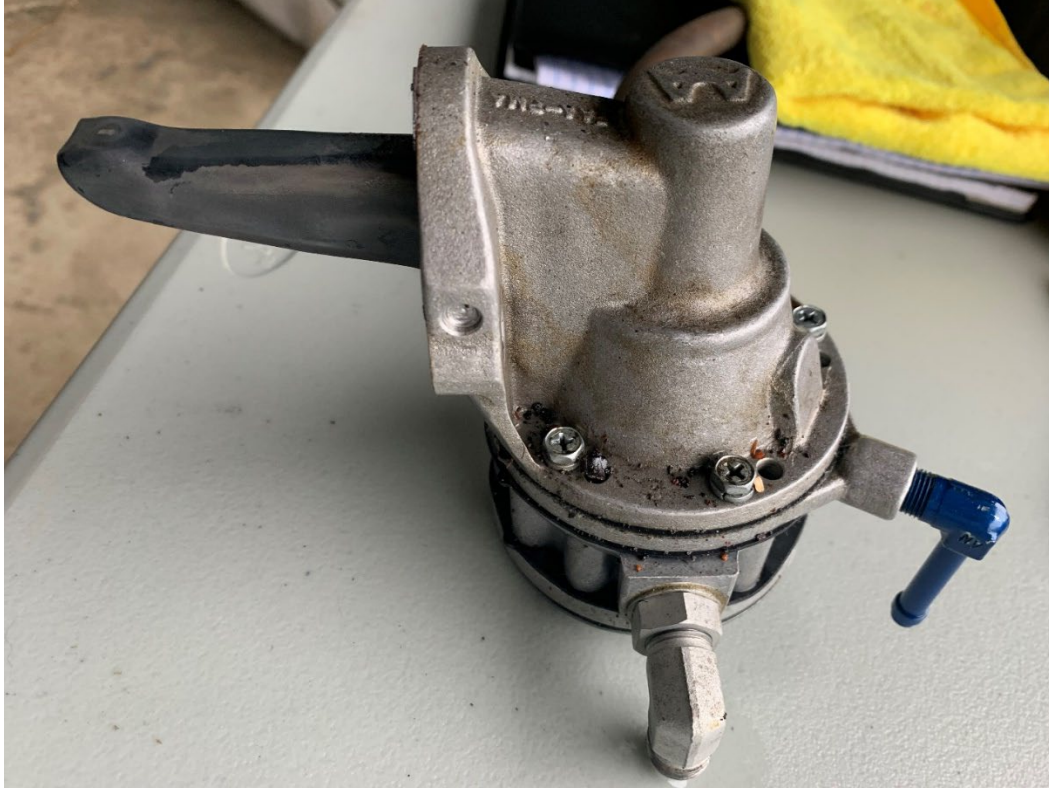
Examination of the mechanical fuel pump revealed that it was intact and undamaged. The actuator control lever remained attached to the fuel pump, was not damaged, and moved from stop to stop. The fuel pump was disassembled, and no debris was observed in the fuel chamber. Oil was observed in the compensator diaphragm chamber. The fuel valves remained in place and were unremarkable. The fuel diaphragm was intact and unremarkable. The oil diaphragm had cracking along the outer edge and a tear about ½ was observed near the center. Per the manufacturer, the tear and cracking on the oil diaphragm would not have an adverse effect on the engine ability to produce power.

Figure 1: View of fuel pump during exam (photo courtesy of the NTSB)

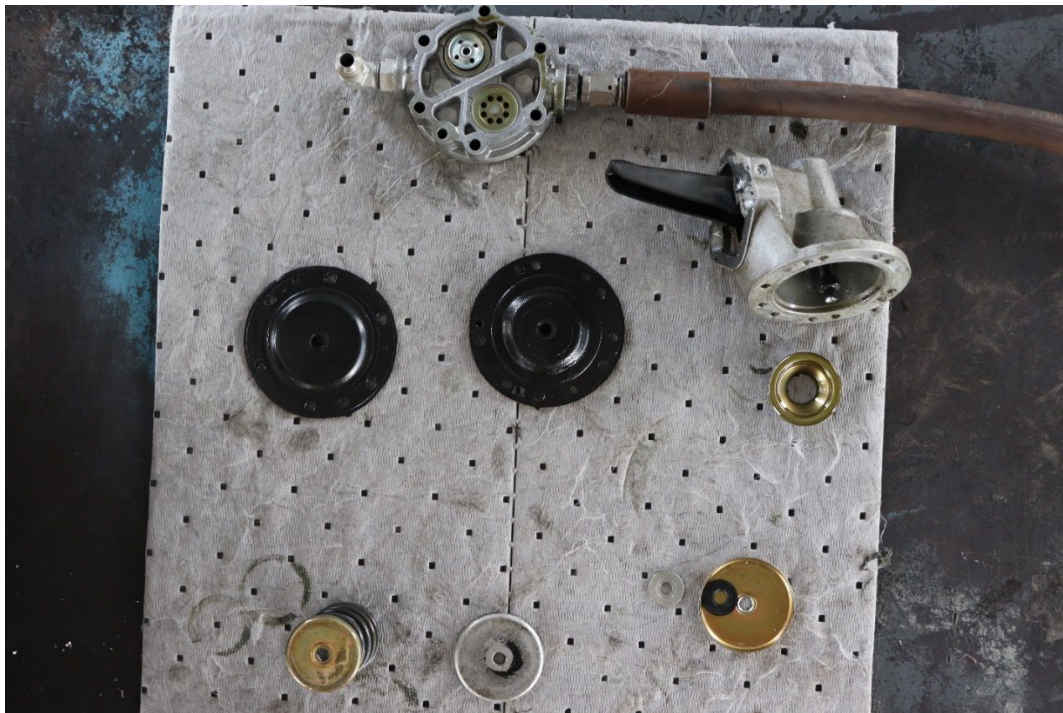
Figure 2: View of disassembled fuel pump during exam (photo courtesy of the NTSB)

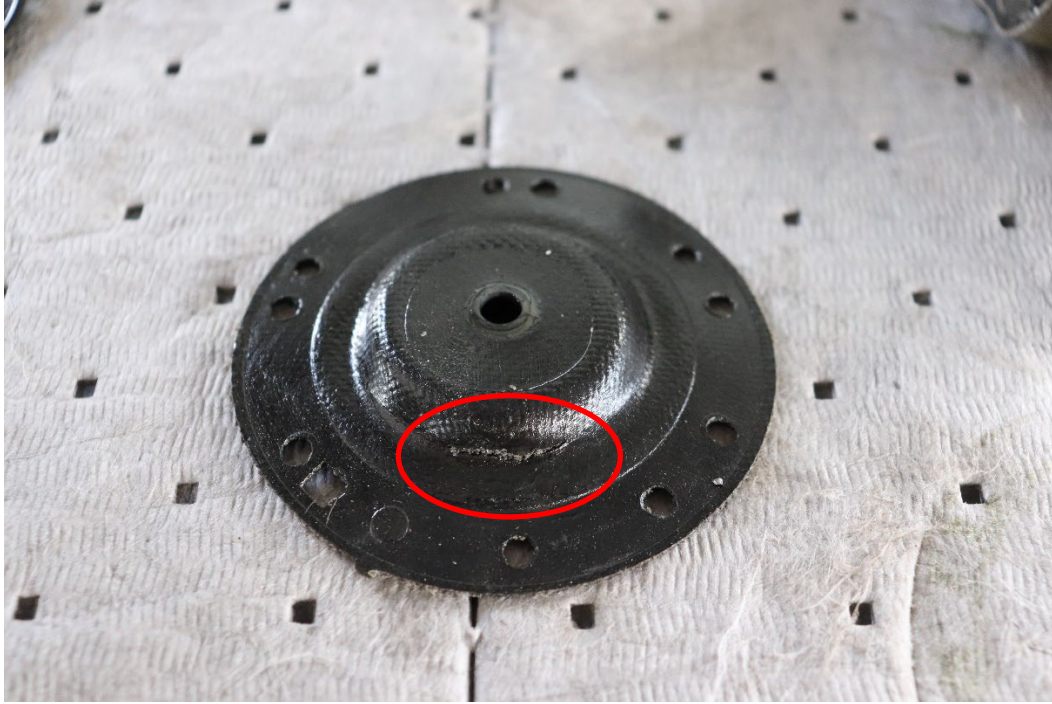
Figure 3: View of oil diaphragm with  $\frac{1}{2}$  tear near center (photo courtesy of the NTSB)

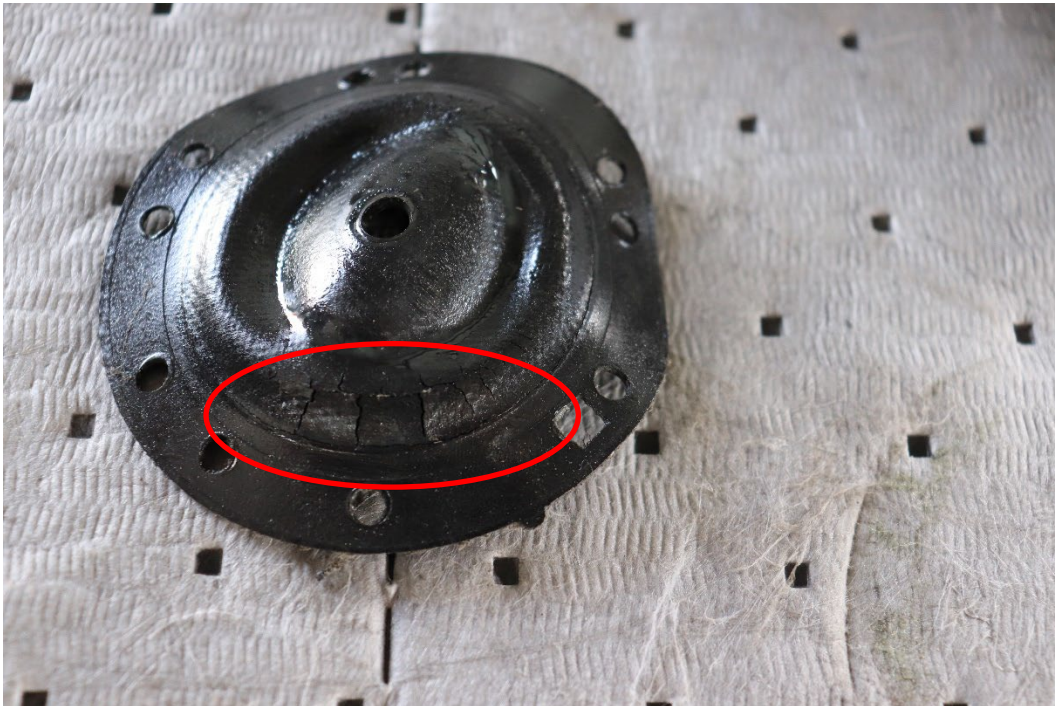
Figure 4: View of oil diaphragm with cracking (photo courtesy of the NTSB)
