April 20, 2021

### Evolution Door Latch Advisory:

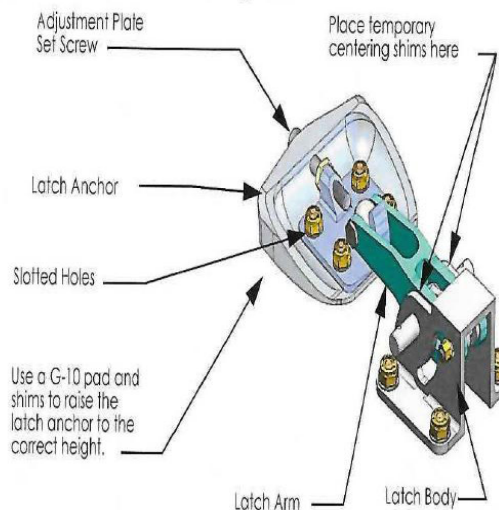
Figure 15.2.D.3 Latch and Anchor Alignment

In the last several months there have been two incidents involving a door latch failure. One incident in late 2020 involved the subject Evolution door partially opening at FL280 resulting in significant damage to the door and another one in February 2021 resulted in the loss of the door at FL240. Previous failures of the door latch assembly appeared to result from door latch locking balls not coming into complete contact with their sockets in the latch anchor. Consequently, the latch did not carry the load and the adjacent latch carried the load and it subsequently failed. The original and redesigned latch bodies were made of aluminum. If all latch sockets are fully seated they will work as designed and will carry the load. However if the ball does not latch completely with its corresponding socket, then the adjacent aluminum latch body cannot fully carry both loads and could ultimately fail. Any door latch failure could result in a loss of cabin pressure, may require use of supplemental oxygen and necessitate an emergency descent. If the door completely departs in flight, damage to surrounding airframe structures could cause a loss of the aircraft.

Latch body (above)

Before the next flight ensure that all seven latch balls fully seat in their sockets. You may have to remove the pilot seat to assess that they do seat properly. There should be no clearance

between the ball and socket. This can be determined using a feeler gauge and a flashlight. Be aware that temperature differences can influence the ball and socket fit—so if your locale experiences wide temperature swings ensure you check ball and socket fit again when temperatures swing.

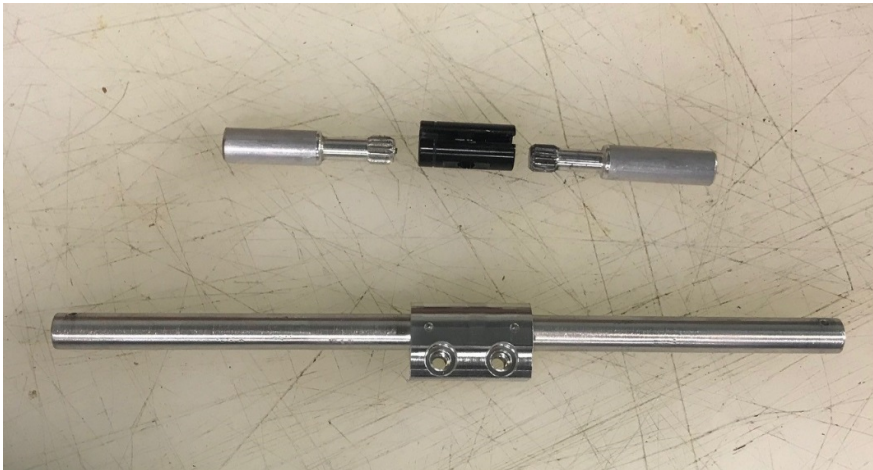
A few original Evolution kits had a non-adjustable latching system. Later Evolutions have an adjustable latching system so that if one ball is not seating properly then it can be adjusted independently of the others by your maintenance shop. The original system cannot be adjusted. A retrofit to the latest Evolution adjustable door latching system is recommended. Determine which system you have.

Original spline drive pictured on top. Current, preferred, coupler system on bottom.

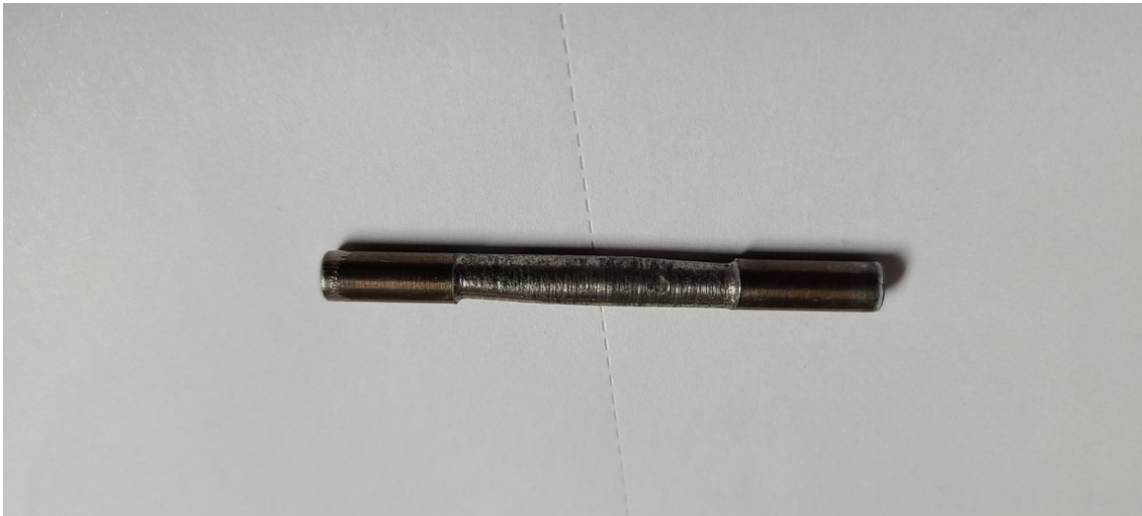
Worn hinge pin pictured.

Annually, during your condition inspection, have your maintenance shop carefully check your door latch system by noting the contact between the ball and socket with a feeler gauge and make adjustments to ensure a proper fit in accordance with Evolution Build Manual page 15-10, paragraph 5). Additionally, since your two door hinges are part of the door system, they should be removed and the pin should be removed and inspected for wear. Replace worn hinges.

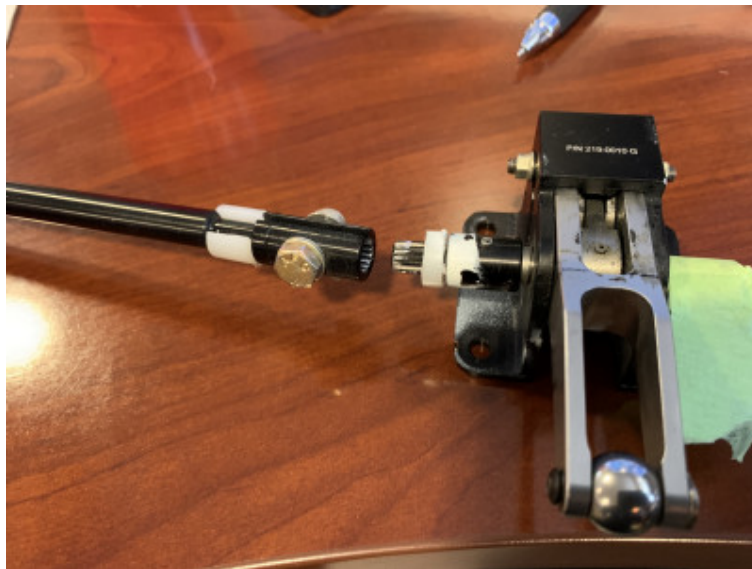
You or your shop should also inspect the spline connections that drive the over center latch mechanism for wear. Failure of the spline mechanism can lead to a door latch not engaging and a resulting door failure inflight.

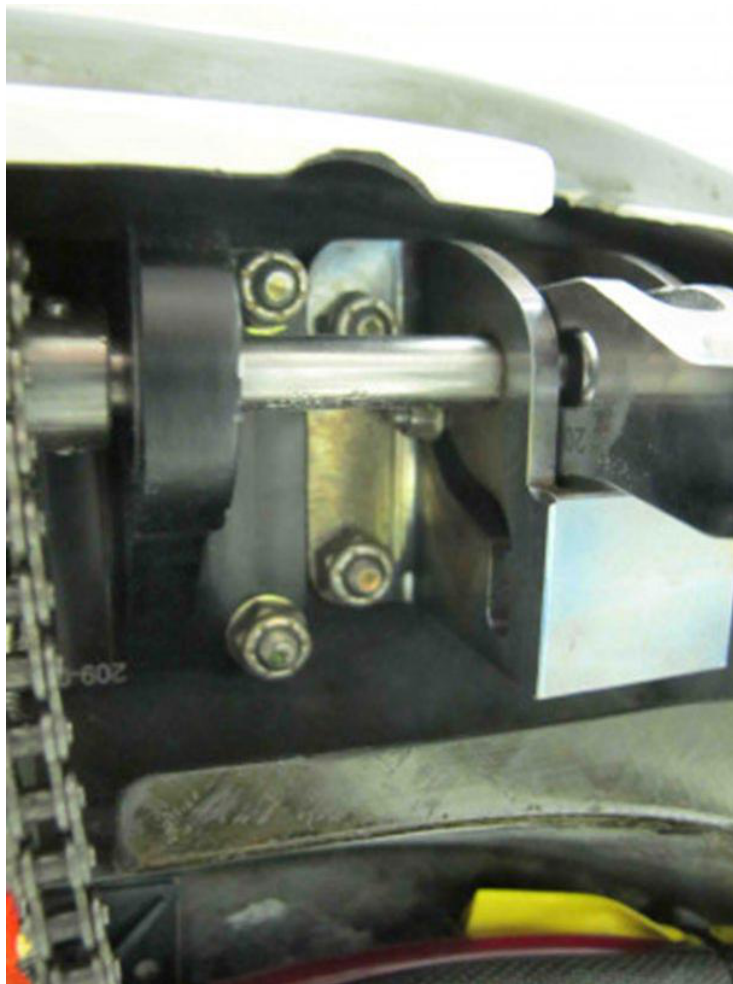
Stainless steel latch body installed (above)

Evolution Aircraft Company has designed and produced a stainless steel latch base with a significant increase in ultimate tensile strength. It is recommended that the aluminum latch bases be replaced at your next condition inspection.

If you would like to replace your door latch bases to stainless steel, contact Kim Lorentzen at [REDACTED] It is recommended that you have a qualified shop complete this installation.

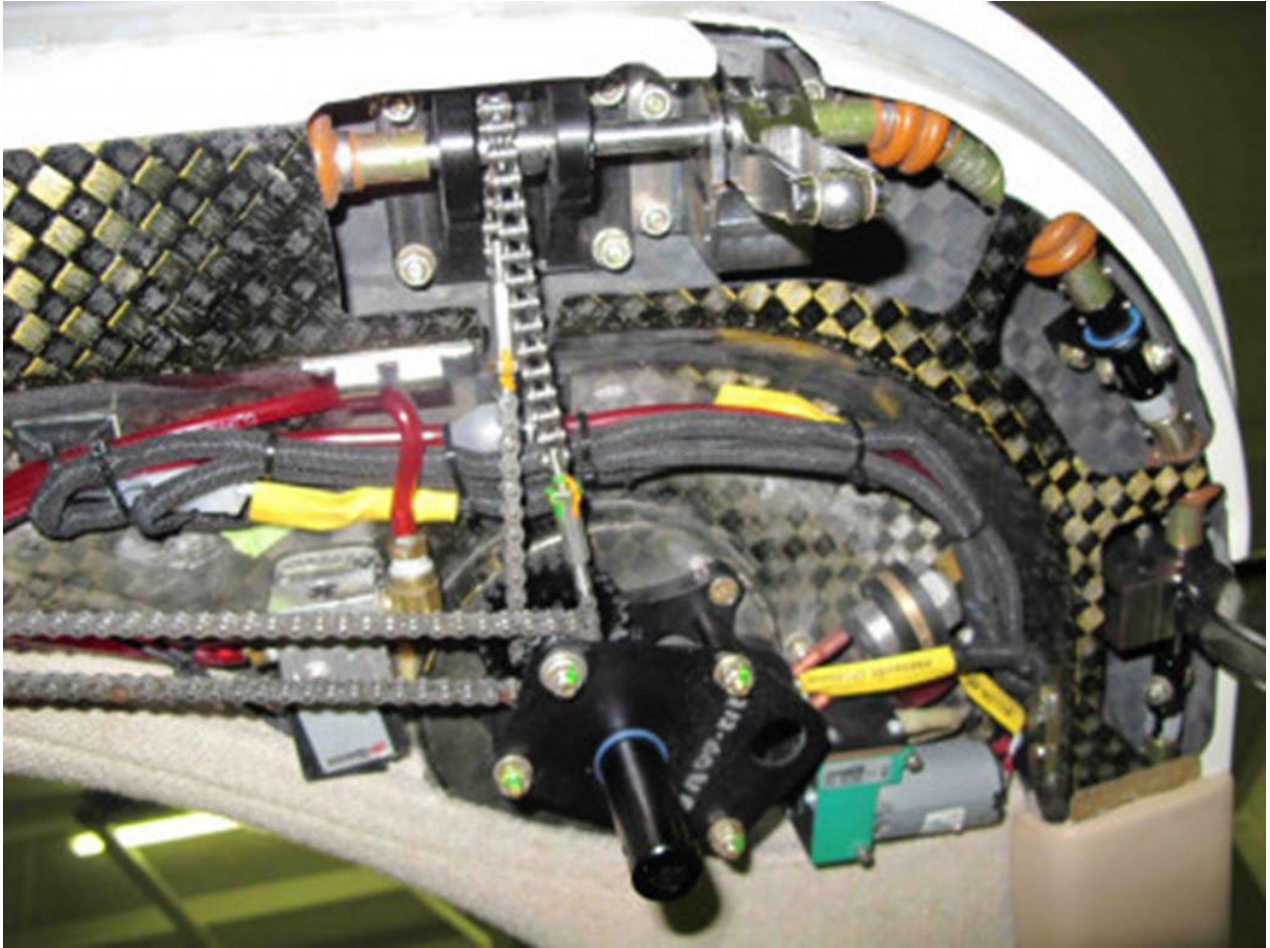
Latch system (above). Above photo is of an earlier Evolution kit.
