## **NATIONAL TRANSPORTATION SAFETY BOARD**

# **ENGINE TEARDOWN AND EXAMINATION SUMMARY**

**WPR21LA145**

Location: Marana, Arizona  
Date: 03/28/2021  
Aircraft: Cirrus SR22; N644SR  
NTSB IIC: James Bledsoe

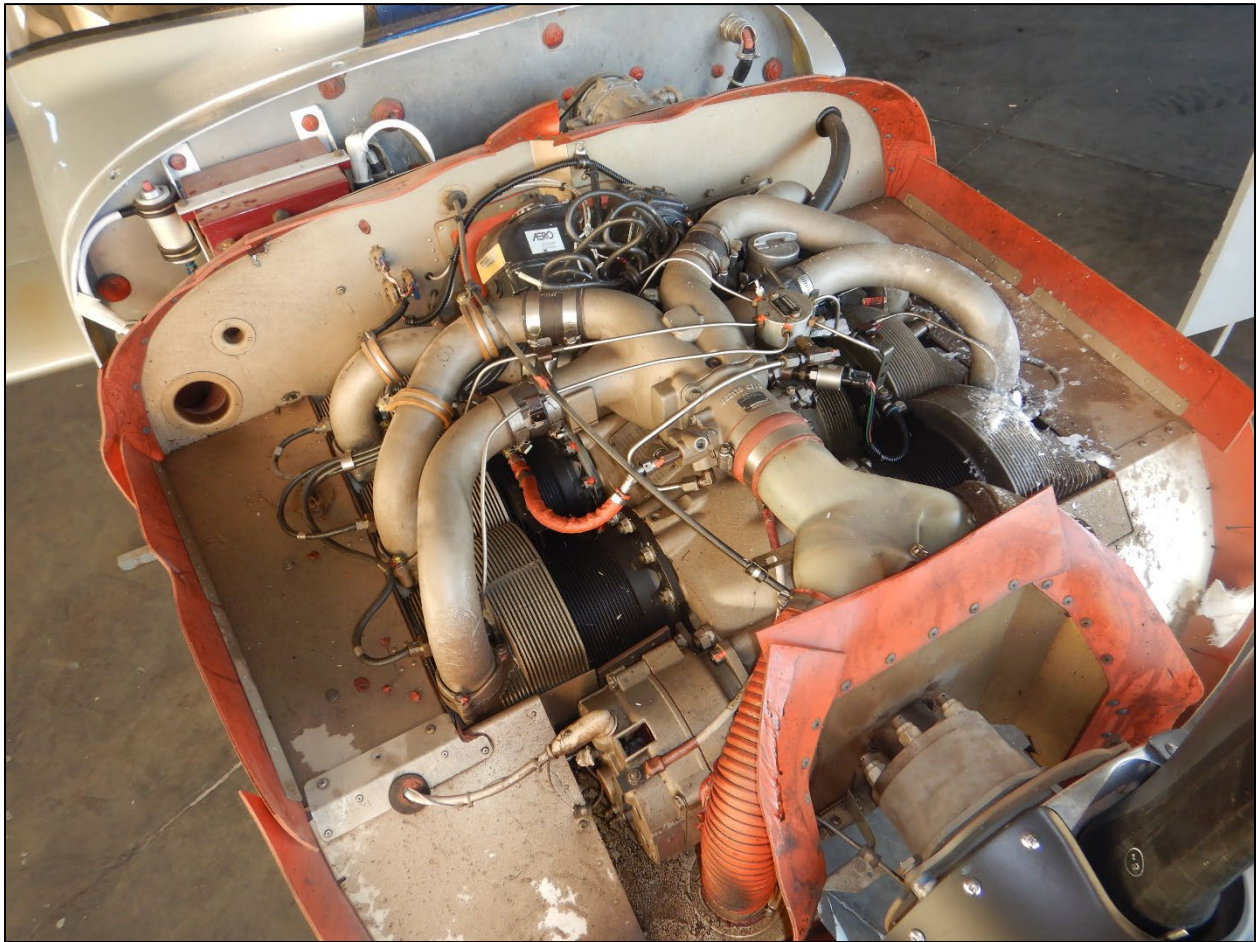
The Continental IO-550-N engine (Serial No. 689836) remained secured to the airframe. The upper and lower cowlings were removed from the airframe. The magnetos were broken from their mounts and located above the crankcase damage between cylinders No. 1 and 2. The magnetos remained attached to all ignition lead ends. Aluminum crankcase parts, the No. 2 wrist pin, No. 2 connecting rod and connecting rod cap that were found during the initial examination of the wreckage, were found packaged on top of the engine. The No. 1 and 3 cylinder through bolt and deck stud nuts had torque seal. The remaining cylinders did not torque seal applied.

Figure 1-Engine and propeller assemblies.

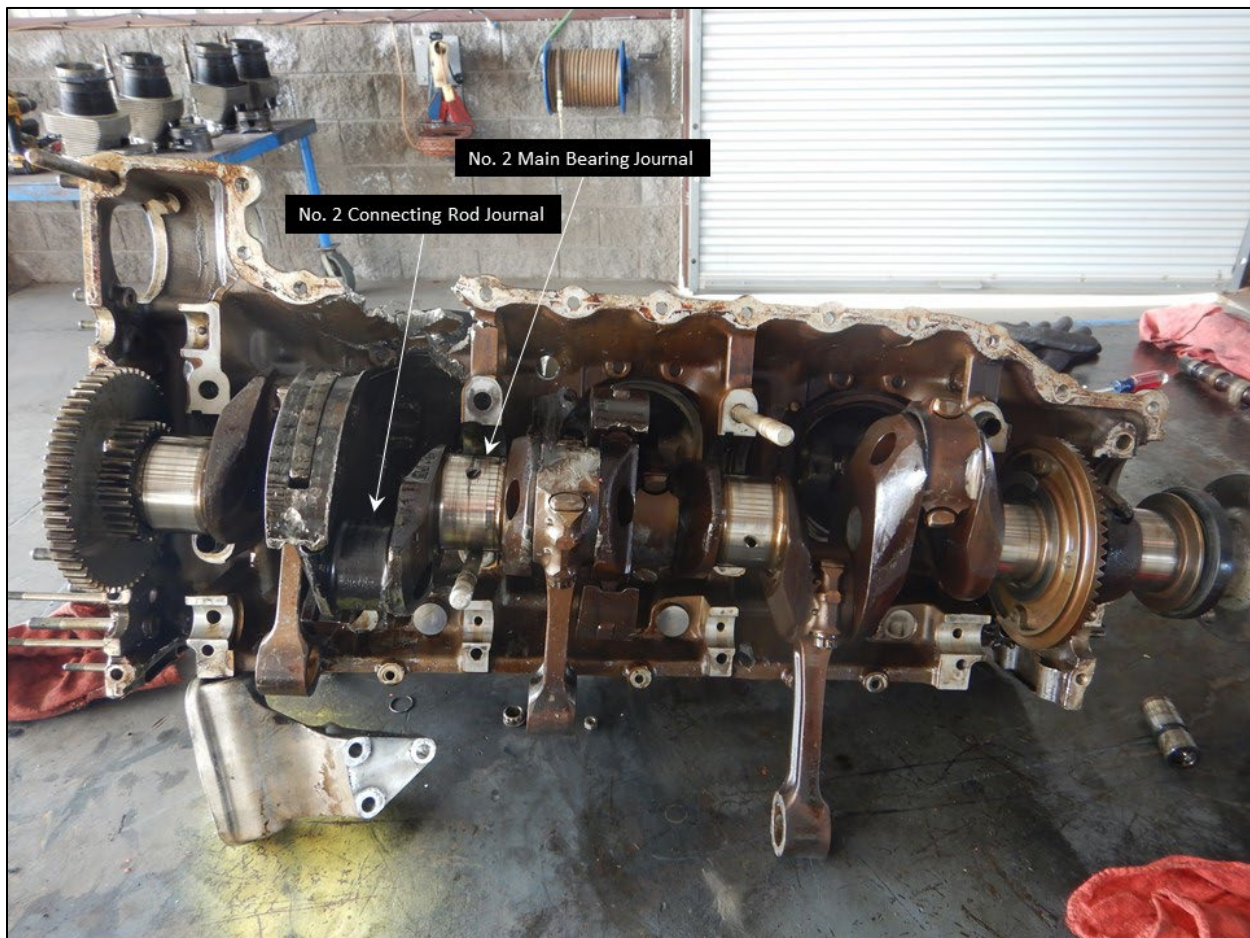
The propeller was undamaged and removed from the engine. The induction and exhaust assemblies were undamaged and removed from the engine. Approximately 5 quarts of dark oil was drained from the oil sump. The oil sump was removed and contained broken aluminum and steel components. The oil vent tube was disconnected from the engine and loose carbon deposits were noted in the tube. The 8-through bolt nuts were retorqued with the specified torque according to the manufacturer and none of the nuts tightened before torque indication was reached. The No. 2 and 4 cylinders could not be removed from the crankcase due to internal mechanical damage to their cylinder skirts. The remaining cylinders were removed. The crankcase halves were split, and internal mechanical damage was noted heavily in the No. 1, 2, 3 and 4 crankcase cylinder bay areas. An unidentified steel part was found imbedded in the forward side of the No. 5 cylinder bay area. Mechanical damage was also noted near the lifter areas and near the camshaft lobe working locations.

Figure 2-Engine left side crankcase side and crankshaft.

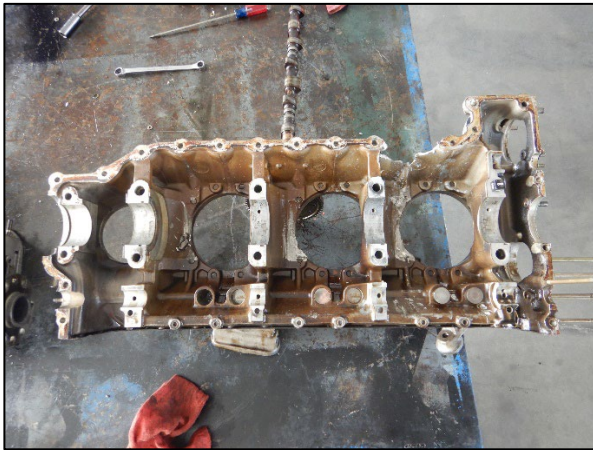
Figure 3-Right-side crankcase half.

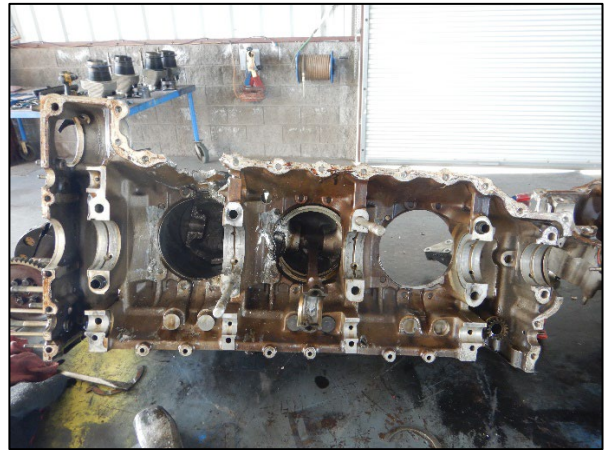
Figure 4-Left-side crankcase half.

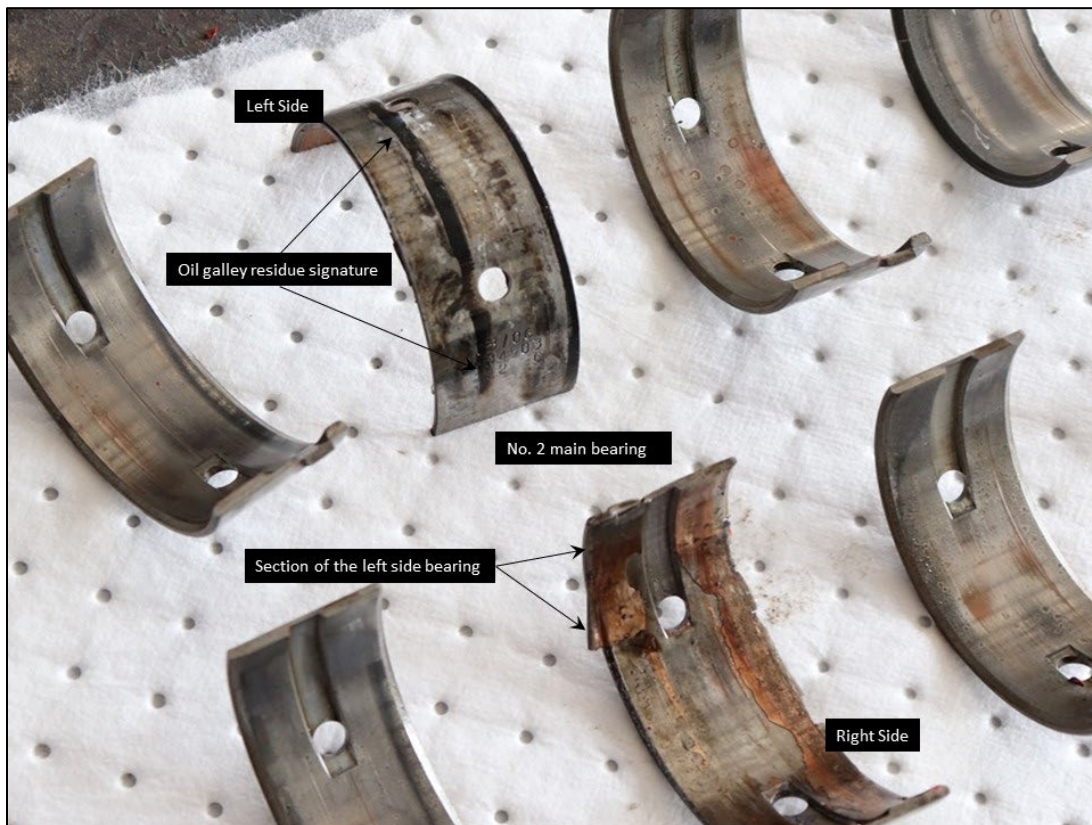
The left No. 2 main bearing half was found rotated within the saddle area about 15-degrees, overlapping the right bearing half. The left bearing half was also shifted forward about 1/8th of an inch from its original position. The bearing halves were removed and bearing material from the left-side bearing was found imbedded onto the working surface of the right-side bearing half. The bearing's working surface revealed the copper layer and portions of the copper layer was missing. Both tangs from the bearing halves had mechanical deformation. The back side of the left bearing half showed a dark line consistent with the location of the bearing saddle oil galley but is adjacent of the bearing's oil holes.

Figure 5-No. 2 crankshaft main bearing.

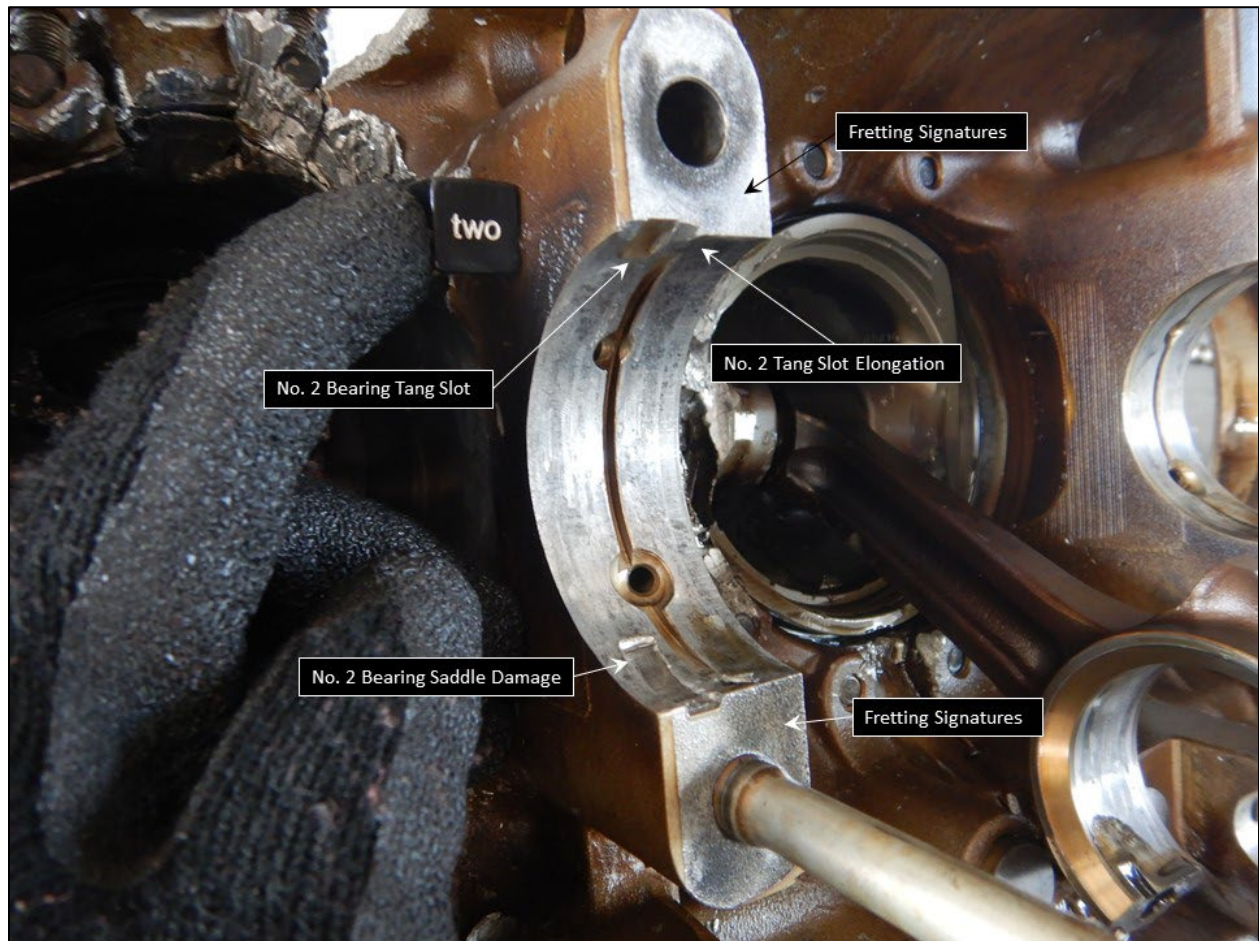
The No. 2 saddle bearing support on the left crankcase half had mechanical damage. (See figure 6.) The saddle bearing support tang slot was also elongated in the forward and aft direction. The saddle bearing support forward surface area has mechanical damage. The lower side of the saddle bearing support surface had mechanical damage consistent with the movement of the right-side bearing tang. The crankcase halves mating surfaces at the No. 2 saddle bearing support show excessive fretting on their entire surface area.

Figure 6-No. 2 crankcase saddle bearing support, left side.

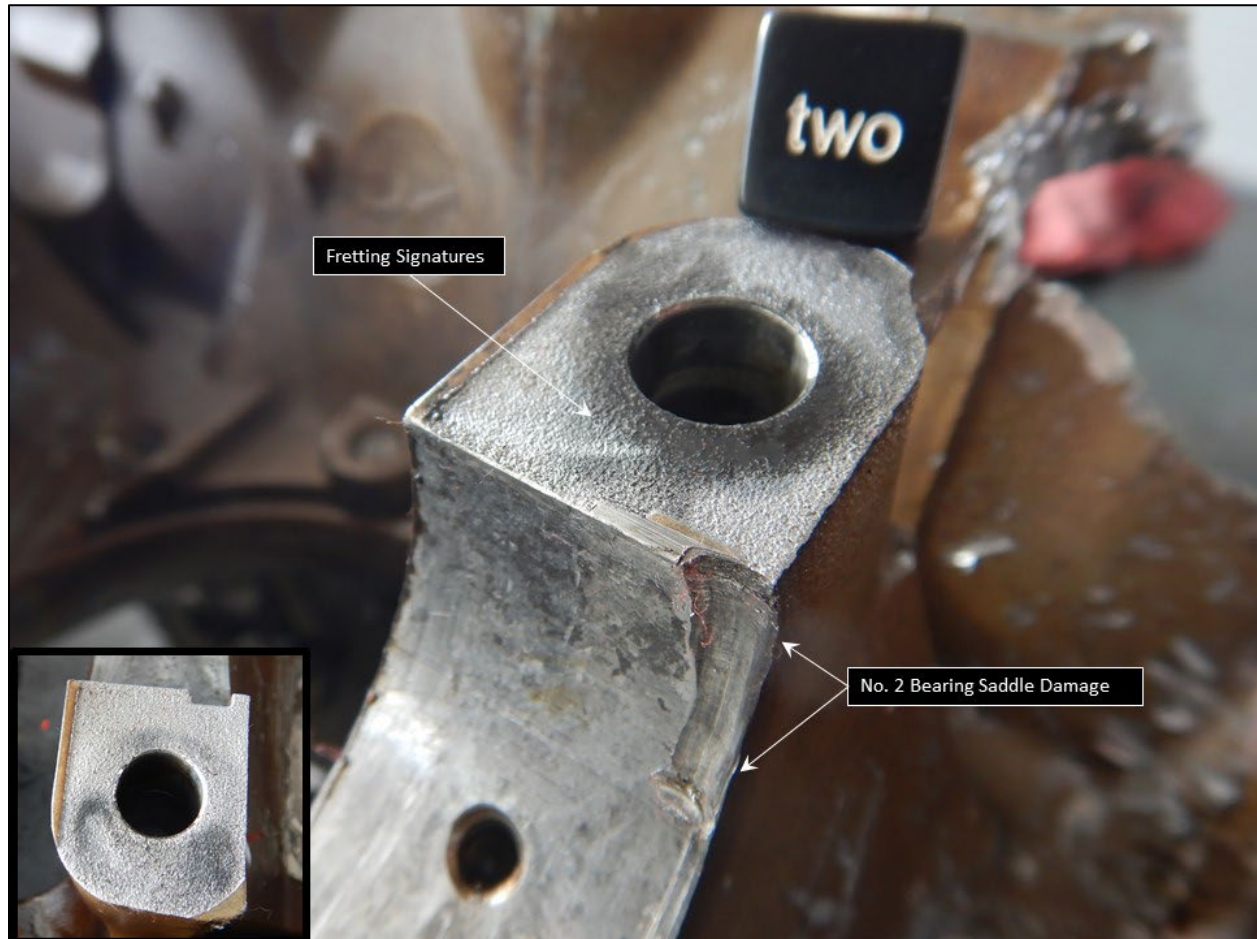
The No. 2 saddle bearing support on the right crankcase half had mechanical damage. (See figure 7.) The saddle bearing support tang slot was not damaged. The saddle bearing support forward surface area has mechanical damage. The right side of the saddle bearing support surface had mechanical damage consistent with the movement of the left-side bearing tang. The crankcase halves mating surfaces at the No. 2 saddle bearing support show excessive fretting on their entire surface area.

Figure 7-No. 2 crankcase saddle bearing support, right side.
