## **NATIONAL TRANSPORTATION SAFETY BOARD**

# **ENGINE EXAMINATION SUMMARY**

**WPR21LA151**

| Aircraft: | N655FL |

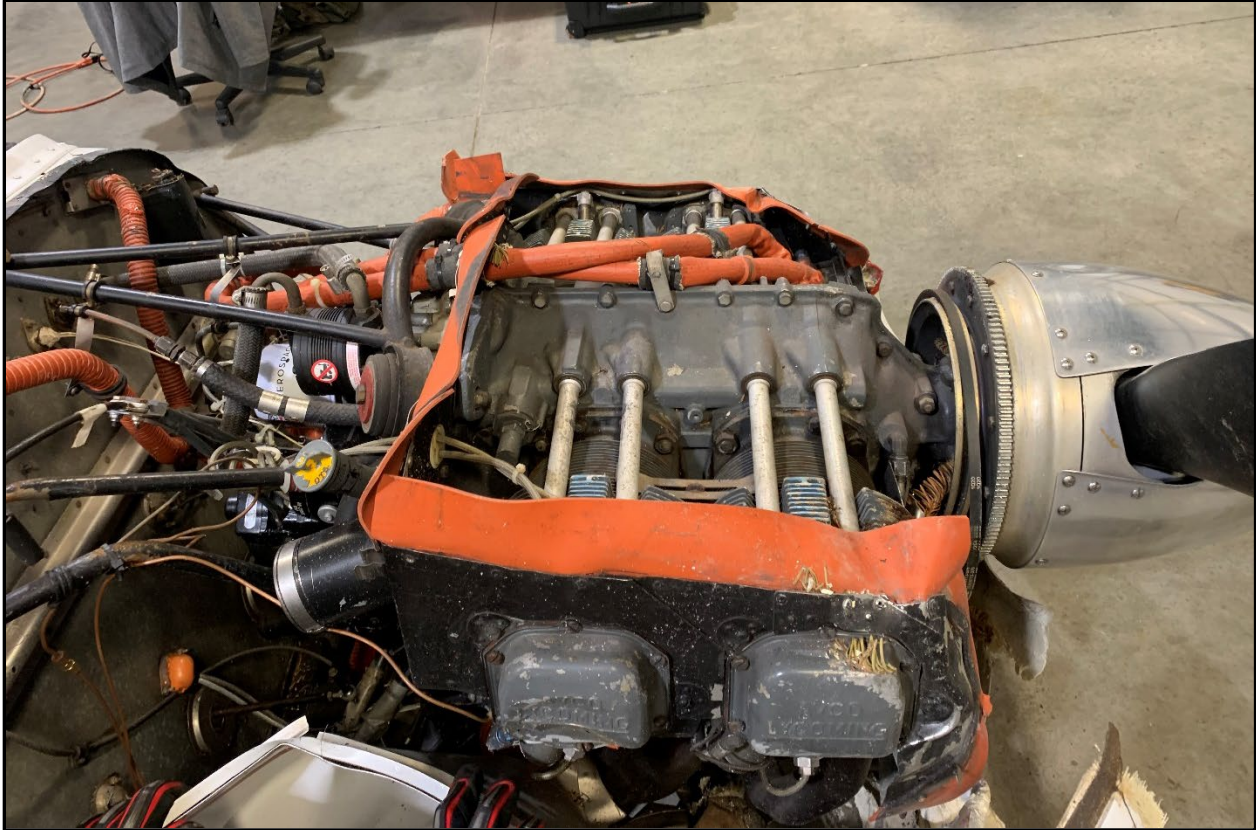
The engine and propeller assembly were attached to the fuselage and the engine mount assembly sustained damage to the right side. One blade tip was bent aft. The other blade was slightly bent forward. The baffling was intact with exception of some impact damage due to tree debris that was present. The rocker covers were removed, and all valves and springs were lubricated.

Figure 1: Engine as viewed from the top right side.

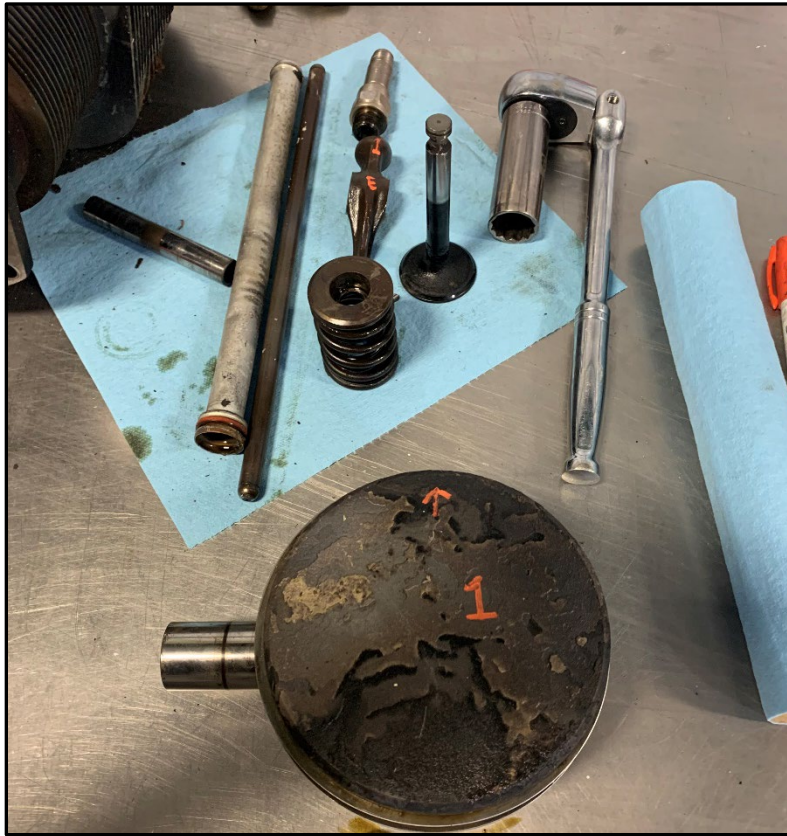
Rotational continuity was established through hand rotation of the propeller and cylinder thumb compression was obtained on cylinders Nos. 2 and 4 but not obtained on cylinders Nos. 1 and 3. Leaking air was heard from the exhaust piping. All engine control continuity was established. Timing was verified to be timed appropriately. Both magnetos were tested to be operational. A compression check revealed that the No. 1 cylinder was 5 psi, the No. 2 cylinder was 72 psi, the No. 3 cylinder 0 psi, and the No. 4 cylinder 68 psi. Borescope examination revealed that the No. 3 cylinder exhibited scoring on the walls and had carbon deposits lodged where the exhaust valve seats. The Nos. 1, 2, and 3 cylinders were removed for examination.

Examination of the cylinders revealed a build-up of carbon deposits on the pistons and valve head guides, faces, and stems. The deposits prevented the valve heads from sealing properly on the seat. The No. 2 cylinder exhibited carbon deposits that were substantially less the Nos. 1 and 3 cylinders.

Figure 2: View of No. 1 piston head and disassembled components for No.1 cylinder valve train.
