## **NATIONAL TRANSPORTATION SAFETY BOARD**

### **ENGINE EXAMINATION SUMMARY**

**WPR21LA173**

| Aircraft: | N378CT Flight Design GMBH, CSTW light sport |

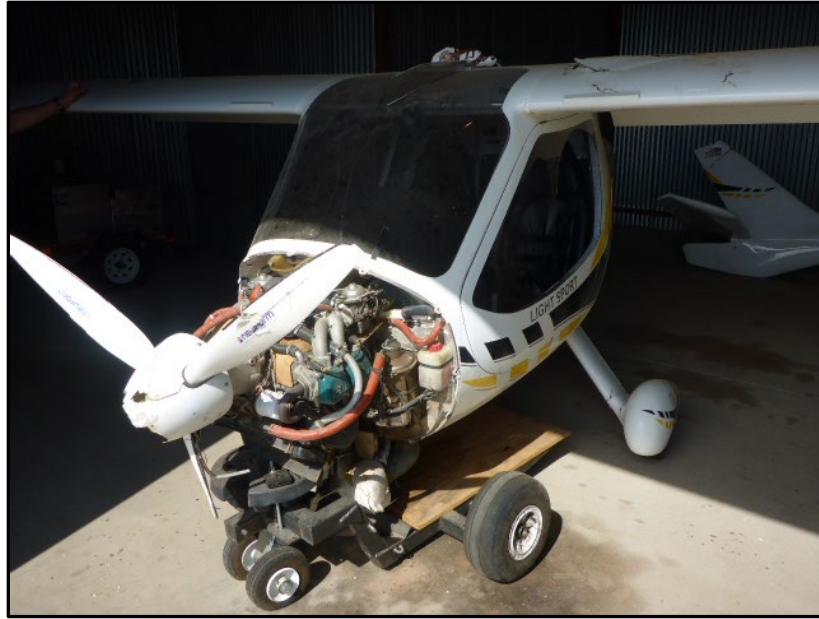
The engine was attached to the fuselage and all the accessories were attached and appeared intact. The only damage observed was to the propeller. The propeller remained attached to propeller flange. Observation of the composite three-bladed propellor revealed that one blade was separated, about 8 inches from the hub. The other two blades sustained leading-edge damage.

**Figure 1: Engine as viewed from the front left side.**

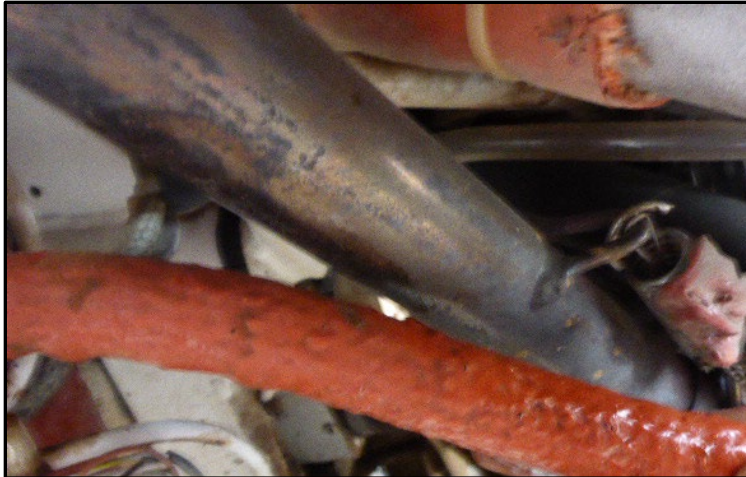
The oil filter was removed. The filter was observed to be an aftermarket, non-approved filter by Rotax. Additionally, minimal oil was contained within the filter. The oil pump was removed disassembled and examined. Examination was revealed no anomalies and when the oil pump was manually rotated, oil was dispersed from the oil pump outlet. The oil pressure line from the oil tank to the oil pump, which supplied oil to the engine, was examined. Examination revealed that once compressed air pressure was introduced into the line, a leak was observed where the oil line was resting against the exhaust manifold.

**Figure 2: Oil line resting against exhaust manifold.**

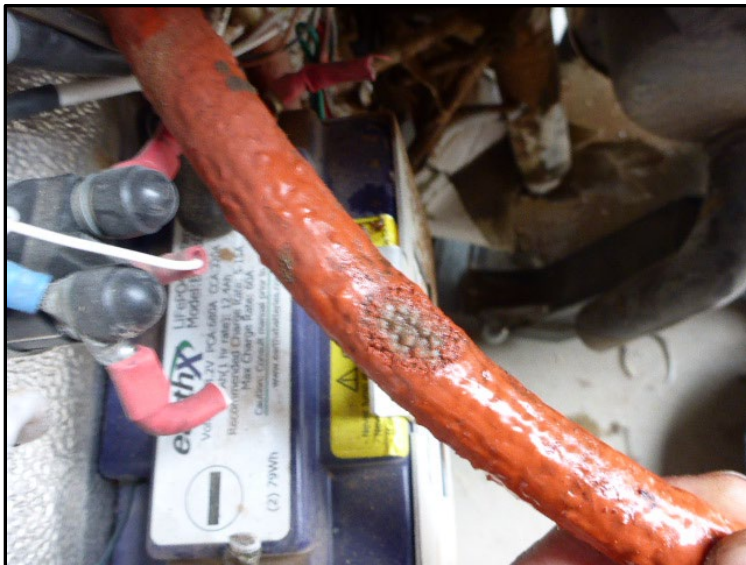
**Figure 3: Oil line damaged by resting against exhaust manifold.**
