## **NATIONAL TRANSPORTATION SAFETY BOARD**

# **AIRFRAME AND ENGINE EXAMINATION**

**WPR21LA194**

| Aircraft: | Cessna, 210, N7350E |

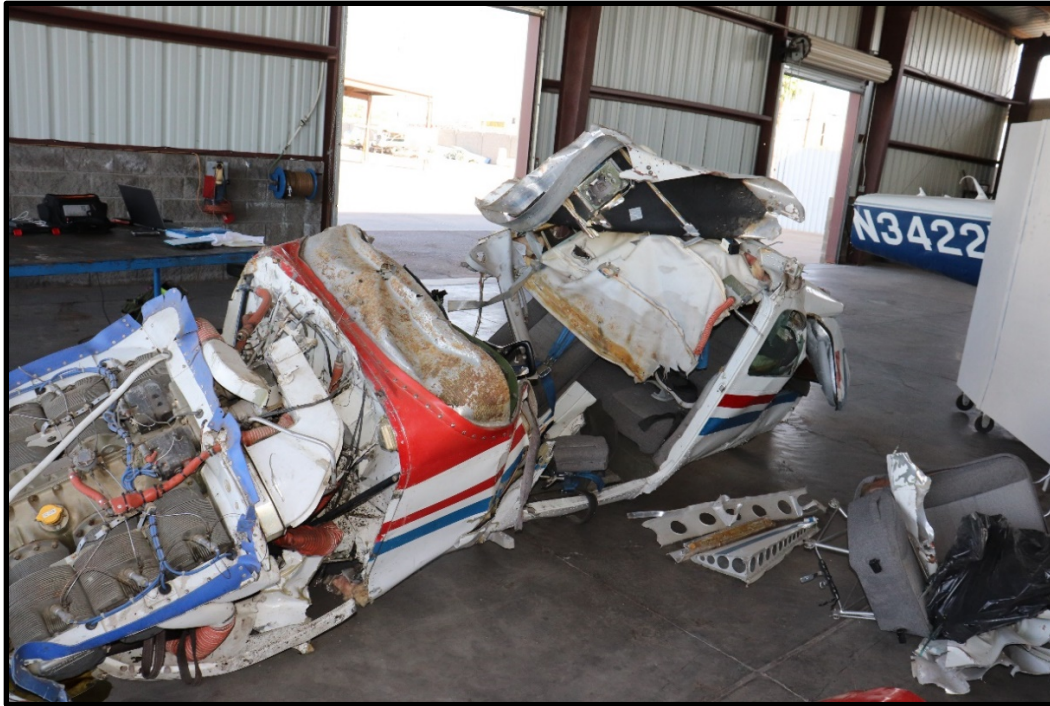
**Figure 1. View of airplane during examination**

Examination of the recovered airframe revealed that the recovery organization had removed both wings and empennage for transport. The forward section of the fuselage, near the passenger door post had impact damage and was partially separated. Additionally, the recovery personnel had drained about 2 gallons of fuel from the left tank. The fuel selector lever was in the off position and the master switch was off. The observed tachometer time was 529.47 hours.

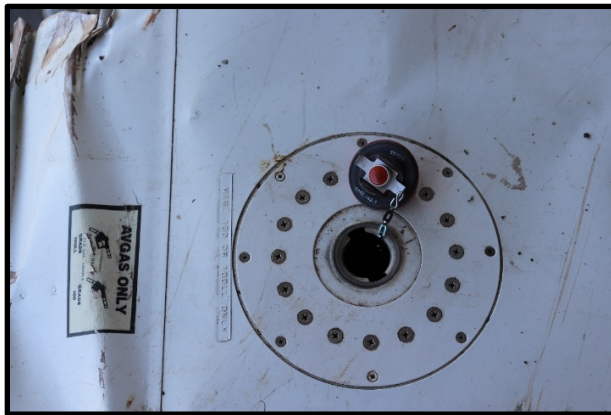
**Figure 2. View of right fuel cap**

The left and right wings exhibited impact damage. The airplane was equipped with bladder fuel tanks. Visual inspection of the right fuel cap revealed that the rubber seal appeared normal and unremarkable. A wrinkle in the right fuel bladder, about 6 inches in length, was noted near the fuel line pick up. The left fuel cap was missing. Both fuel filler ports were normal and unremarkable.

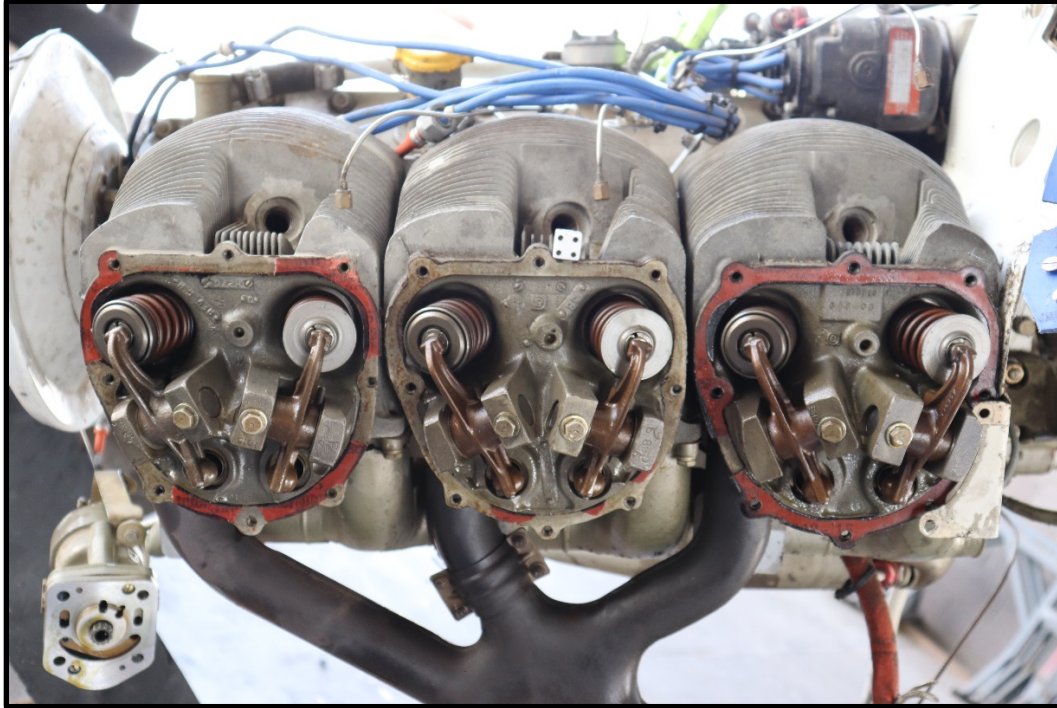
Figure 4. View of left side of the engine

Examination of the recovered engine revealed that the four engine mounts had fracture separated. All six cylinders and all engine accessories remained attached. All fuel and oil lines that were removed were tight. No evidence of any mechanical damage was observed to the engine crankcase.

The rocker box covers were removed. The intake and exhaust rocker arms were intact and oil coated on all cylinders. All intake and exhaust valve springs were in place and visually appeared to be undamaged. The upper spark plugs were removed, and all six cylinders were examined internally using a lighted borescope. A normal amount of combustion deposits was observed within the combustion dome of each cylinder and piston face. All of the intake and exhaust valves were unremarkable. The crankshaft was rotated by hand using the propeller. Rotational continuity was established throughout the engine and valve train. Thumb compression and suction was obtained on all six cylinders.

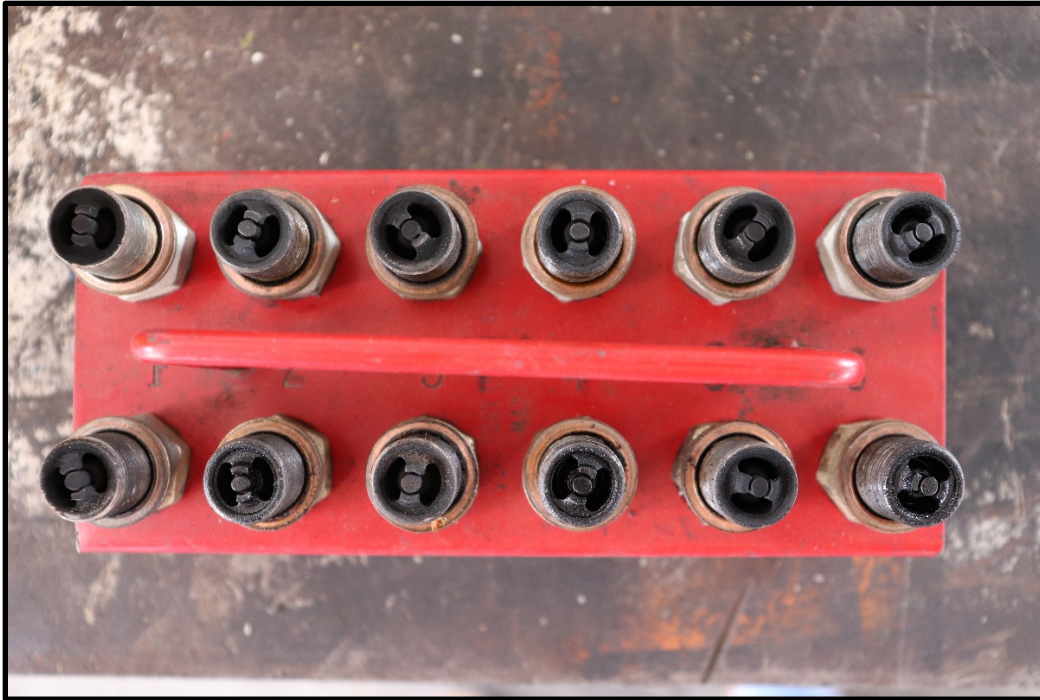
**Figure 6. View of spark plugs**

Examination of the recovered airframe and engine revealed no anomalies that would have precluded normal operation and the production of power. However, the upper and lower spark plug electrode areas were black in color, consistent with a rich fuel/air mixture.

The spark plugs were removed from the engine and they were the massive electrode type. All sparkplugs exhibited black deposits within the electrode area with the exception of the bottom cylinder 2, 4, and 6 spark plugs, which were oil soaked. All of spark plugs exhibited signatures consistent with worn-normal when compared to the Champion Check-A-Plug comparison chart.

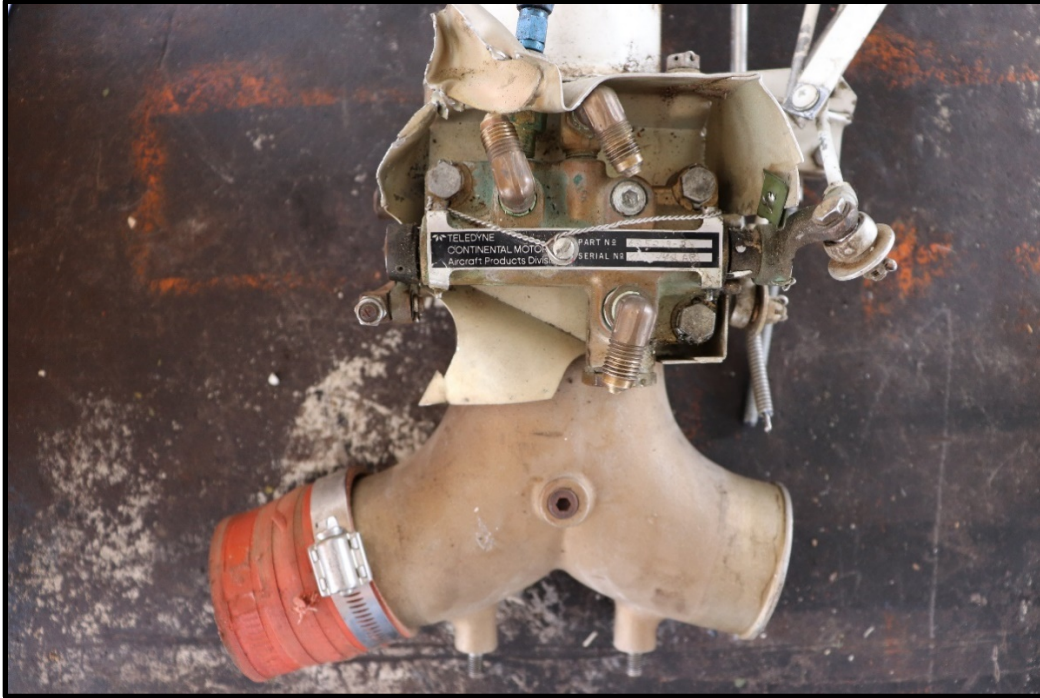
**Figure 7: View of throttle body**

The throttle body remained attached to the engine. The throttle plate to fuel control interconnect was removed and visually examined. The throttle lever was intact, moved freely from stop to stop, but the connecting linkage to the throttle cable was fracture separated, consistent with impact damage. The mixture control cable remained attached to the throttle body and unremarkable. The mixture control moved the available length. . The fuel inlet fuel screen was removed, and a slight amount of debris was observed.

The air induction system remained attached to the engine baffle. The air induction body had fractured separated at the throttle body assembly. The air induction conduit was clear of obstructions and debris.

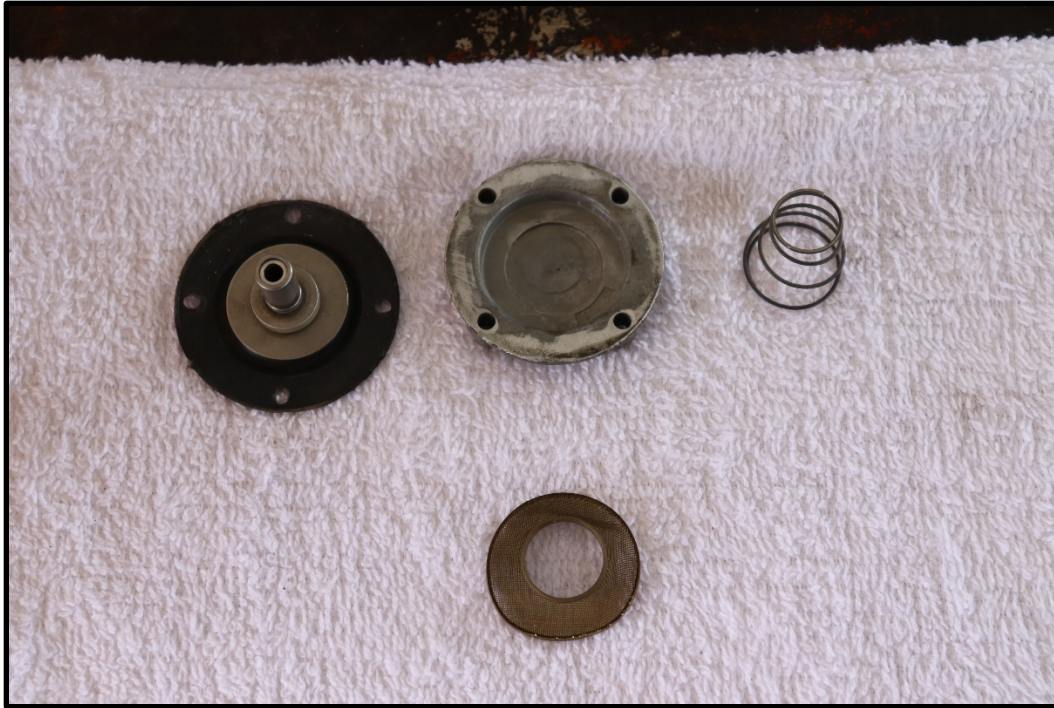
Figure 9: View of fuel flow manifold spring and diaphragm

The fuel flow manifold valve was intact, undamaged, removed and disassembled. The screen was clear and free of debris. The spring and diaphragm were intact and undamaged.

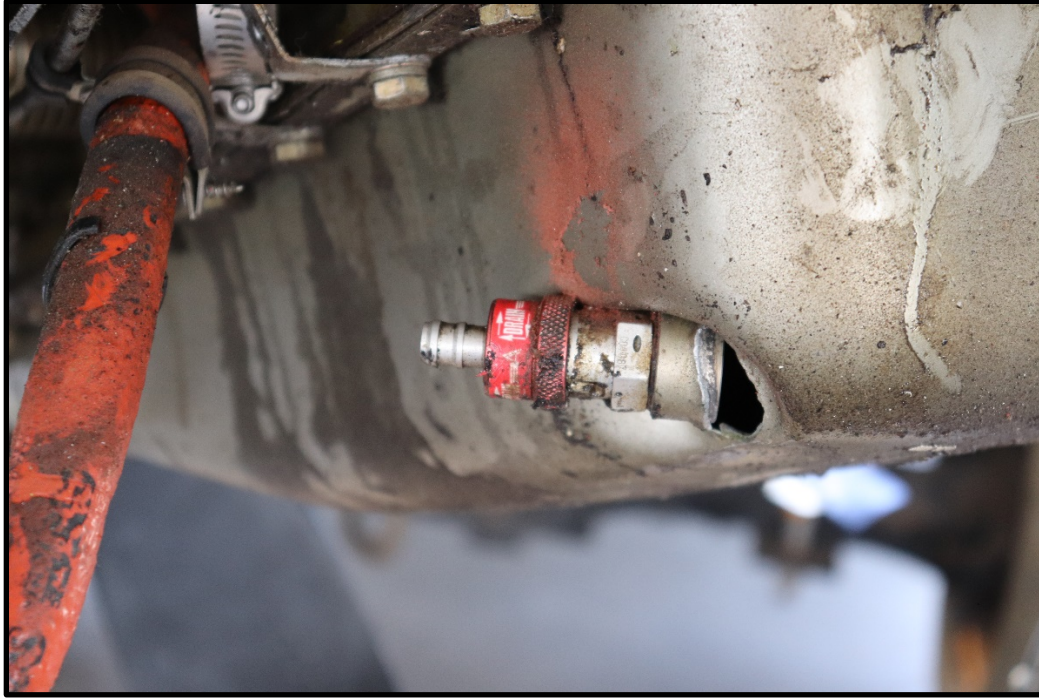
**Figure 10: View of oil pan damage**

The engine oil sump had impact damage and the oil quick drain was partially separated.
