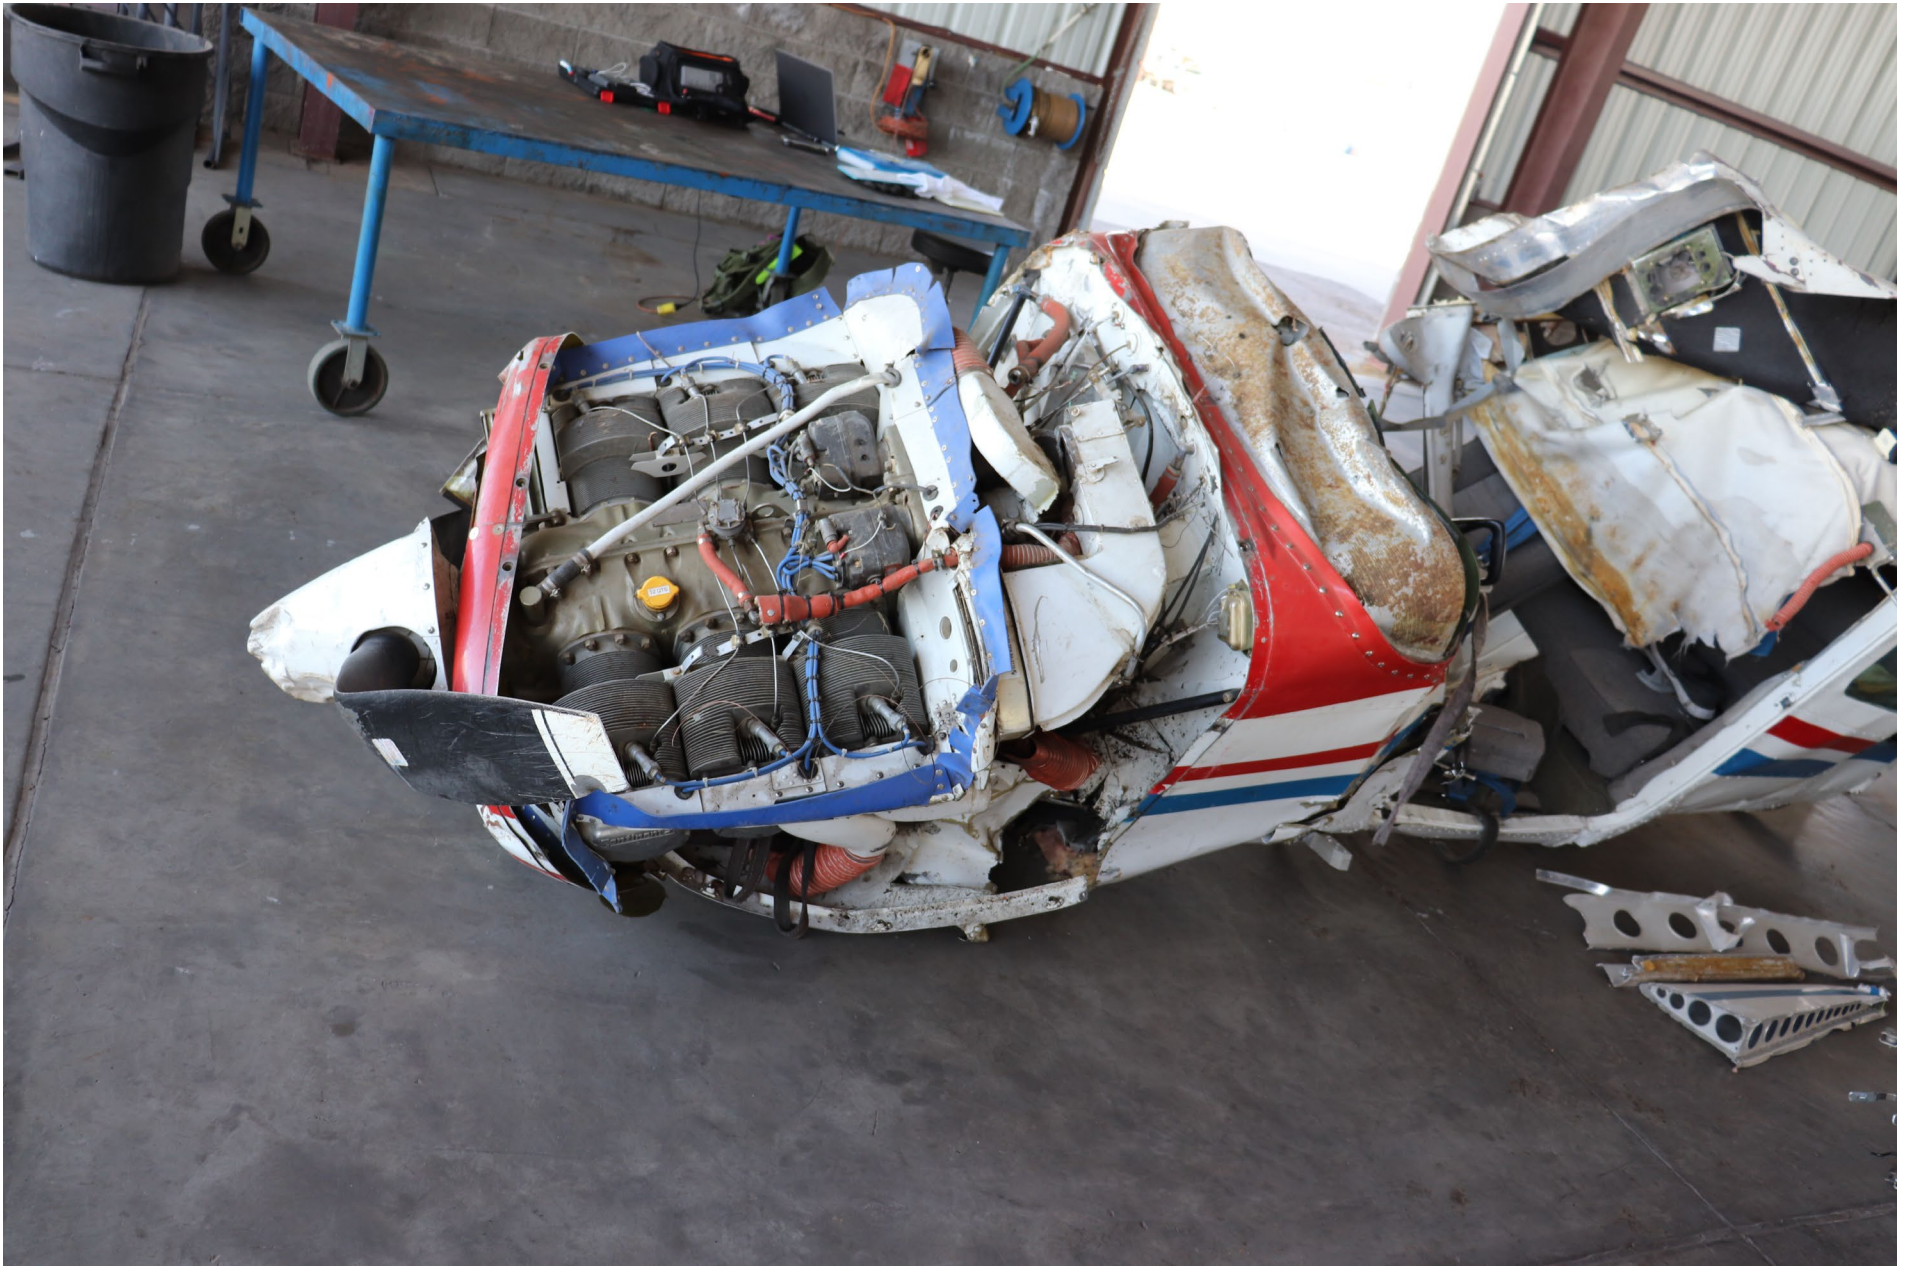
**Photo 1 – Left side view of fuselage damage (photo courtesy of the NTSB)**

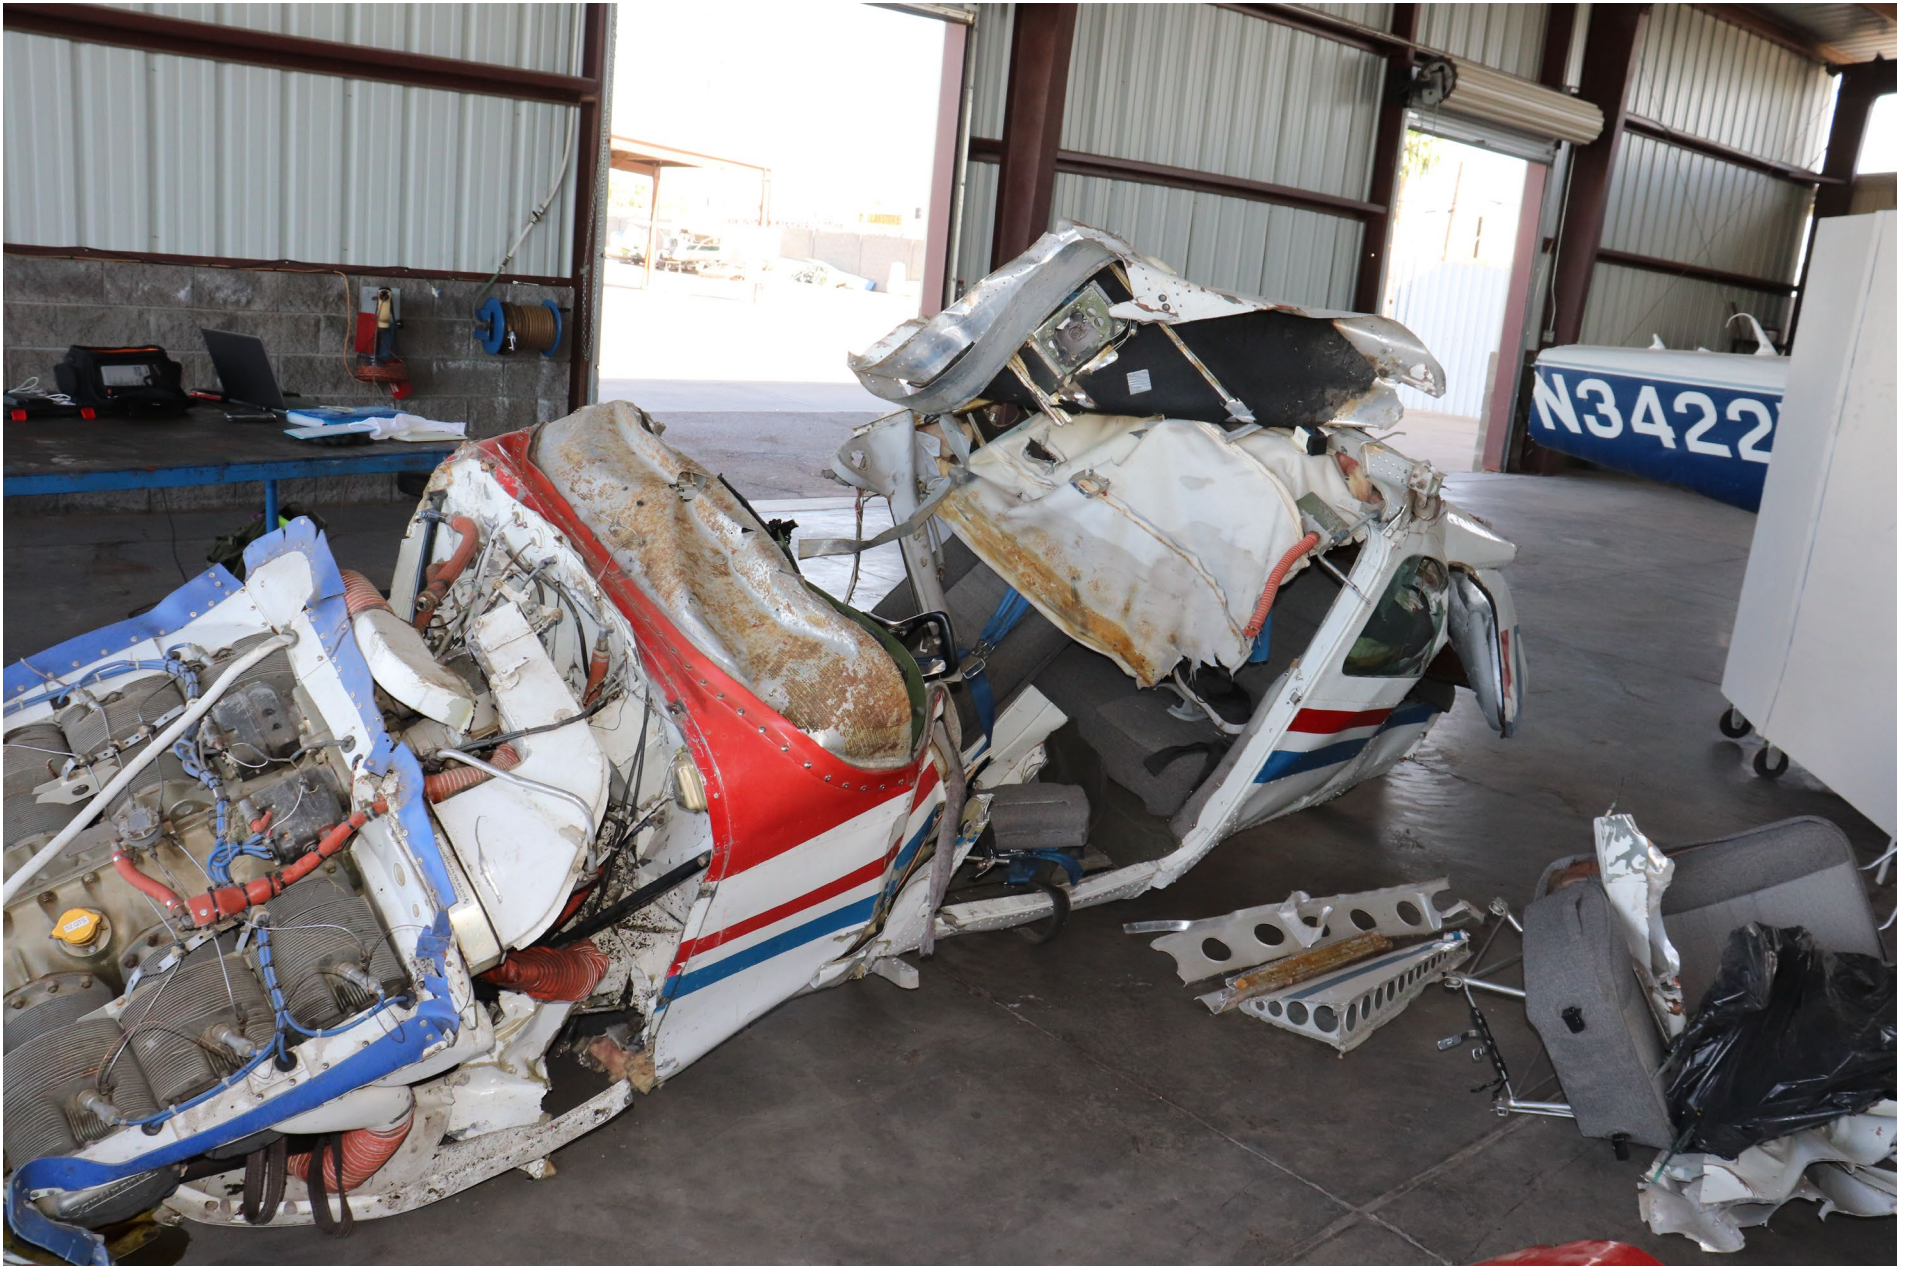
**Photo 2 - Left side view of fuselage damage (photo courtesy of the NTSB)**

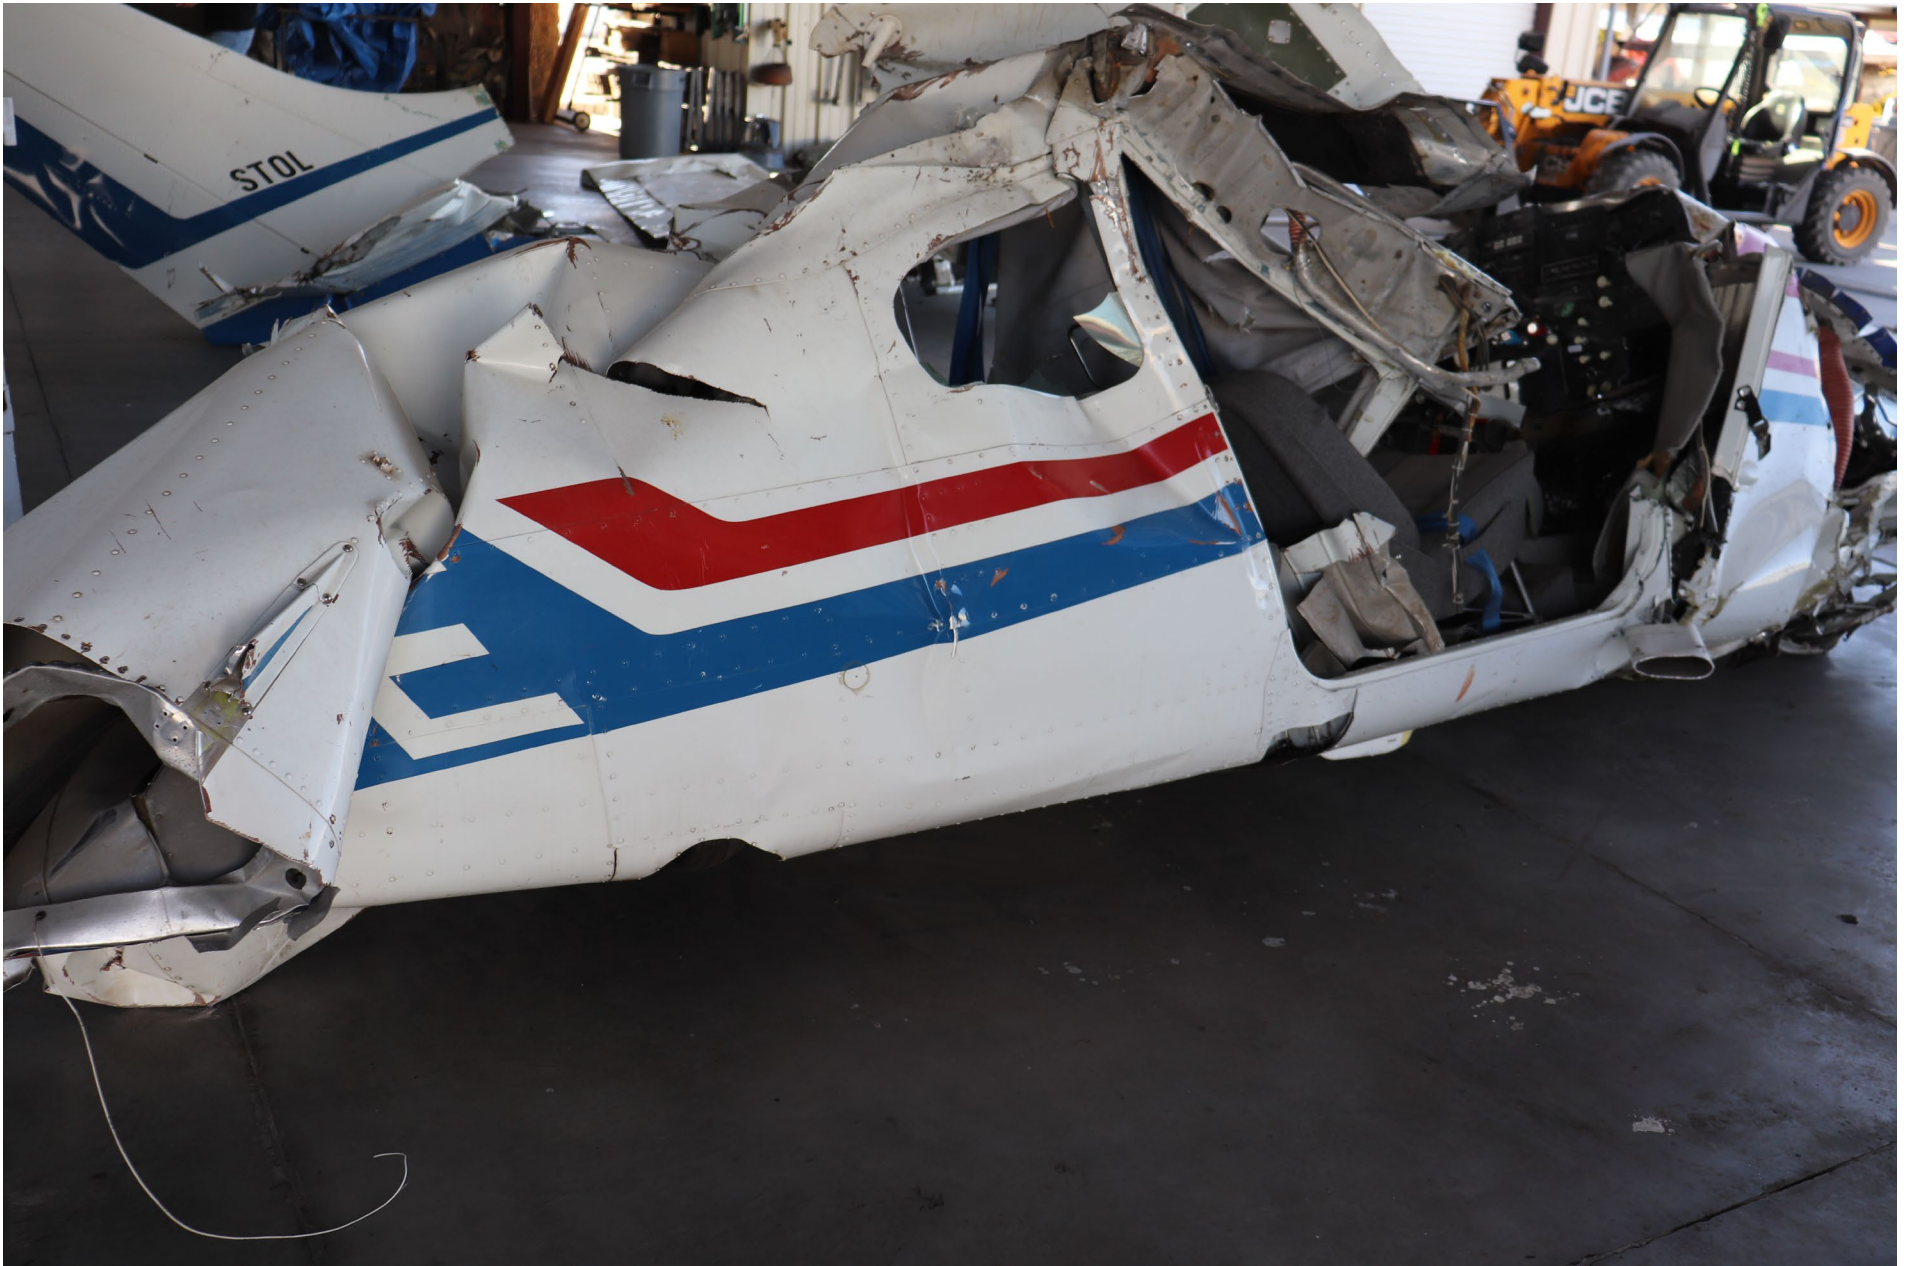
**Photo 3 - Right side view of fuselage damage (photo courtesy of the NTSB)**

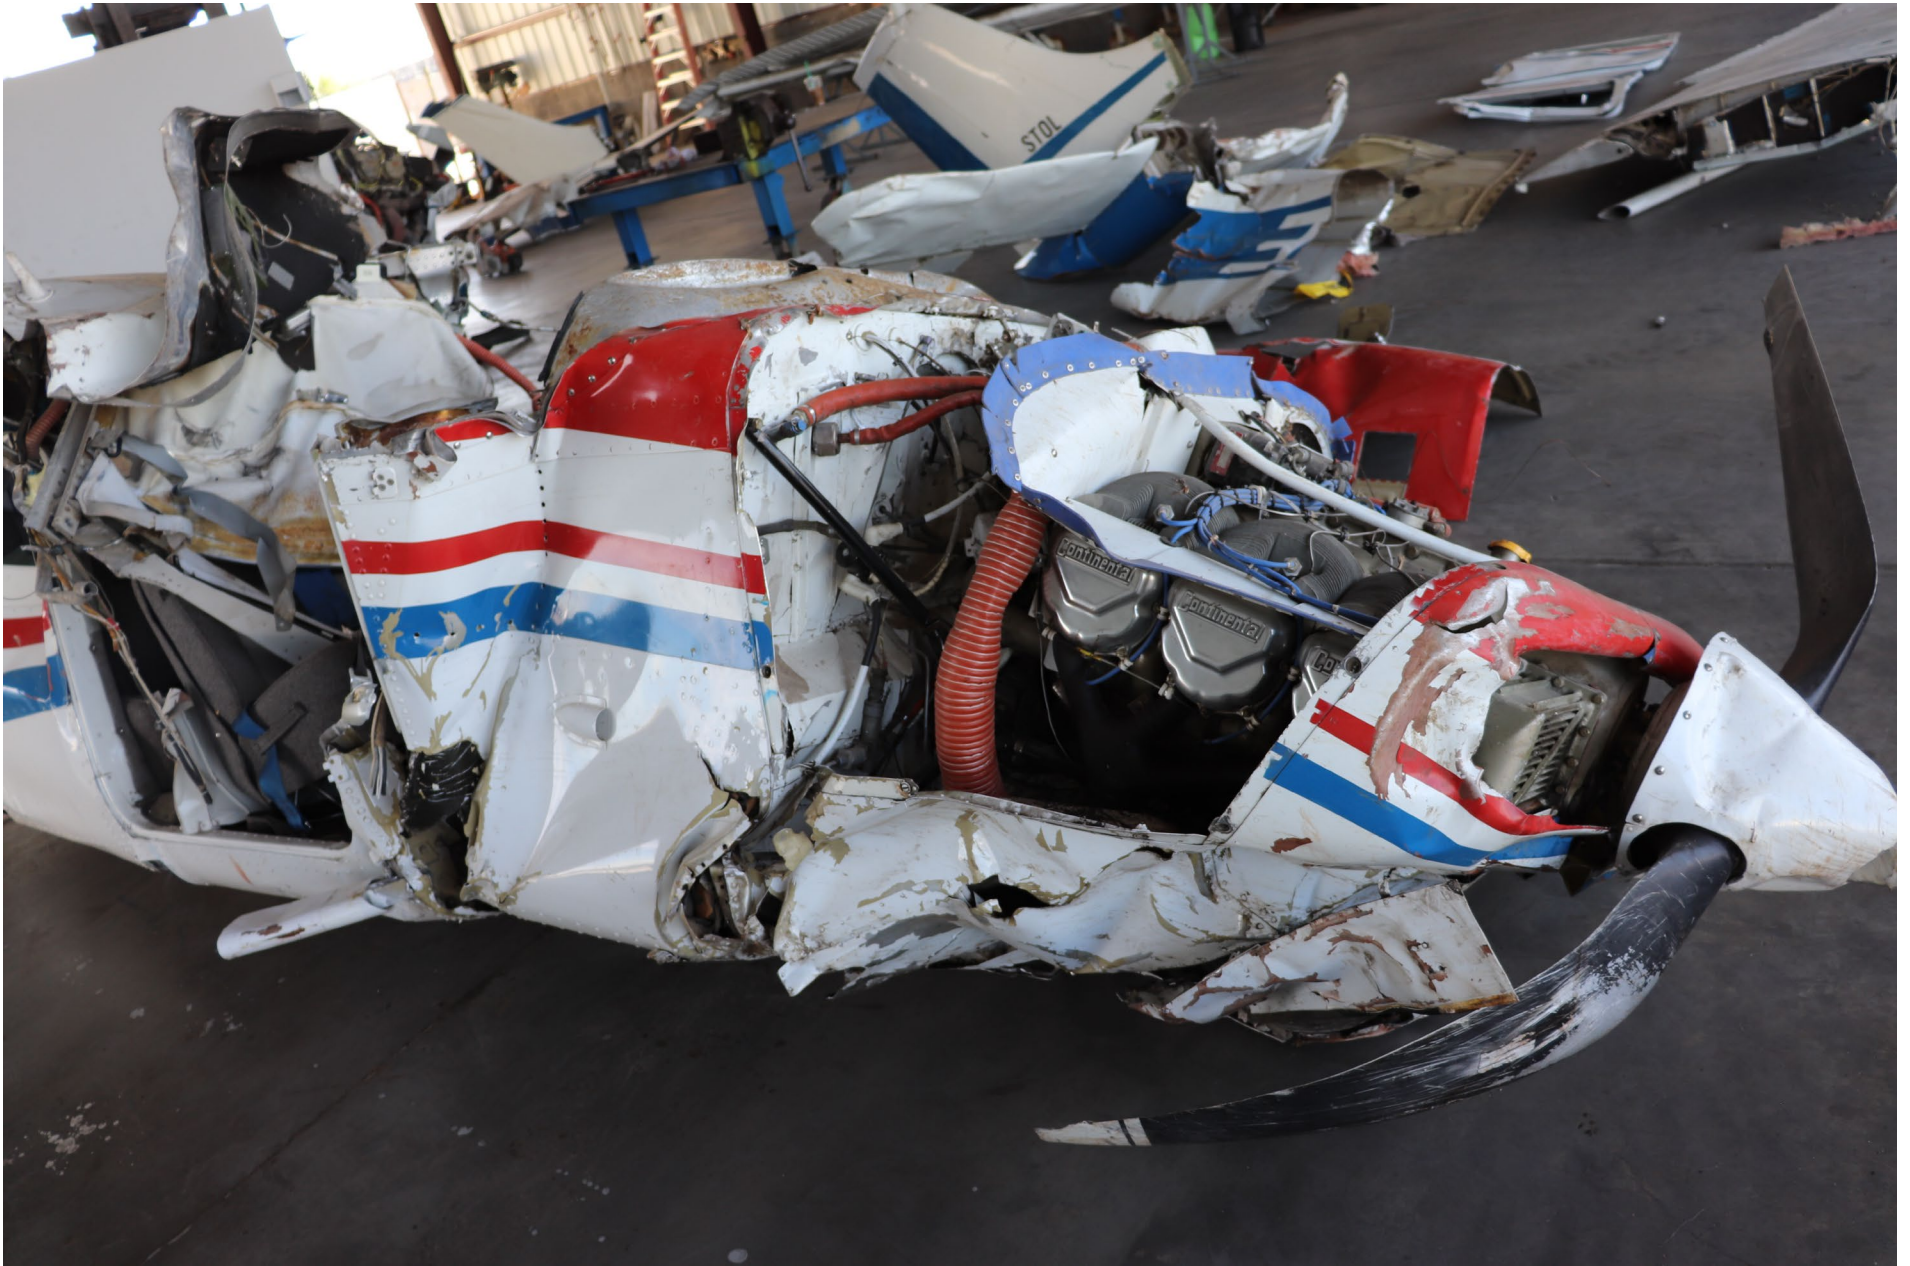
**Photo 4 - Right side view of fuselage damage (photo courtesy of the NTSB)**

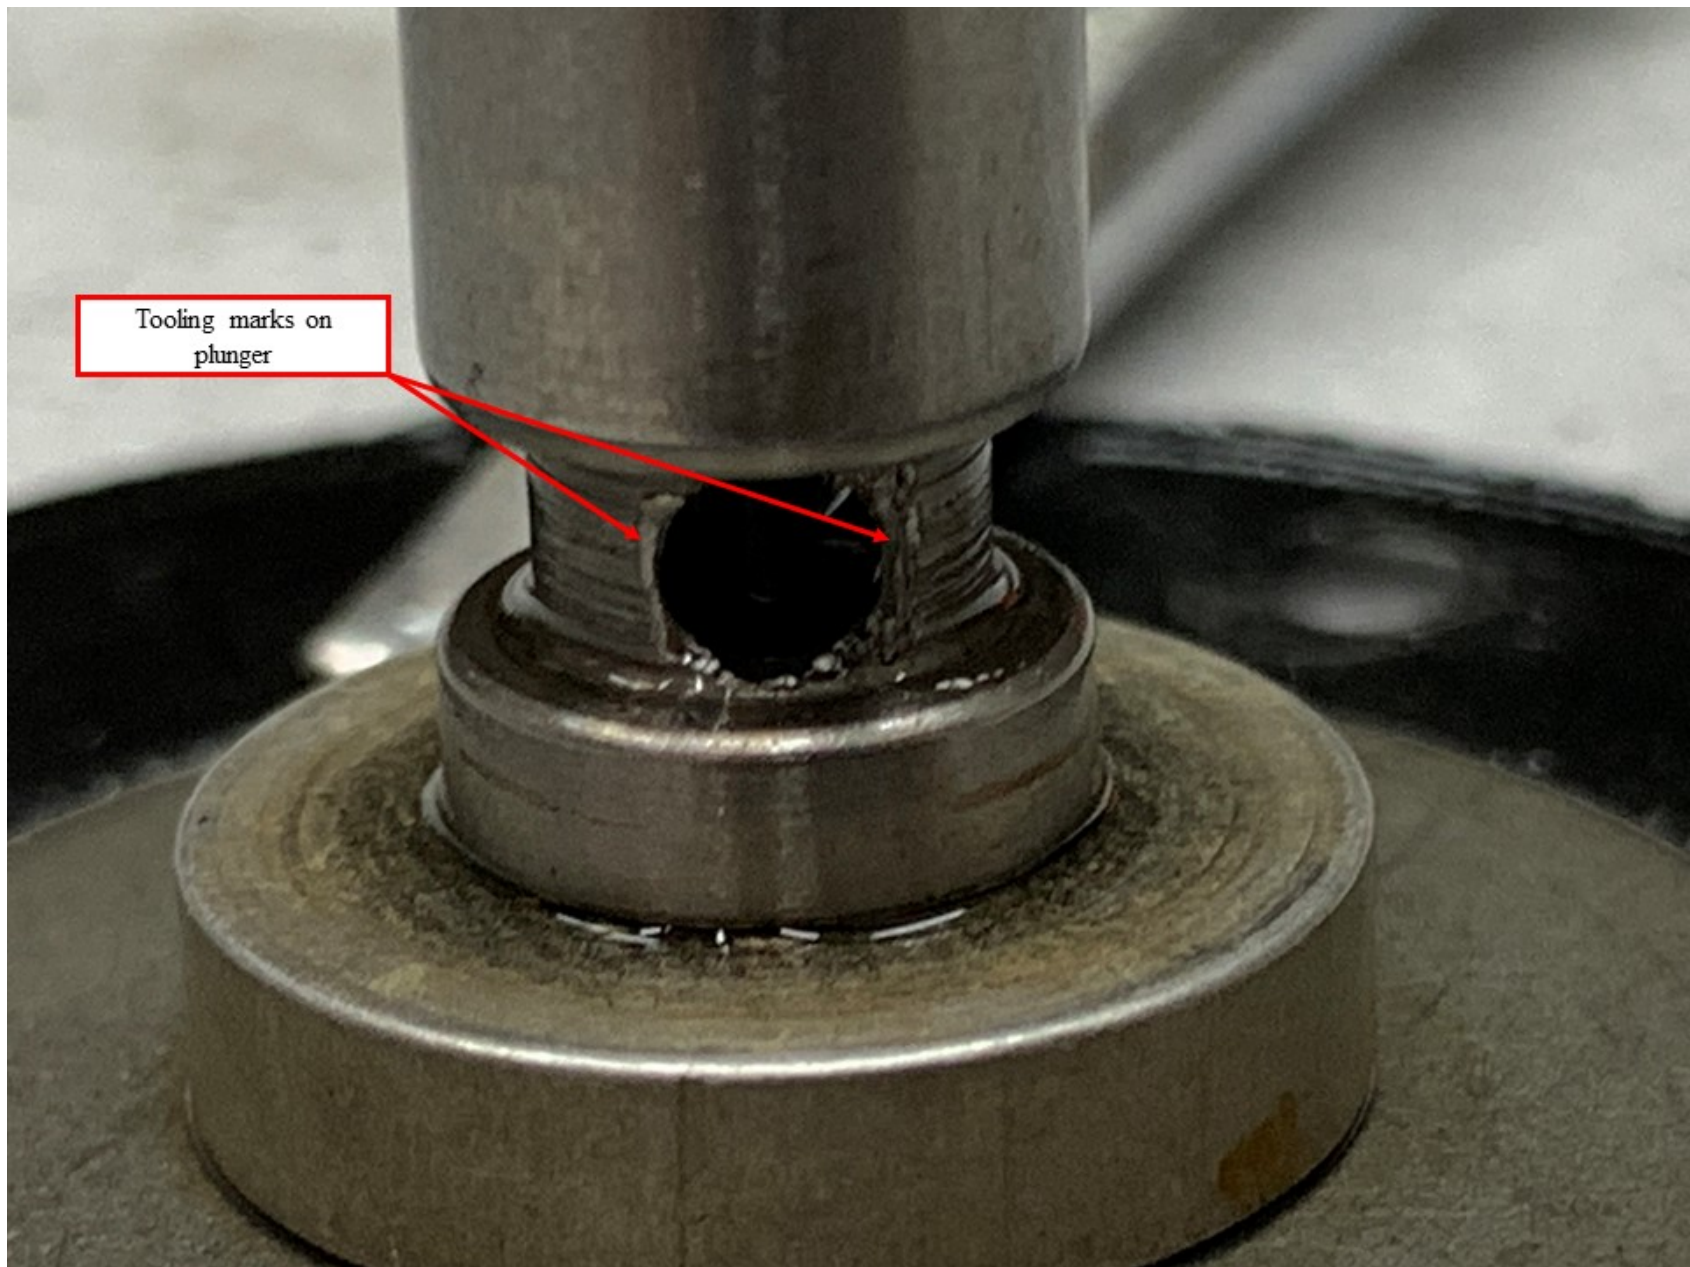
**Photo 5 - View of tooling marks on fuel flow manifold valve plunger (photo courtesy of the NTSB)**

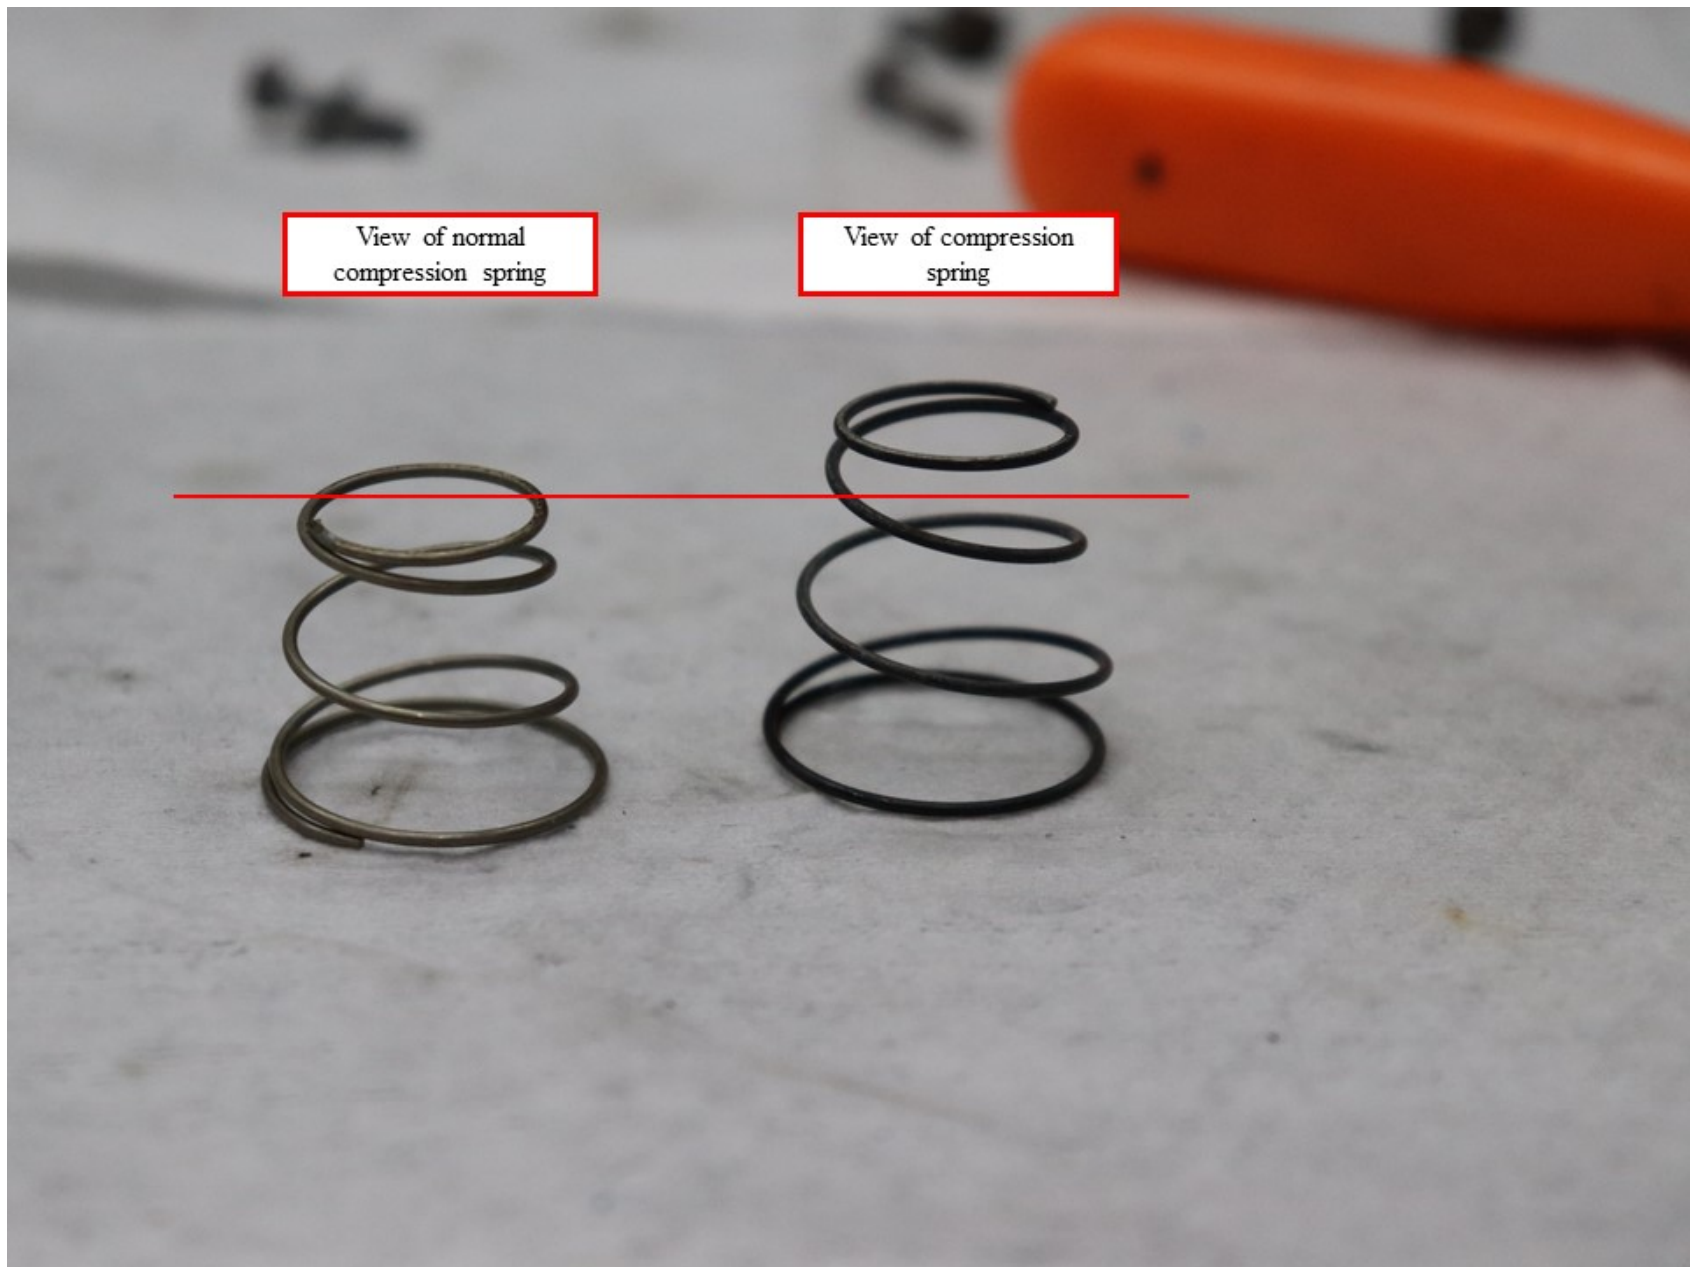
**Photo 6 - View of fuel flow manifold valve compression spring comparison (photo courtesy of the NTSB)**
