## **NATIONAL TRANSPORTATION SAFETY BOARD**

# **FUEL SYSTEM COMPONENTS EXAMINATION**

**WPR21LA194**

| Aircraft: | Cessna, 210, N7350E |

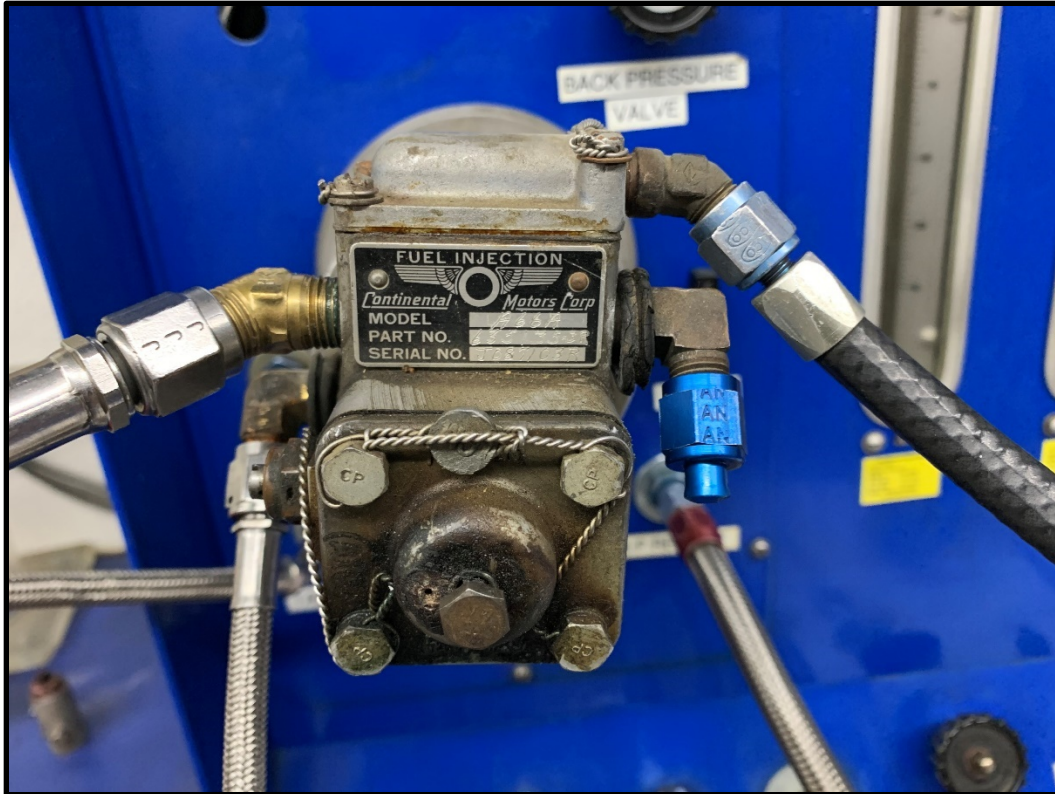
### **1.0 Engine Driven Fuel Pump**

A visual examination of the recovered engine driven fuel pump revealed that fuel pump cover plate was discolored consistent with a fuel leak, no further anomalies were noted.

The fuel pump was connected to a test stand. Initial start of the fuel flow test revealed a short spike for about 5 seconds of about 35 pounds per square inch (psi) and about 30 pounds per hour (fuel flow) at 600 revolutions per minute (rpm). Further attempts to duplicate the fuel flow spike could not be produced. The fuel pump performed within manufactures specifications when tested at 600 rpm and 2625 rpm.

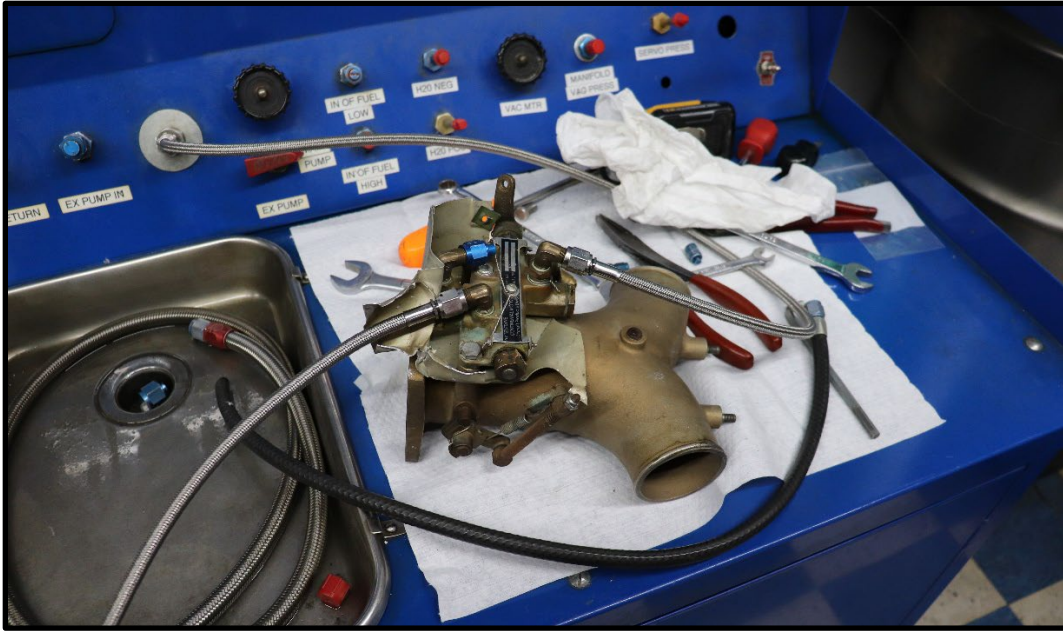
## 2.0 Throttle Body Examination

Examination of the recovered throttle body that the throttle lever was intact, moved freely from stop to stop, but the connecting linkage to the throttle cable was fracture separated, consistent with impact damage. The mixture control lever attached to the throttle body was damaged but moved freely from stop to stop. The fuel inlet fuel screen was removed, and debris was observed.

The throttle body was connected to a test stand and performed within manufactures specifications when tested. Fuel leaking near the throttle and mixture lever was observed consistent with impact damage.

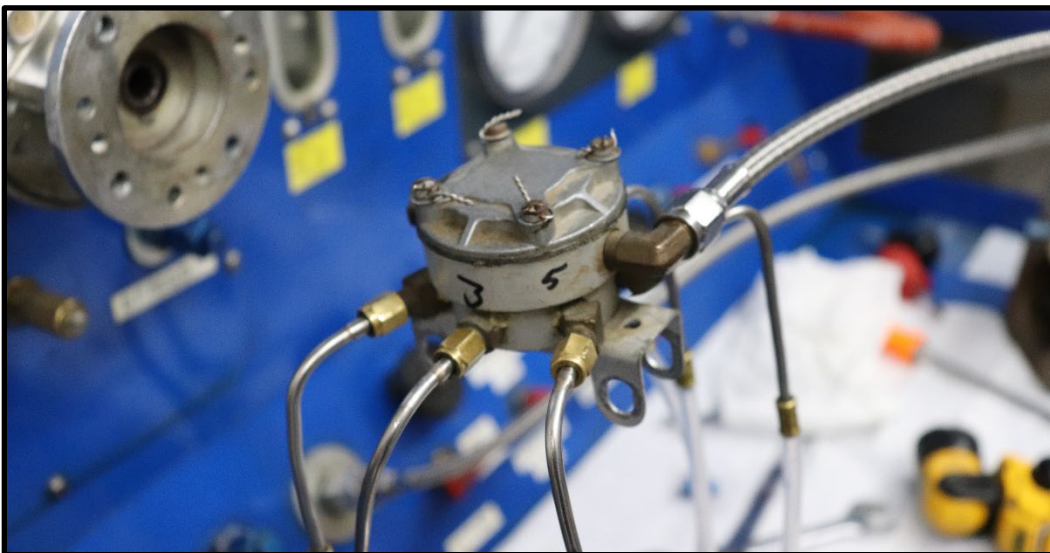
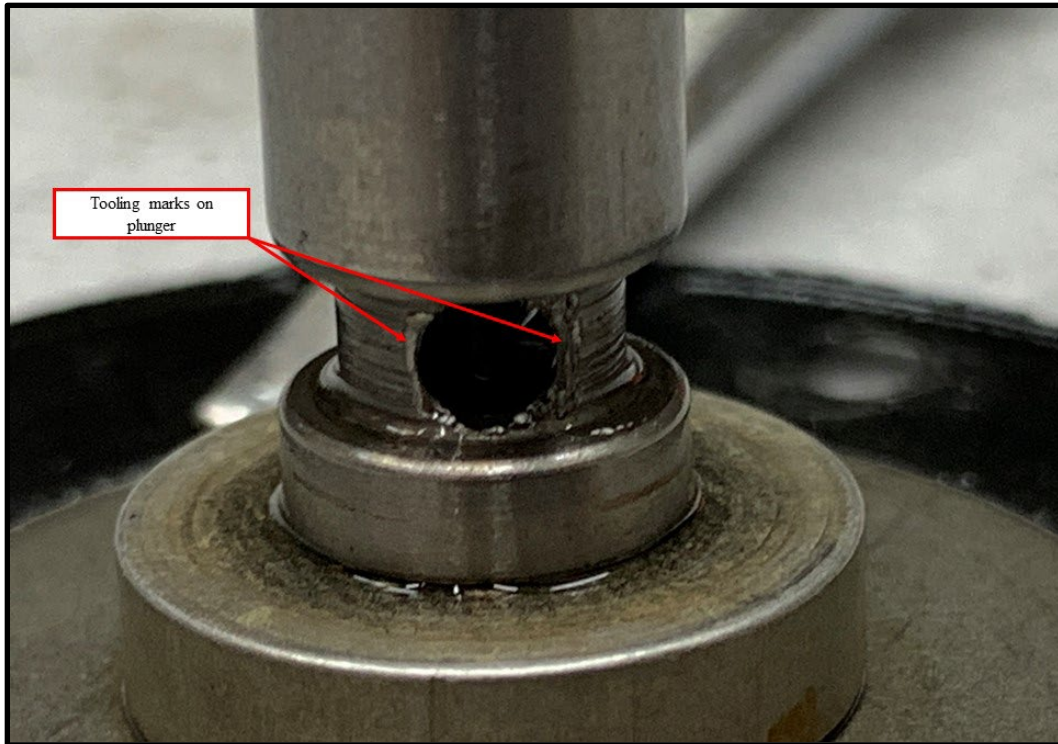
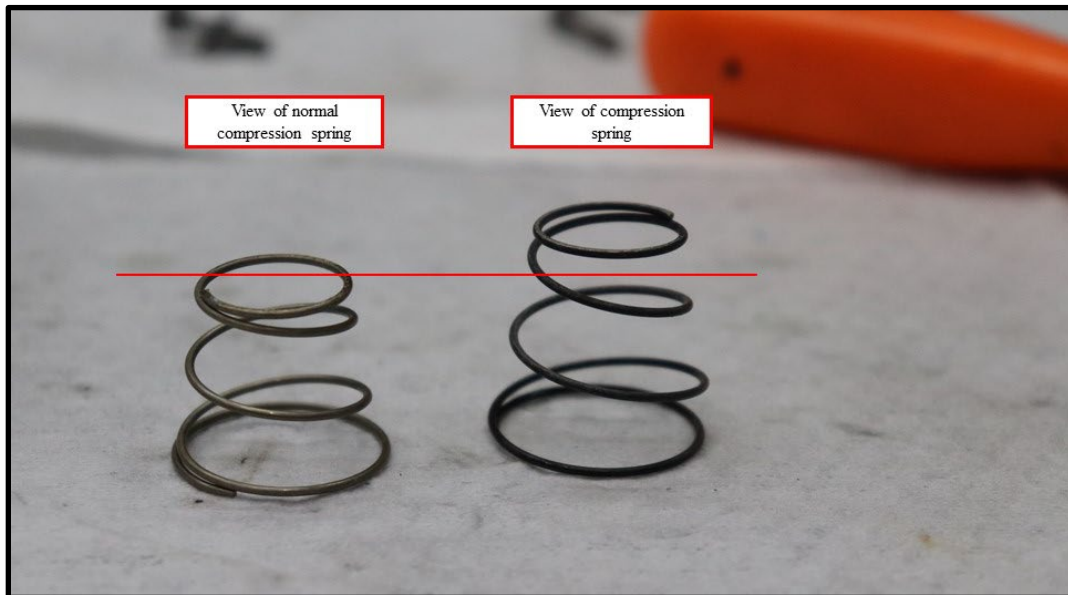
### 3.0 Fuel Flow Manifold Valve Examination

The examination of the fuel flow manifold valve, throttle body/fuel control, and engine driven fuel pump revealed a malfunction of the fuel flow manifold valve plunger preventing normal operation.

Examination of the recovered fuel flow manifold valve was intact and undamaged. The fuel flow manifold valve was connected to a test stand, the valve failed to open when fuel pressure was applied. The fuel flow manifold valve was disassembled, tooling marks were observed on the plunger, the seal near the plunger was deformed and not seated flat on the manifold body. The diaphragm spring was longer when compared to a normal spring, consistent with stretching. The plunger assembly and diaphragm were substituted in the fuel flow manifold valve. The fuel flow manifold valve was reattached to the test stand and performed within manufactures specifications when tested. The tooling marks on the plunger are consistent with binding of the plunger preventing normal operation.
