## **NATIONAL TRANSPORTATION SAFETY BOARD**

### **ENGINE EXAMINATION SUMMARY**

**WPR21LA204**

Location: Eugene, OR  
Date: May 20, 2021  
Aircraft: Glasair III, N54CB  
NTSB Investigator-in-Charge: Tealeye Cornejo

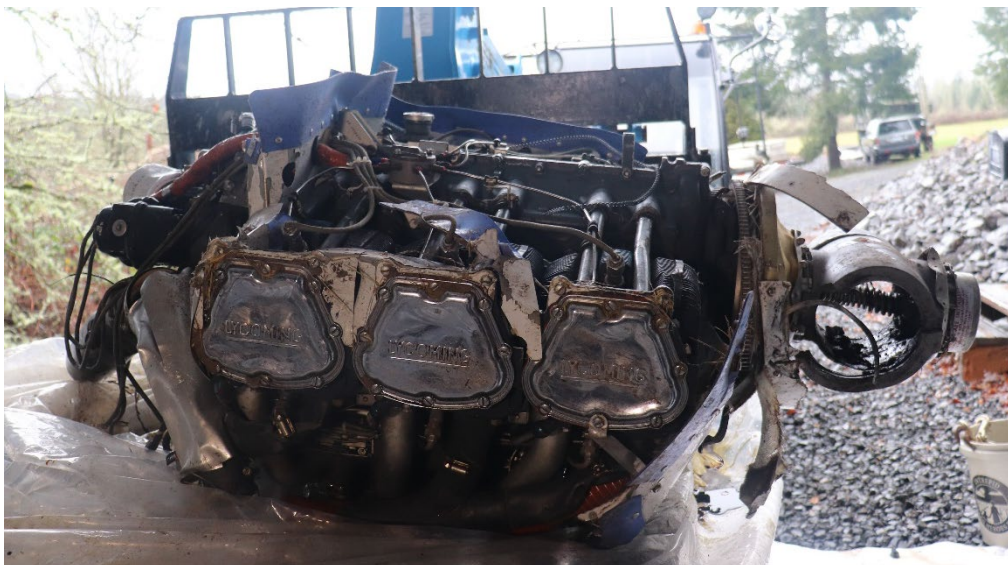
**Figure 1. Picture of accident engine**

Examination of the recovered engine was conducted on March 2, 2022, at the facilities of Nu Venture Air Services, LLC. The engine a Lycoming IO-540-K1H5, serial no. L-24507-48A was separated from the airframe during recovery.

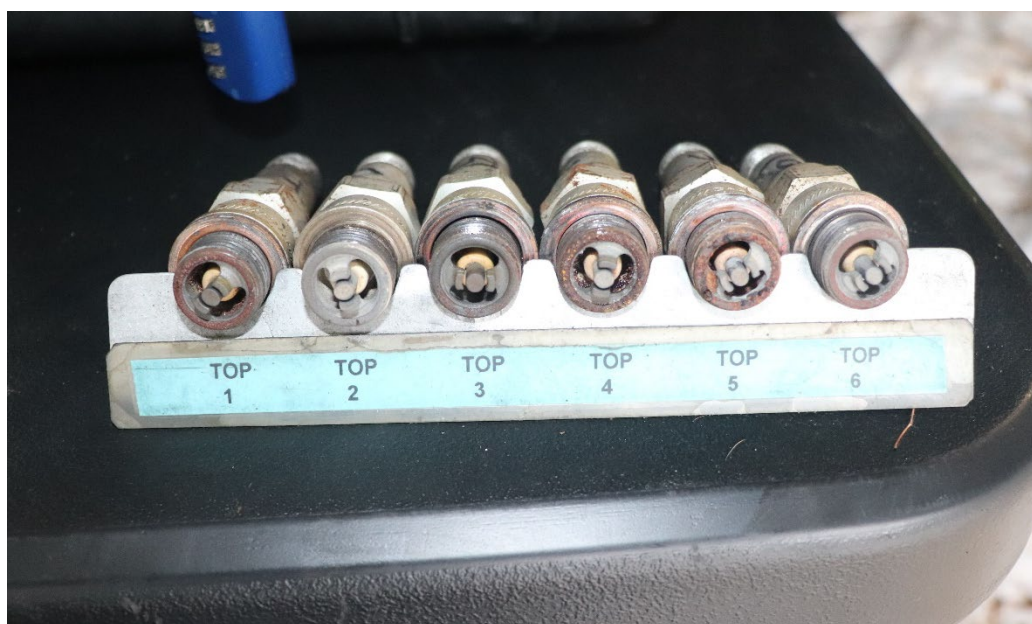
**Figure 2. Picture of six top spark plugs**

The top spark plugs were removed, and all spark plug electrodes were intact with carbon build-up; all spark plugs revealed symmetrical wear. The crankshaft was manually rotated using the propeller; thumb compression, mechanical and valve train continuity were established except at the No. 6 exhaust valve, which had sustained impact damage to the exhaust pushrod tube. Compression was found in all 6 cylinders.

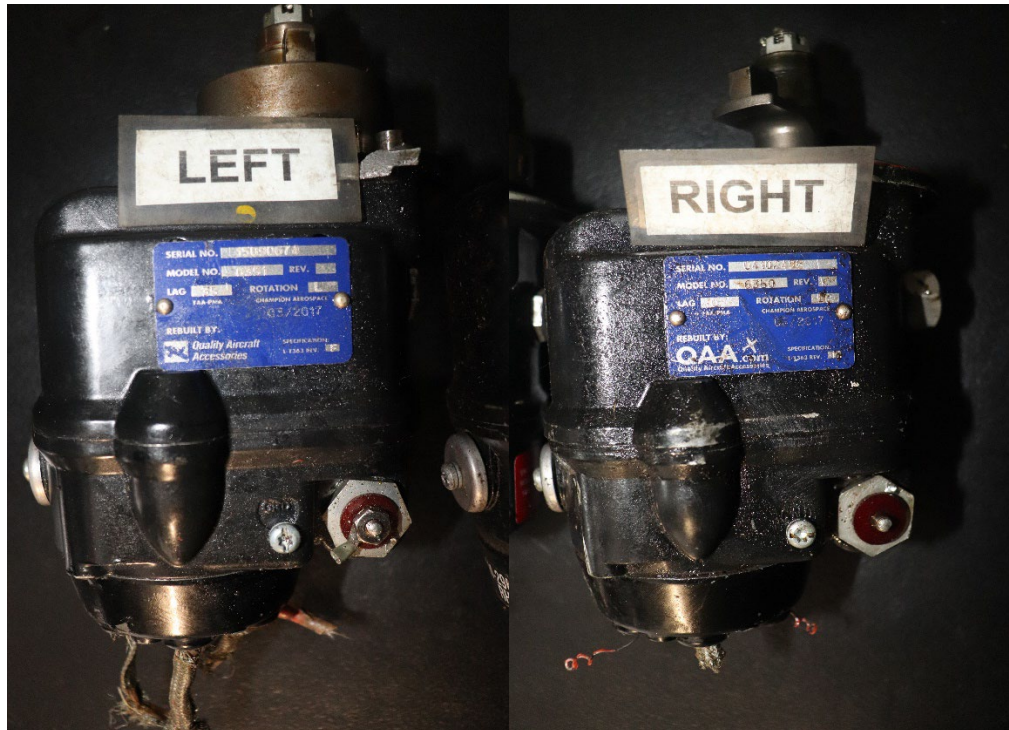
**Figure 3. Picture of left and right magnetos showing data plates**

Slick Magnetos manufactured both magnetos. According to the data plate, both magnetos were overhauled by Quality Aircraft Accessories. The right magneto model No. 6320, serial No. U4102486, remained secure at its mounting pads on the engine and the left magneto model No 6351, Serial No. 15090674, sustained impact energy damage at the magneto-mounting flange and was partially displaced from the mounting pad. The magneto to engine

timing checks revealed that the right magneto was set to 23° before top dead center. The left magneto's timing could not be verified due to it being displaced.

Both magnetos were removed and manually rotated and produced spark at each plug lead.

The ignition harness was intact, and each lead remained connected to its appropriate spark plug. All contact springs were found unremarkable.

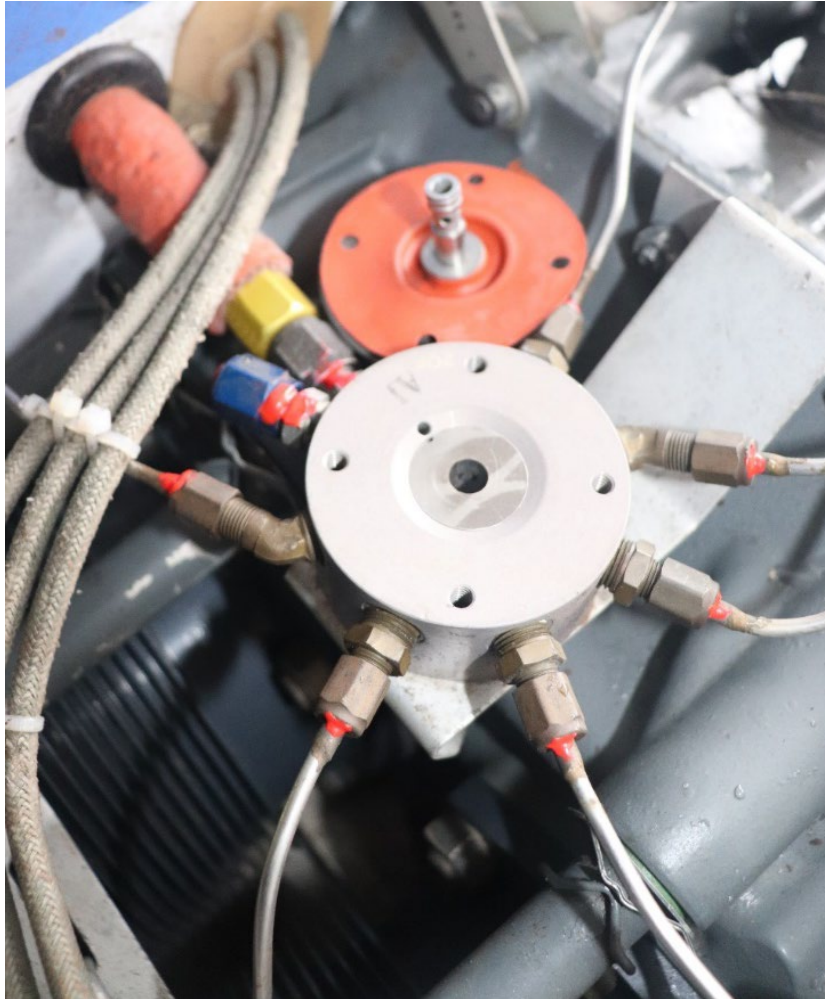
**Figure 4. A close-up picture of the fuel flow divider showing diaphragm**

The fuel flow divider remained intact. All six output fuel lines to the cylinders remained intact and connected to its respective fuel nozzle. The fuel flow divider cover was removed and revealed that the diaphragm and spring were intact. No water or contaminants were found within the cavity.

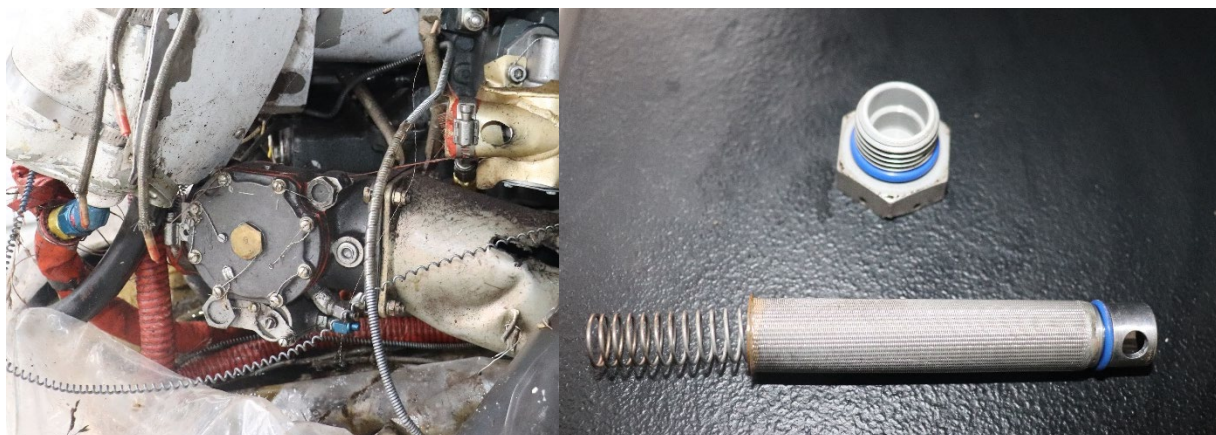
**Figure 5. Close-up views of fuel flow servo and internal fuel filter**

The fuel flow servo body remained secured on its mounting pad. The input and output fuel lines were impact damage. Fuel was not found within the cavity of the servo. The internal fuel filter was removed and found unremarkable.

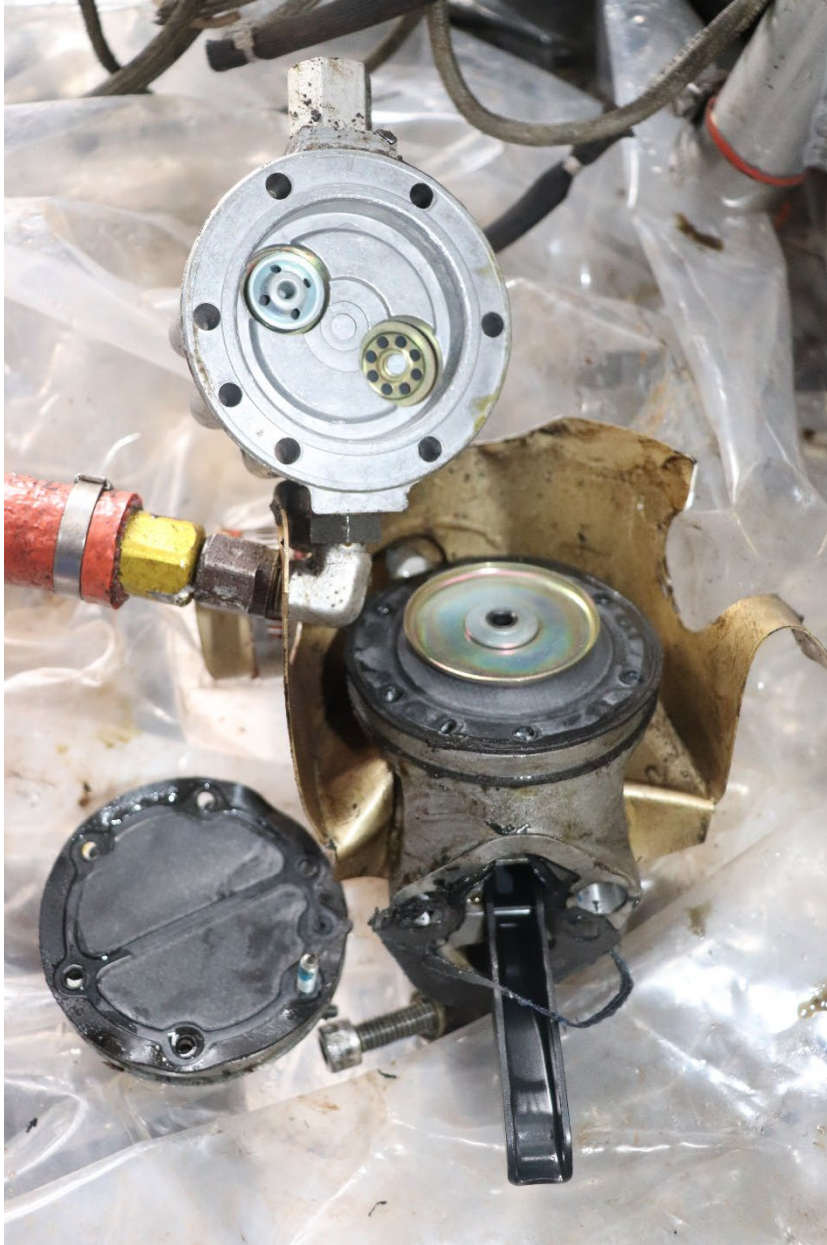
Figure 6. A picture of the disassembled fuel pump

The mechanical fuel pump remained intact and secure at its mounting pad on the accessory case. It was removed and disassembled. The diaphragm and internal components were unremarkable.
