# National Transportation Safety Board

WPR21LA204

## **FLAP EXAMINATION REPORT**

Airplane: Experimental McClure Glasair III, N54CB

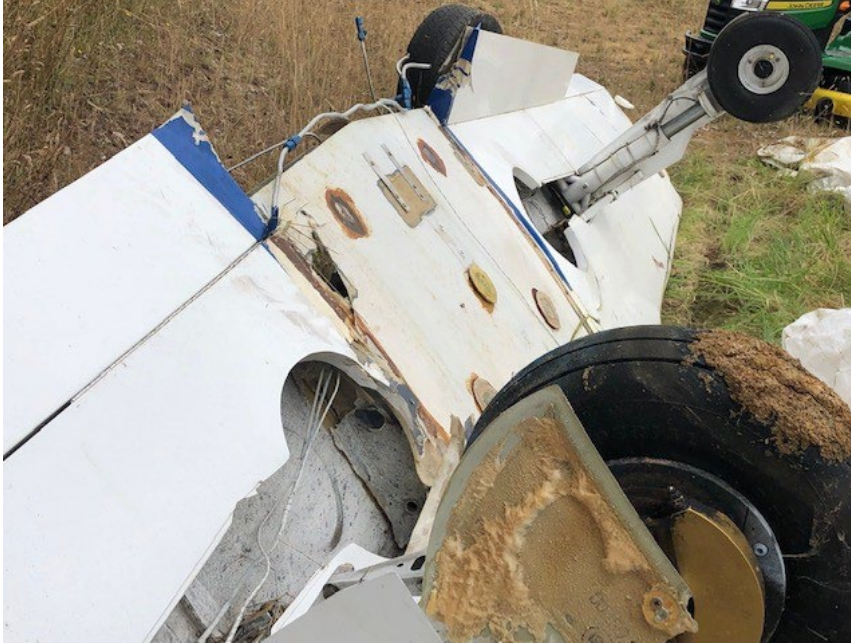
The entire wing assembly with landing gear separated from the airframe in one piece. The flap bar is a one-piece tubular bar that remained in place in the center box.

Figure 1. Landing gear assembly (Photo Courtesy of Nu Venture)

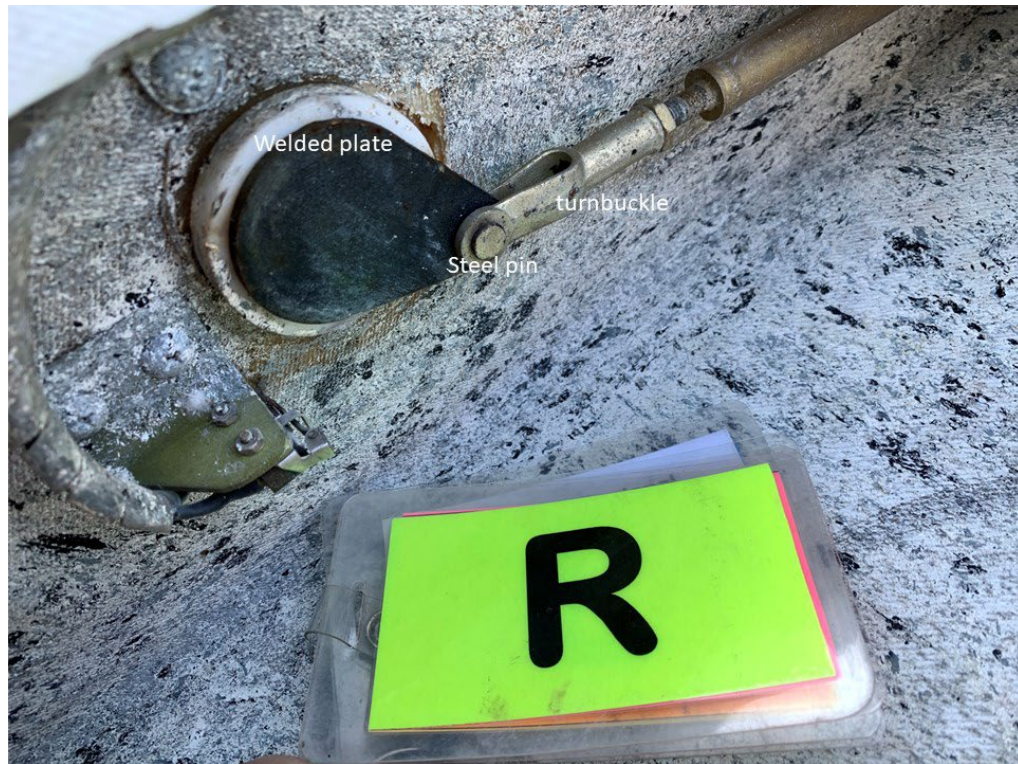
The right-wing flap hardware remained connected and intact from the flap tubular bar welded plate at the wing root to the wing-to-flap attachment.

Figure 2. Flap Assembly - Right Wing

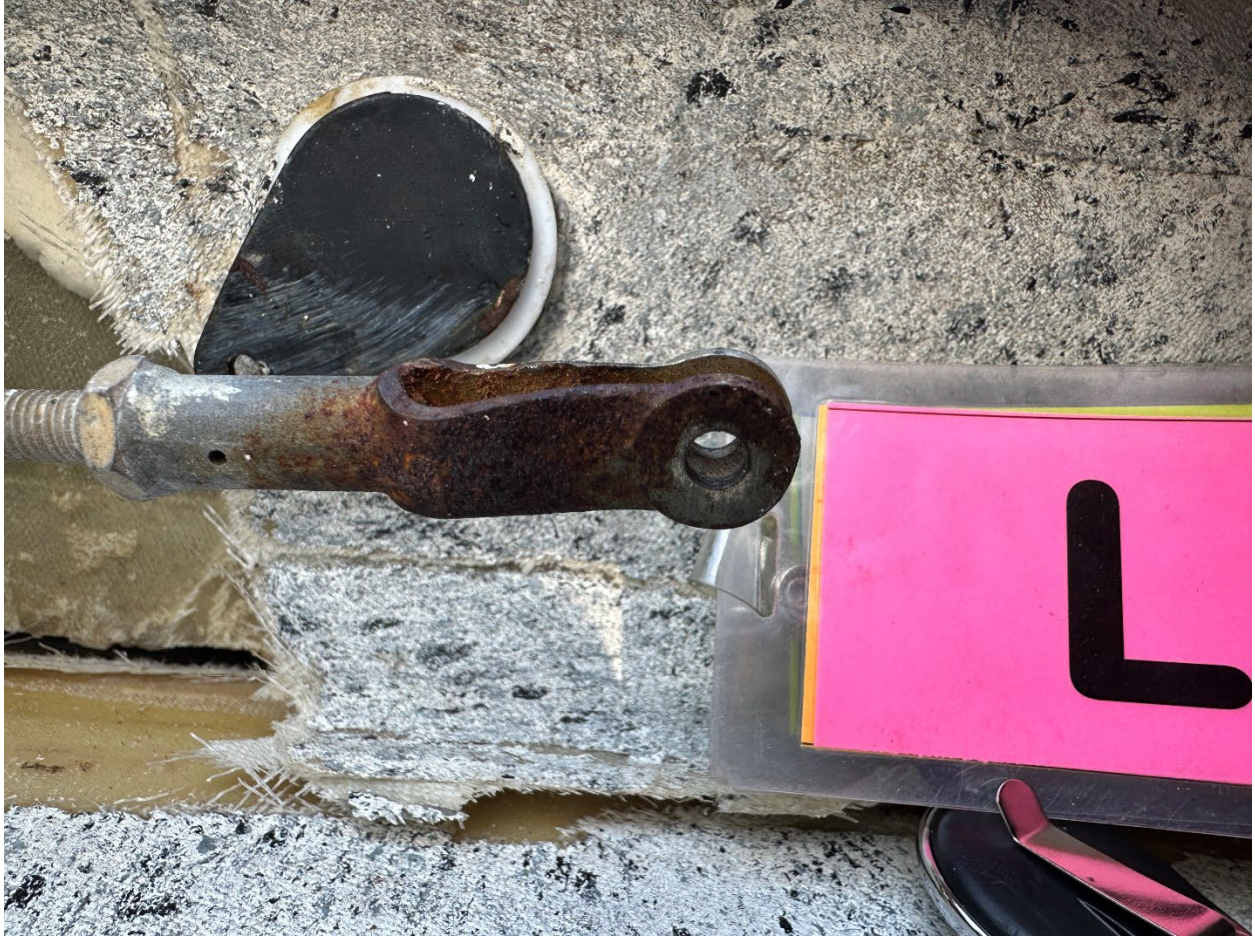
The left- wing flap actuator push-pull assembly was detached at the welded plate to adjustable turnbuckle fork, the non-threaded steel steel clevis pin, and cotter key were not found in the wreckage. The flap actuator rod end at the wing-to-flap attachment remained attached.

Figure 3. Detached left wing flap hardware welded plate and turnbuckle fork

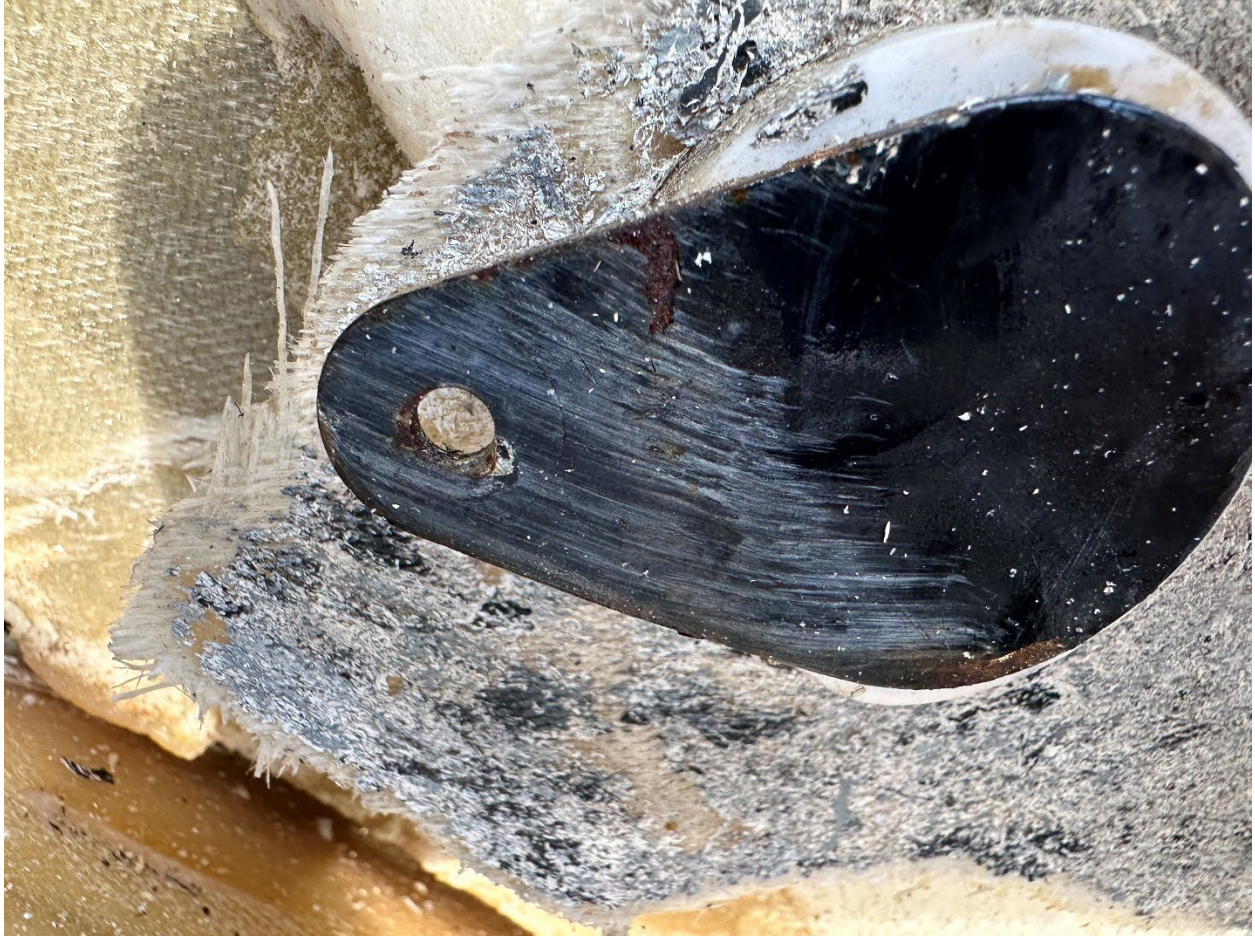
Figure 4. welded plate bent at the tab area with scratch marks

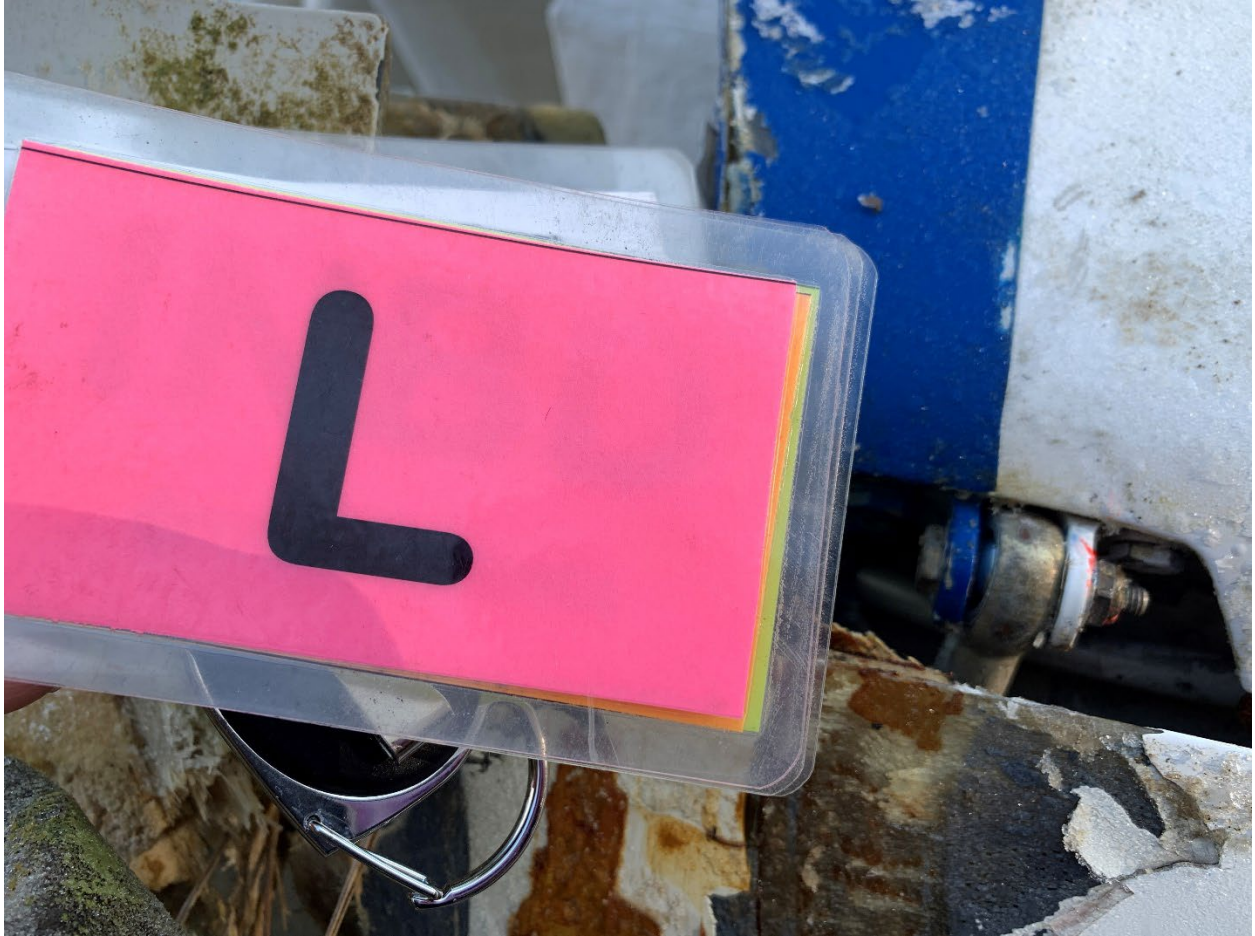
Figure 5. Flap actuator remained attached at the wing-to-flap attachment point
