**From:** [Meskimen, Troy \(FAA\)](#)  
**To:** [Smith Maja](#)  
**Subject:** WPR21LA219 N8176J  
**Date:** Monday, August 2, 2021 12:05:03 PM  
**Attachments:** [N8176J Engine tear down notes.docx](#)  
[1.pdf](#)  
[2 .pdf](#)  
[3.pdf](#)  
[4.pdf](#)  
[5.pdf](#)

Accident WPR21LA219

N8176J Engine tear down notes,

Engine Make: Experimental - Eggenfellner / Subaru

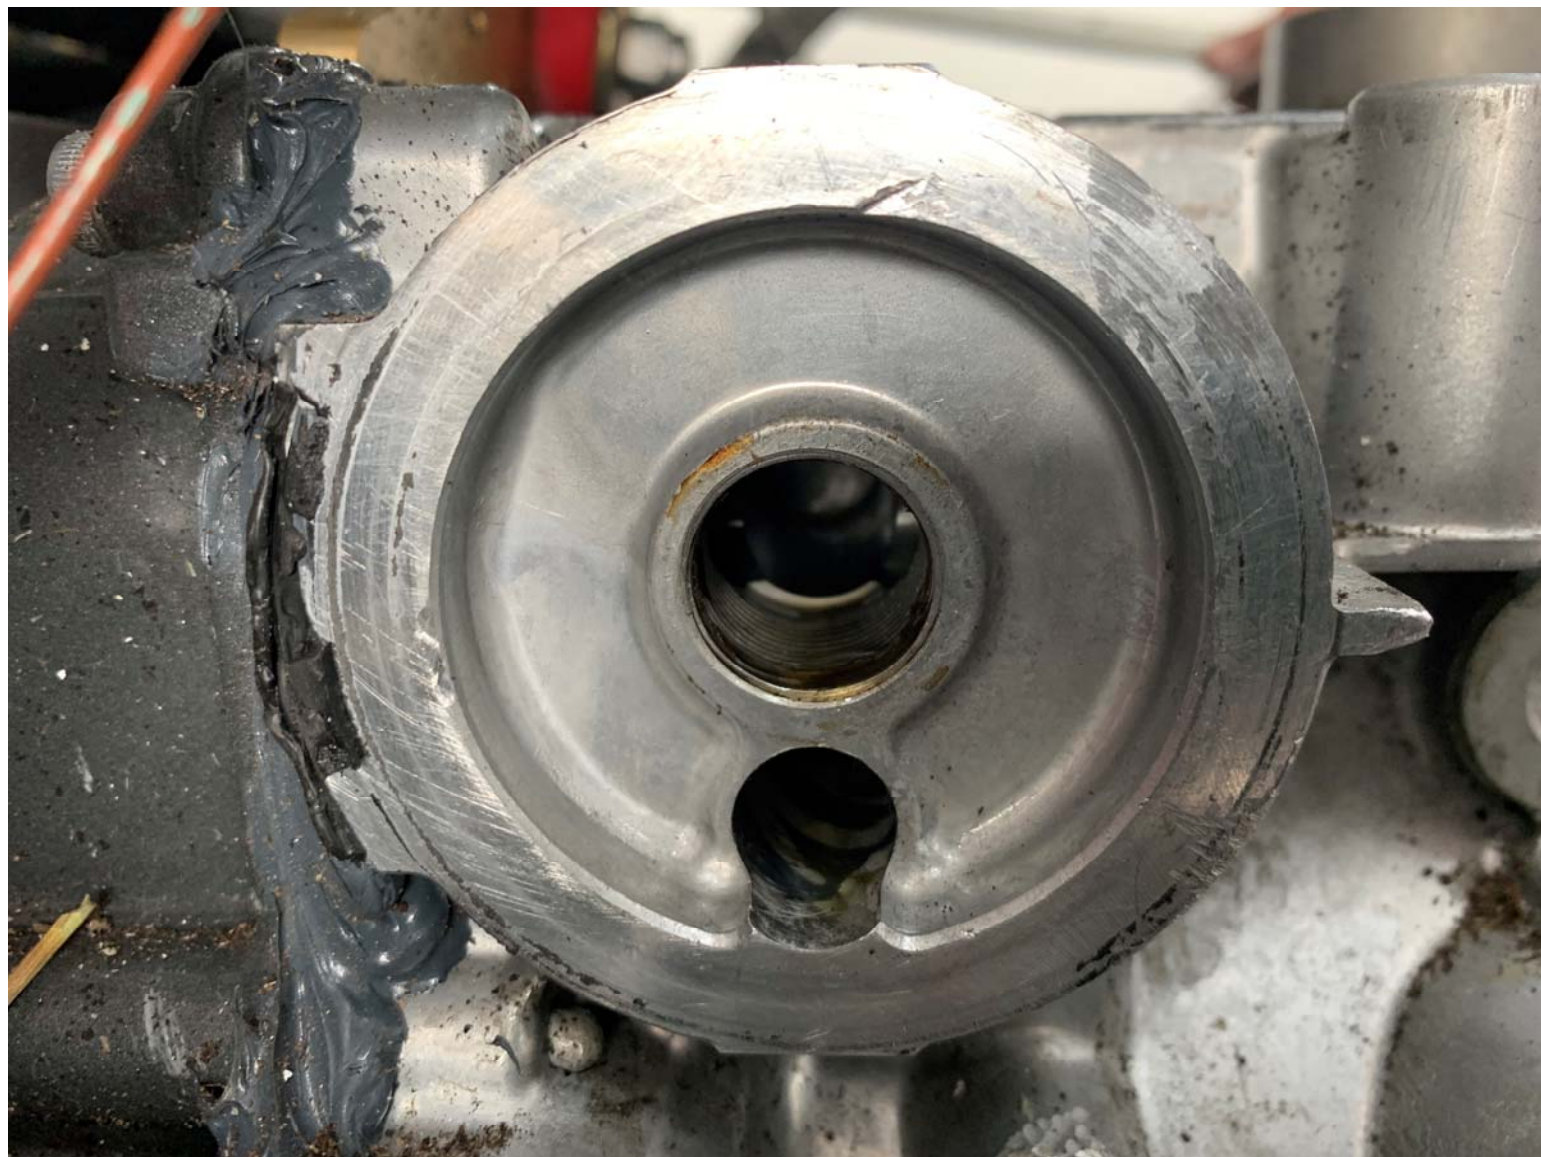
Removed oil filter and oil filter adapter, noted RTV sealant around base of oil filter adapter, O-ring nicked and deteriorated and in overall poor condition. Oil adapter mating flange on engine block has minor nicks and scratches. (See pictures) Engine block around oil filter / oil filter adapter has light film of oil.

#1 Oil filter adapter mount pad on engine (NOTE: Black RTV on face and around edge)

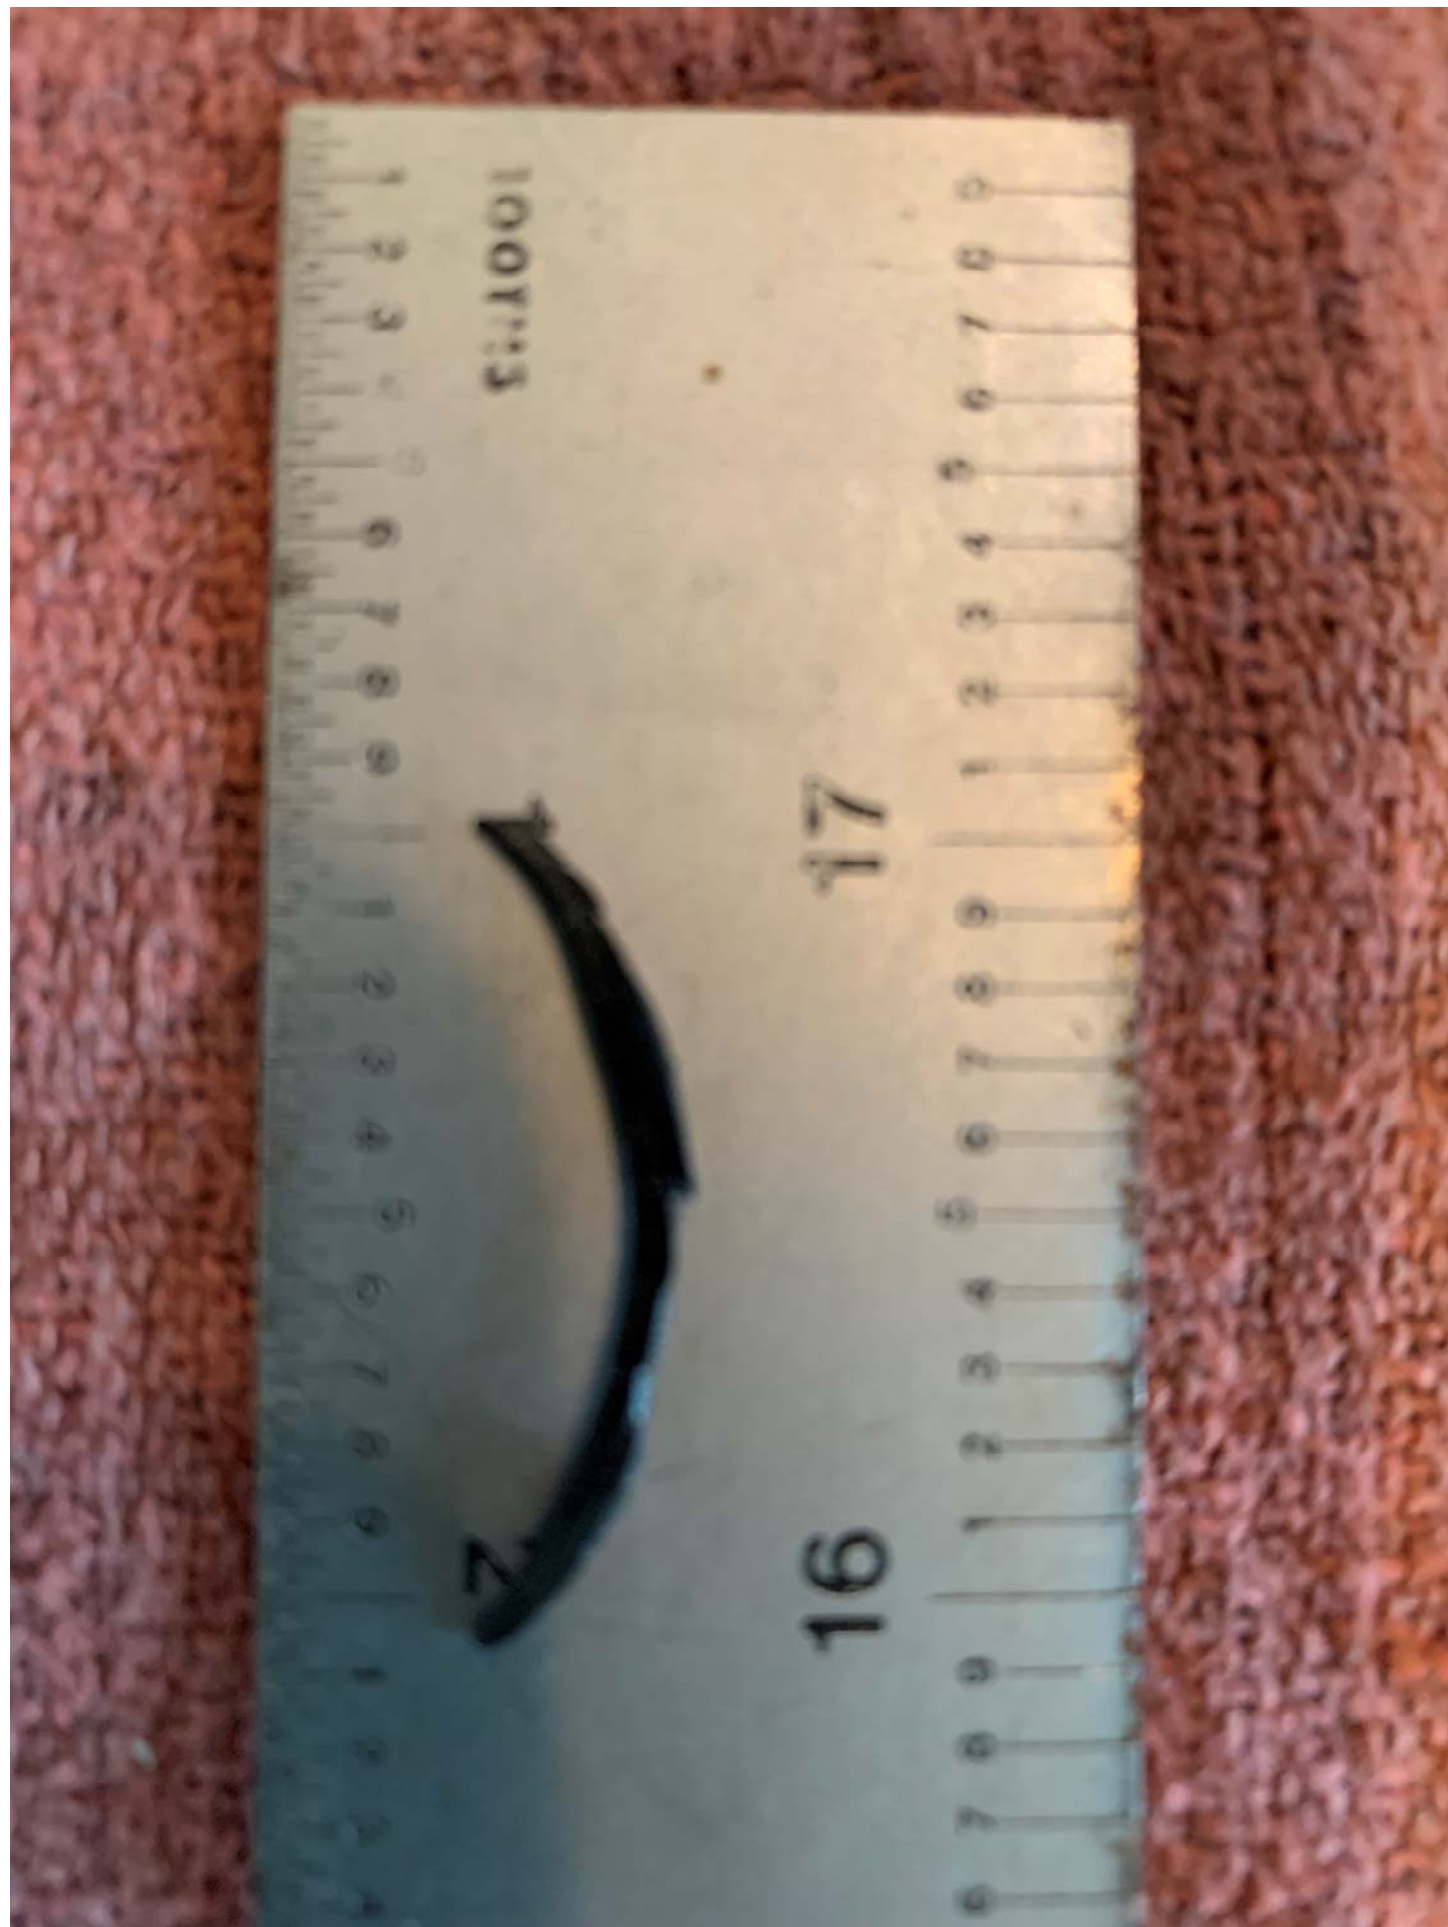
Cut open oil filter, discovered sliver of RTV sealant about an inch long similar in appearance to the RTV sealant around base of oil filter adapter.

*Summary: We didn't see anything that would lead us to believe that the engine oil pressure was actually dropping, however we lacked the special tooling needed to remove the oil pump for testing. As of this moment, since we found RTV in the oil filter, my best guess would be that RTV possibly partially plugged the Oil Pressure transducer, or the oil pump failed.*

#2 RTV found in Oil Filter.

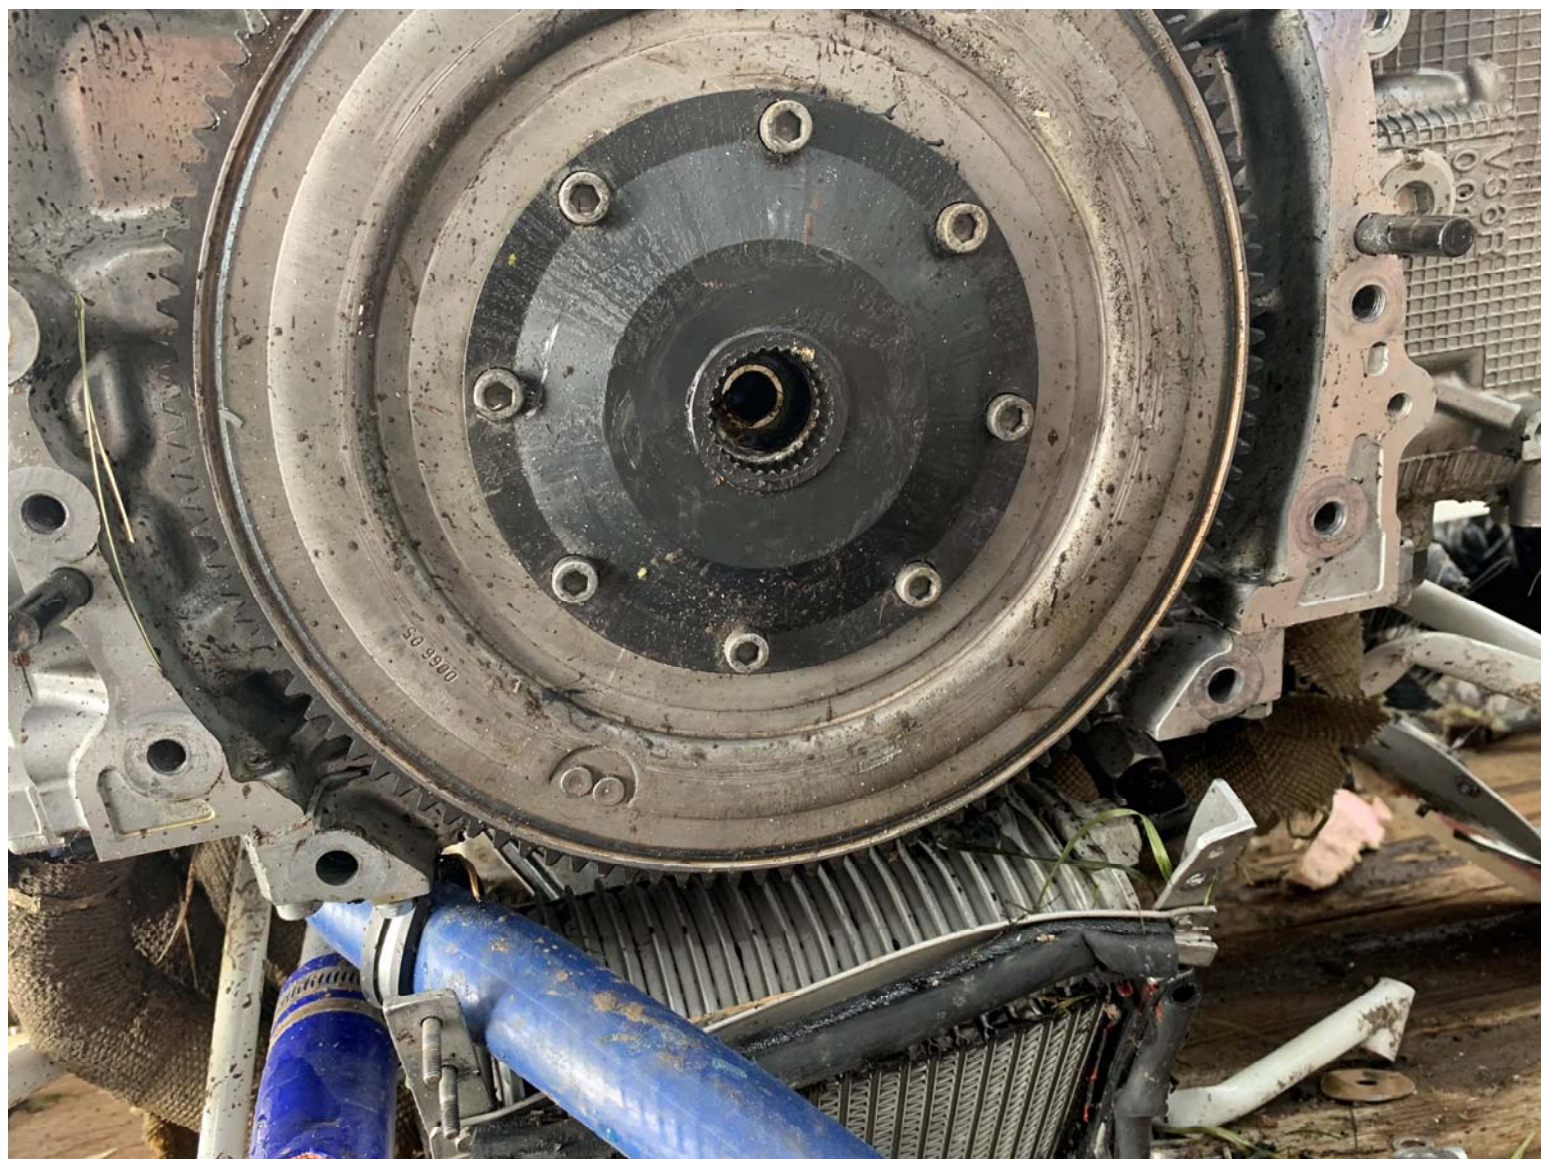
Aluminum forward mount plate shows signs of rubbing on flywheel. No significant signs of wear on fly wheel. **See picture**

#3 Fly Wheel

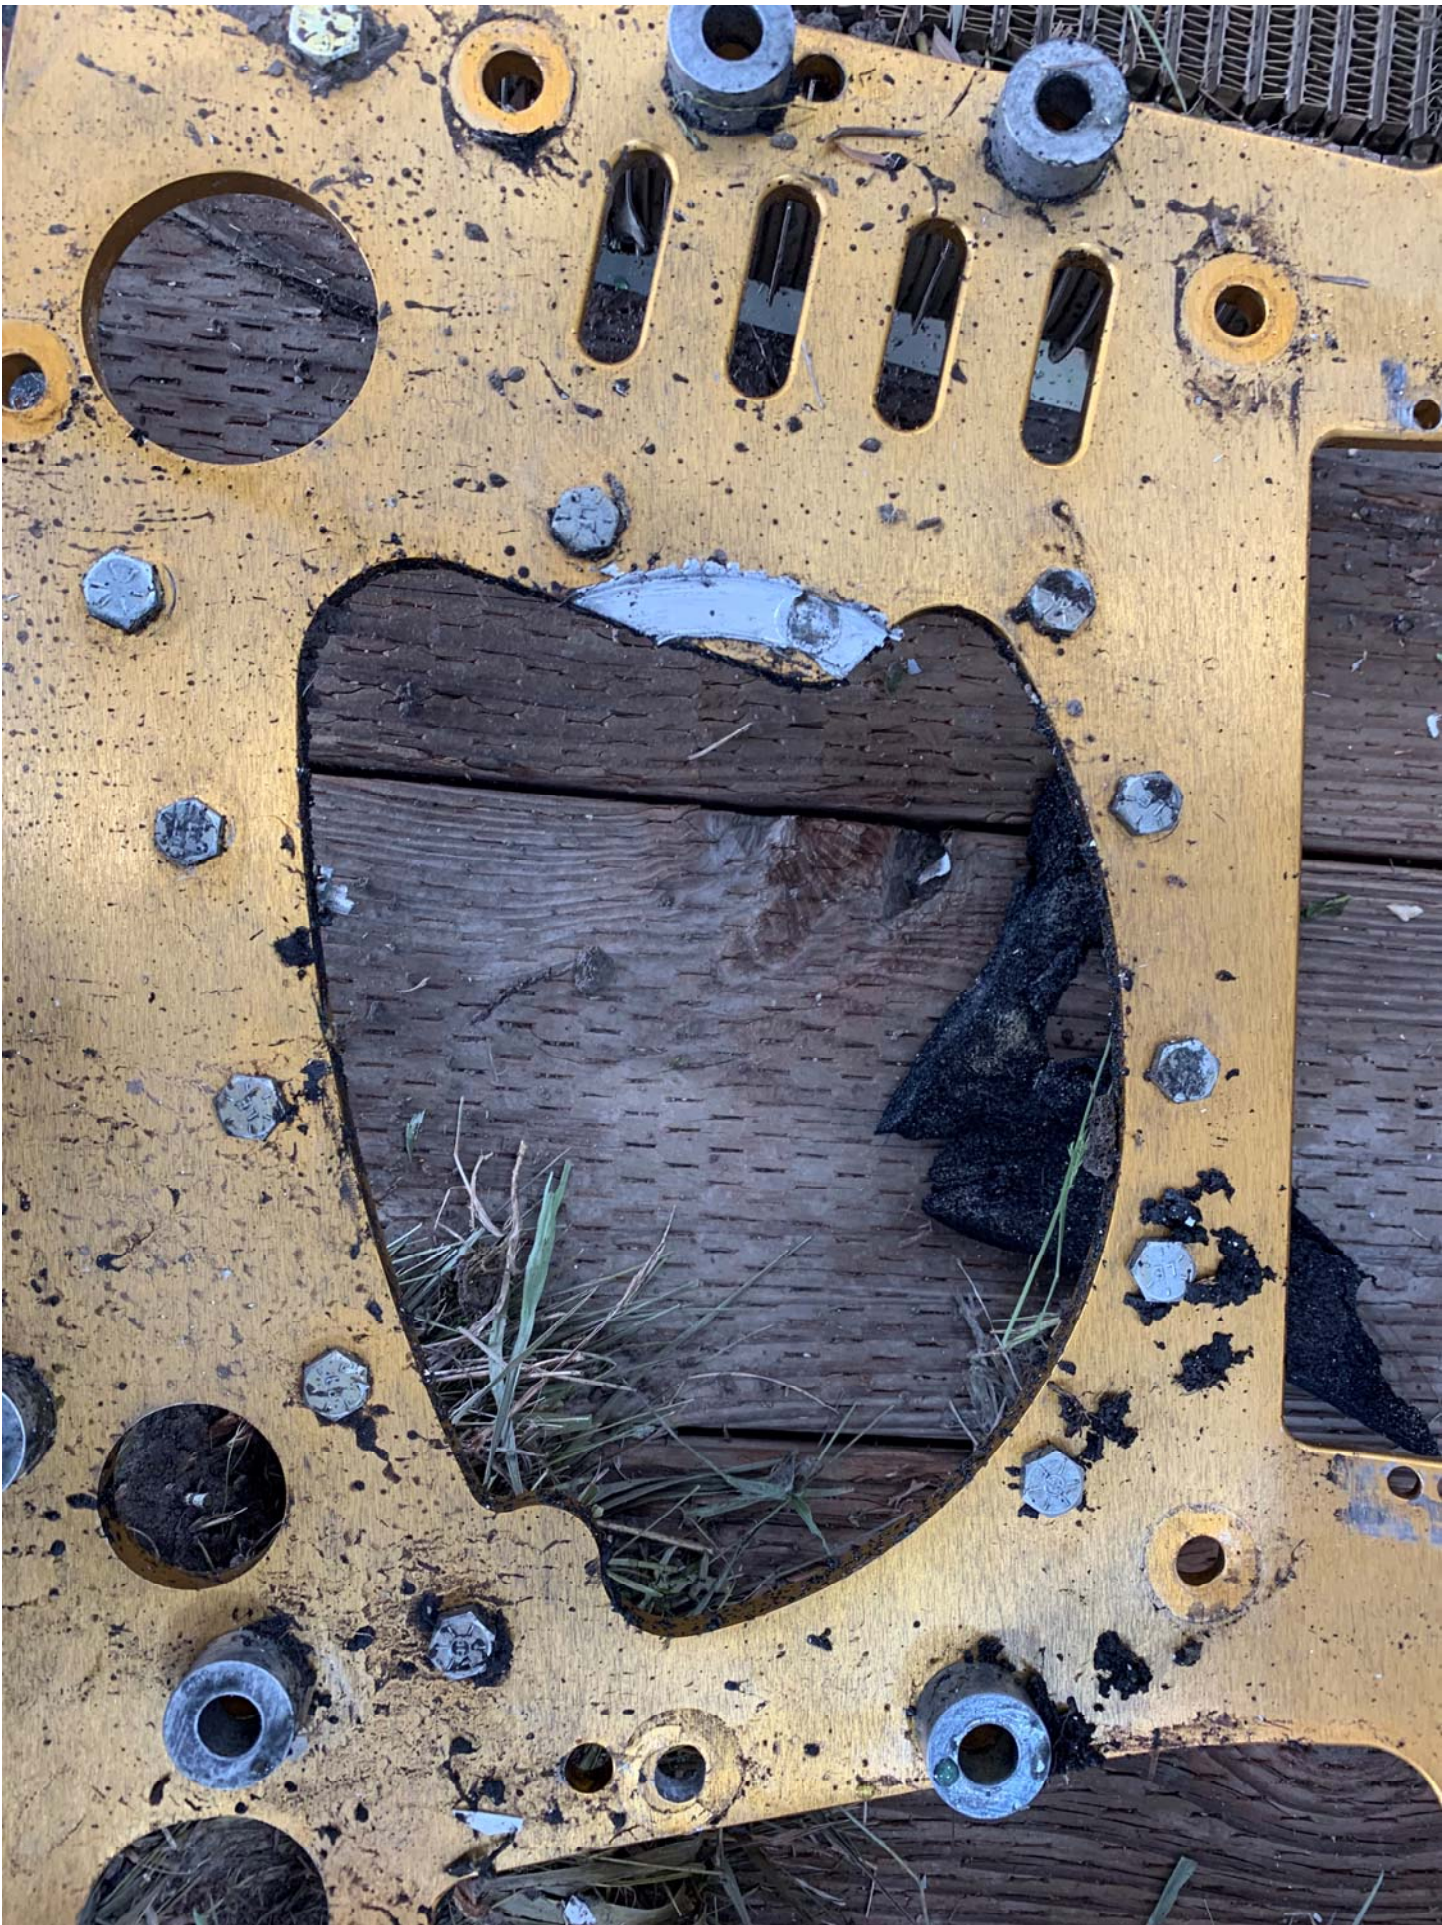
#4 Forward Mount Plate

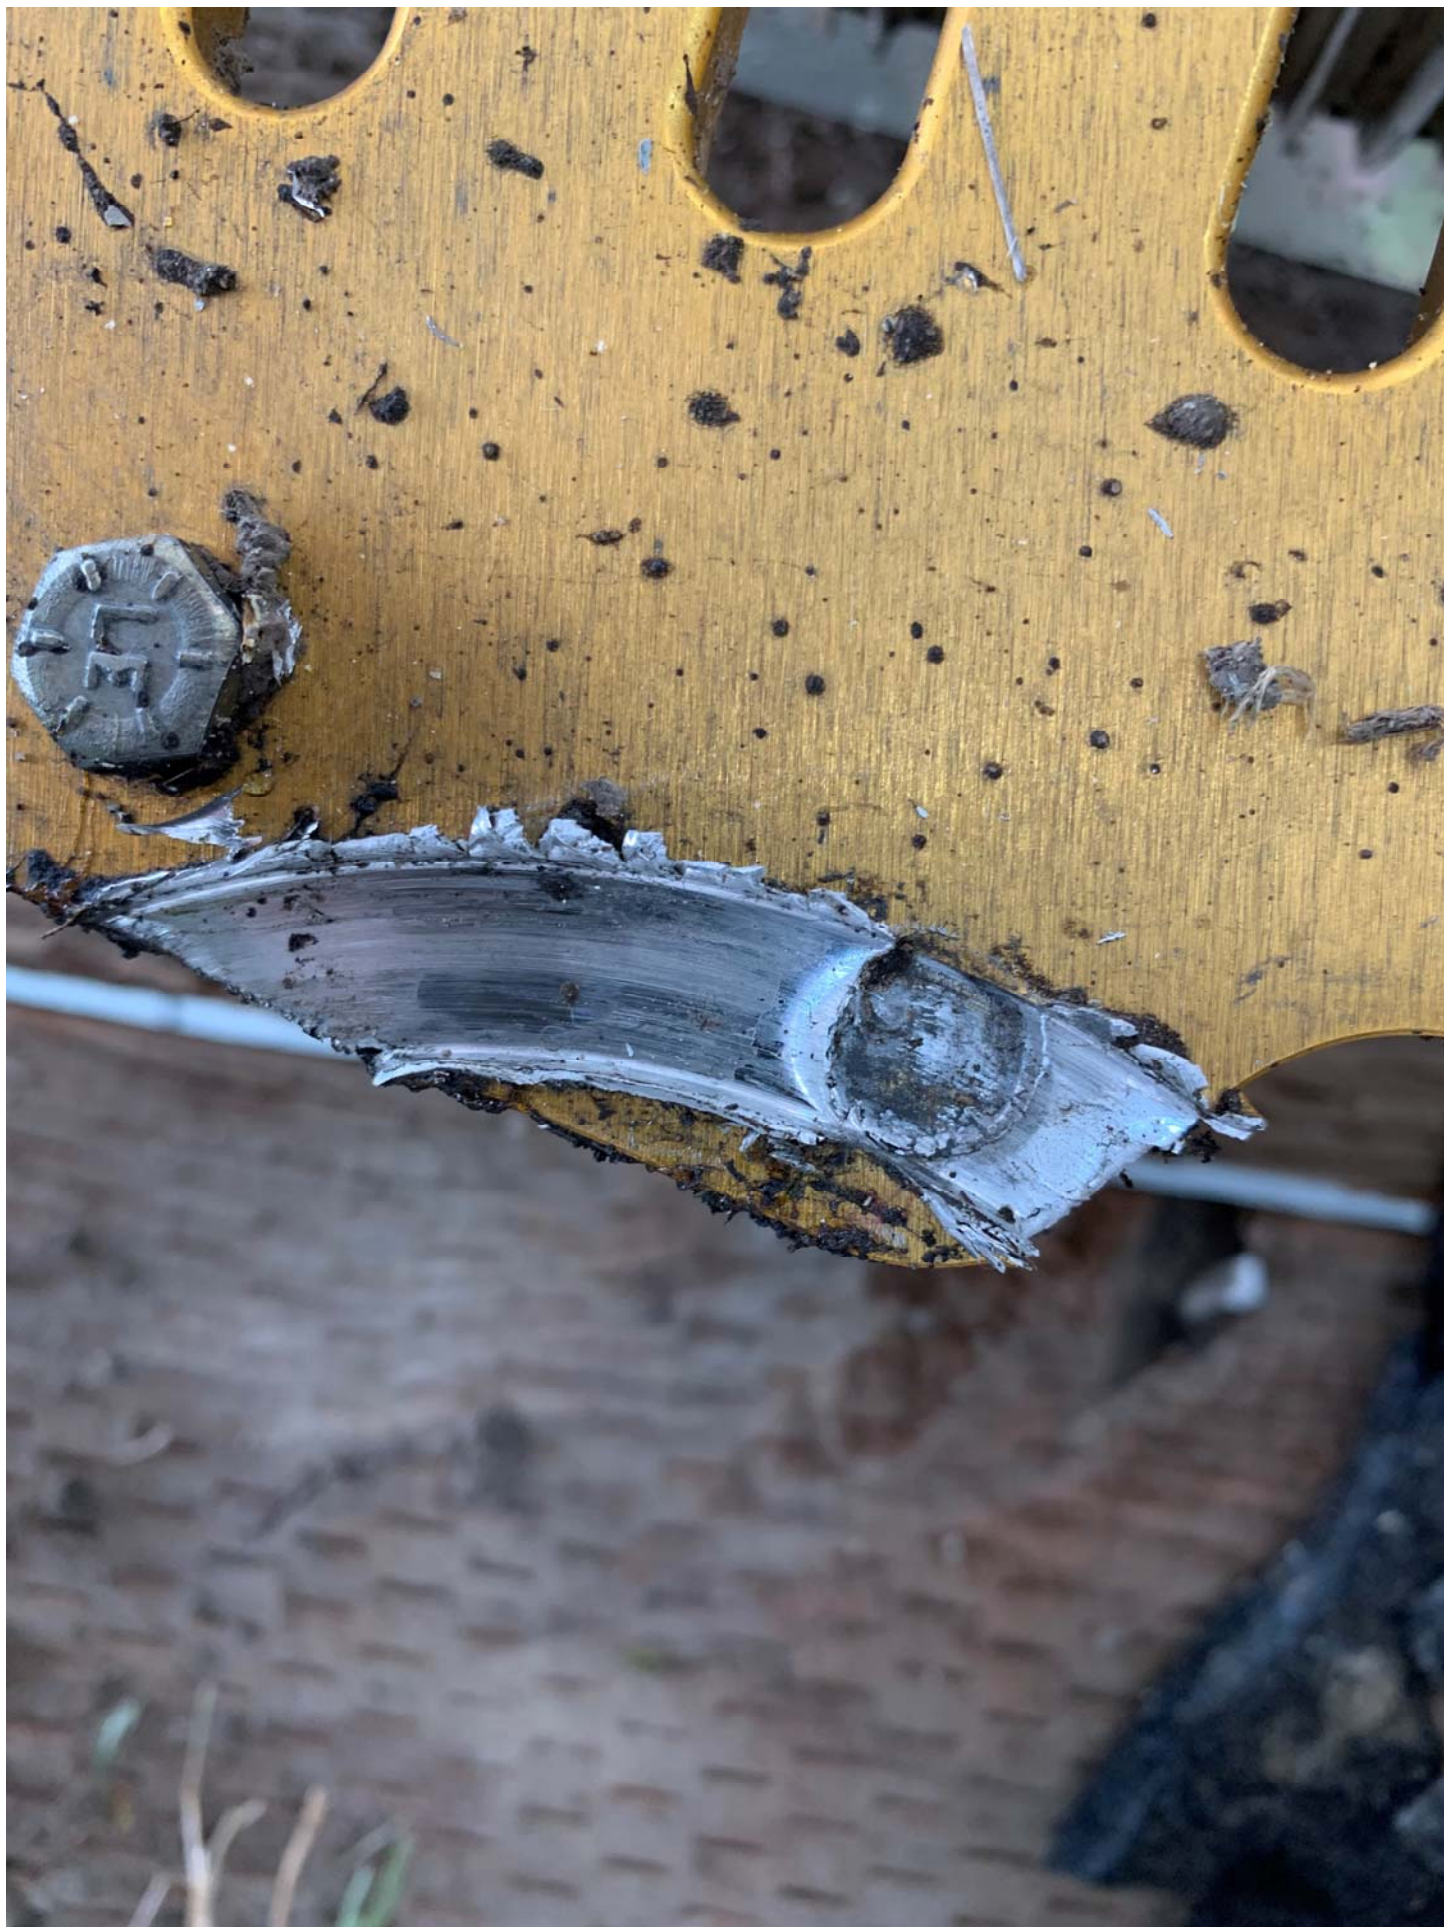
#5 Forward Mount Plate
