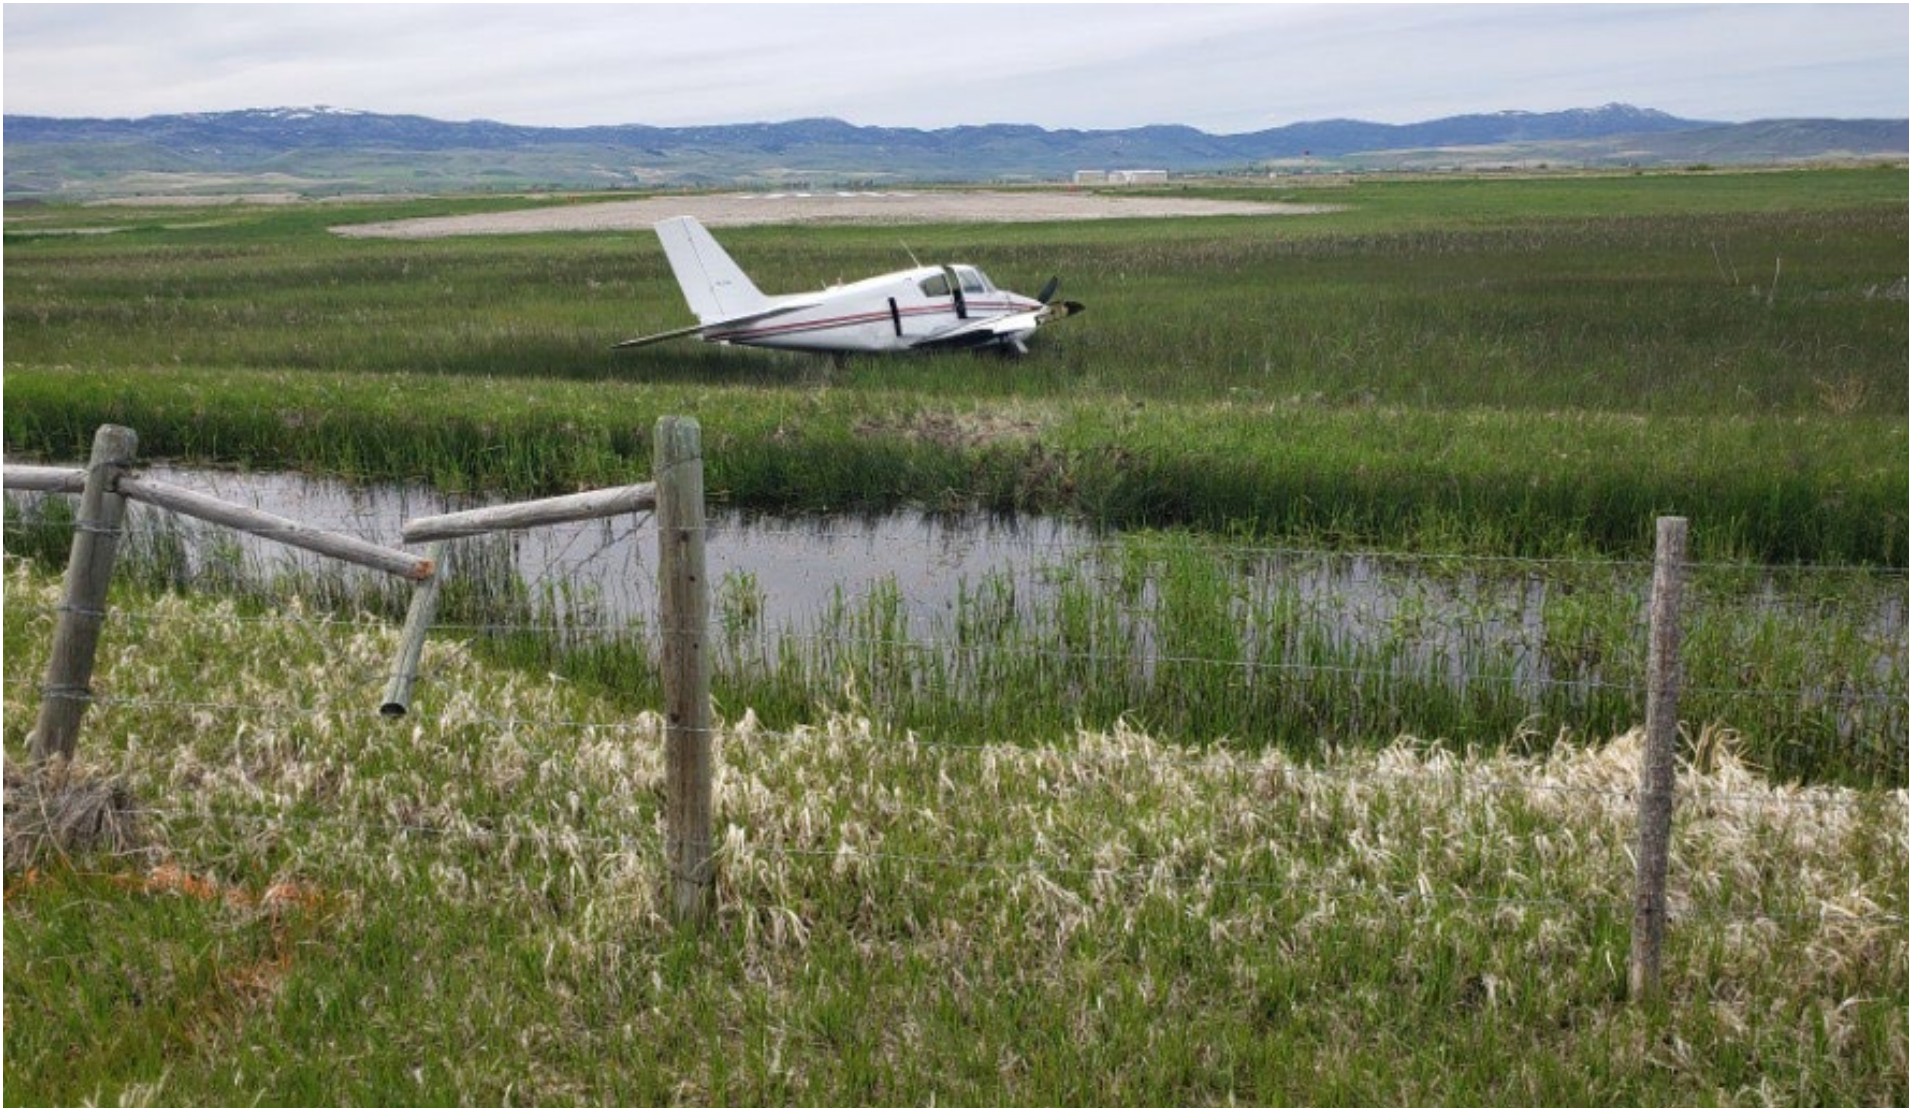
**Photo 1 – View of damage to right wing (owner)**

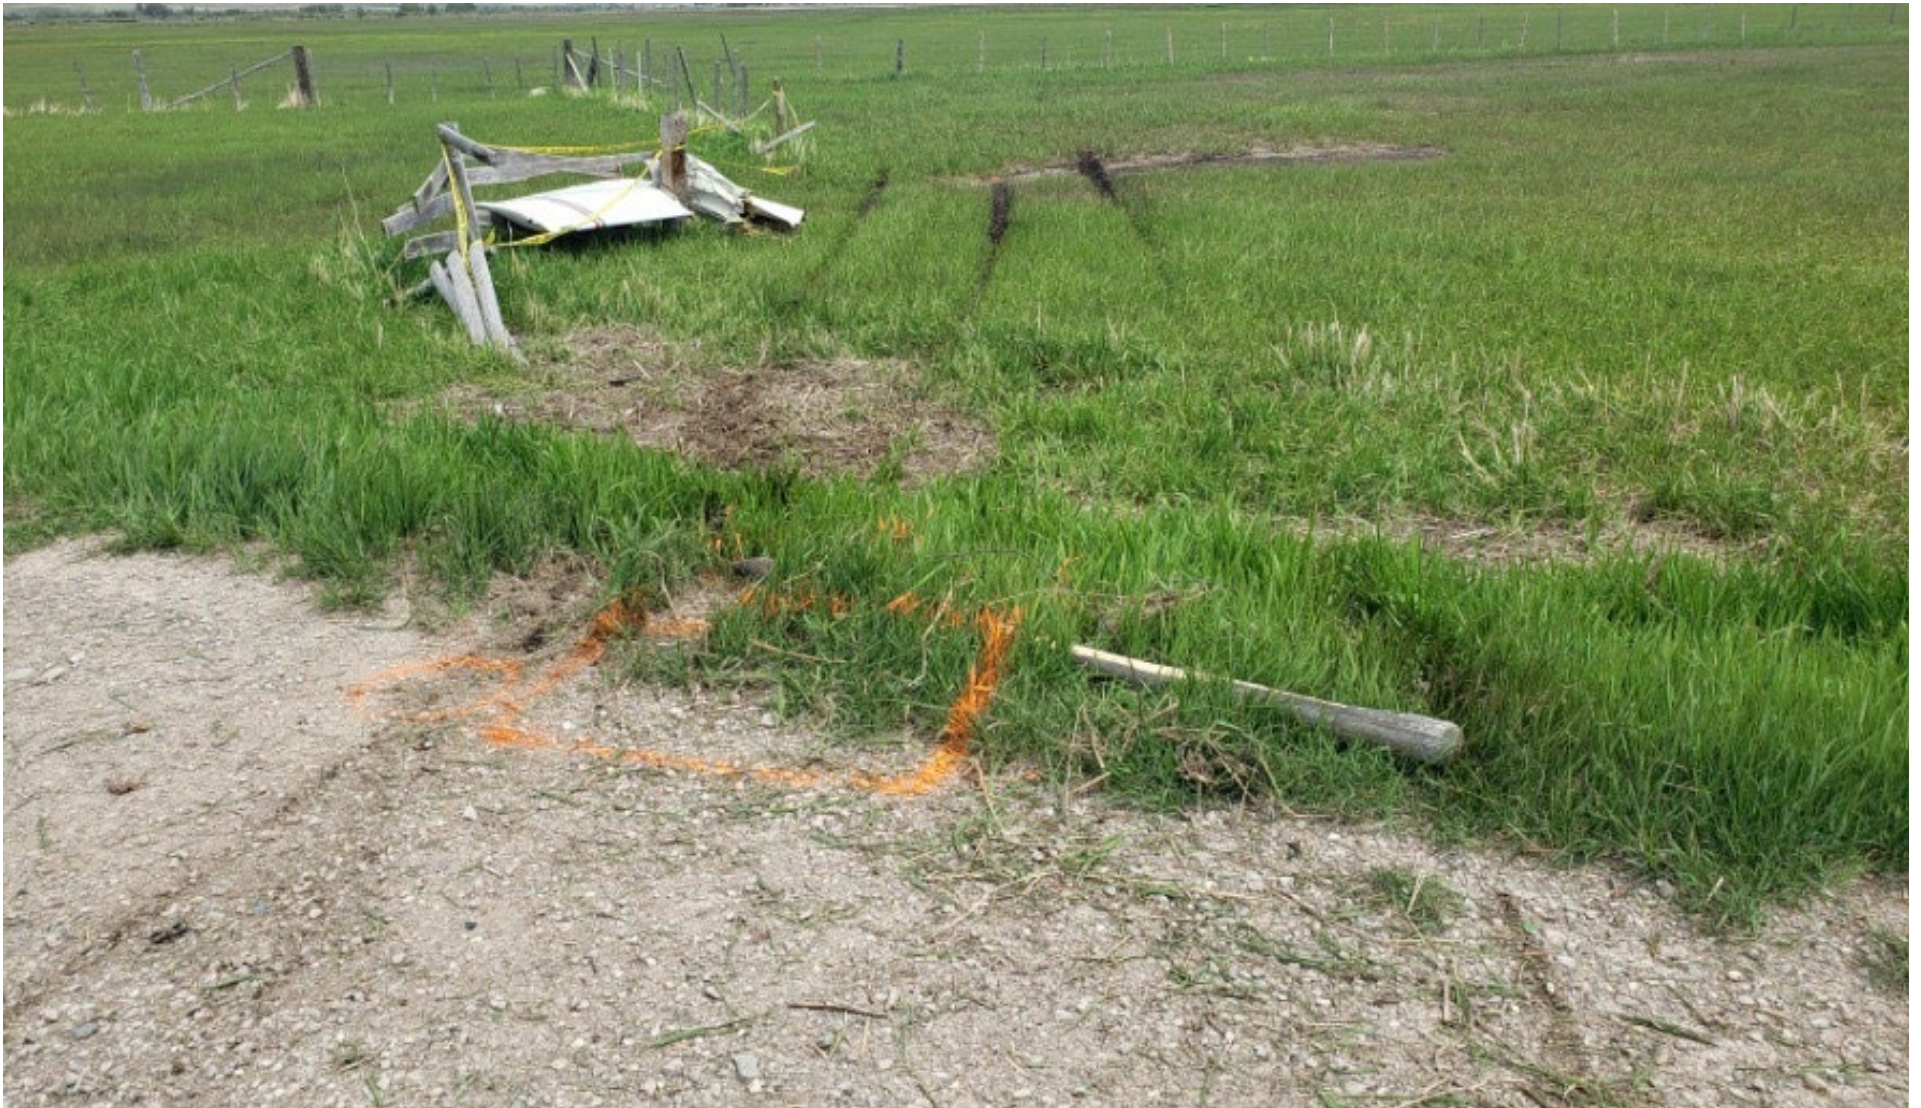
**Photo 2 – Separated section of right wing (owner)**
