# National Transportation Safety Board

WPR21LA220

## **ENGINE EXAM REPORT**

Location: Paris, Idaho  
Date: May 29, 2021  
Airplane: Piper PA24 N6334P

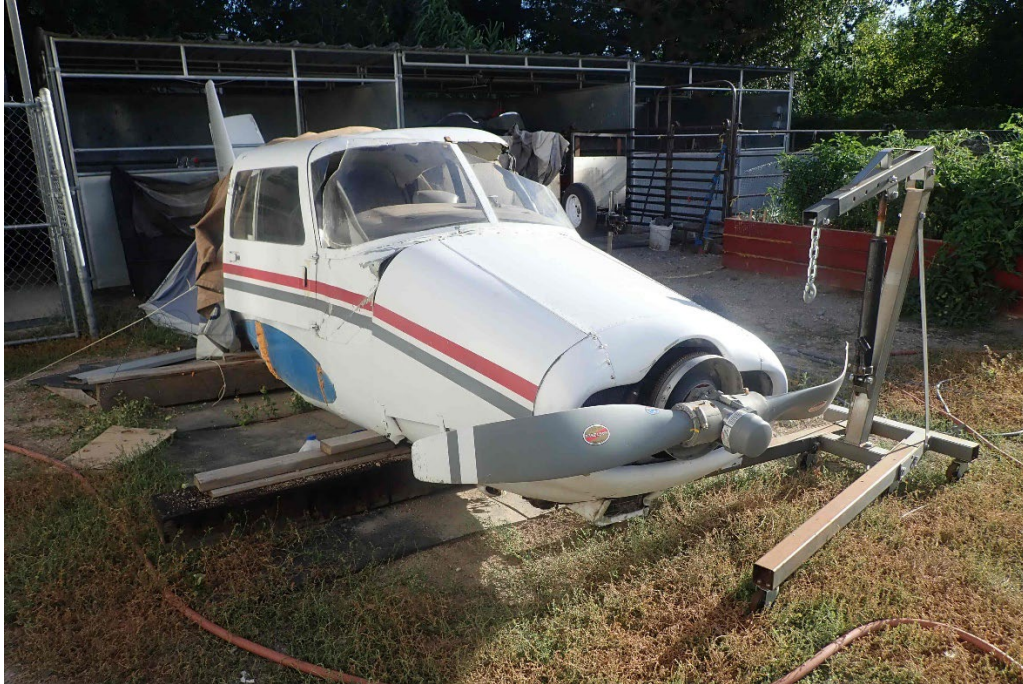
**Figure 1 - Airplane at exam location**

The airplane was examined in the back yard of a residence. The wings had been removed, and wing root openings sealed with expanding foam. The windshield was cracked and open, as such the cabin was exposed to the elements (figure 1). According to the property owner, the airplane cabin had been occupied by younger family members multiple times during storage. As such, the cockpit controls at the time of the accident could not be evaluated.

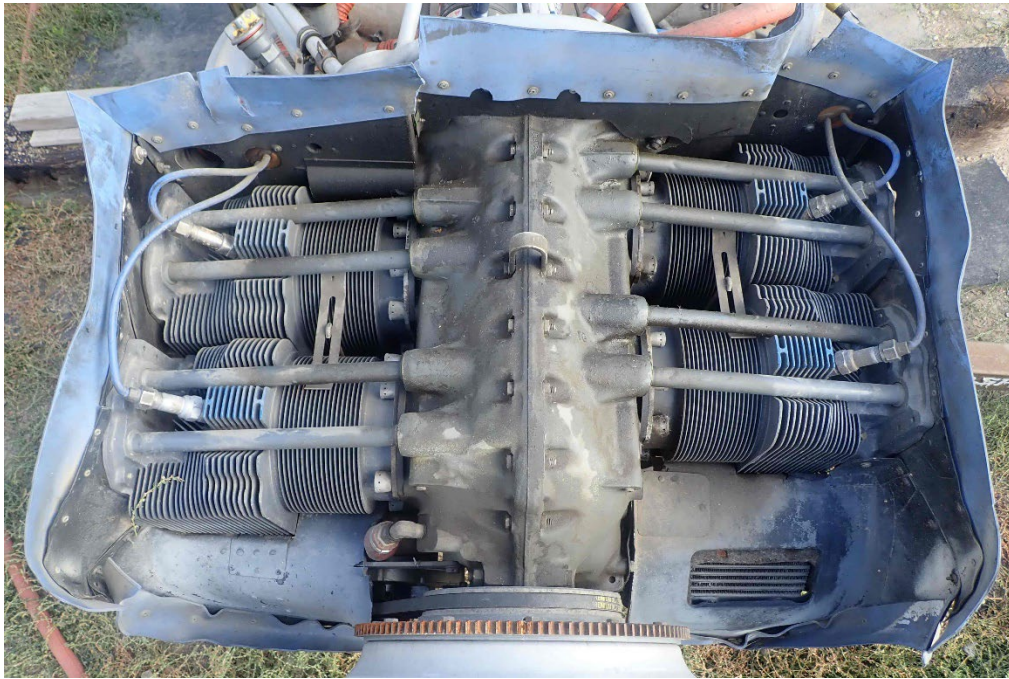
**Figure 2 - Engine**

The engine appeared to have sustained minimal damage during the accident sequence (figure 2). Buckling was observed to the engine mount, and the engine was pointing slightly down.

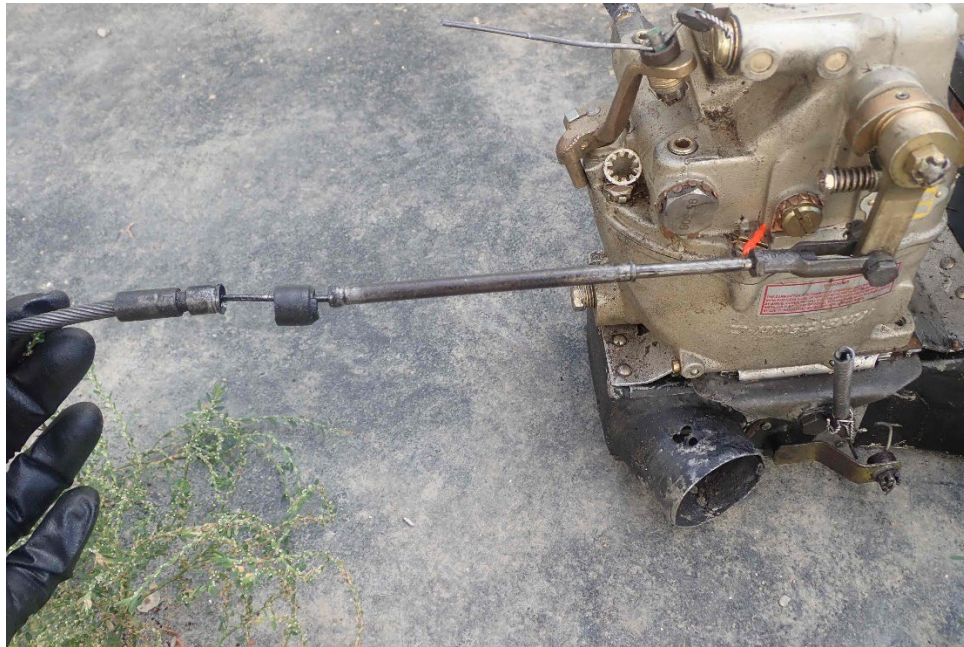
**Figure 3 - Throttle cable**

All engine controls were continuous from their respective control arms through to the cabin controls. The throttle extension tube had broken away from its outer cable assembly and displayed oval signatures at the separation point consistent with bending due to impact (figure 3). The area at the break was also adjacent to the largest point of deformation of the lower engine mount.

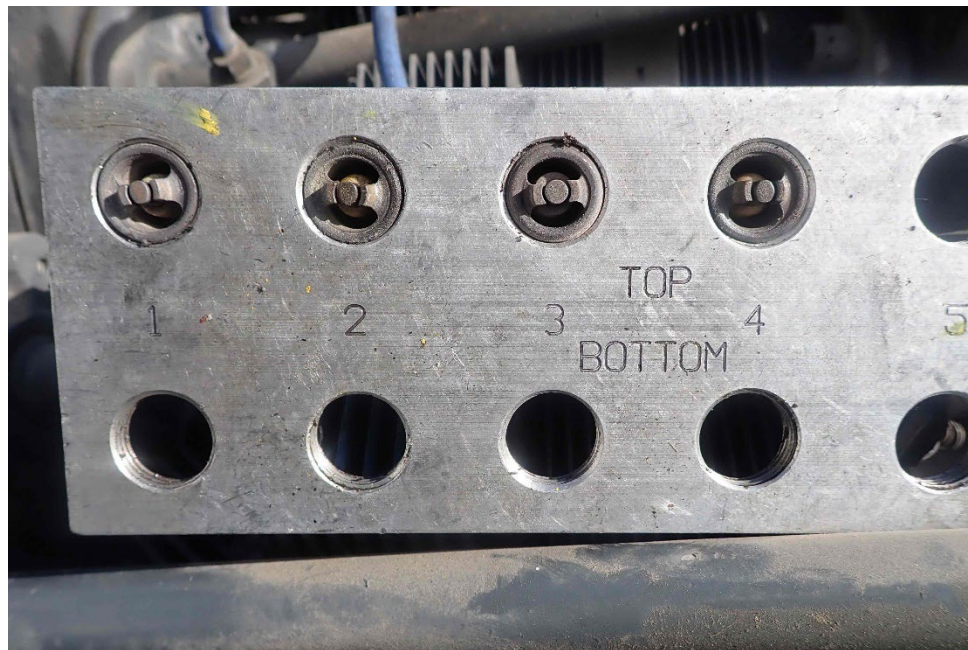
**Figure 4 - Top spark plugs**

The top spark plugs were removed and examined. Their electrodes remained mechanically undamaged, coated in light grey deposits, and displayed "normal" to "worn-out normal" wear signatures when compared with the Champion Spark Plugs AV-27 Check-A-Plug chart (figure 4). The exhaust pipes exhibited light grey deposits and were free of oil residue.

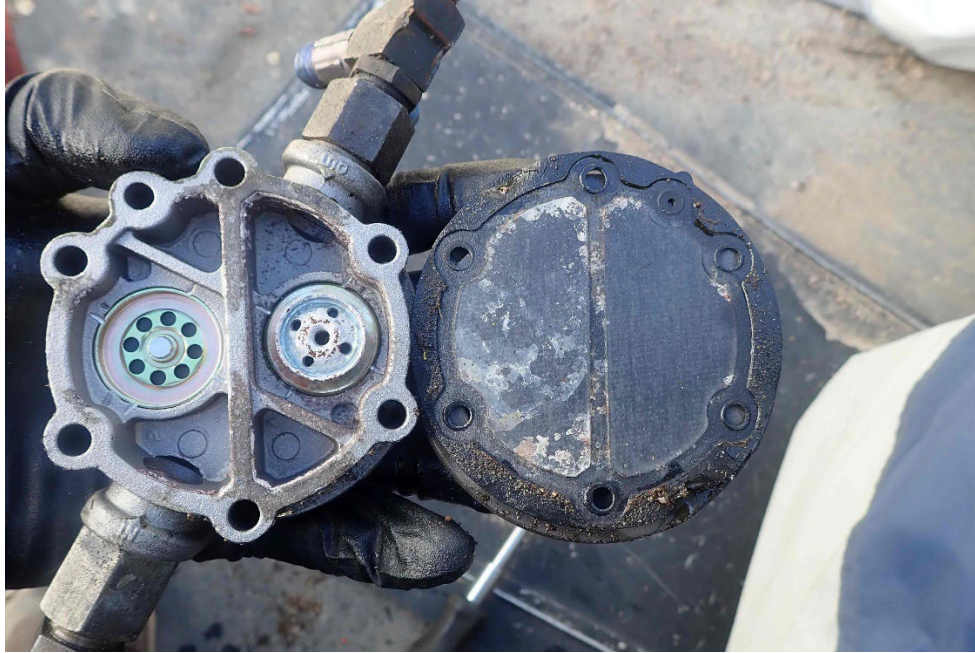
**Figure 5 - Fuel pump cavity**

The fuel pump appeared relatively new. Disassembly revealed light corrosion consistent with long-term storage following the accident but were otherwise internally intact and free of damage (figure 5).

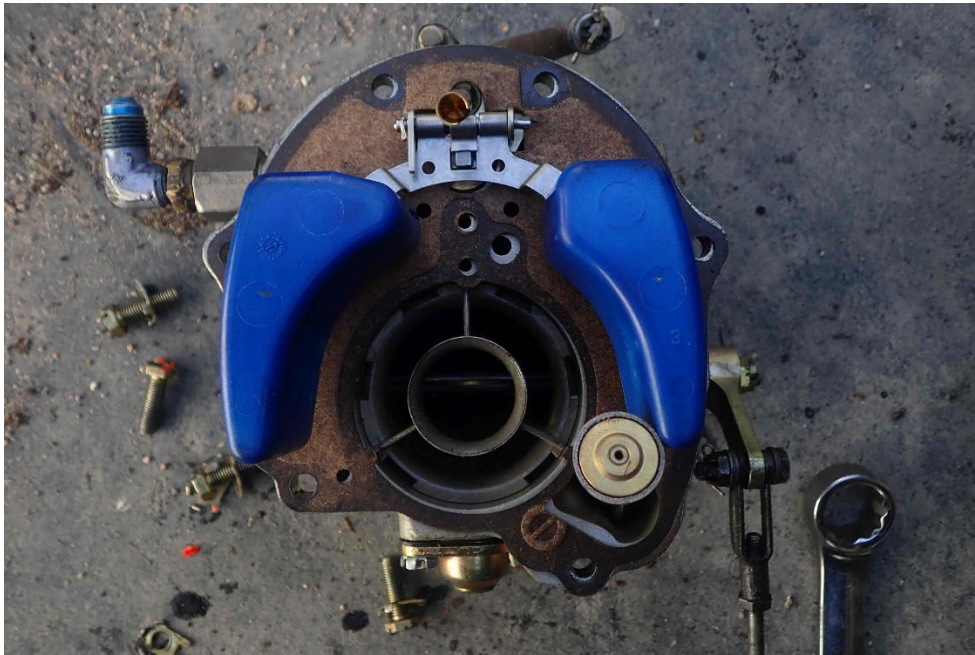
**Figure 6 - Carburetor floats**

The carburetor fuel inlet screen was free of debris, and the carburetor appeared relatively new. The throttle butterfly valve could be moved freely at its input shaft. Disassembly revealed that it was equipped with the blue epoxy floats (figure 6). The float bowl was empty, and no debris was observed. There was no evidence of float-to-bowl contact, and the float height was about 0.2 inches, which was appropriate according to the Marvel Schebler overhaul manual. The throttle body-to-bowl gasket was intact, and there was no evidence of fuel leak. The float valve tip was still pliable, and there was no evidence of debris on its accompanying seat.

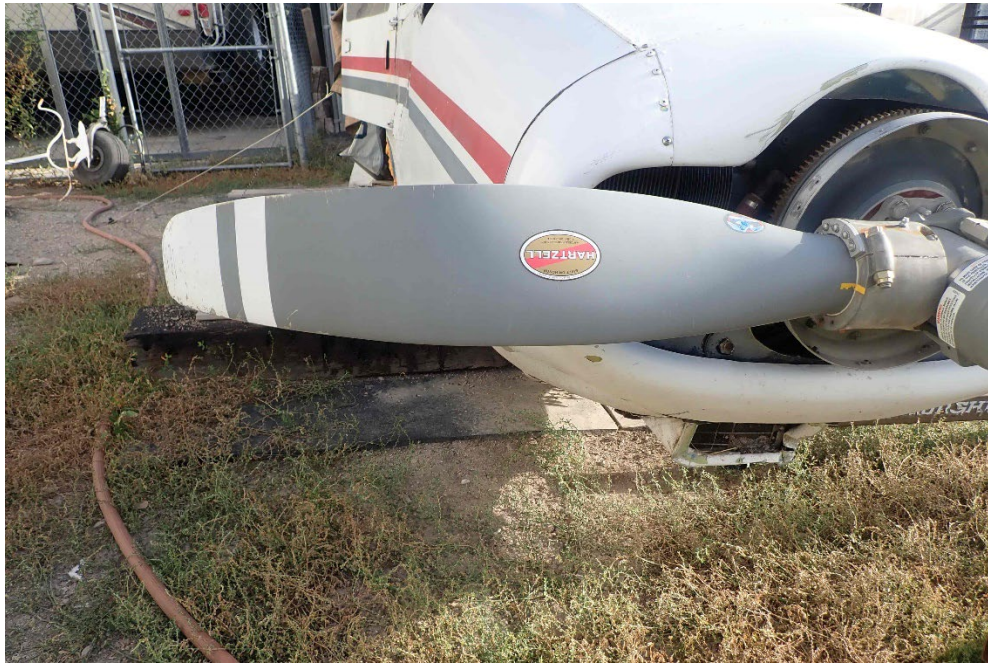
**Figure 5 - Propeller blade 1**

The propeller remained attached to the crankshaft. One blade was intact, straight, and undamaged (figure 7). The blade was bent about 20 ° aft, mid-span. Outboard of

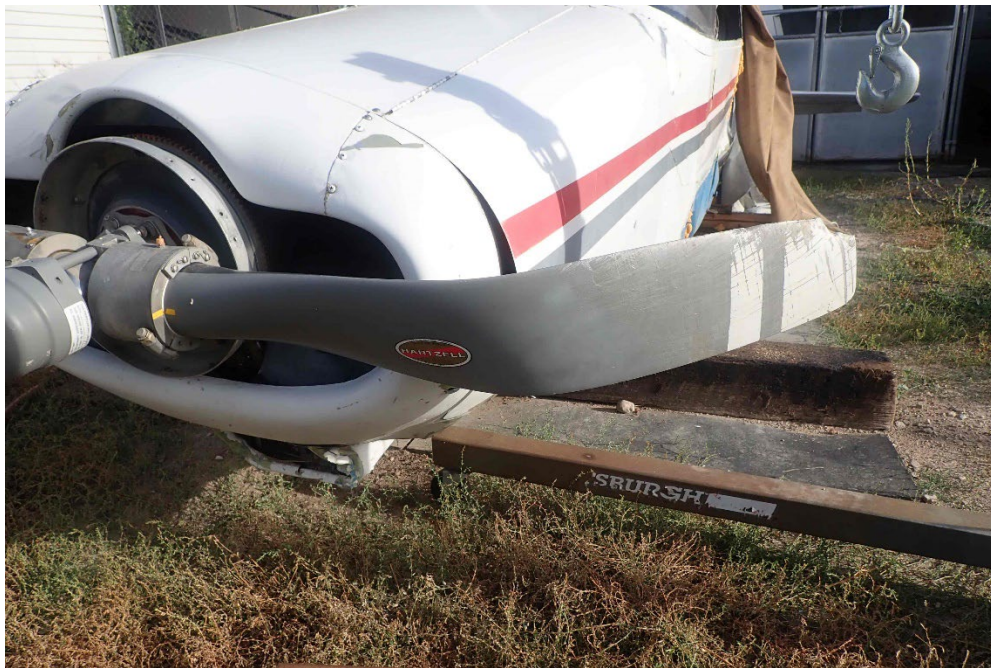
**Figure 6 - Propeller blade 2**

the bend, the blade exhibited both chordwise and diagonal scratches along with dent and nicks to the tip (figure 8).
