**NATIONAL TRANSPORTATION SAFETY BOARD**  
Office of Aviation Safety

**Airframe and Engine Examination**

**WPR21LA224**

Aircraft: 1965 Cessna, 172G, N3871L (S/N: 17254040)

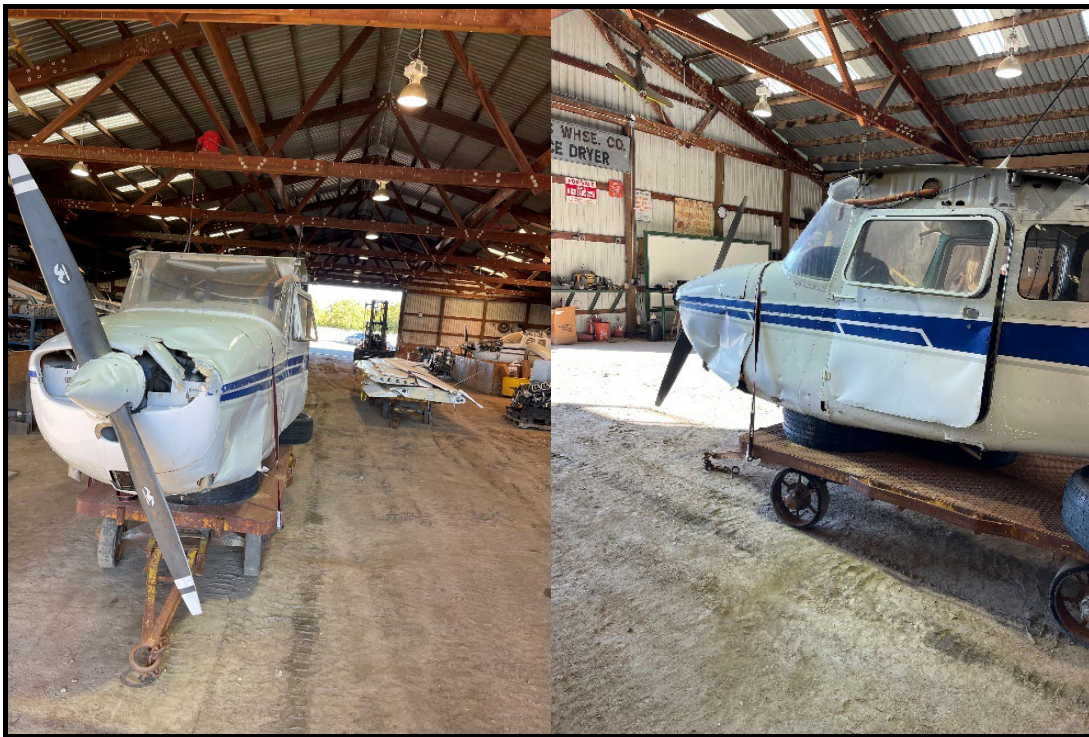
*Figure 1: Images of accident airplane prior to examination*

Examination of the airframe revealed that both wings, the horizontal and vertical stabilizers, the elevator, and rudder were removed by the recovery company to transport the airplane to a secure facility. The upper and lower engine cowling and left entry door sustained impact damage. The nose landing gear and the left main landing gear were separated from the fuselage resulting from impact damage.

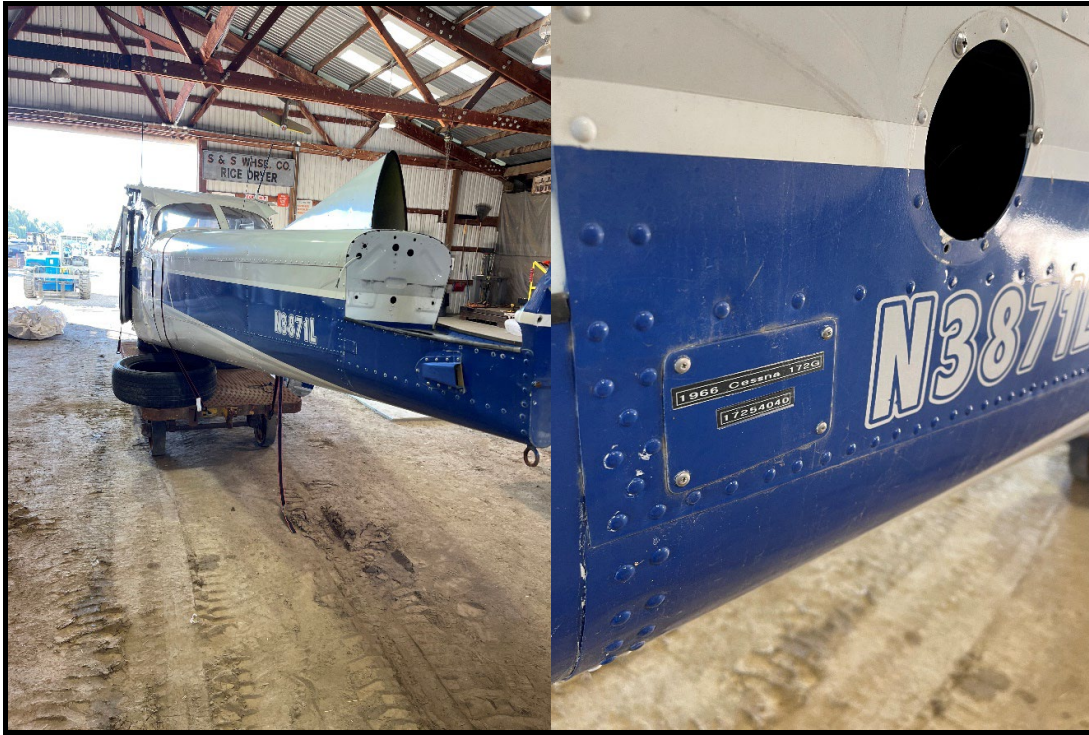
Figure 2: Images of accident airplane prior to examination

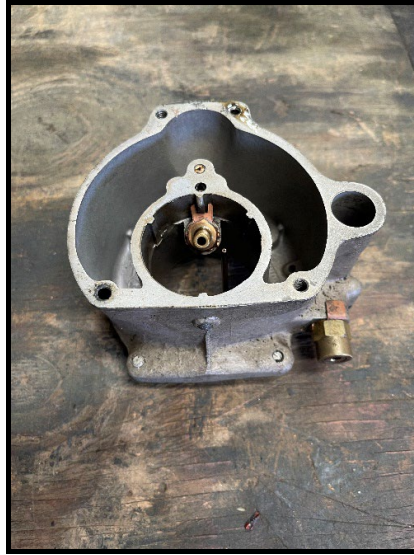
*Figure 3: Image of disassembled carburetor bowl*

The carburetor remained attached to the engine oil sump and the induction box remained attached to the carburetor. The fuel inlet line was attached and secure at the carburetor inlet fitting and the fuel strainer fitting. The carburetor was removed and examined externally which revealed no impact damage. The carburetor was disassembled, and the float bowl was free of contaminants. The fuel inlet line was introduced to compressed air and the floats operated without impedence. The blue in color, composite floats were unremarkable and remained buoyant when removed from the carburetor and submerged. The needle valve was removed, and the stainless-steel tip was clean and moved freely. No fuel stains were observed around the throttle plate valve O-rings. The accelerator pump housing and assembly were unremarkable and free of contaminants. The mixture metering valve was present and unremarkable.

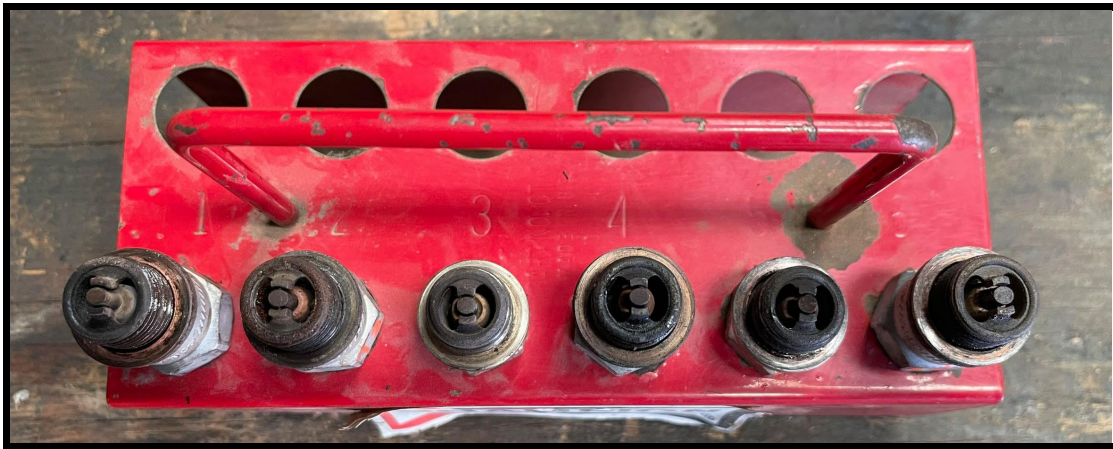
*Figure 4: Image of top spark plugs*

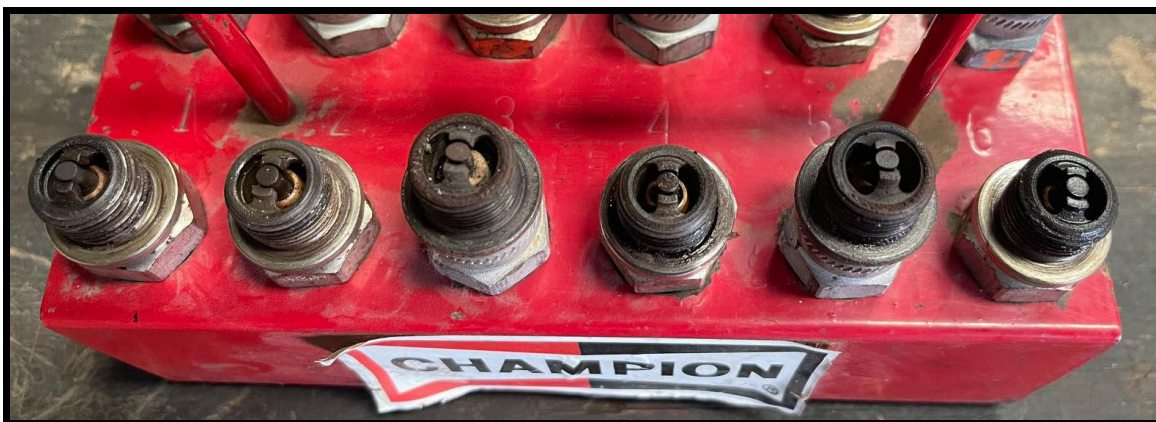
*Figure 5: Image of bottom spark plugs*

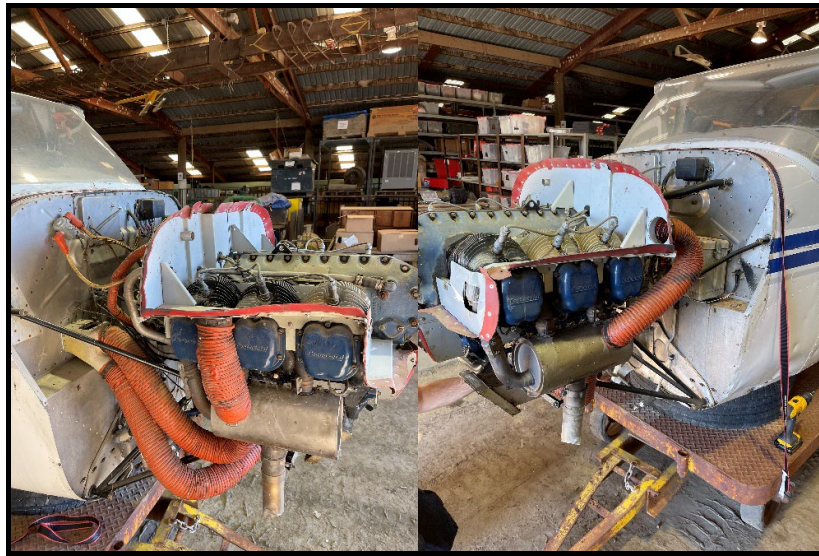
All cylinders remained attached and secured to the crankcase. Only the No. 6 cylinder sustained minor impact damage specifically to the cooling fins. Each of the intake and exhaust push rod tubes were intact, and securely affixed to the to the cylinder and crankcase lifter housing cover. All rocker covers remained attached to their respective cylinder and were unremarkable. The engine crankshaft rotated freely by hand using the propeller. Rotational continuity was established throughout the engine and valve train. Thumb compression was obtained on each of the cylinders, but the No. 2 cylinder exhibited low compression. All pistons moved within their respective cylinders, verifying engine and valve train continuity. Each cylinder's rocker box cover was removed, and equal travel of the intake and exhaust valve rocker arm movement was observed in correct firing order when the crankshaft was rotated.

*Figure 6: Images of right and left side of engine before examination*

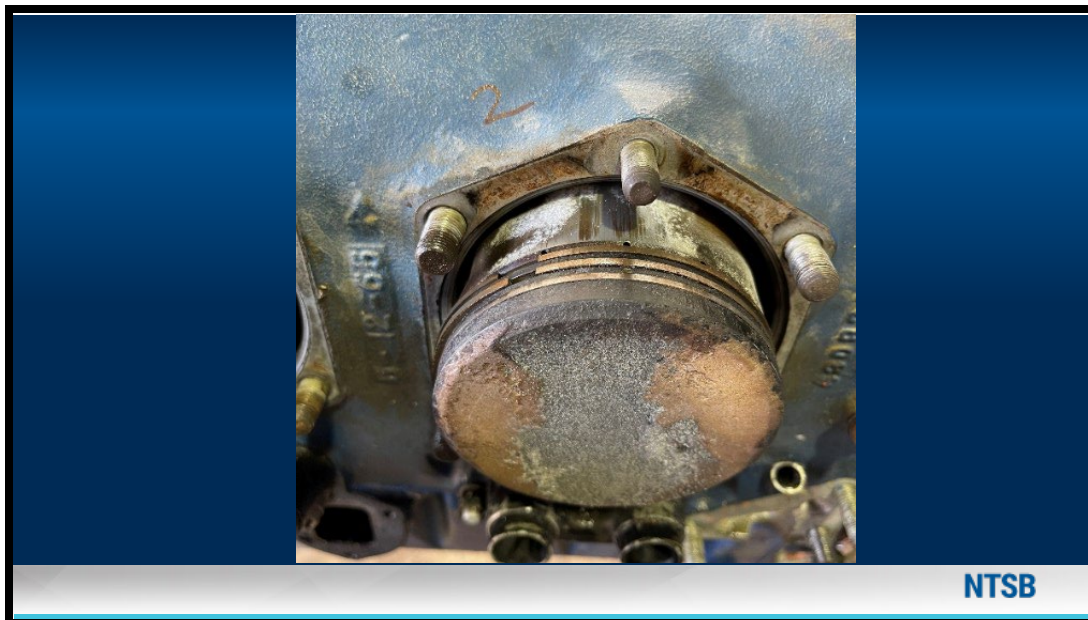
Magneto to engine timing was Left: 33° before top dead center (BTDC) and Right: 32° BTDC. The engine manufacture specification for magneto to engine timing was Left: 28° BTDC and Right: 26° BTDC. About 6 qts of engine oil were extracted from the oil sump. The No. 2 cylinder exhibited low compression and a lighted borescope was used to assess the internal components of each cylinder. The circumference of the No. 2 piston face was degraded, and the outer compression ring had seized to the ring lands and was unmovable.

The piston's top compression ring was seized to the ring land and flat spots were observed on the ring. The middle and bottom compression rings were present, unremarkable and the gaps were not lined up together. The oil scraper ring was present and unremarkable and moved without impedance. The ring lands exhibited heavy scuffing. The cylinder walls were unremarkable. The piston face exhibited normal operational signatures. The exhaust and intake valve guides, keepers, springs, retainers, push rods, rocker arms and shaft were unremarkable. The exhaust valve was unremarkable. The intake valve exhibited discoloration about the stem with lead and carbon deposits at the base.

*Figure 8: Image of No. 2 piston with seized top compression ring and flat spots*

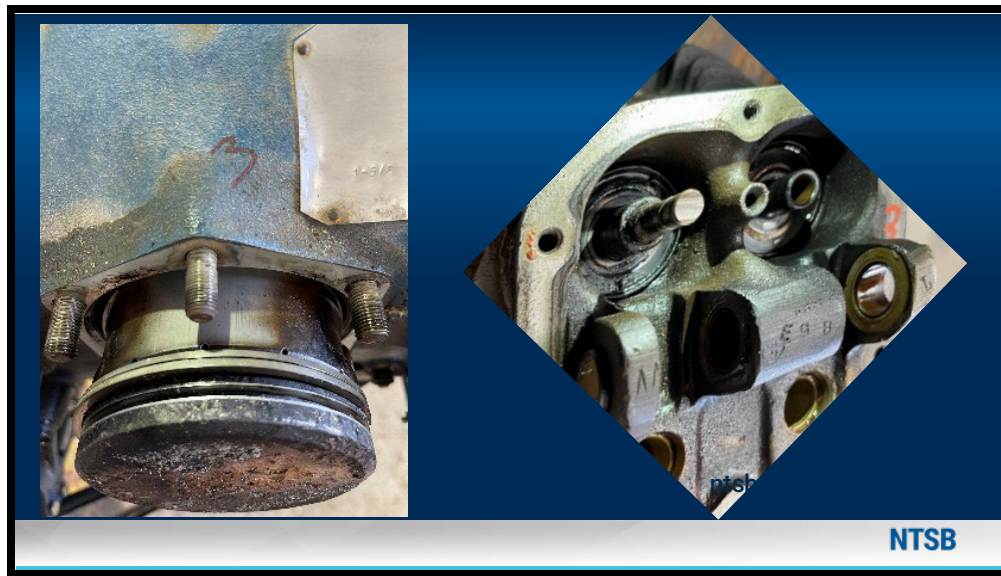
The piston's top compression ring remained its respective land but was broken into two pieces. The middle and bottom compression rings were present in their respective land and the gaps were not lined up together. The oil scraper ring was present and unremarkable and moved without impedance. The piston face exhibited normal operational signatures. The intake valve guides, keepers, springs, retainers, push rods, rocker arms and shaft were unremarkable. The exhaust valve was stuck in the guide. The intake valve exhibited thermal discoloration about the stem with lead and carbon deposits at the base.

*Figure 9: Images of No. 3 piston with missing top compression ring No. 3 cylinder stuck exhaust valve*

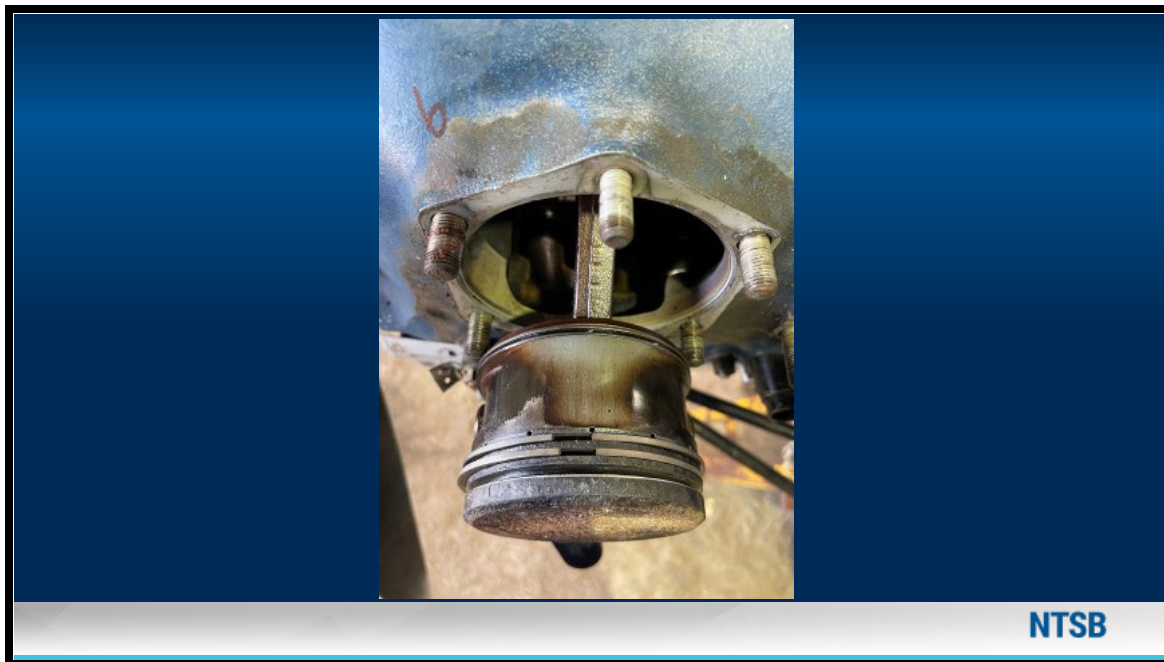
The piston's top compression ring remained in its respective land but was broken into four pieces. The middle and bottom compression rings were present in their respective land and the gaps were not lined up together. The oil scraper ring was present and unremarkable and moved without impedance. The piston skirt exhibited thermal signatures. The cylinder walls were unremarkable. The piston face exhibited normal operational signatures. The exhaust and intake valve guides, keepers, springs, retainers, push rods, rocker arms and shaft were unremarkable. The exhaust valve was unremarkable. The intake valve exhibited thermal discoloration about the stem with lead and carbon deposits at the base.

Figure 10: Image of No. 6 piston with missing top compression ring
