**NATIONAL TRANSPORTATION SAFETY BOARD**  
Office of Aviation Safety

**WRECKAGE EXAMINATION GROUP FIELD NOTES**

**A. ACCIDENT      WPR21LA268**

Location:      Weed, CA  
Date:      July 7, 2021  
Time:      1645 Pacific Daylight Time (PDT)  
Operator:      Rogers Helicopters Inc  
Aircraft:      Bell 212  
Registration:      N911KW

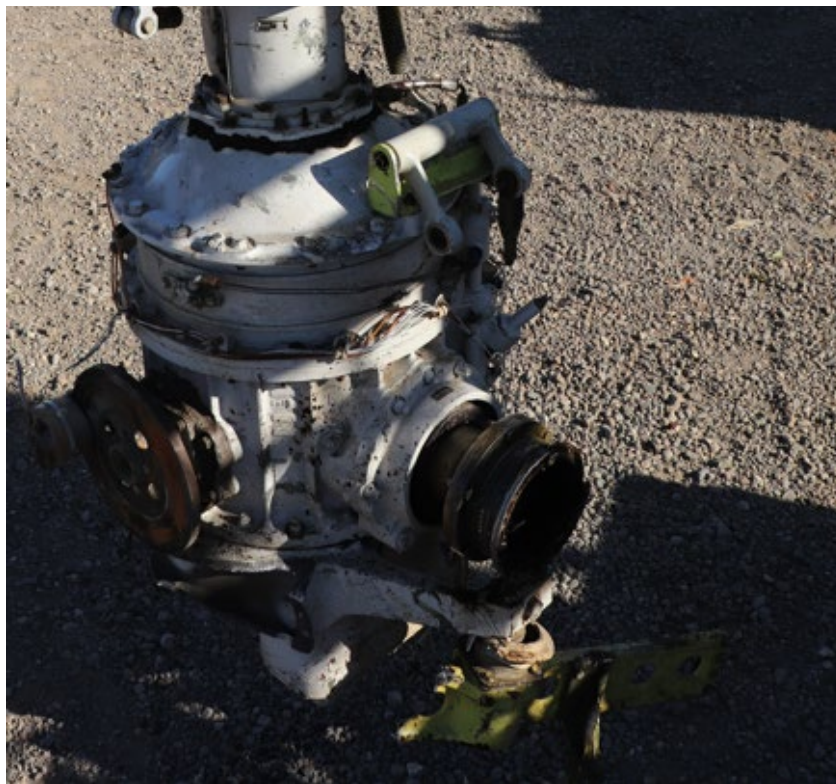
The lower section of the transmission and its oil sump separated consistent with impact damage. The sump was devoid of oil. The hydraulic pump and its corresponding line were attached and secured. The lift link was secured with a slight torsional deformation. The synchronized elevator control linkages displayed overload from impact damage. The transmission support case was separated from all 4 corners mounts. Transmission freely rotated at the output quill without binding, which also rotated the rotor blade and mast. The 5<sup>th</sup> mount beam remained attached to the transmission; its beam was fractured on the left side about 3 inches from the pylon mount. The hydraulic pump was intact and secured to the transmission body. The four transmission corner mounts and 2 aft dampeners were still attached to the airframe. They were all removed and collected for further testing. The main driveshaft input quill was still attached to the transmission, but the main driveshaft was separated consistent with overload. Its chip detector was removed and found no debris. The right side of the transmission case sustained impact damage.

*Figure 2. view of transmission*

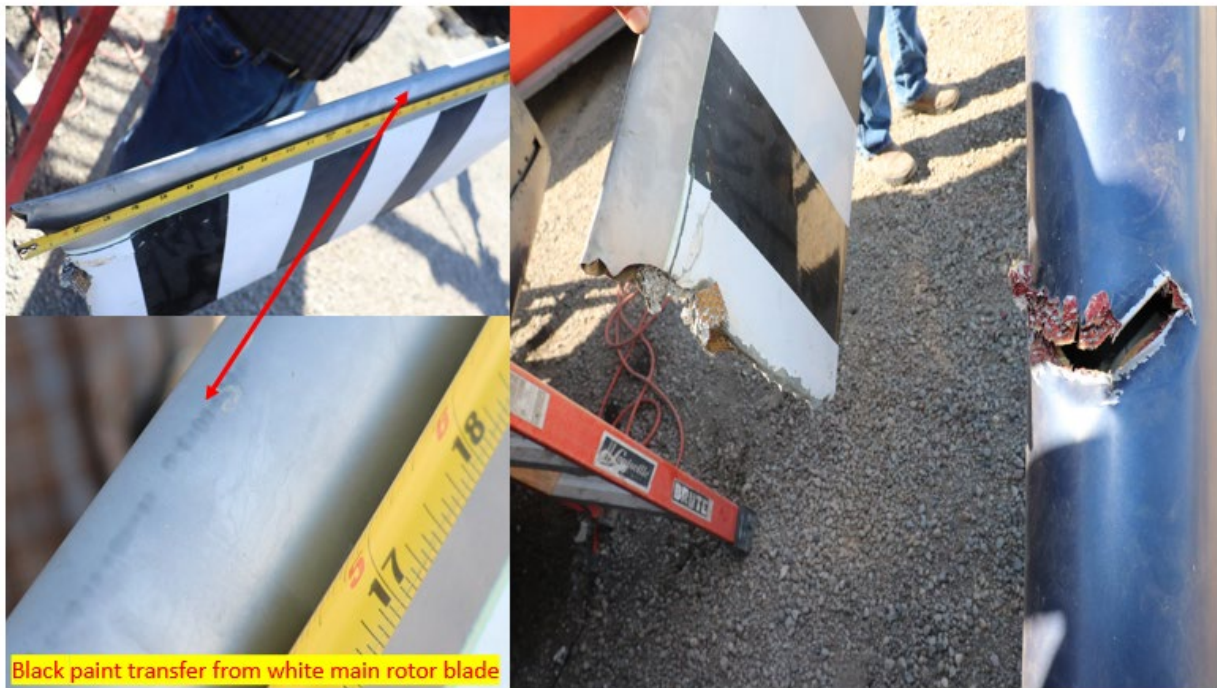
The vertical fin driveshaft cover had a witness mark about 1/3 span, consistent with a main rotor blade strike. The damaged tail rotor blade had a black paint transfer on its leading edge, about 17 inches across the leading edge, consistent with the bottom section of the blade impacting the leading edge of the tail rotor blade. Corresponding witness marks was found on the displaced blade body recovered from the accident site.

Figure 3. right photo: view of damage to vertical driveshaft cover and tail rotor blade; upper & lower left photos: view of close-up views of damage to leading edge

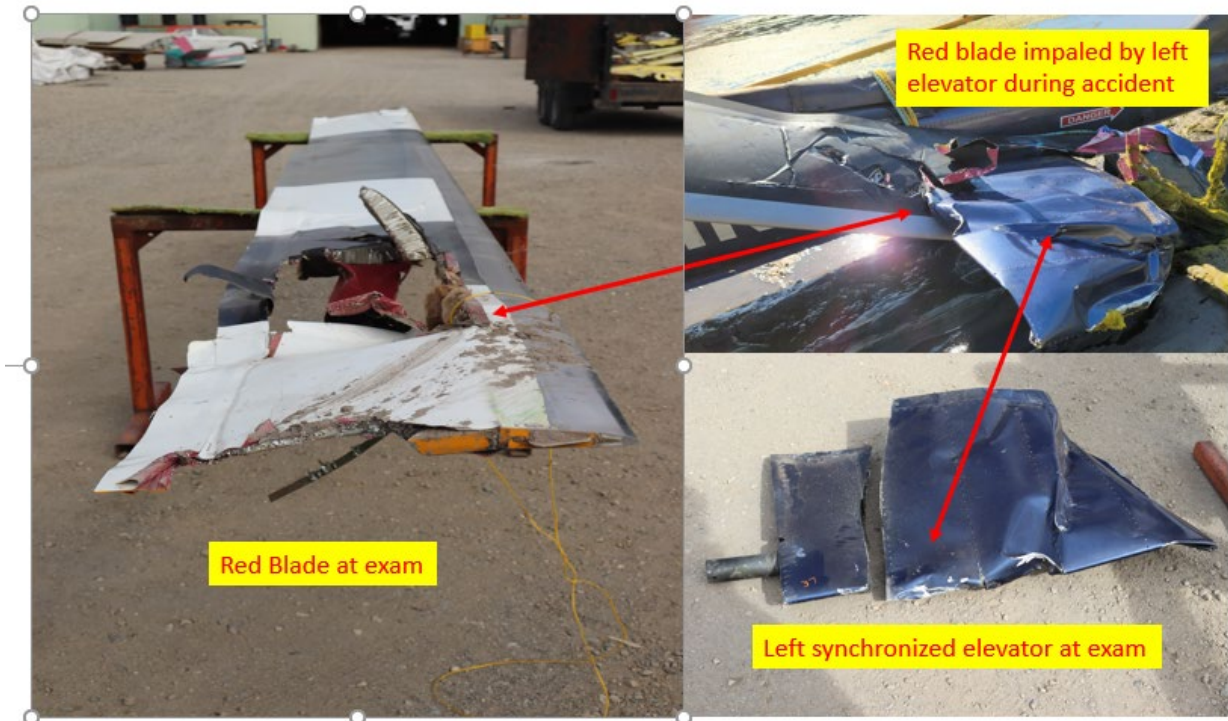
white main rotor blades were removed from its corresponding blade grip during recovery. The red blade, part number 212-015-501-115, serial no. BH368215 sustained impact damage but mainly intact except that both pitch horns were separated from the attachment points on their respective grips. About 43 inches to 74 inches from the tip of the blade, a section of the blade revealed impact damage from the left synchronized elevator.

Figure 4. Left photo: view of red main rotor blade at exam; lower right photo: view of left synchronized elevator at exam; upper left photo: view of red blade impaled by left elevator during accident

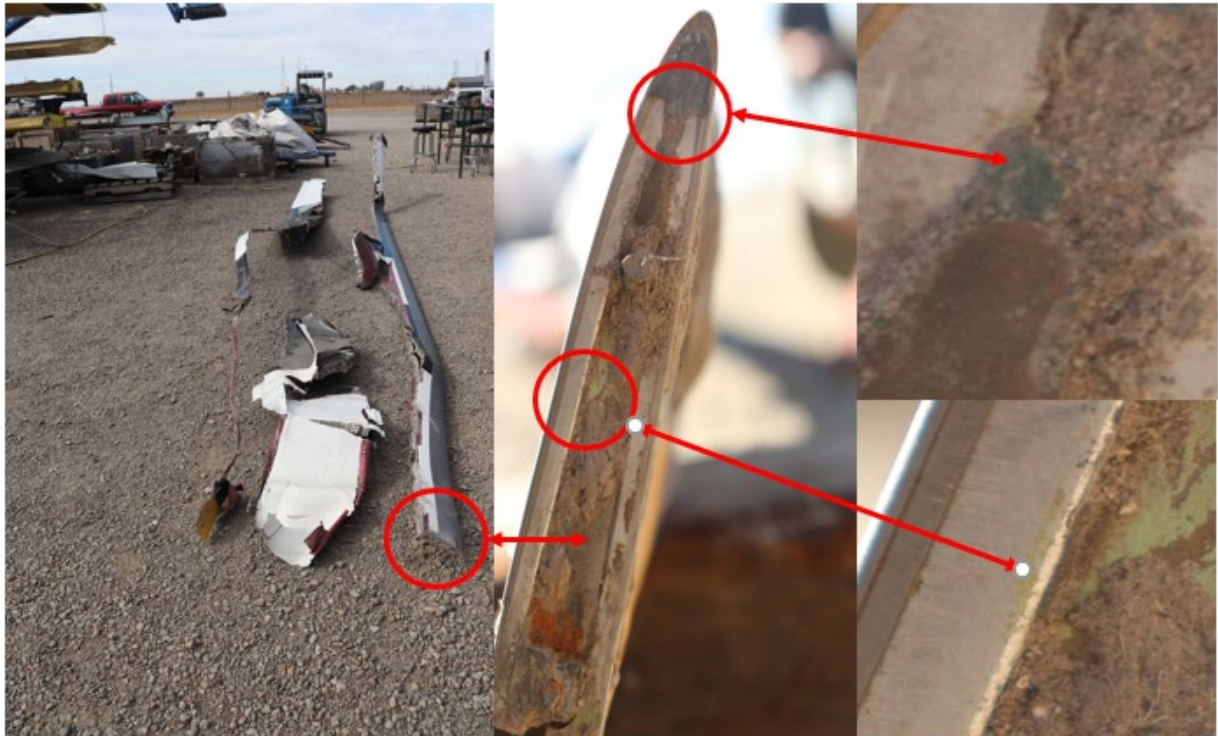
The white blade, part number 212-015-501-115, serial no. A-4880, separated from the spar into two main sections. The span of the leading edge and the trailing edge were recovered along with two dislodged blade body pieces. The impact damage revealed that the main rotor blade struck the driveshaft cover from the outboard side and traveled inboard, which then struck the tip of a tail rotor blade (S/N A-18172). The outboard edge of the white blade's leading edge revealed a blue paint transfer consistent with the driveshaft cover and a yellow "paint" transfer, consistent with "paint" found within the tail rotor blade.

*Figure 5. Left photo: view of white main rotor blade; middle and right photos: close-up views of outboard section of leading edge with paint transfers*

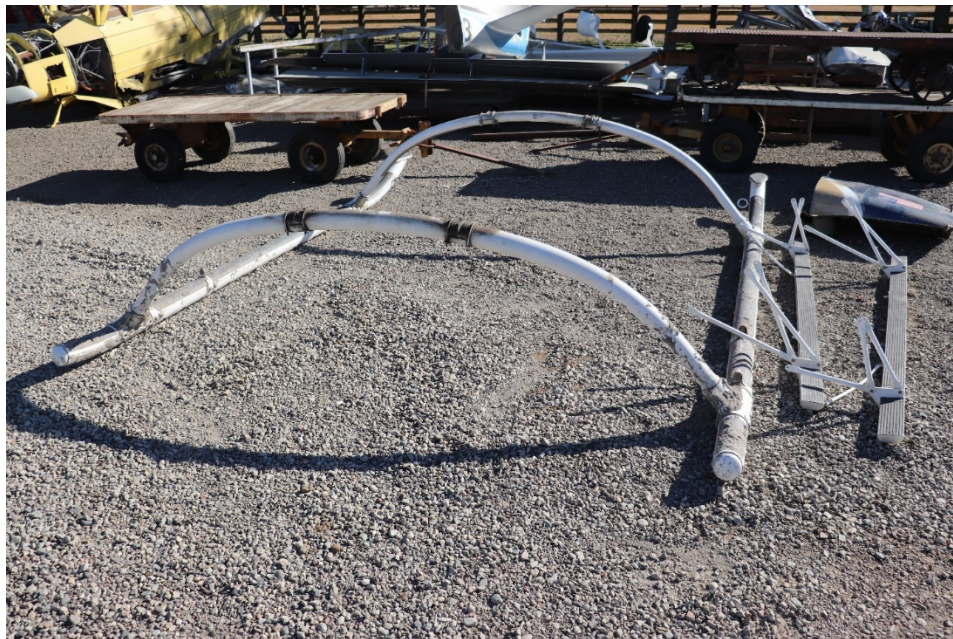
The skid was separated from the fuselage prior to the investigation during recovery. The skids were intact with no visible damage.

*Figure 6. View skid assembly*

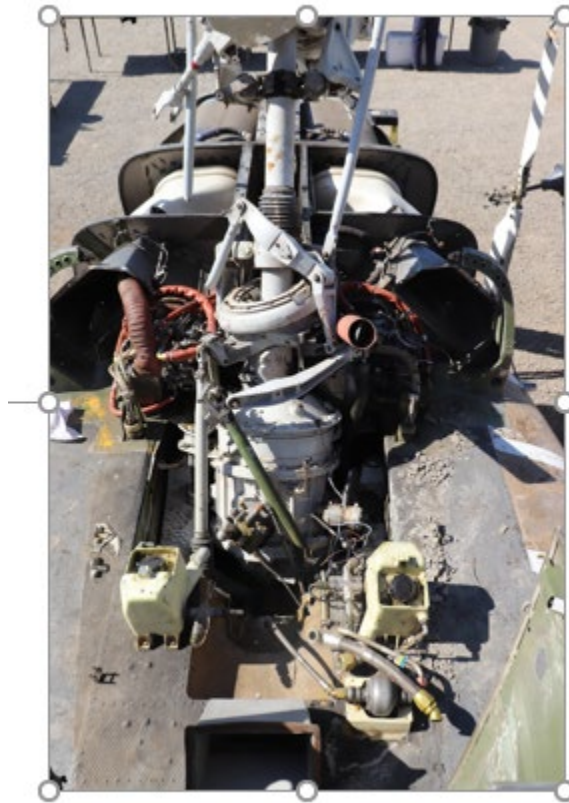
*Figure 7. View of damaged transmission*
