**NATIONAL TRANSPORTATION SAFETY BOARD**  
Office of Aviation Safety

**PYLON MOUNTS & FRICTION DAMPER EXAMINATION FIELD NOTES**

**A. ACCIDENT      WPR21LA268**

Location: Weed, CA  
Date: July 7, 2021  
Time: 1645 Pacific Daylight Time (PDT)  
Operator: Rogers Helicopters Inc  
Aircraft: Bell 212  
Registration: N911KW

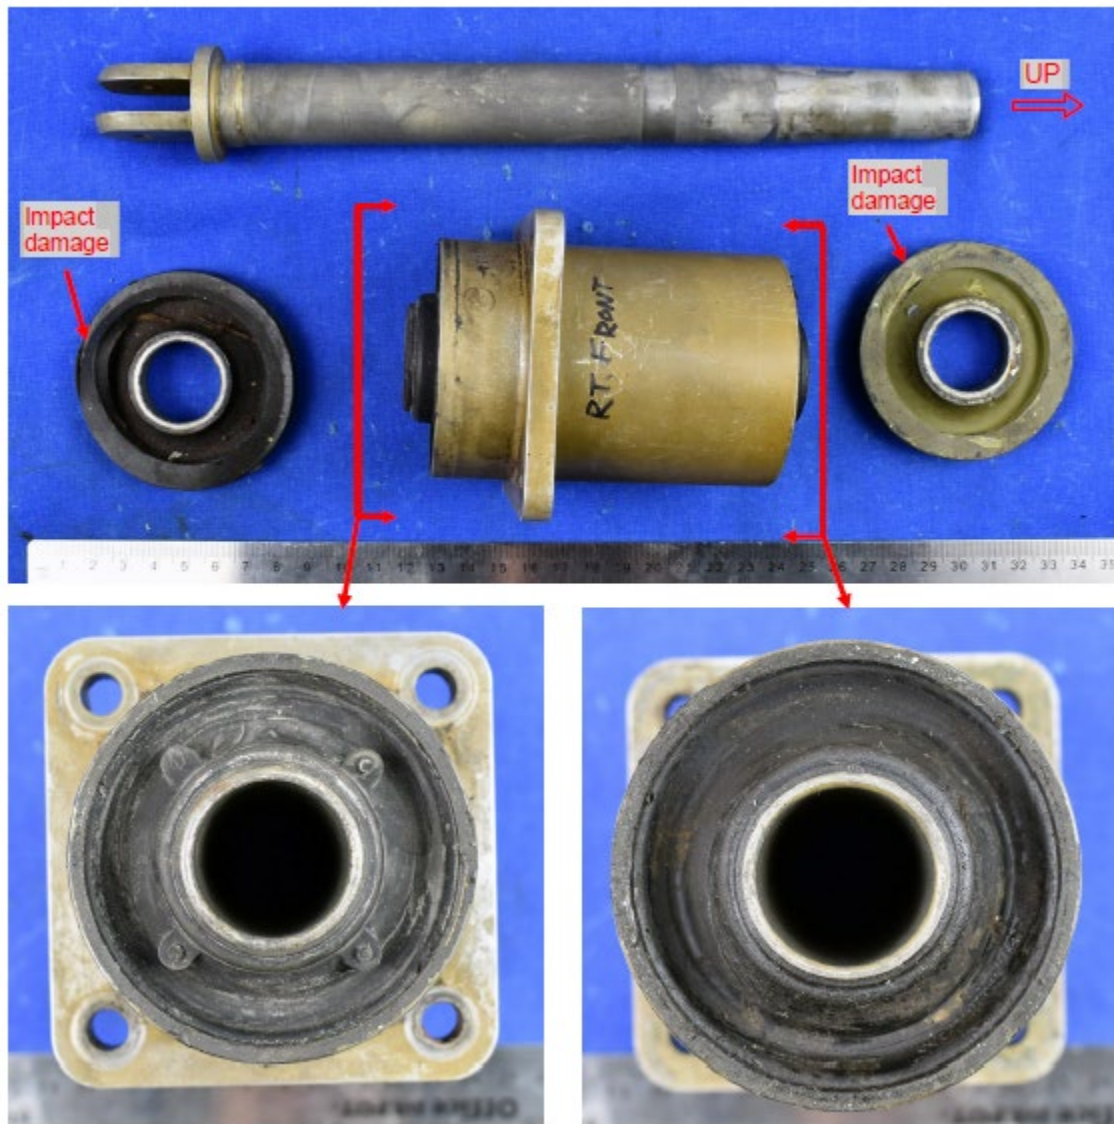
Figure 2. View of Right Forward Pylon Mount

Superficial, minor scoring was found on the upper and lower elastomer consistent with mechanical damage. The housing and the mount bolts were found unremarkable. No bonding discontinuities between the outer housing or the inner tube were observed on the lower surface of the mount (surface exposed during testing) while under load.

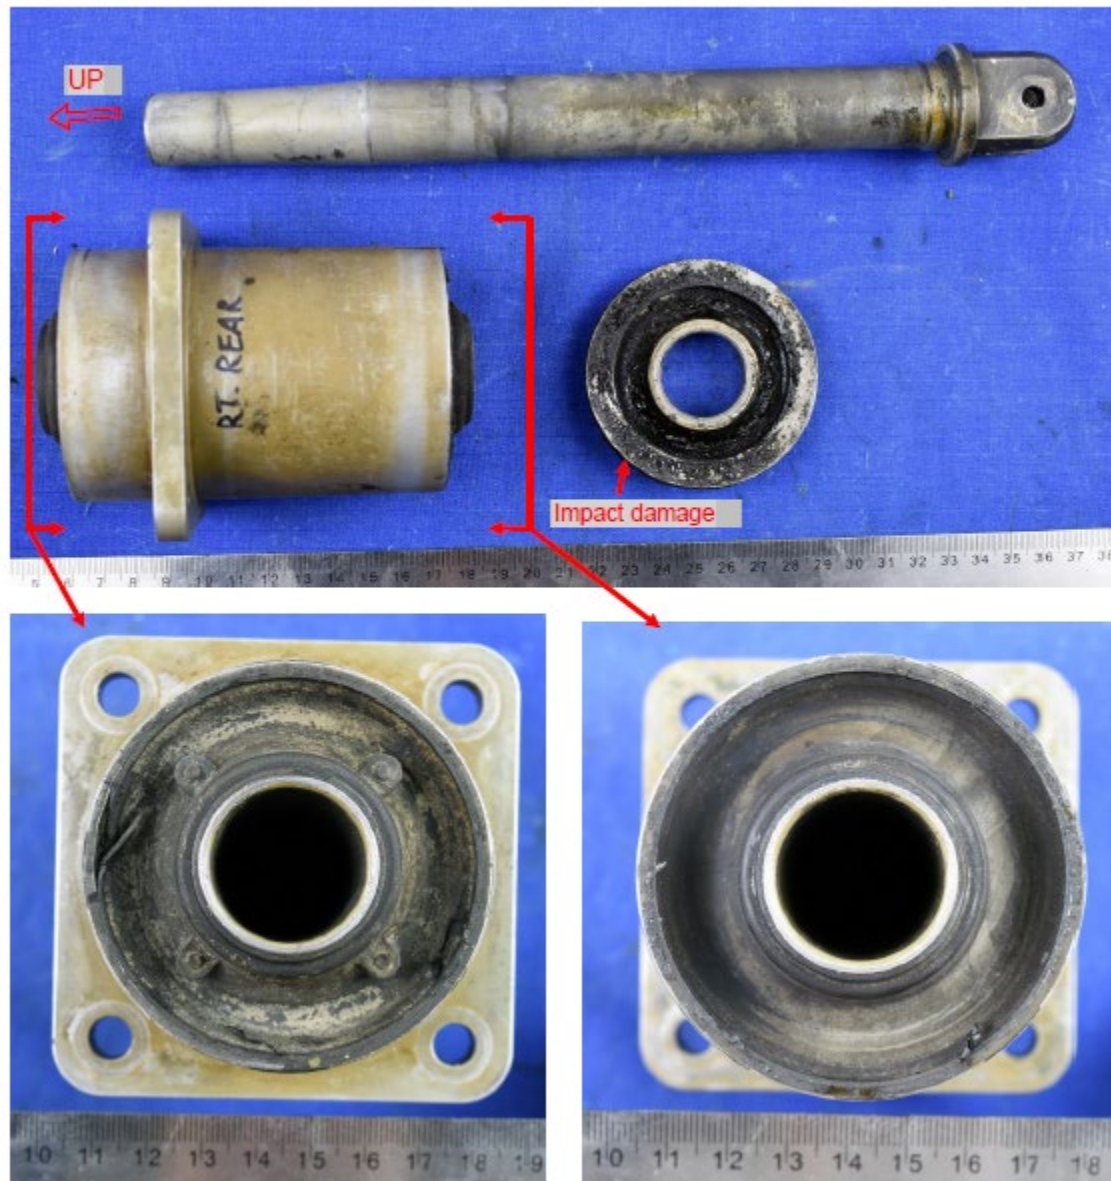
Figure 4. View of Right Aft Pylon Corner Mount

Superficial, minor scoring was found on the upper and lower elastomer consistent with mechanical damage. The housing and the mount bolts were found unremarkable. No bonding discontinuities between the outer housing or the inner tube were observed on the lower surface of the mount (surface exposed during testing) while under load.

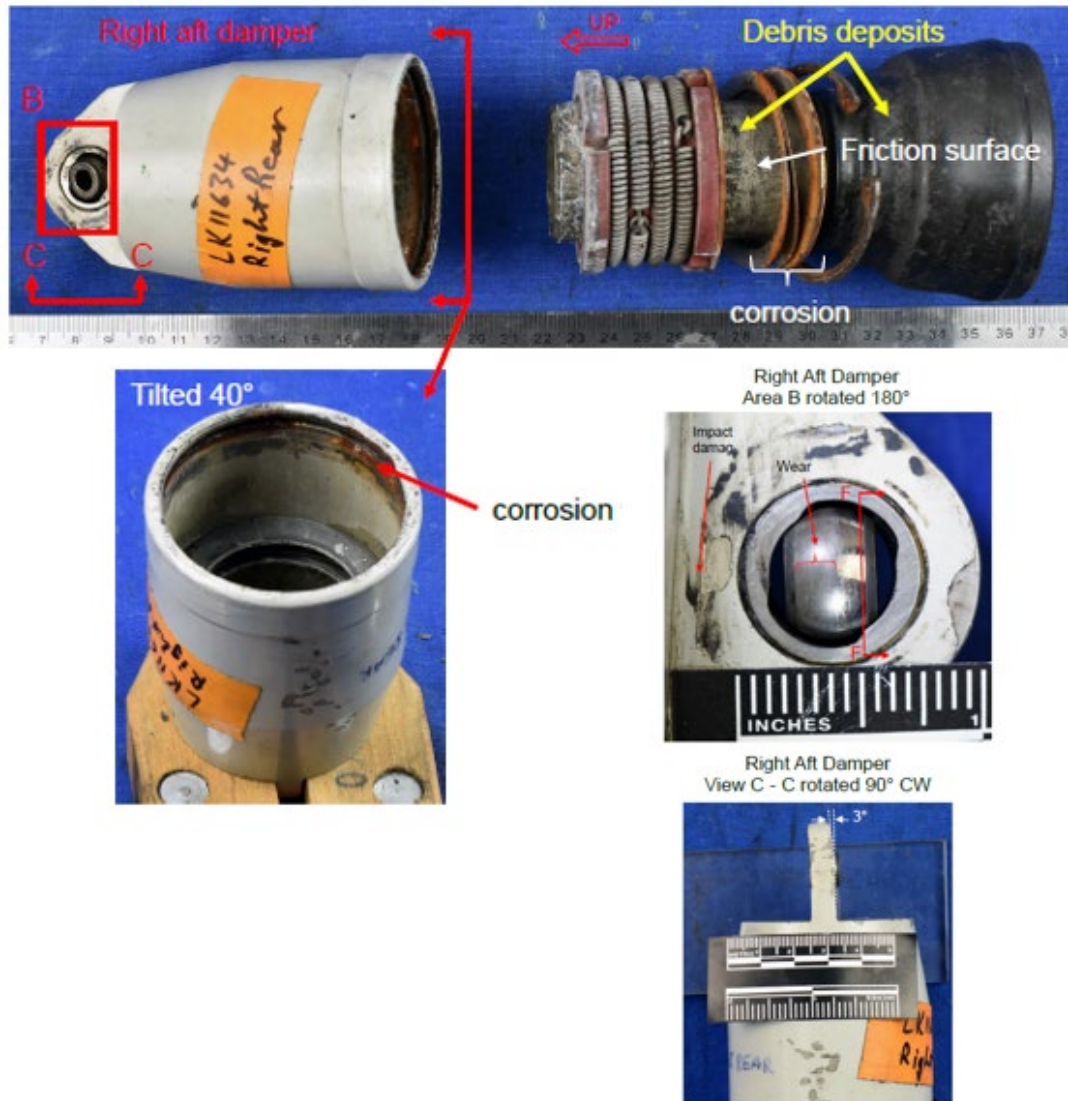
Figure 5. View of Right Aft Friction Damper

Visual inspection revealed particulates underneath the piston protective boot. The top mounting boss (spherical bearing eyebolt housing) sustained plastic deformation from its principal axis of about 3°. Black residue (smelled like grease and dirt) was observed on damper shaft under the rubber boot. The damper was initially stuck and unresponsive to 600 lbs. of load in compression but broke free when it was loaded in tension. The damper completed cyclical dynamic testing after it could actuate with no anomalies observed. The damper was further disassembled, and corrosion was observed on the inner components. A

subsequent dynamic test was performed, which revealed the aft damper to be out of specifications. The radial play of the right friction damper rod end ball was approximately 0.006 inch, which exceeded the allowed 0.004 inch maximum per the Bell 212 Maintenance Repair and Overhaul Manual.

*"Excessive radial clearance in the pylon damper rod end bearing has been found as the assignable cause for a high vibration incident on the 412 model, which uses the same damper. The worn rod end bearings reduce the amount of damper stroking to counteract vibratory motions of the pylon after they initiate."*

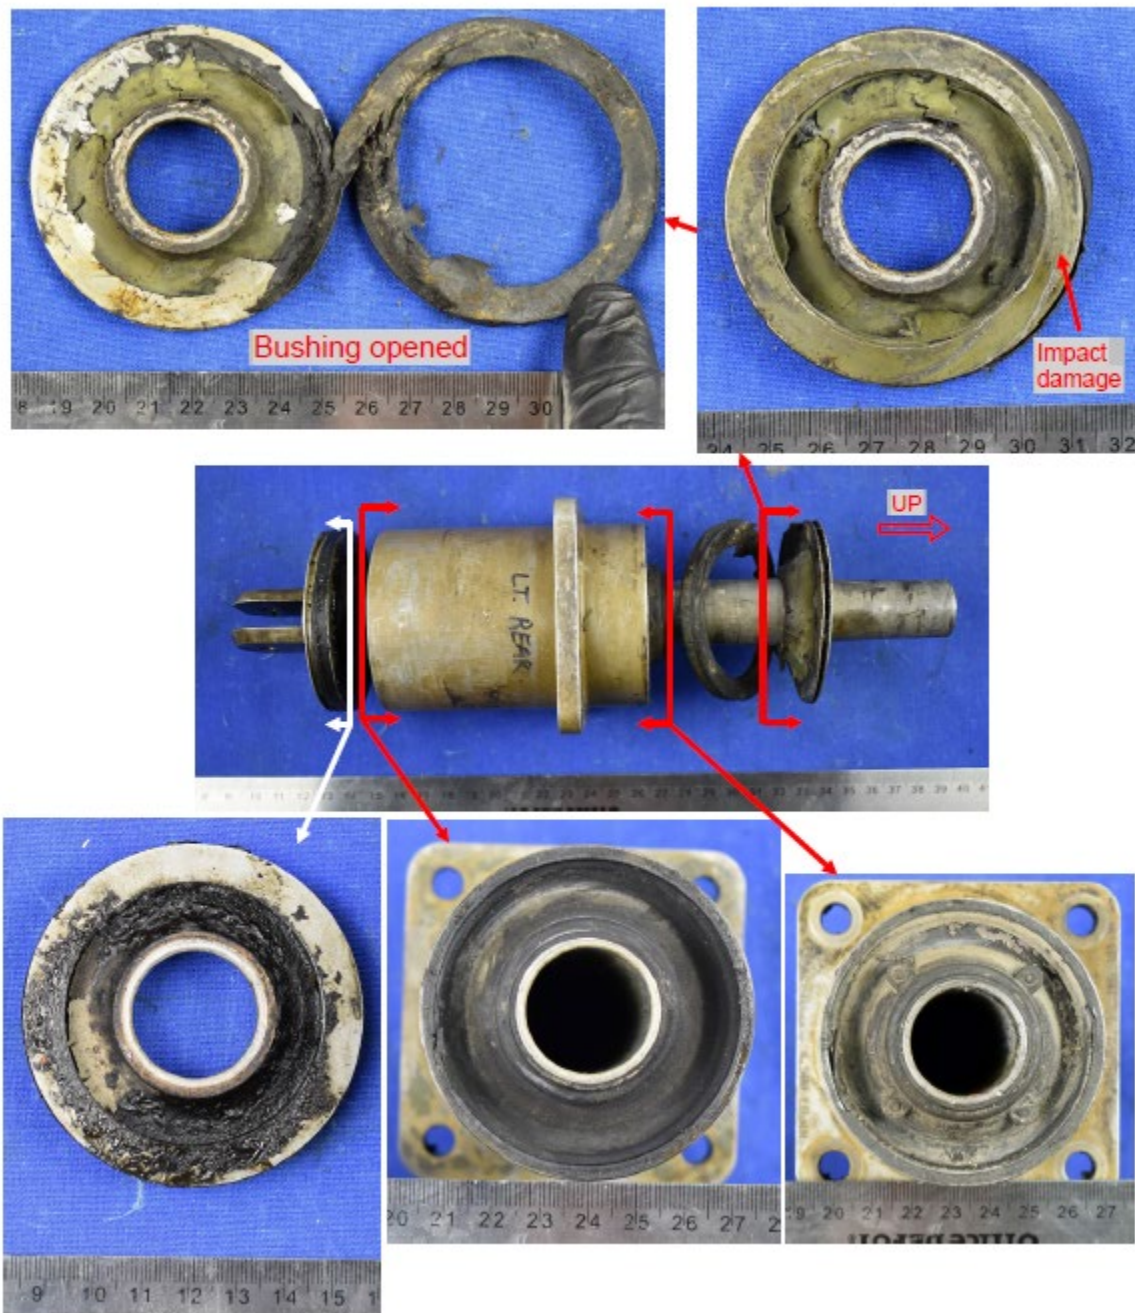
Figure 6. View of Left Aft Pylon Mount

Superficial, minor scoring was found on the upper and lower elastomer consistent with mechanical damage. The housing and the mount bolts were found unremarkable. No bonding discontinuities between the outer housing or the inner

tube were observed on the lower surface of the mount (surface exposed during testing) while under load.

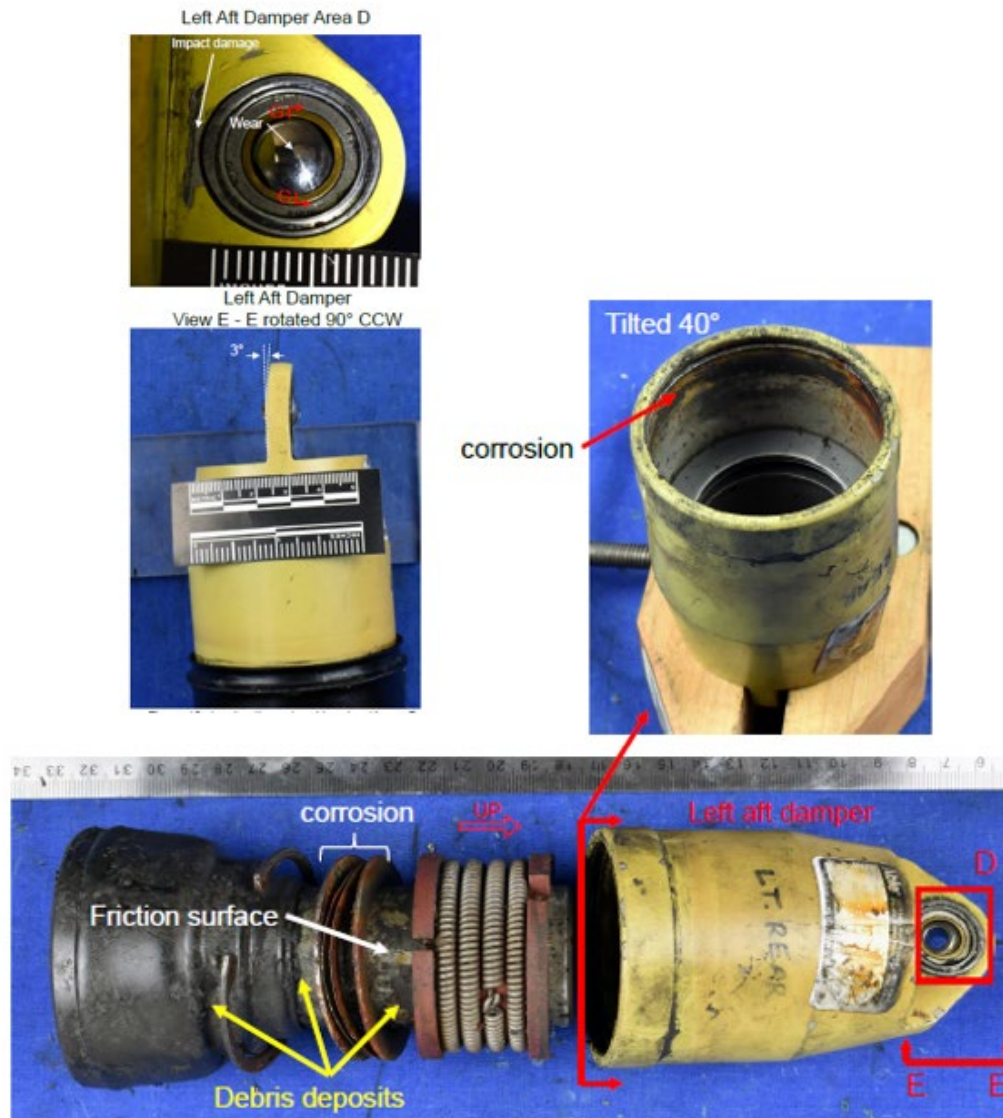
Figure 7. View of Left Amp Friction Damper

Visual inspection revealed particulates underneath the piston protective boot. The top mounting boss (spherical bearing eyebolt housing) sustained plastic deformation from its principal axis of about 3°. The

damper was initially stuck and unresponsive to 1,000 lbs. of load in compression but broke free when it was loaded in tension. The damper completed cyclical dynamic testing after it could actuate with no anomalies observed. The damper was further disassembled, and corrosion was observed on the inner components. A subsequent dynamic test was performed, which revealed the aft damper to be out of specifications. The radial play of the left friction damper rod end ball was approximately 0.016 inch which exceeded the allowed 0.004 inch maximum per the Bell 212 Maintenance Repair and Overhaul Manual.

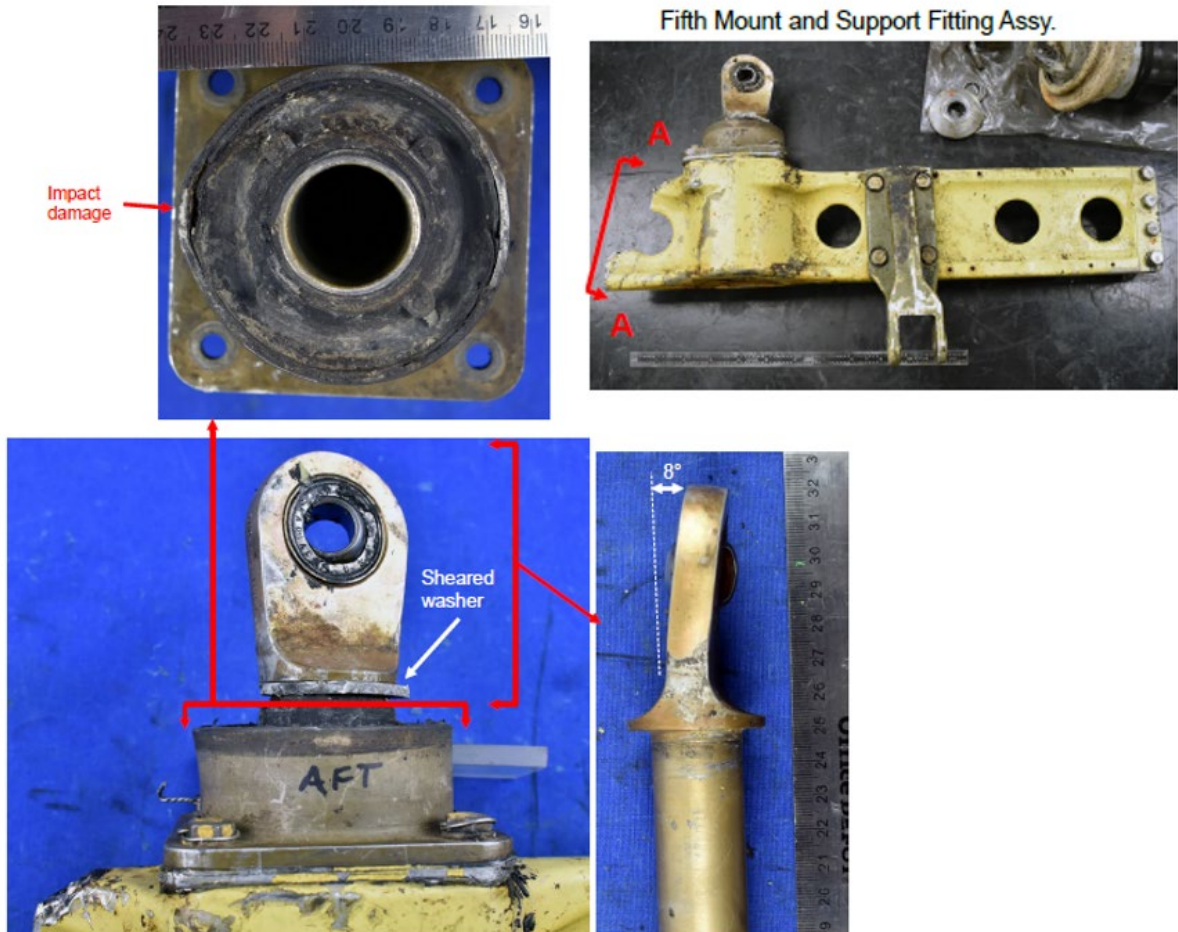
Figure 8. View of 5th Mount and Supporting Fitting Assembly

Visual exam revealed that the upper circular housing sustained superficial impact damage. Moderate circumferential scoring was found on both upper and lower elastomer. The eyebolt sustained plastic deformation consistent with impact damage. Due to the housing damage, the static and dynamic test was not performed. Instead, the 5<sup>th</sup> mount was CT scanned and it revealed no anomalies to the elastomer.
