# National Transportation Safety Board

WPR21LA271

## ENGINE EXAMINATION

Location: Riverside, California  
Date: July 15, 2021  
Time: 0845 Pacific daylight time  
Airplane: Experimental Vans Checca RV6, N468AC

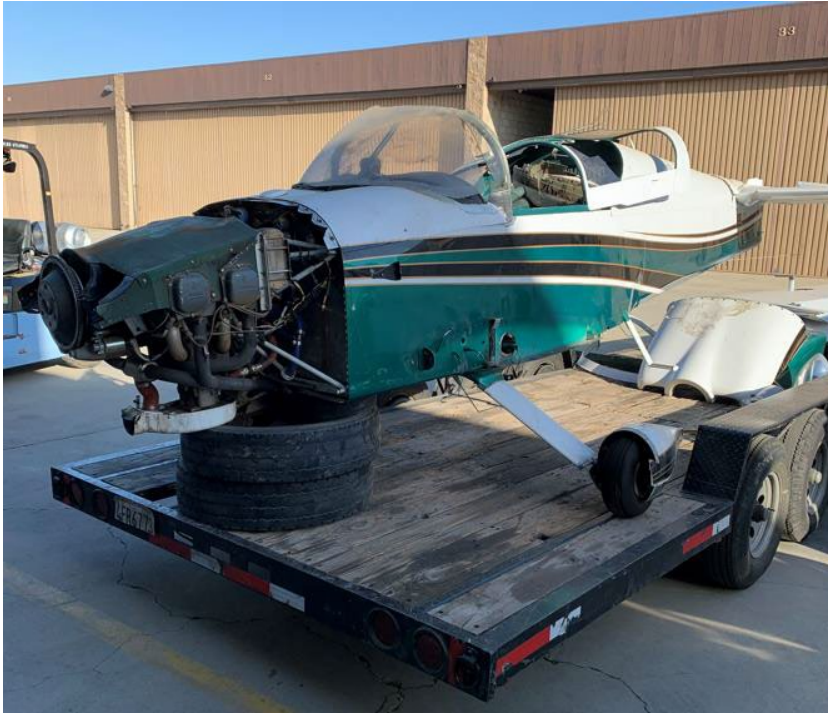
Figure 1: N468AC at storage facility, secured to a trailer for the engine test run

Examination of the recovered engine revealed no evidence of any preexisting mechanical malfunction or failure that would have precluded normal operation. The engine ran at various power settings for several minutes uneventfully. Due to malfunctioning instrument displays, the maximum engine rpm reached during the engine run was not captured. However, the engine ran consistently when full power was applied.

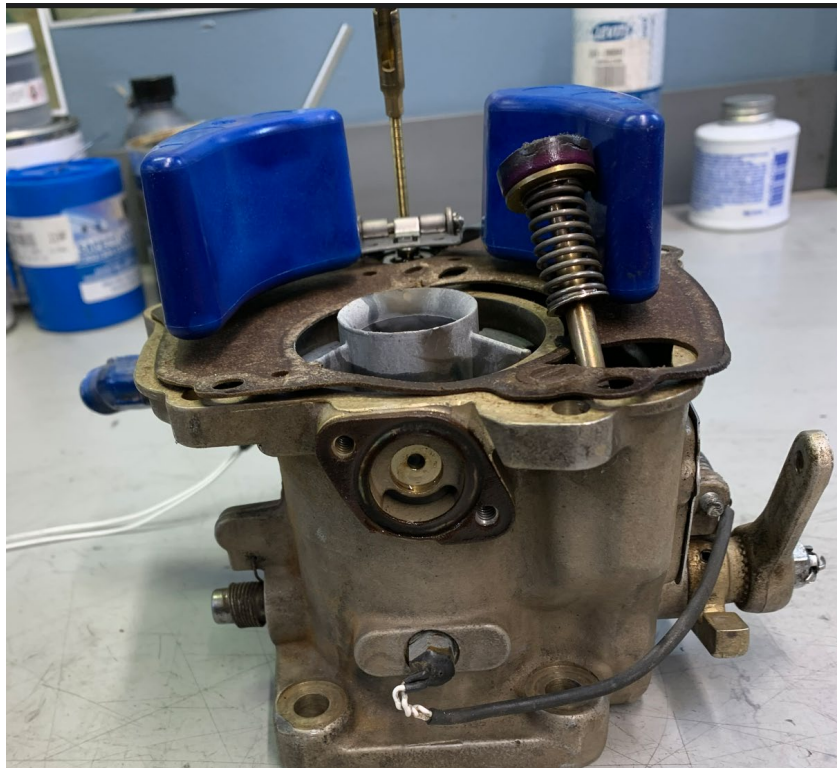
Figure 2: Carburetor

- Make: Precision Airmotive Corporation/ Marvel-Schebler
- Model: MA-4-5
- Part No: 10-4164-1
- Serial No: 75308515
- Disassembled carburetor and presence of fuel was noticed in quantity, odor, and the fluid color had a blue-ish hue, confirming the presence of 100LL.
- The float material was royal blue in color, solid epoxy material, and stamped with the numerals 30-862. Floats remained sealed and were not infused with fuel and the float was buoyant while the float bowl remained occupied with fuel.
- The one-piece venturi exhibited mild oxidation and remained intact.
- The mixture metering valve remained intact and exhibited no sign of deformity, discoloration, or presence of debris.

- The needle valve seat did not appear worn or disfigured and exhibited a normal range of motion when manually adjusted.
- The finger screen remained intact and was free of contaminants.

- Excessive wear from the float was not observed on float bowl. However, the bottom, exterior of the float bowl exhibited trace amounts of carbon, where the carburetor attached to the air filter.

- The accelerator pump was operational when manually manipulating the throttle, exemplified by a strong stream of fuel that exited the carburetor after removal. The accelerator pump fuel screen contained trace contaminants that occupied about 5 percent of the screen.

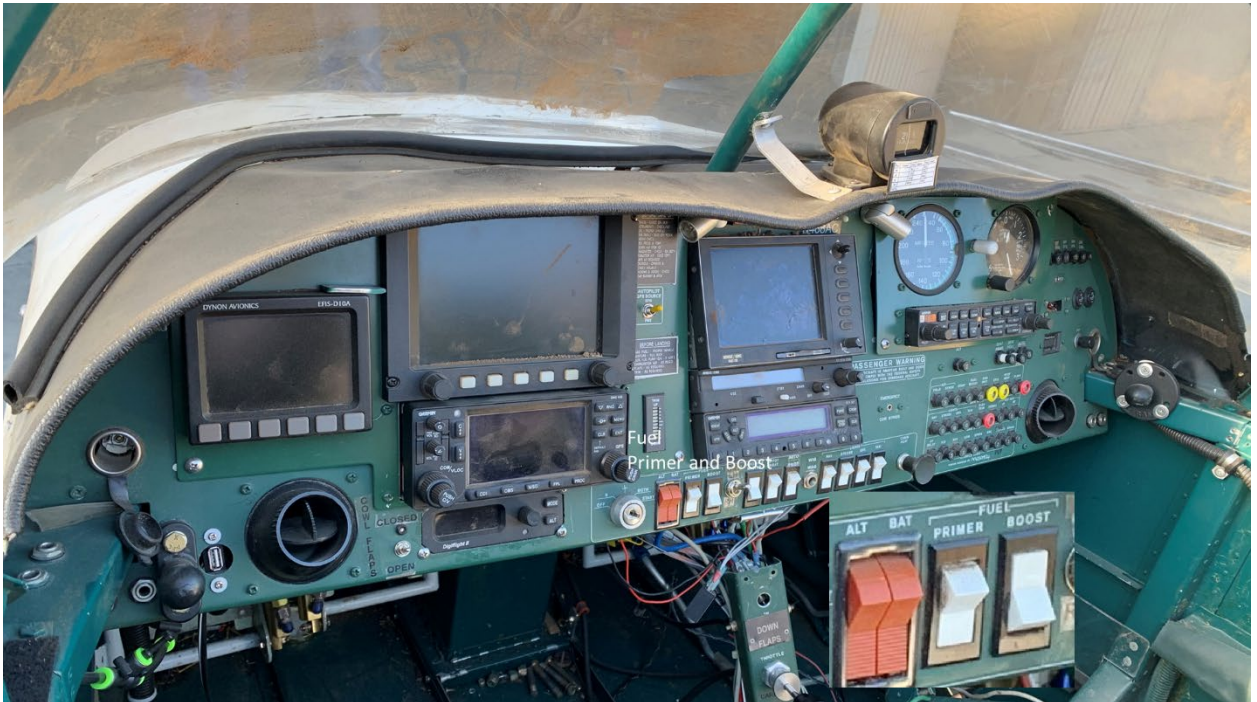
Figure 3: Instrument Panel

The digital instruments inside the panel were not operational. Each of the Garmin products and the Dynon, were energized when external battery power was applied. However, a faint error message appeared in the upper left corner of the MFD, that stated "Operating System Not Found." An attempt was made to troubleshoot the instrument panel to document the engine parameters during the test run, to no avail.
