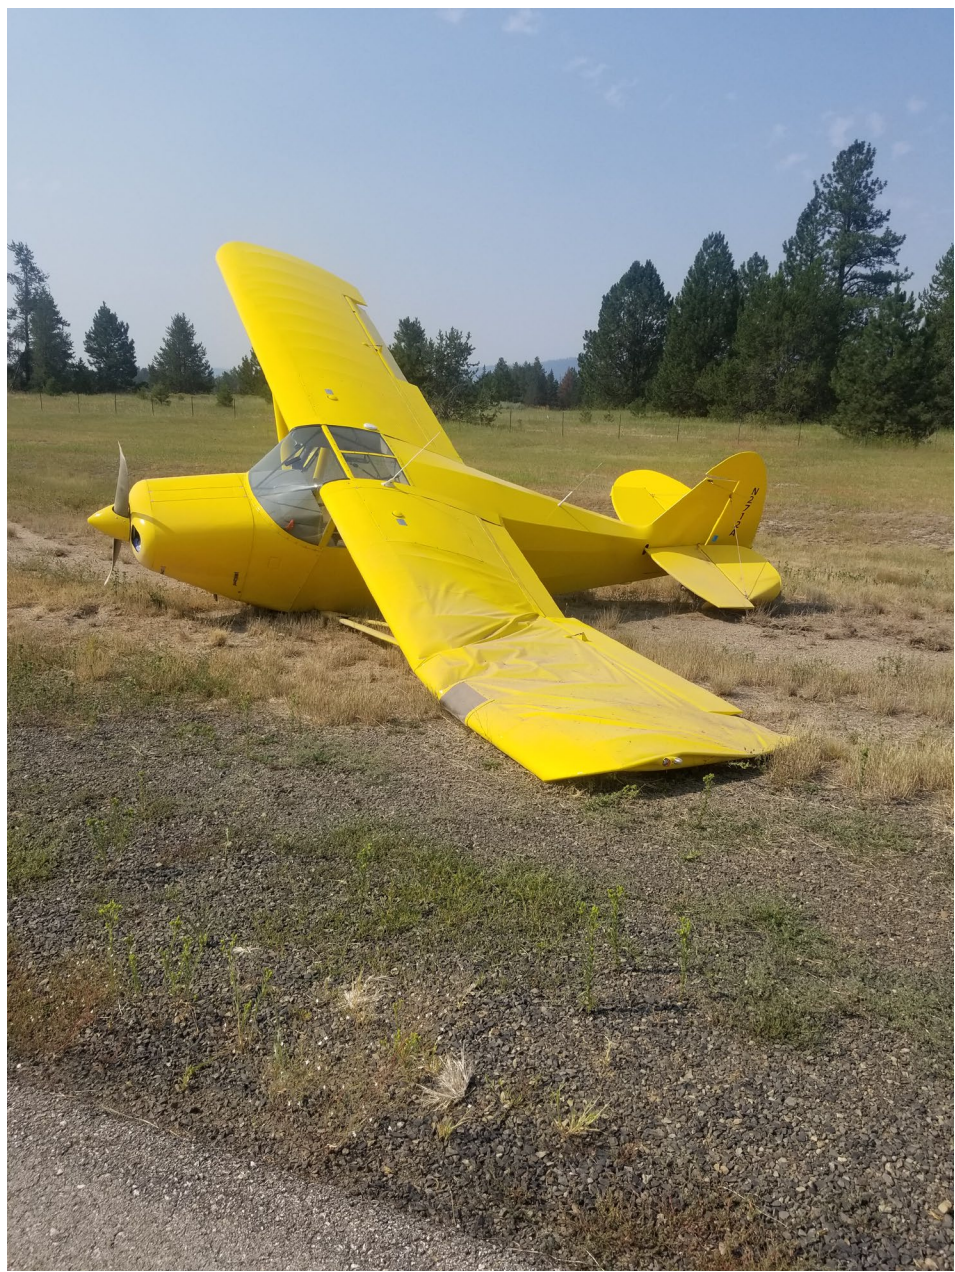
**Photo 1 – View of left wing damage (Picture courtesy of owner)**
