# WPRNational Transportation Safety Board

WPR21LA287

## **ENGINE EXAMINATION**

Location: Chandler, Arizona  
Date: July 10, 2021  
Time: 07:21 MST  
Airplane: Beech, A36TC, N222HC

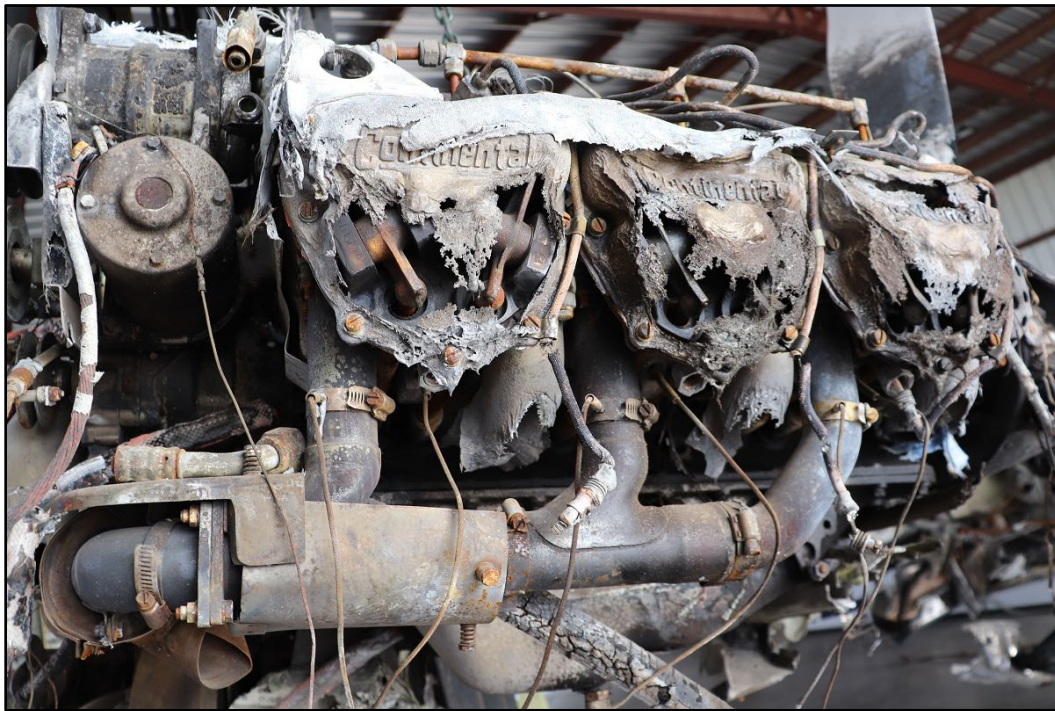
Visual examination of the engine revealed extensive thermal damage throughout the engine. All engine accessories and propeller remained attached to the engine.

All of the engine accessories were removed along with the upper spark plugs and rocker box covers. The crankshaft was rotated by hand using the propeller. Thumb compression and suction was obtained on all 6 cylinders. The intake and exhaust valve rocker arms on all 6 cylinders exhibited equal movement when the crankshaft was rotated.

***Figure 1: View of Engine Right Side, Photo Courtesy NTSB***

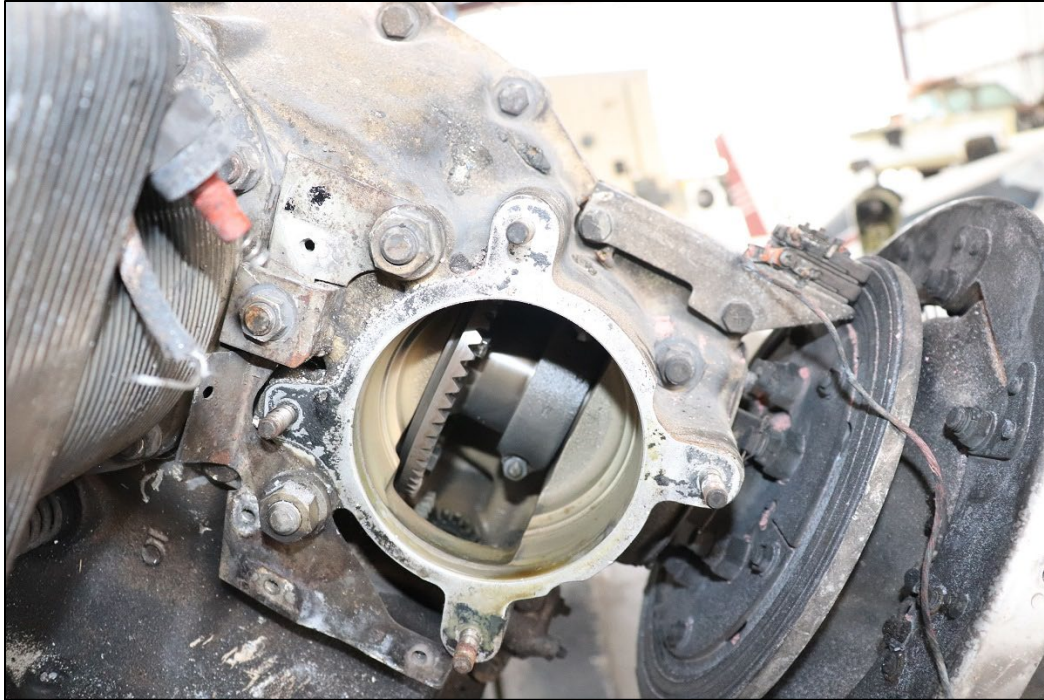
The alternator remained attached to the crankcase. Once removed, the drive shaft rotated freely by hand. Internal examination of the crankcase through the alternator drive mount revealed normal operational signatures.

**Figure 2: View of Alternator Port, Photo Courtesy NTSB**

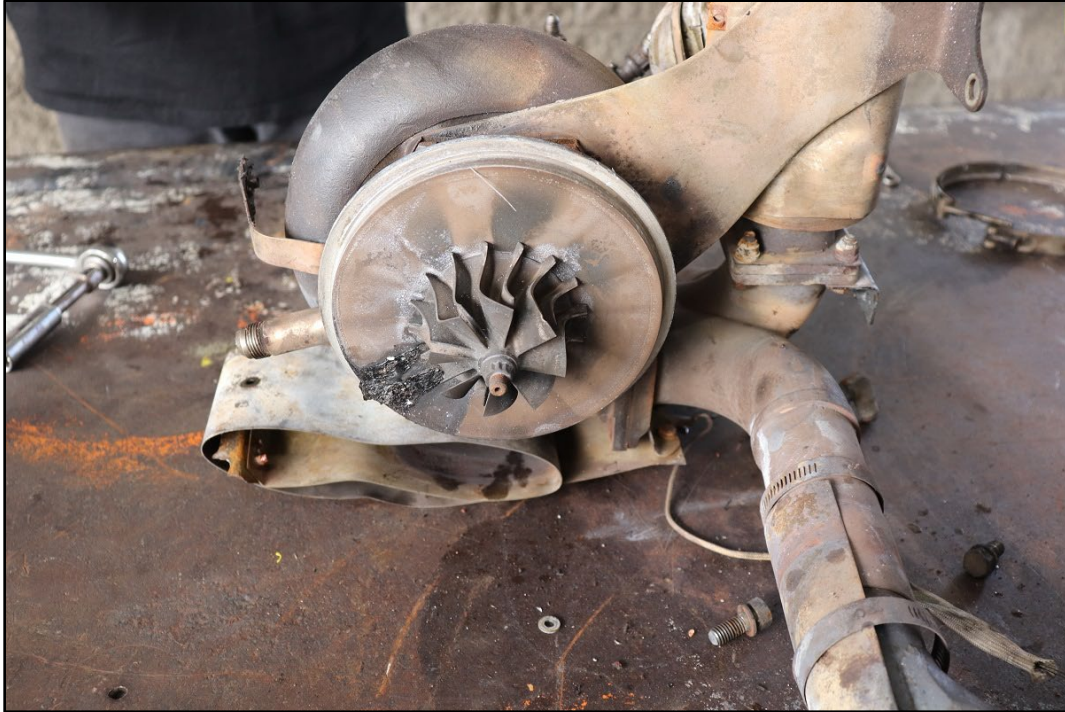
The turbine and compressor impellers spun freely by hand with no binding noted. The compressor and turbine impellers were intact with slight lateral play in the shaft between the compressor and turbine impellers was noted, with some slight rub marks on the housing.

**Figure 3: View of Turbocharger Axial Impeller, Photo Courtesy NTSB**

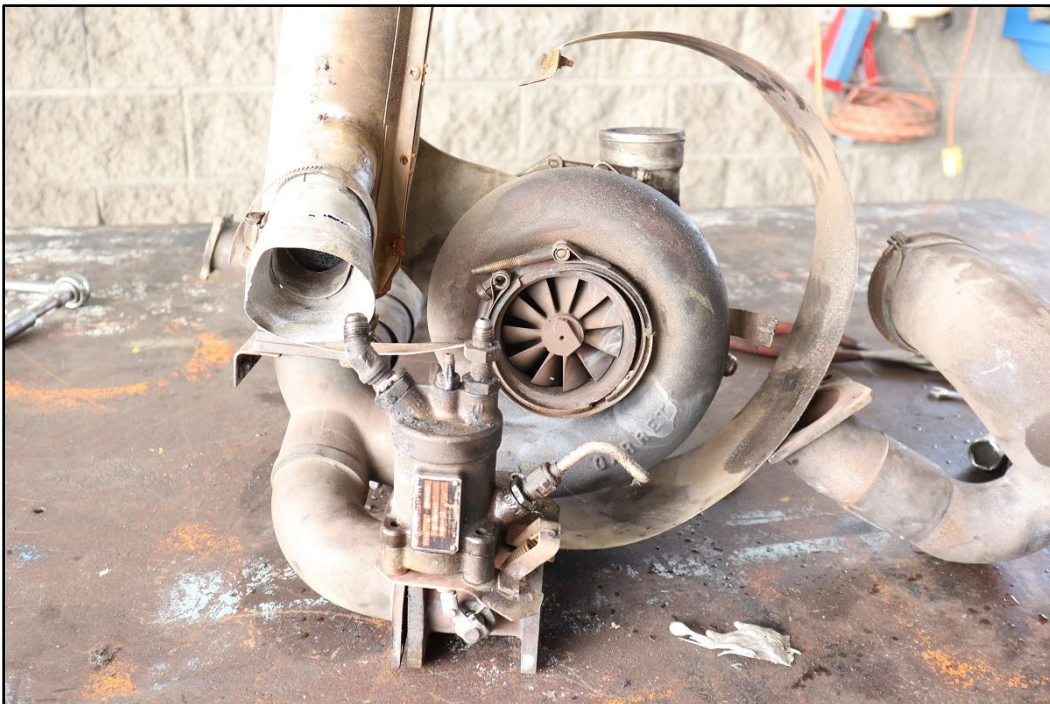
The exhaust was cut. Inspection of the turbo waste gate showed the control cables to be intact. Inspection of the turbo revealed it to be in normal condition with all pieces intact. The last 14 inches of the exhaust was bent and crushed upward. The waste gate oil line was severed two inches from the waste gate. The intercooler showed thermal damage to about 10% of the box.

The turbo charge waste gate remained attached in its respective position. The butterfly valve was in the "open" position. The control arm was actuated by hand using a hand tool and movement of the butterfly valve was observed, and opened once pressure was released.

**Figure 4: View of Turbo Charger, Photo Courtesy NTSB**
