## **NATIONAL TRANSPORTATION SAFETY BOARD**

# **AIRFRAME AND ENGINE EXAMINATION**

**WPR21LA292**

Location: Mt. Hood, OR.  
Date: July 23, 2021  
Aircraft: Cessna 180 / N8884  
NTSB IIC: Fabian Salazar

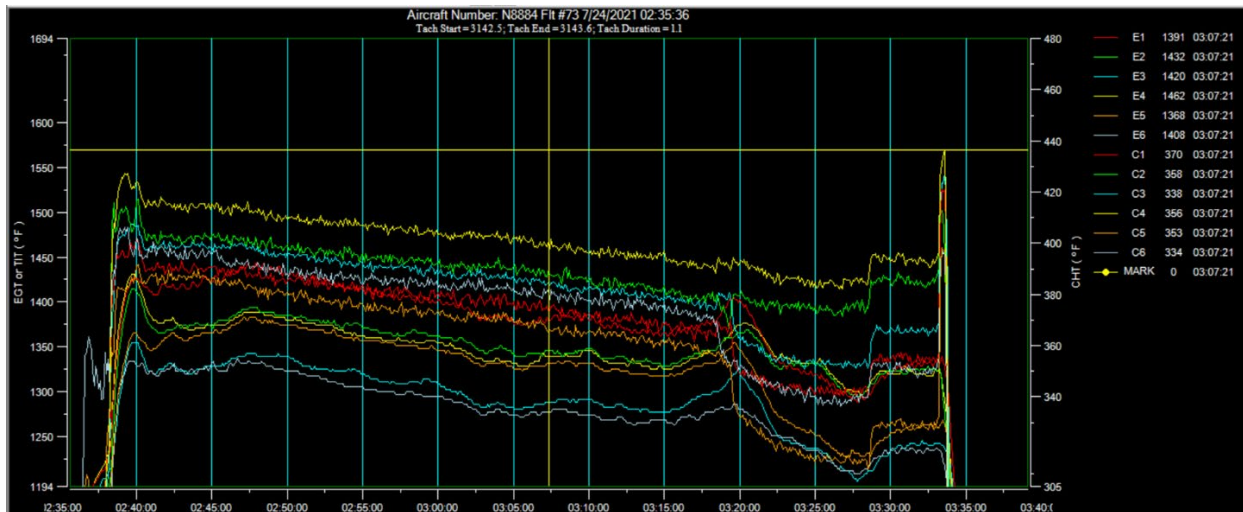
**JP Instruments Engine Data Monitor (EDM, model JPI-830).** The airplane was equipped with an EDM. The EDM was found in good condition, still mounted in the airplane. Data from the EDM was downloaded. The non-volatile memory contained 63 events or flights. Numbers 1 through 10 were not present. Numbers 11 through 73 remained. Event number 73 was the accident flight. Figure 1 shows the performance of the exhaust gas temperature (EGT) and cylinder head temperature (CHT) of the six individual cylinders. Figure 2 shows the performance of the engine RPM, fuel flow, manifold pressure, and oil temperature.

Figure 1. Graph showing the EGT and CHT for the engine.

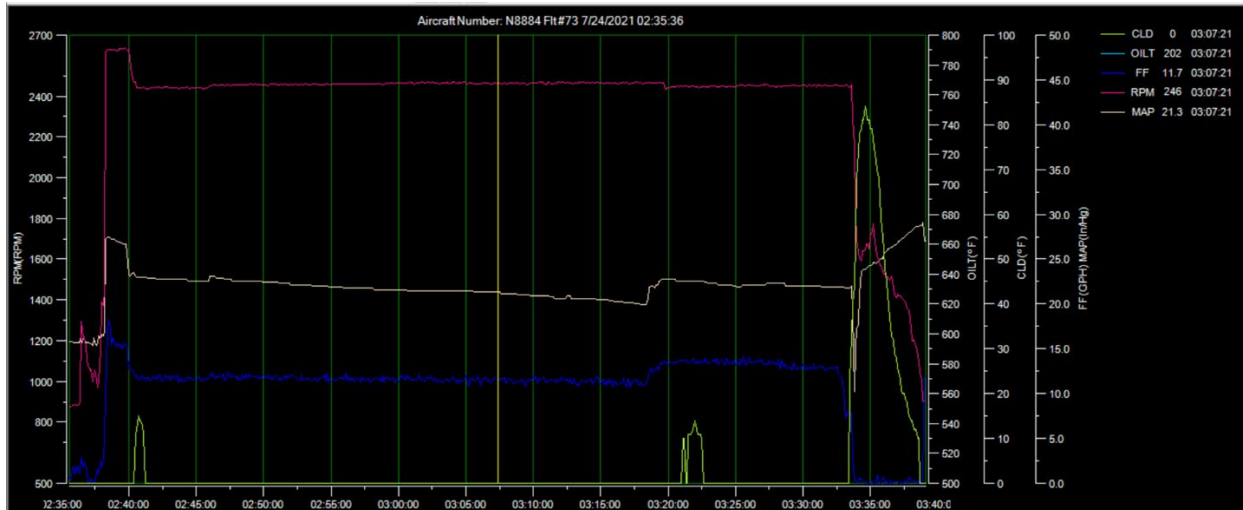
Figure 2. Graph showing the engine RPM, fuel flow, manifold pressure, and oil temp.

According to the data recovered from the EDM, the internal clock was set to coordinated universal time (UTC) and recorded a 1.06-hour flight on July 24, 2021, from 0235:35 until 0339:06. Data captured included exhaust gas temperature, cylinder head temperature, manifold pressure, engine RPM, and oil pressure. At 0235:36 all data rose in a manner that was consistent with the engine starting and producing power until about 0333:42 when all recorded data began to decrease sharply and continued to decrease until the end of the recorded data. At 0333:48, the fuel flow fluctuated from 0.6 to 0.0 for the remainder of the recorded data.

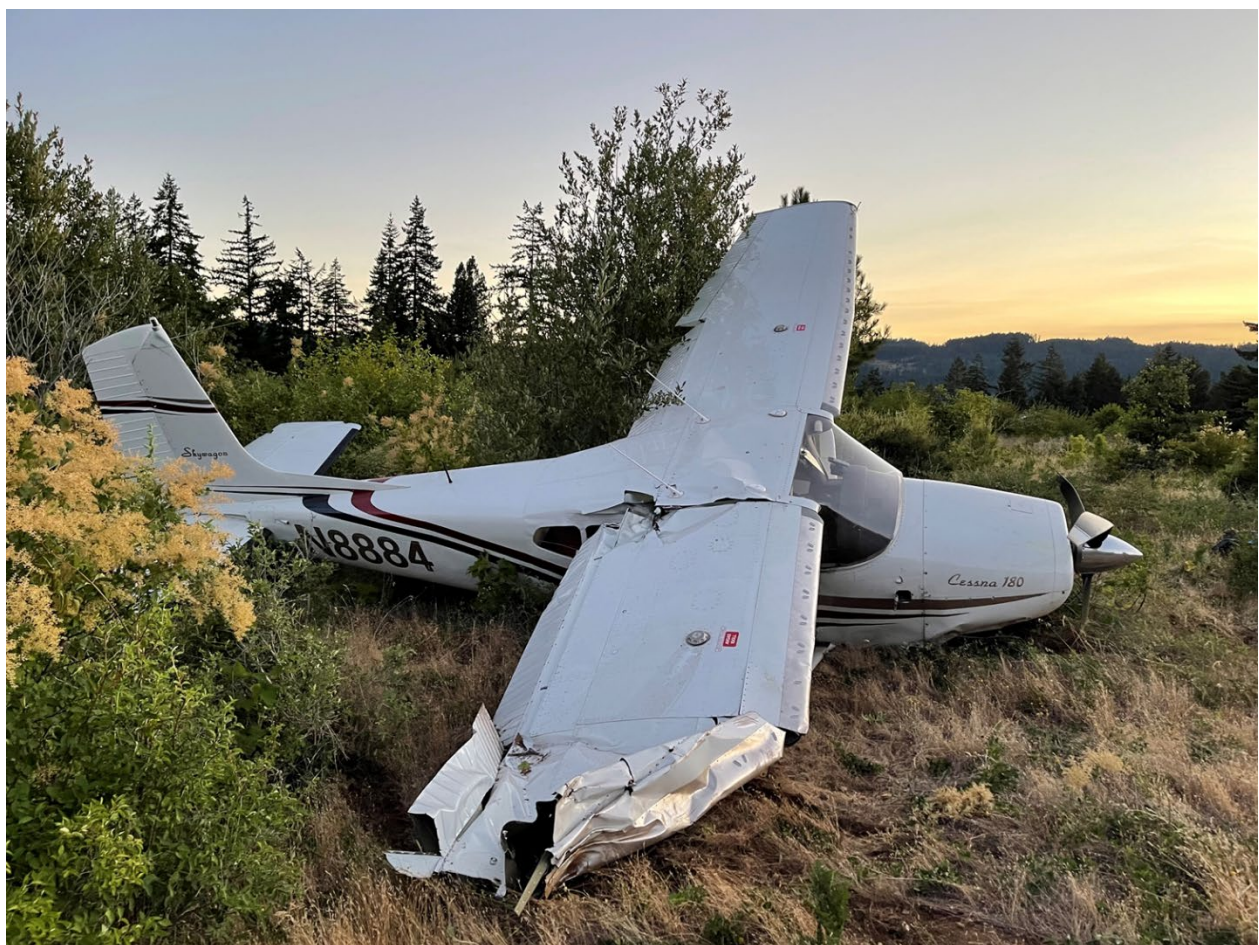
Figure 3. N8884 at the accident site.

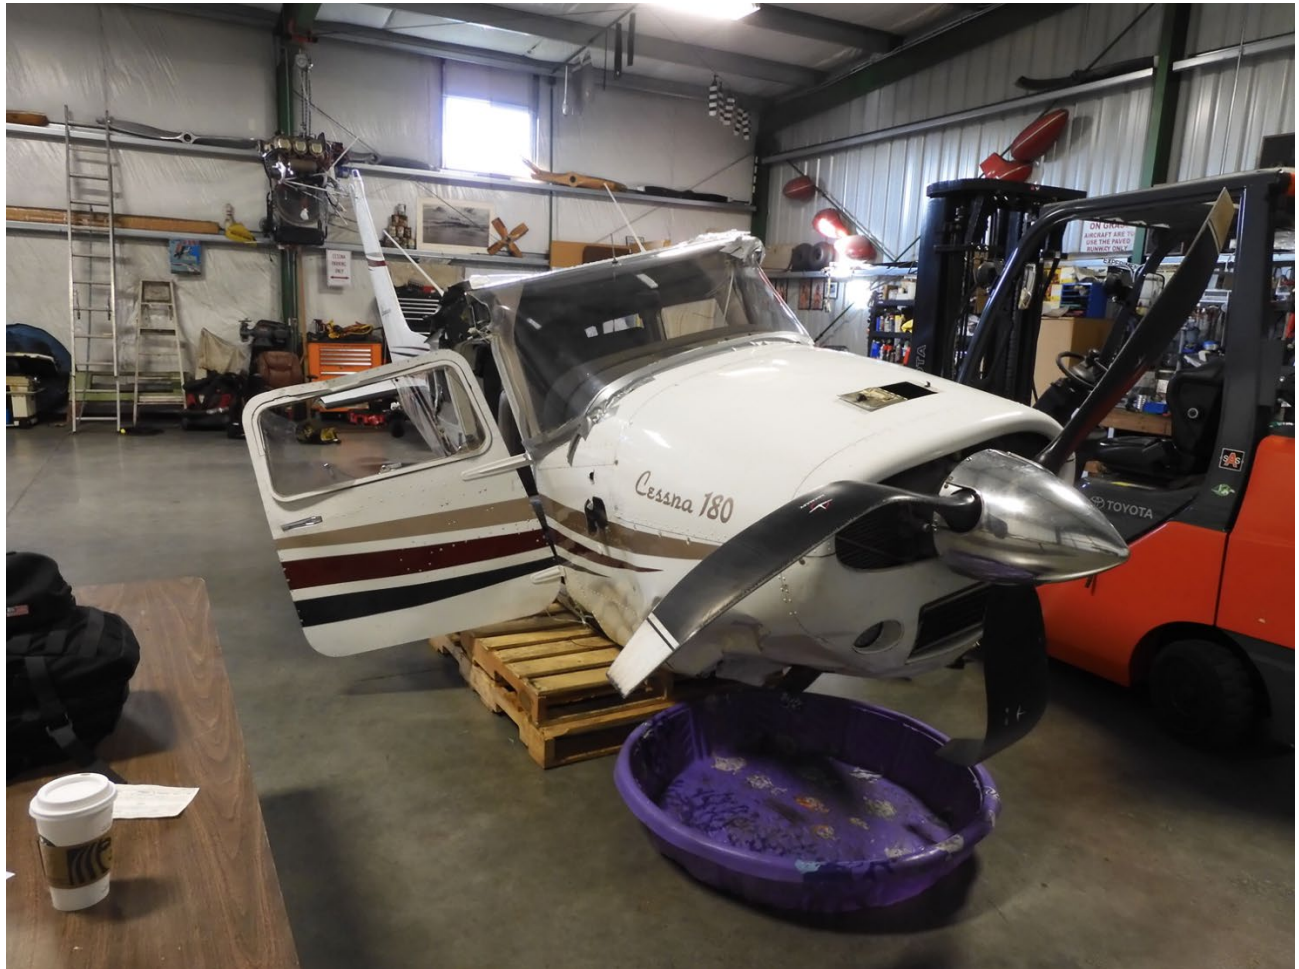
Figure 4. N8884 at the recovery site.

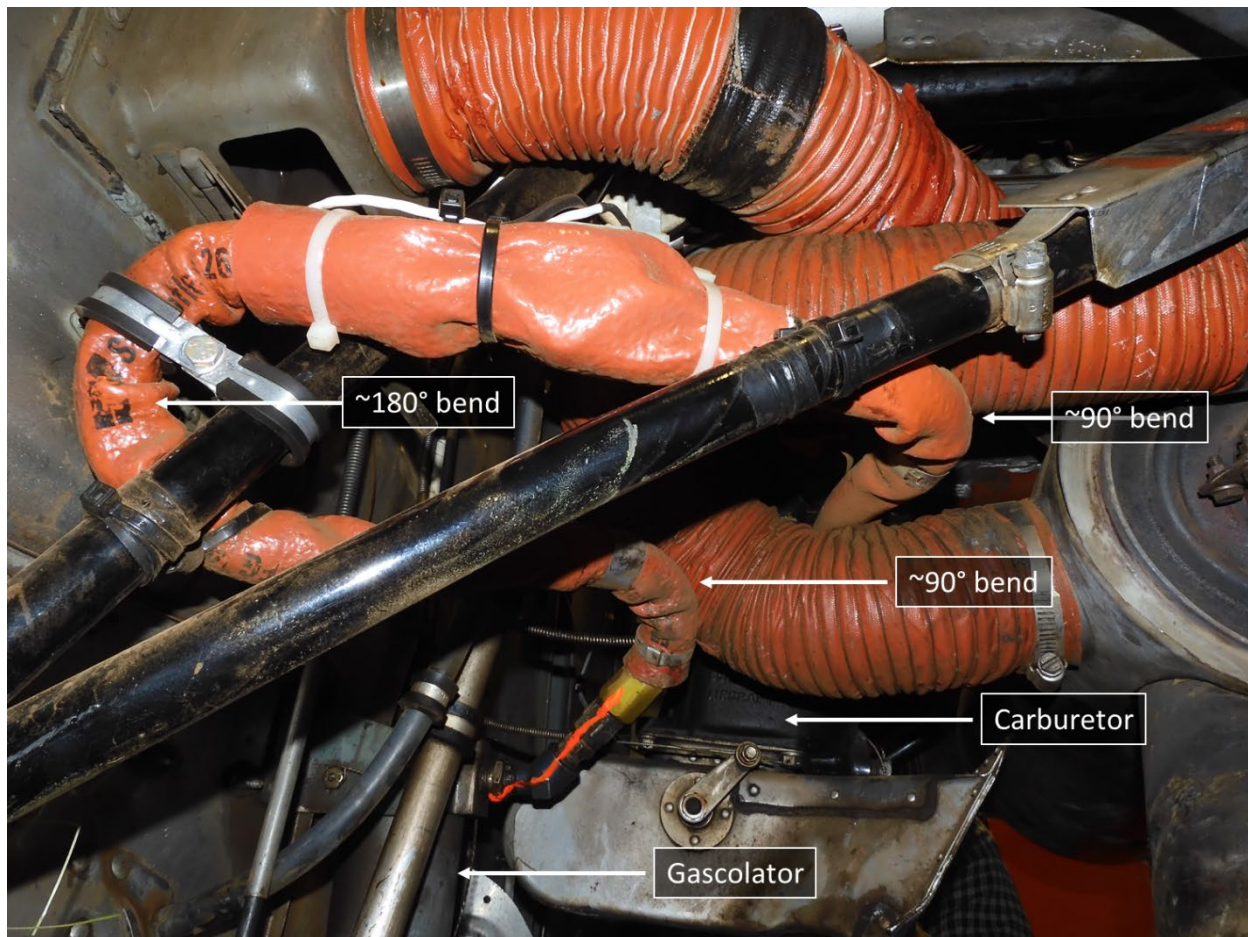
Examination of the airframe and engine was conducted at Auburn, Washington on October 7, 2021. There was no evidence of preimpact mechanical malfunction or failures with the airplane that would have precluded normal operation. The fuel hoses from the gascolator to the carburetor had been modified to include fuel flow meter transducer. After the modification, the two hoses had multiple bends. It could not be determined if the fuel hose bends causal to the loss of power.

The engine remained secured to the fire wall by three of the four engine mounts. There was no damage to the engine or engine-mounted components. The fuel line from the gascolator remained secured to the gascolator to the fuel flow transducer and the second line from the fuel flow transducer to the carburetor remained secured. The fuel lines had two 90° bends and one 180° bend. There were no leaks detected. A blue colored fluid with the smell of aviation gasoline was present in the fuel lines. No water was detected in the fuel lines, gascolator or the carburetor bowl.

Figure 7. Fuel line from gascolator to the carburetor showing multiple bends.

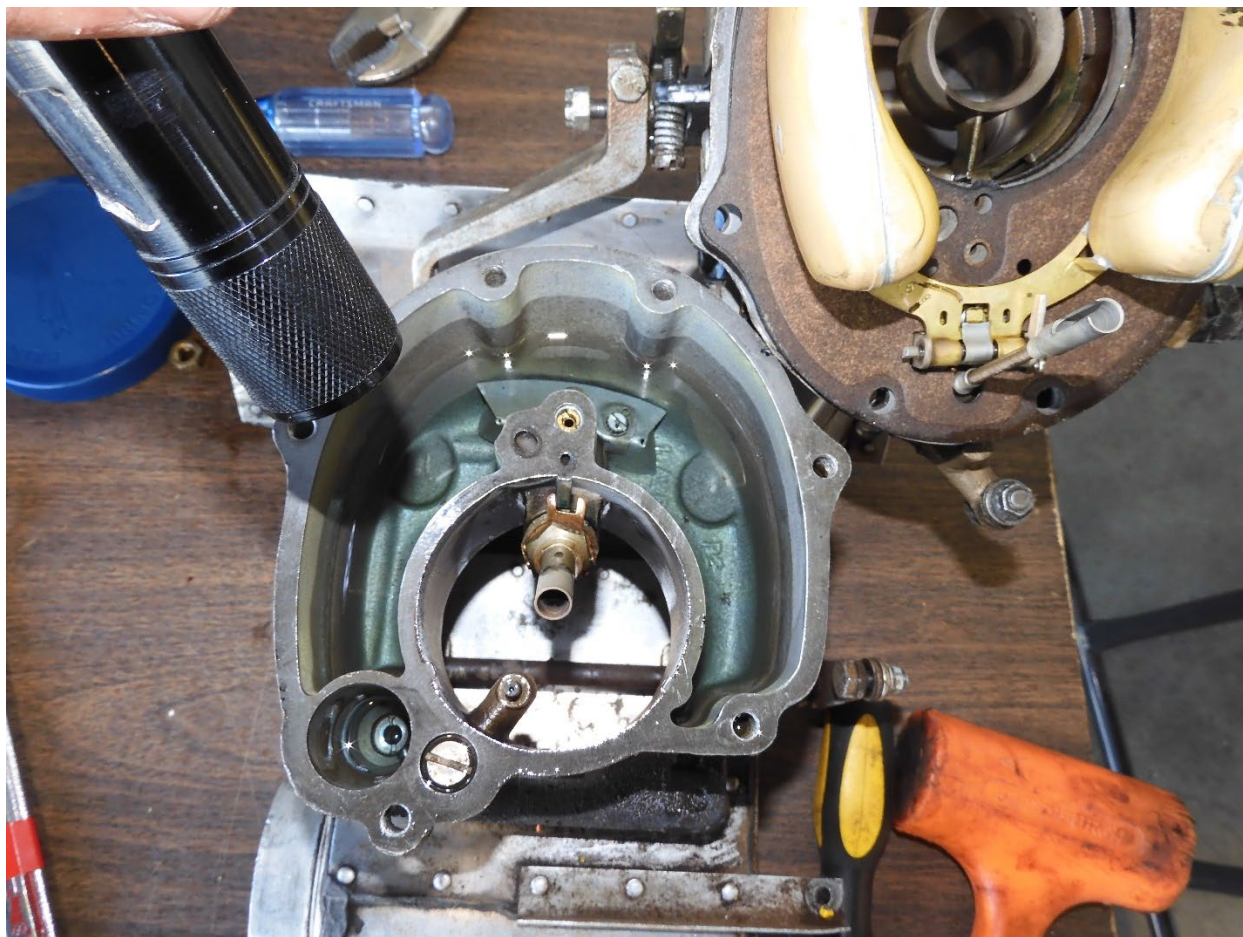
The engine was subsequently test run for ten minutes up to full power. The engine ran normally for the entire ten minutes with no anomalies observed or heard. After the engine run, the carburetor was removed and examined. There was no foreign debris found in the carburetor bowl.

Figure 8. Carburetor bowl showing no debris.
