**Photo 1 – N8884 at the accident site. Photo courtesy of the pilot.**

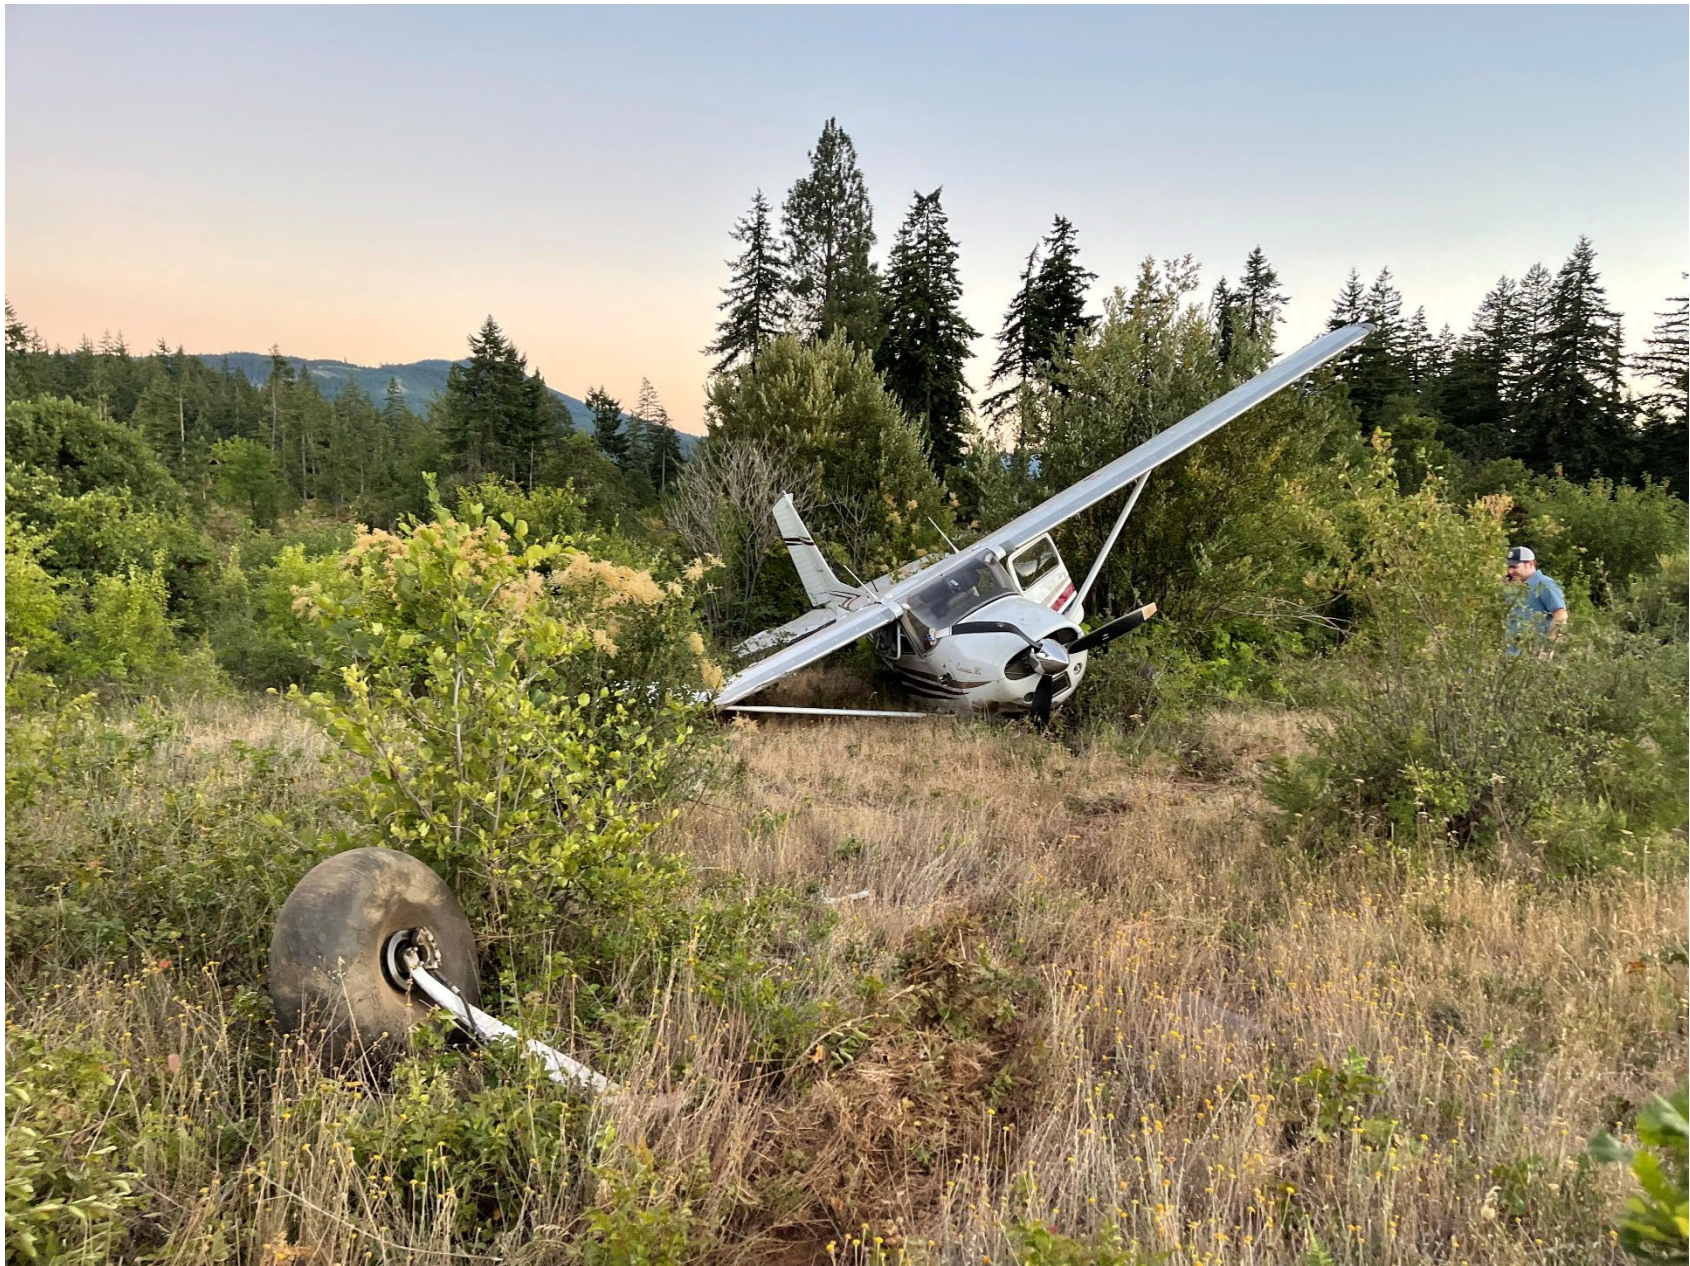
**Photo 2 – N8884 front-right view, showing the right landing gear assembly. Photo courtesy of the pilot.**

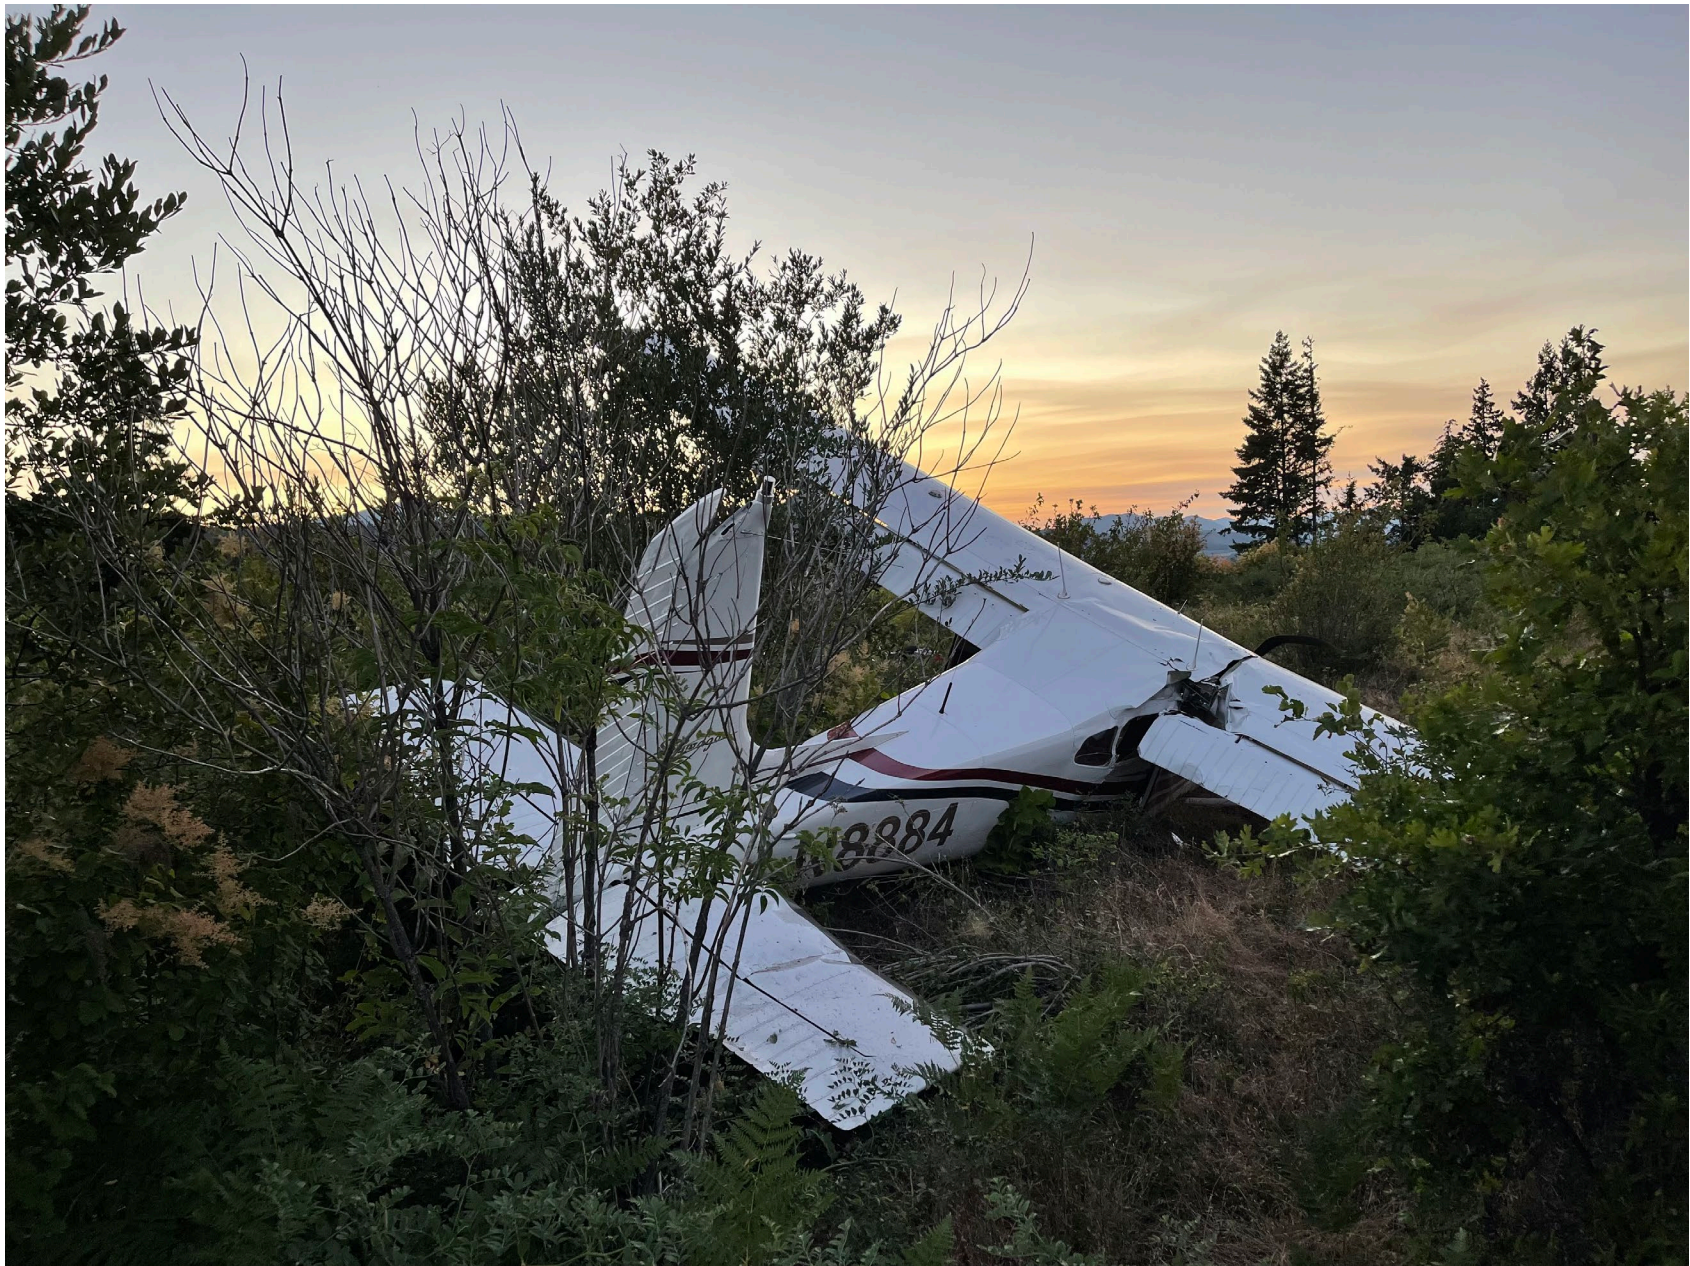
**Photo 3 – N8884, right-rear view. Photo courtesy of the pilot.**

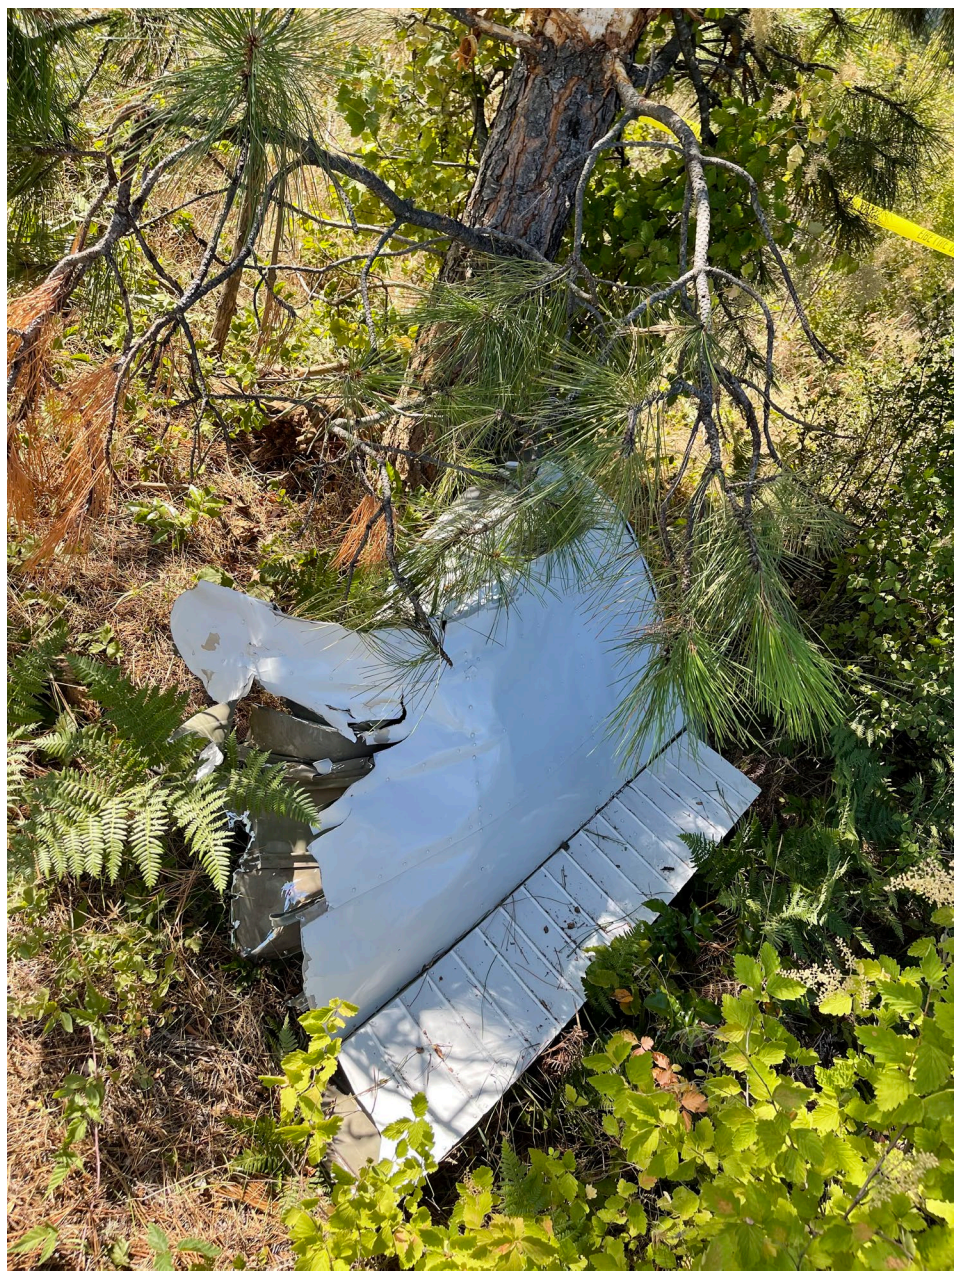
**Photo 4 – Right outboard tip and aileron. Photo courtesy of the pilot.**

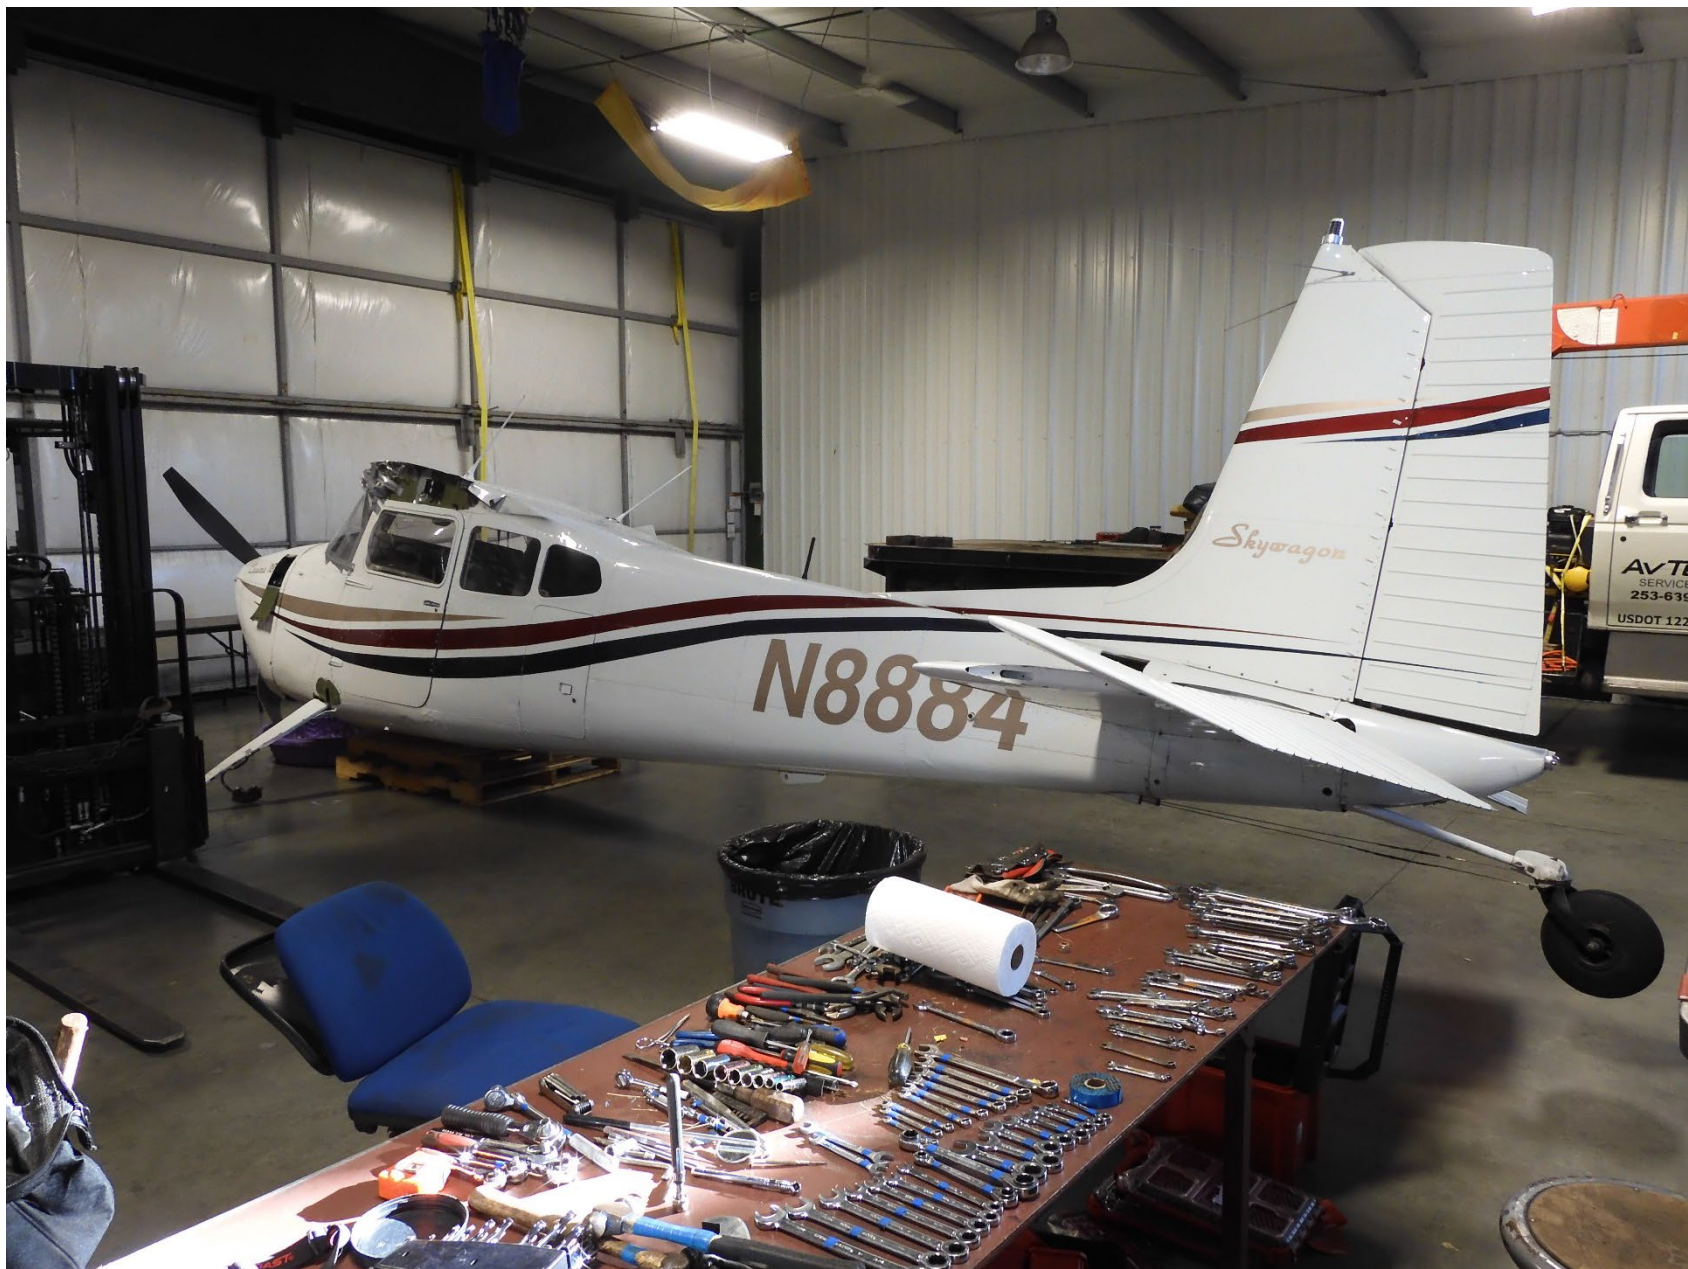
**Photo 5 – N8884 at the recovery facility. Photo NTSB.**

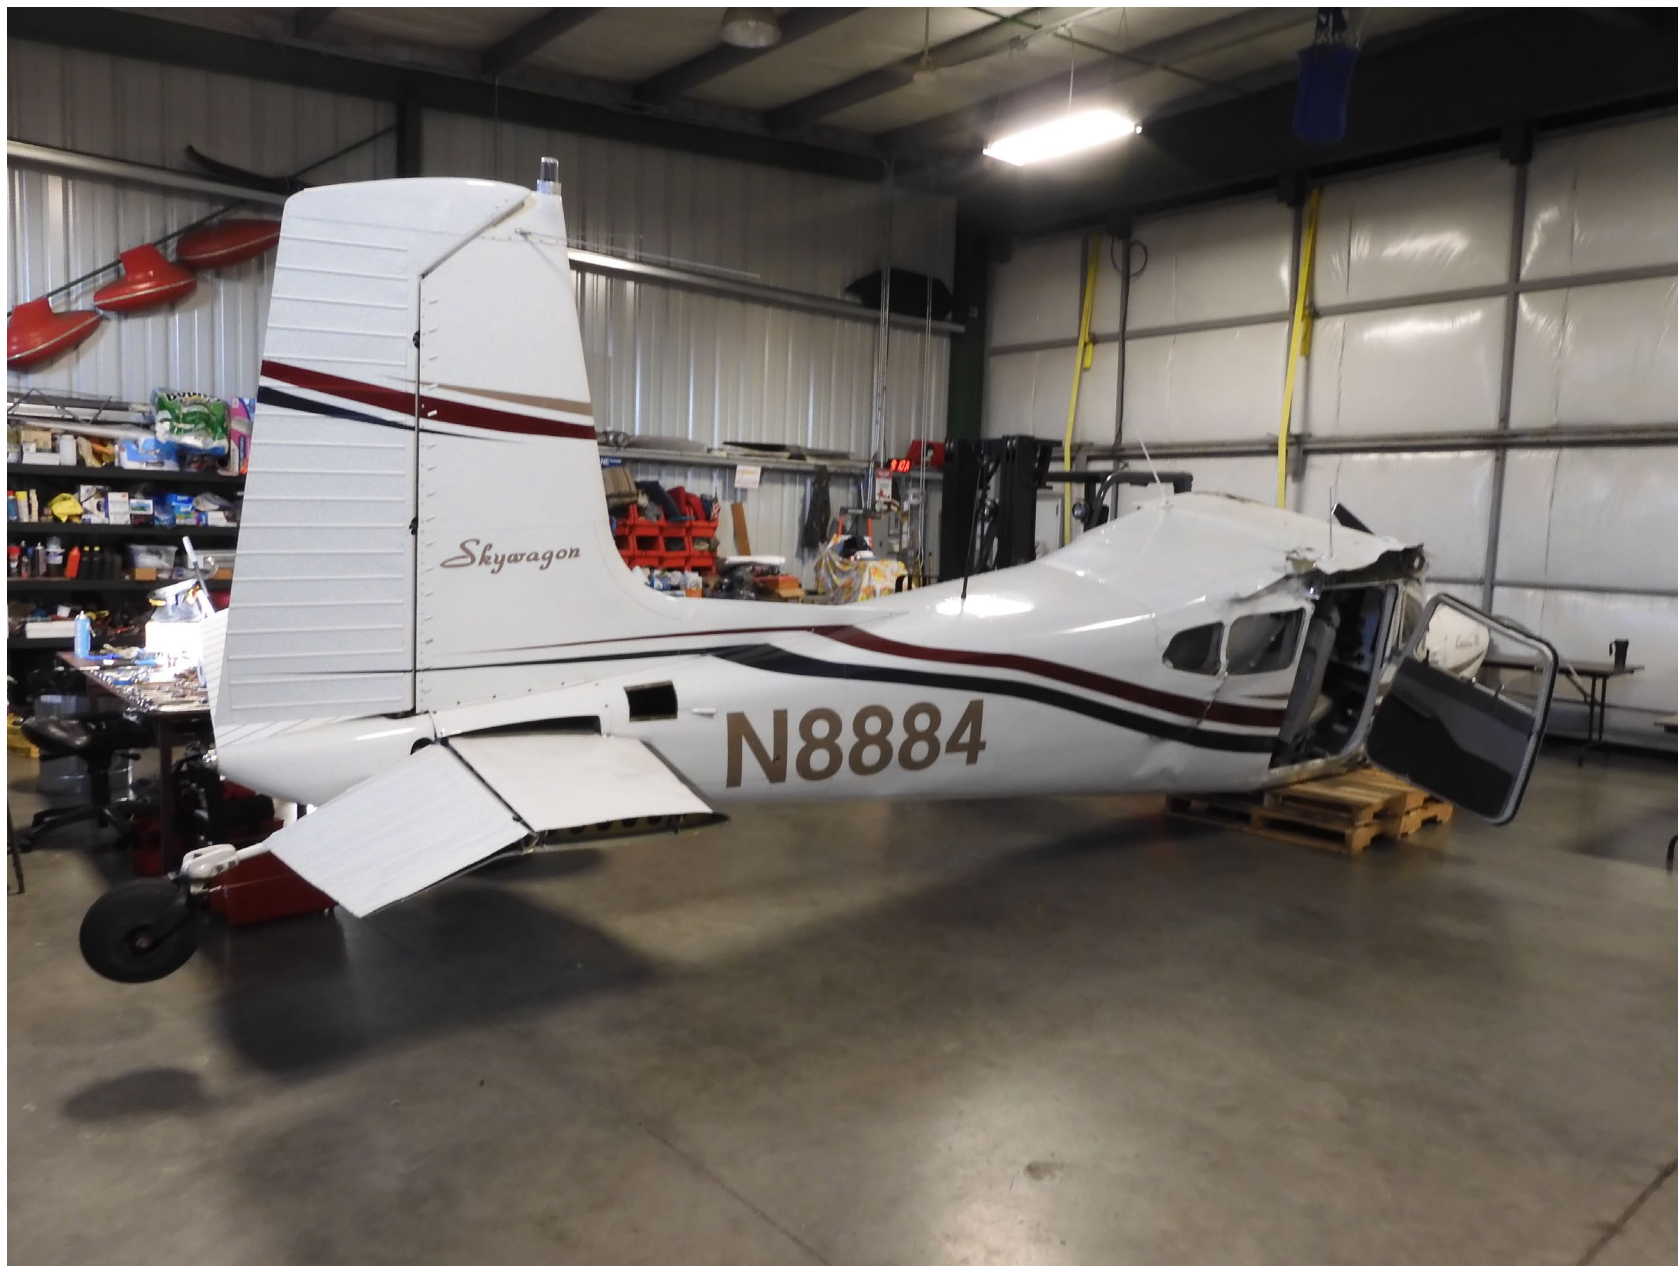
**Photo 6 -N8884 at the recovery facility. Photo NTSB.**
