## **NATIONAL TRANSPORTATION SAFETY BOARD**

### **ENGINE EXAMINATION**

**WPR21LA294**

| Aircraft: | Kuykendall Charles, Lancair IV, N26PD |

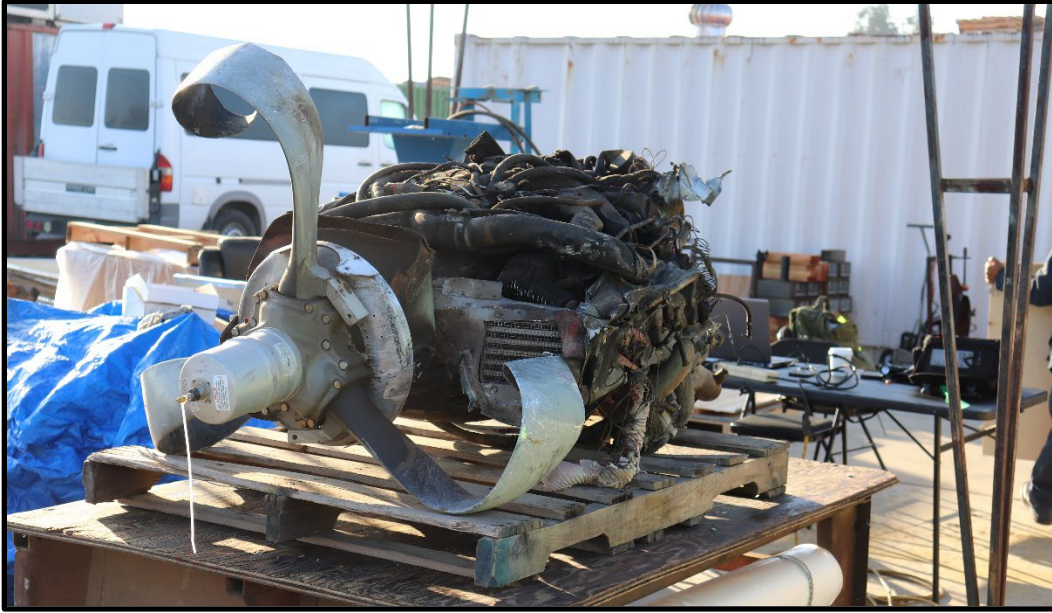
Examination of the recovered engine revealed that it remained attached to the engine mount attachment points. The engine mount frame was cut from the airframe to facilitate transportation. All six cylinders and all engine accessories remained attached. No evidence of any mechanical damage was observed to the engine crankcase. Impact damage was observed throughout the entire air induction system. The entire engine sustained thermal damage. Additional impact damage was observed to the intake port on the No. 1 cylinder.

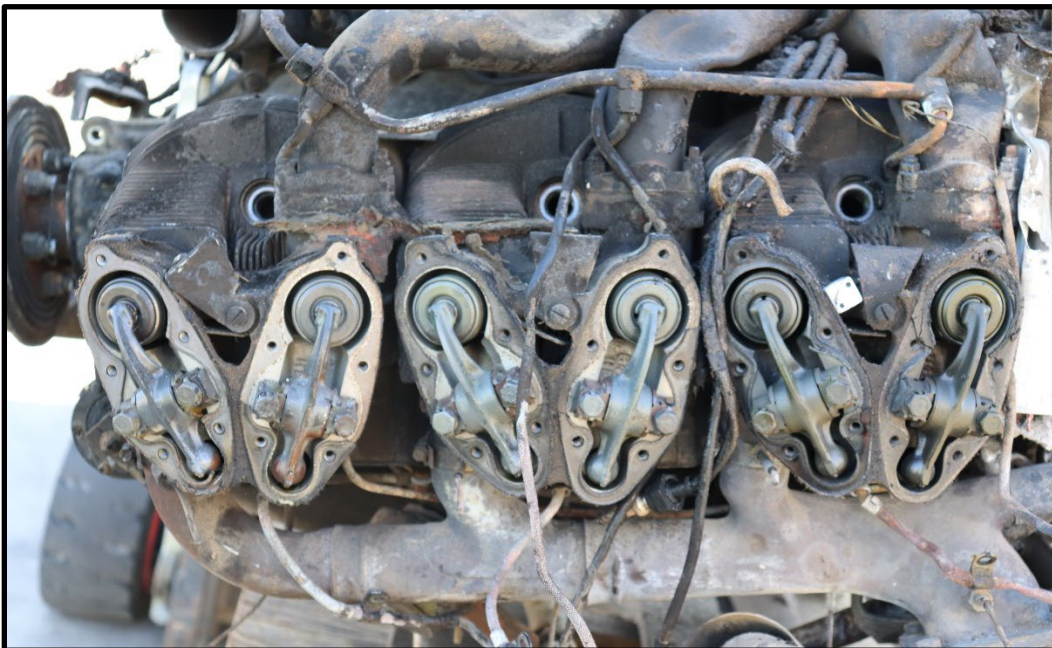
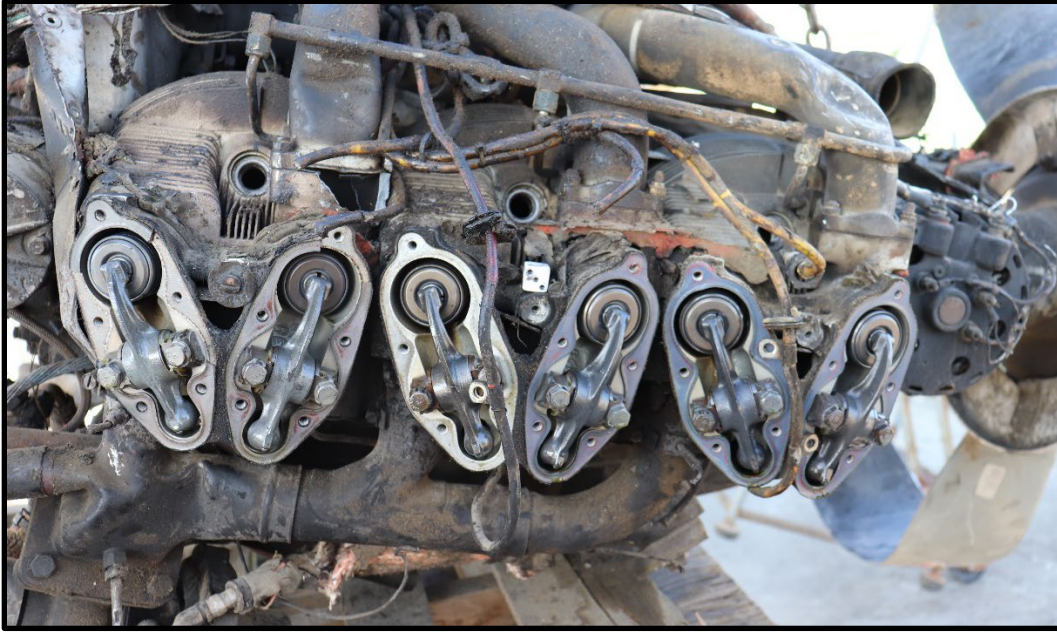
The rocker box covers were removed. All intake and exhaust rocker arms were intact, and oil coated. All intake and exhaust valve springs were in place and visually appeared to be undamaged. The upper spark plugs were removed, and all six cylinders were examined internally using a lighted borescope. A normal amount of combustion deposits was observed within the combustion dome of each cylinder and piston face. All the intake and exhaust valves were unremarkable. The crankshaft was rotated by hand using the propeller. Rotational continuity was established throughout the engine and valve train. Thumb compression and suction were obtained on all four cylinders.

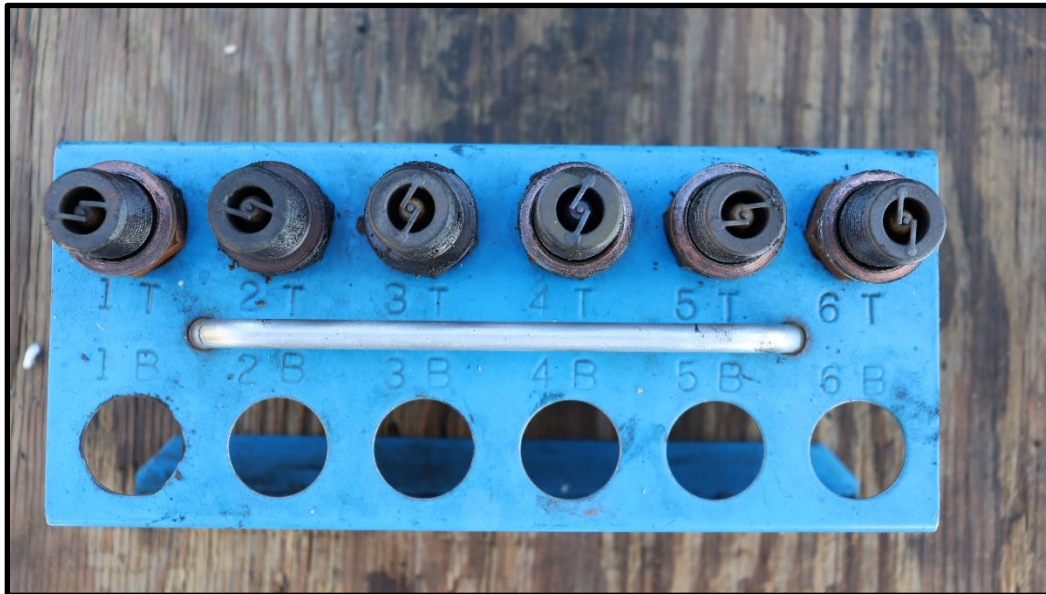
The top spark plugs were removed from the engine, and they were the fine-wire type. When compared to the Champion Check-A-Plug chart, the sparkplugs were light grey in color and exhibited "NORMAL".

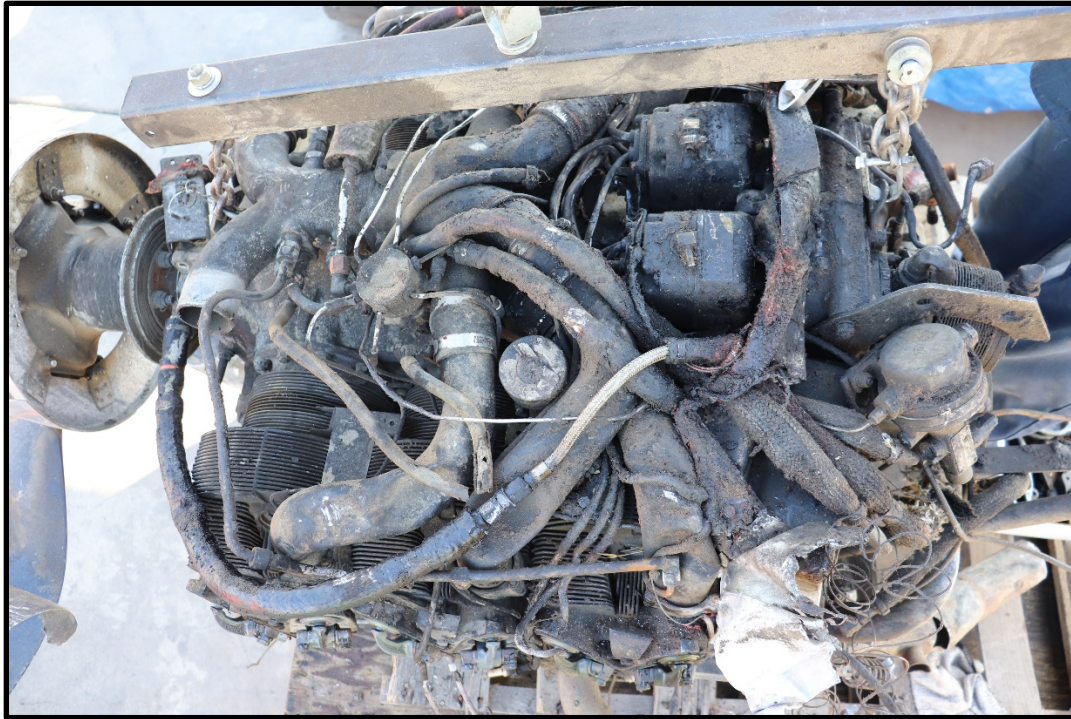
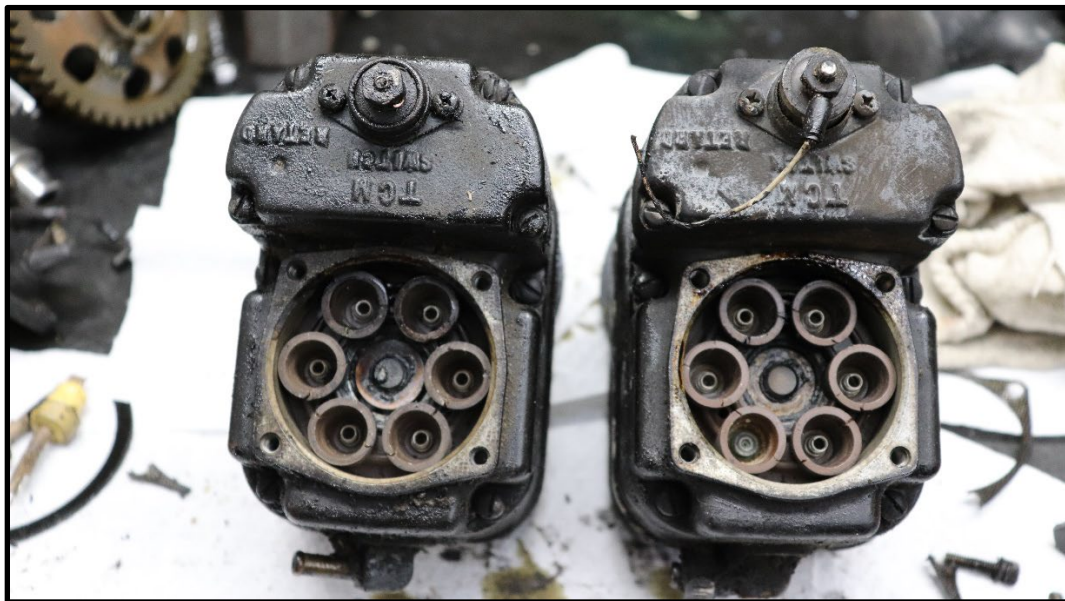
The left and right magnetos remained attached to the engine accessory case with no external damage noted. Both magnetos were removed and disassembled. Impact damage was observed to both magneto distributor blocks, which prevented functional testing.

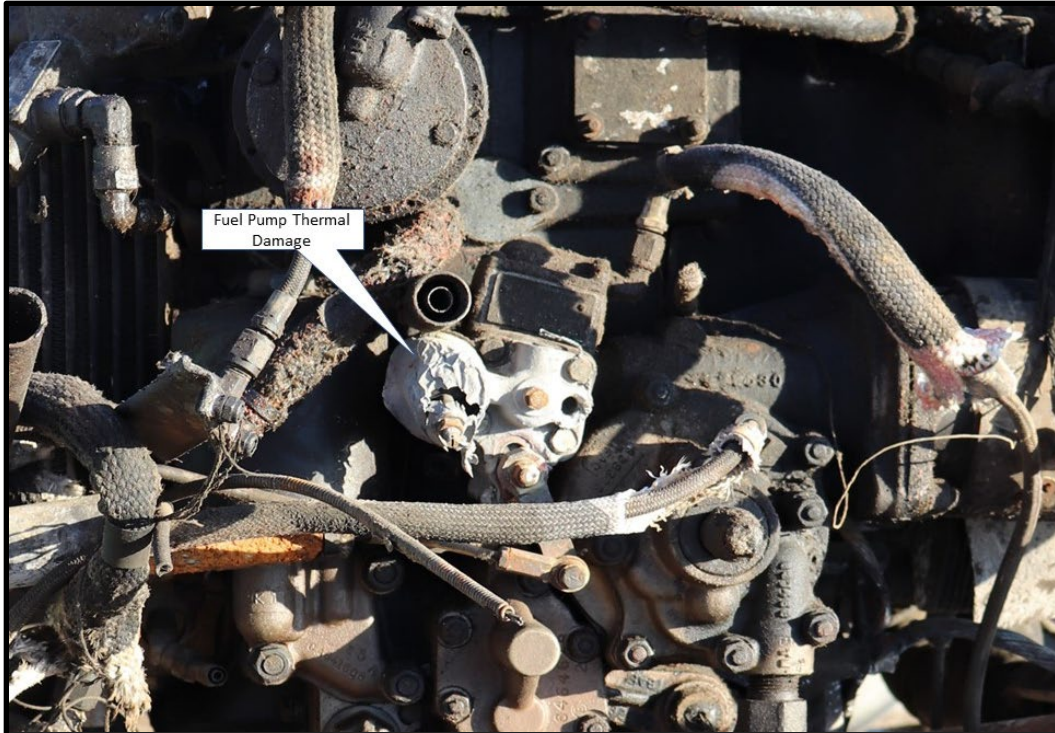
The engine driven fuel pump remained attached to the engine accessories case. Thermal damage was observed to the fuel pump, which prevented functional testing.

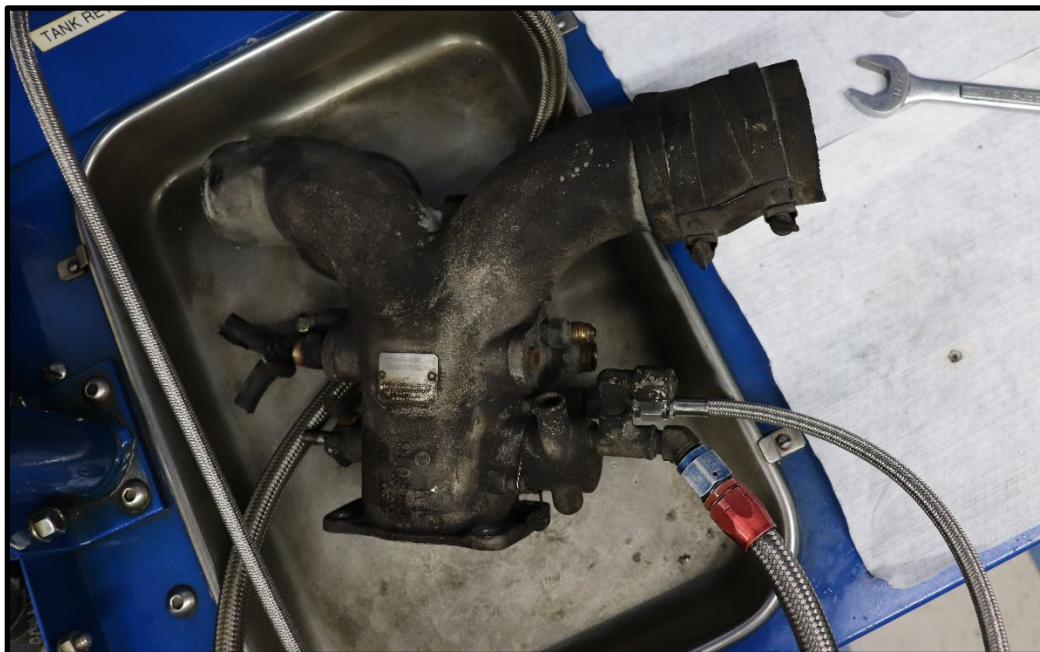
The throttle body was intact and undamaged. The throttle body was removed, connected to a test stand, and performed within manufactures specifications when tested.

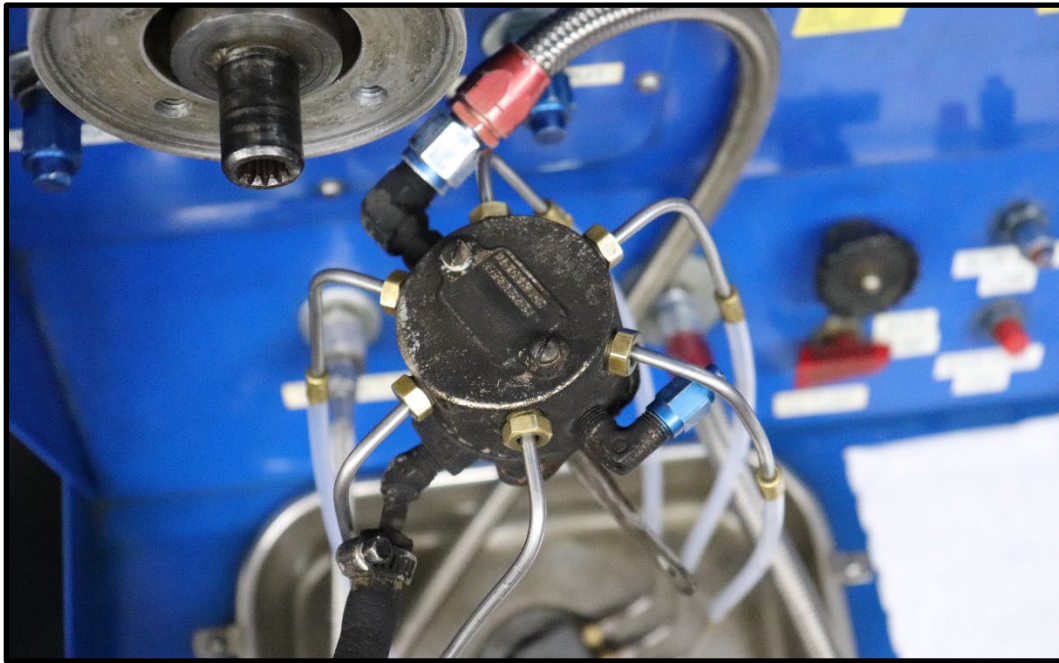
The fuel flow divider was intact and undamaged. The fuel flow divider was removed, connected to a test stand, and performed within manufactures specifications when tested.

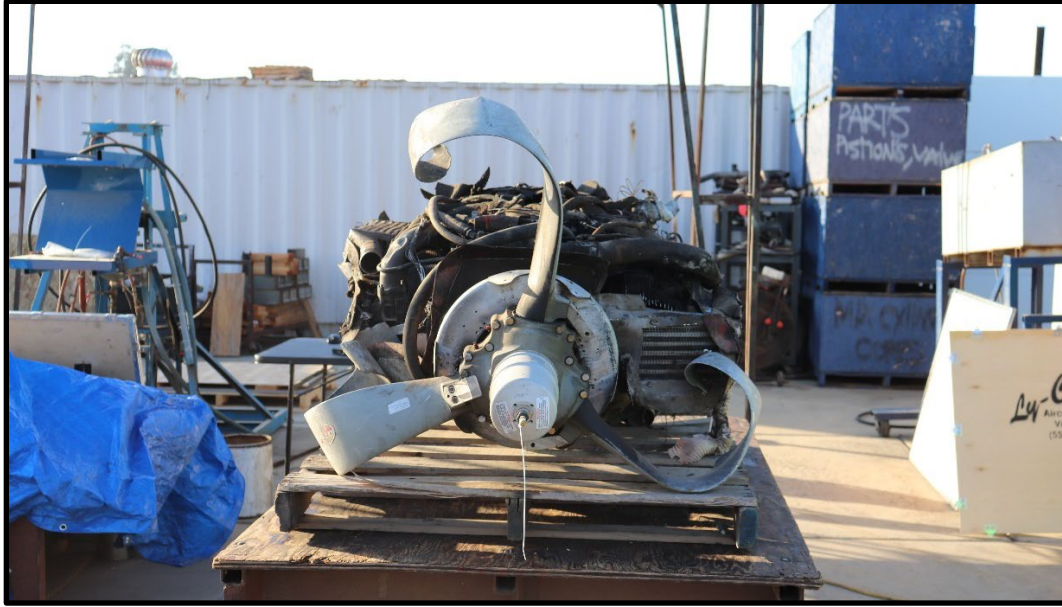
The engine was equipped with a three blade, constant speed propeller. All three propeller blades remained attached to the propeller hub, with S-bending present about mid span on all three propeller blades. The blades exhibited various striations on the cambered side of the blades.
