# **WPR21LA299**

## **Hartzell Propeller Exam Report**

NTSB File No. WPR21LA299

Aircraft: Schweizer/Grumman G-164B Ag Cat with Honeywell TPE331-6 conversion

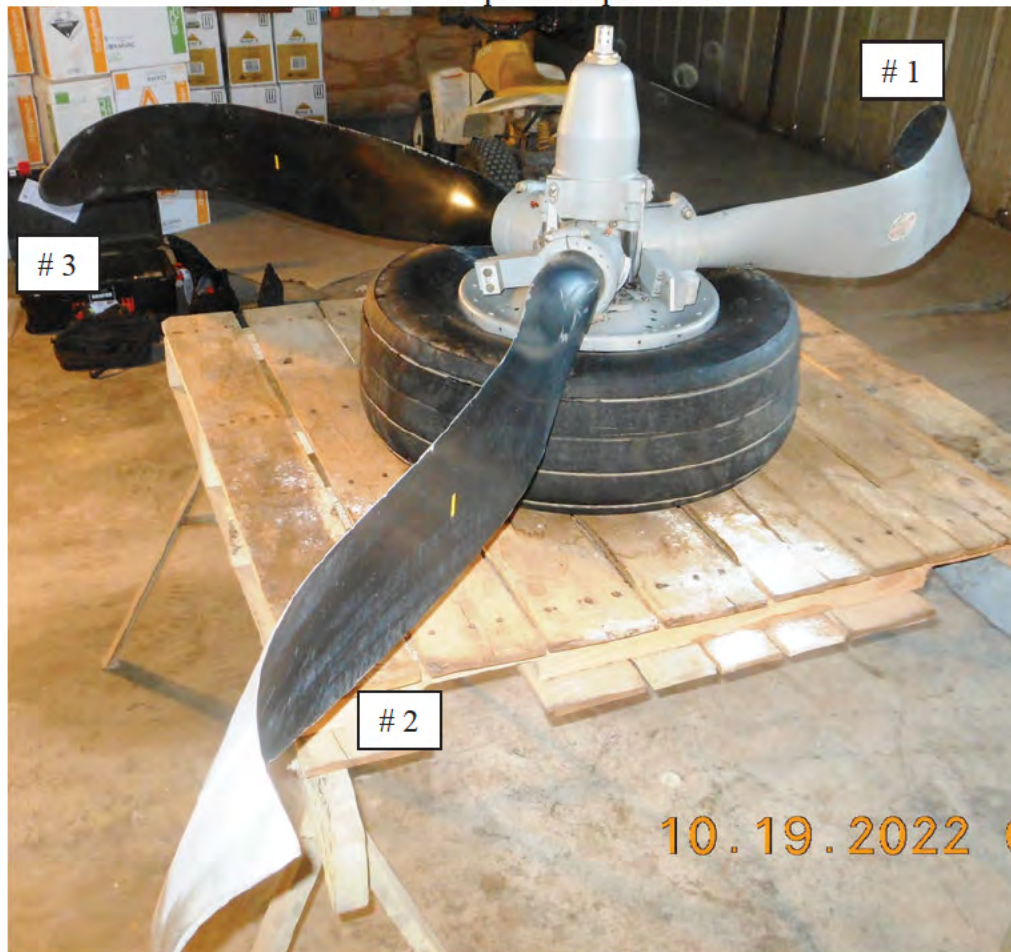
The propeller was presented for examination as shown in Photo #1. The propeller was removed from the engine propeller shaft flange prior to this examination. The spinner dome and beta tube were not presented for examination. The propeller presented in the feathered position. There were no indications the blades had slipped in the clamps (Photo #2). All three blades exhibited varying degrees of chordwise/rotational scoring. Blade #2 had approximately 3" of the tip fracture-separated; the fragment was not recovered or not presented for examination. Blade #2 also exhibited some S-bend characteristics and all three blades were bent aft at the tip. Blades #1 and #3 exhibited some bending opposite rotation and twisting towards low pitch. The #1 link screw/link arm forcefully contacted the piston guide collar and left a dent/gouge. All three start lock bracket assemblies were fractured and the start lock plates had signatures of forceful impact with the start lock pin (Photo #3)

Photo #1 –Propeller as-presented

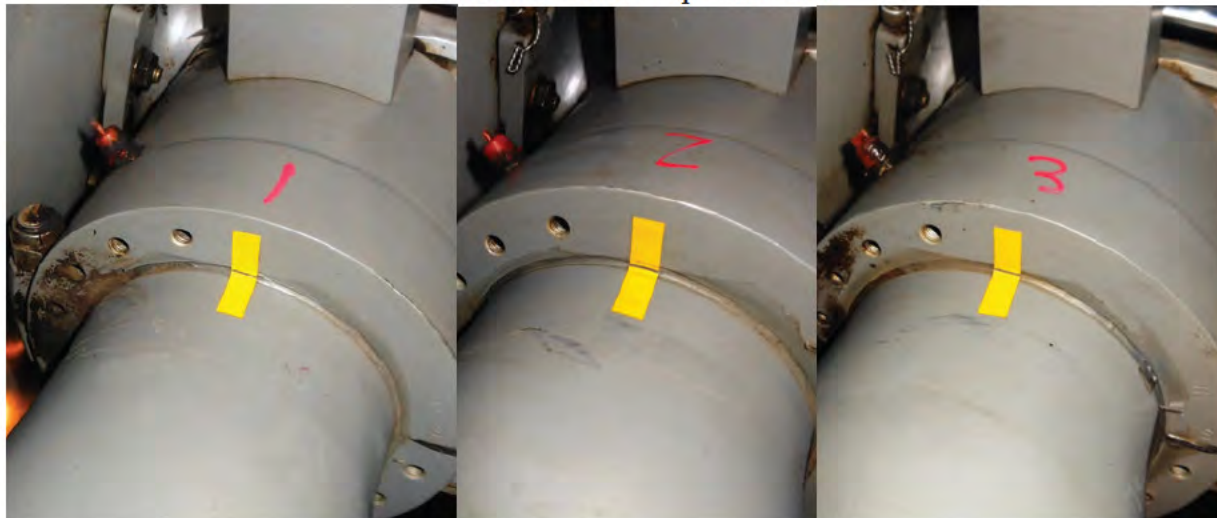
Photo #2 - Blade slip indicators

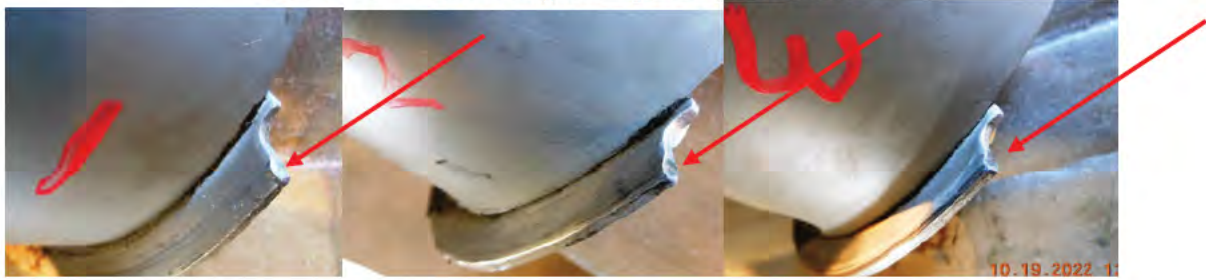
Photo #3 – Start lock plate - pin impact marks

Damage to the start lock brackets, start lock plates and a contact mark on the internal surface of the piston suggested the propeller was on or below the start lock angle at impact.

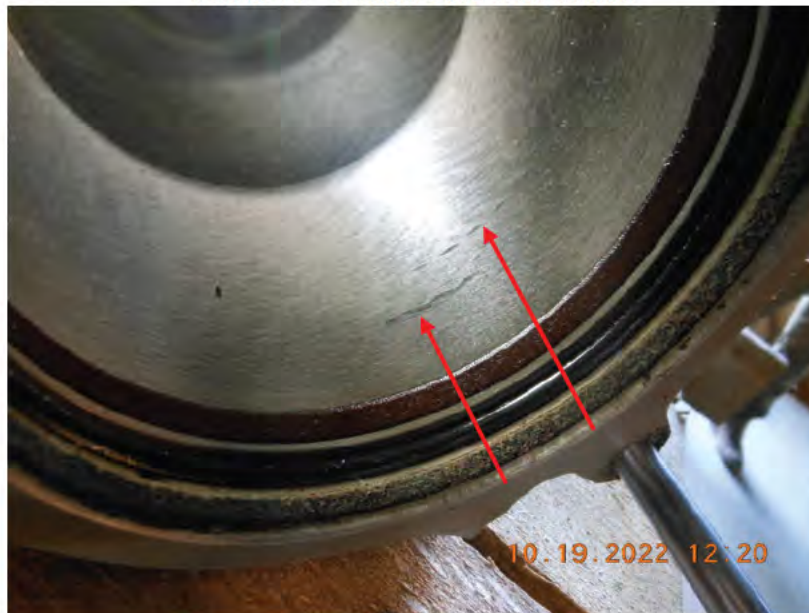
There were two marks on the internal surface of the piston (Photo #4) that may suggest a blade angle at impact. There was a distinctive scuff mark on the cylinder wall approximately 1.85-1.9" from the top corner (Photo #6). These marks translated to a blade angle with corresponding confidence levels are summarized below in Table #1. For reference, at 110 KTAS (127 mph), 15.6° at 2000 RPM, SL/ISA this propeller model is absorbing approximately 47 Hp, at 40 KTAS it is absorbing 300 Hp.

| Internal Marks from Bottom Piston Edge | Approximate Equivalent Blade Angle | Pre-impact Confidence Level / Why? |
|---|---|---|
| 1.85" | $\sim -1^\circ$ | High to Medium – Near start lock angle of $2.0^\circ$ |
| 2.35" | $\sim +15.6^\circ$ | Low – Mark does not appear to be from cylinder corner, blade angle at low impact speeds is not consistent with pilot's "power loss" statement. |

Photo #4 – Piston bore with marks

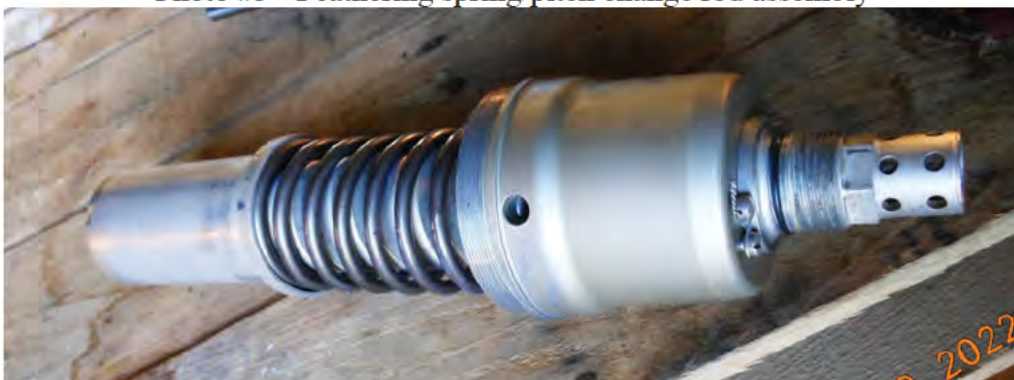
The piston was removed without difficulty and the piston guide rods were slightly but visually bent in the direction of rotation. The feathering spring assembly was removed without difficulty, was intact and loaded with the forward and aft spring retainers in-place (Photo #5).

Photo #5 - Feathering spring/pitch change rod assembly

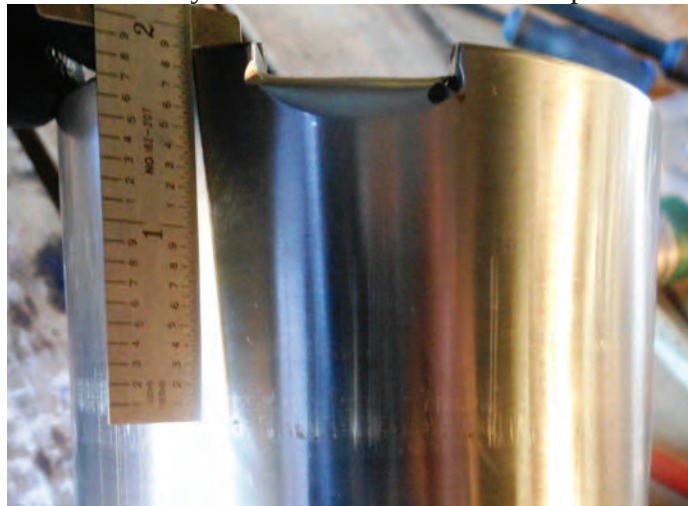
| Internal Marks from Bottom Piston Edge | Approximate Equivalent Blade Angle | Pre-impact Confidence Level / Why? |
|---|---|---|
| Cylinder circumferential from top at 1.9" (Photo #6) | $\sim -1$ to $+0.7^\circ$ | High to Medium – matches piston marks and consistent with blade damage and near start lock angle |

Photo #6 - Cylinder mark at ~1.9 below top corner

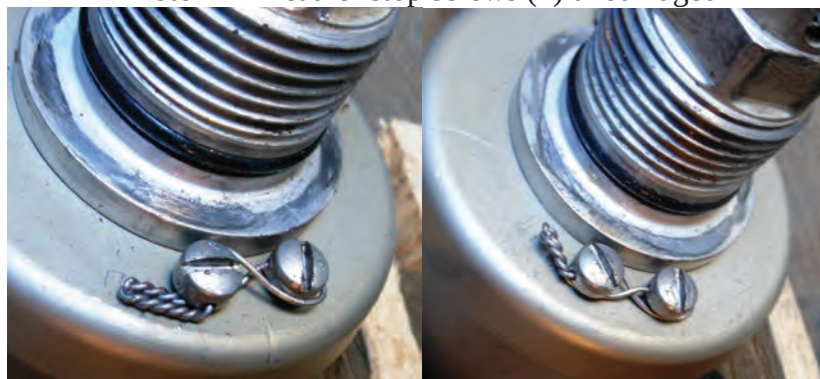
The internal ceiling of the piston and the feather stop screws (Photo #7) were not damaged indicating the propeller was not feathered at impact.

Photo #7 – Feather stop screws (4) undamaged

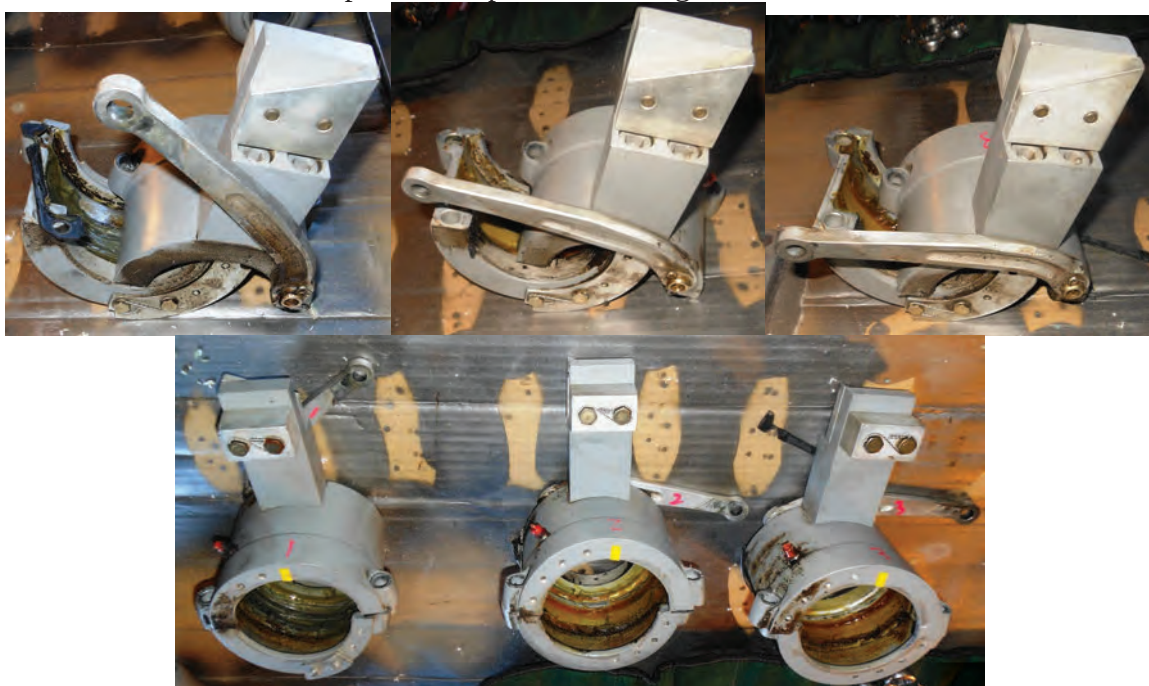
All three clamps and counterweights appeared intact and undamaged (Photo #8).

Photo #8 – Propeller clamps, counterweights and link screws/arms

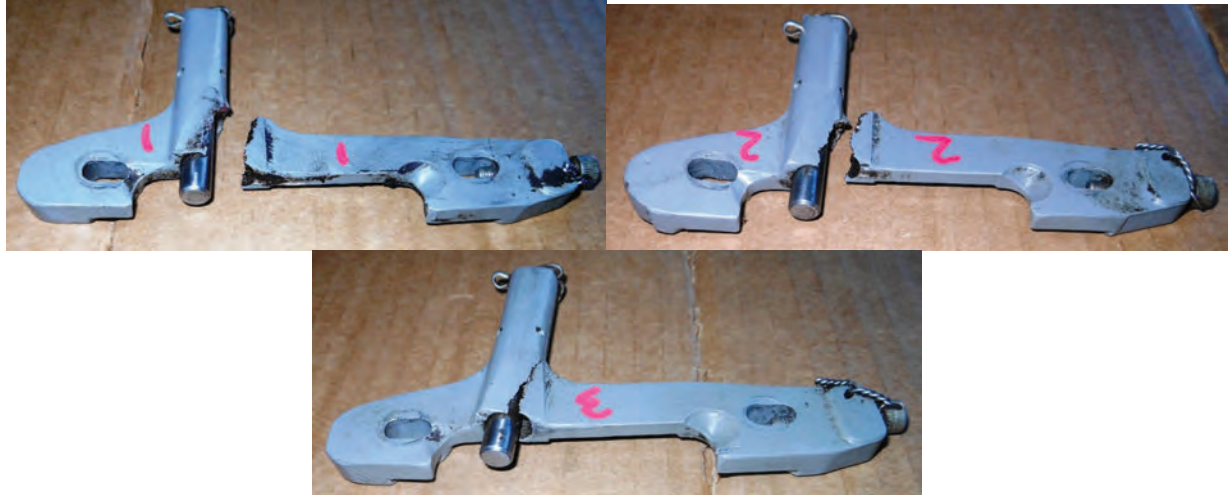
All three start lock brackets were fractured (Photo #9). Based on a photo provided by the Honeywell ASI, the propeller was shown on the start locks after recovery and before the propeller was removed (Photo #10). A counterweight puncture in the spinner dome is consistent with a low blade angle when the spinner impacted terrain (Photo #10). In subsequent Honeywell photos the start lock brackets appeared fractured with the start lock plate loaded against the pin before propeller removal (Photo #11); those fractures occurred either during the impact sequence or aircraft recovery. Signatures on the start lock bracket indicated forceful contact in the high pitch direction.

Photo #9 - Start lock brackets and plungers

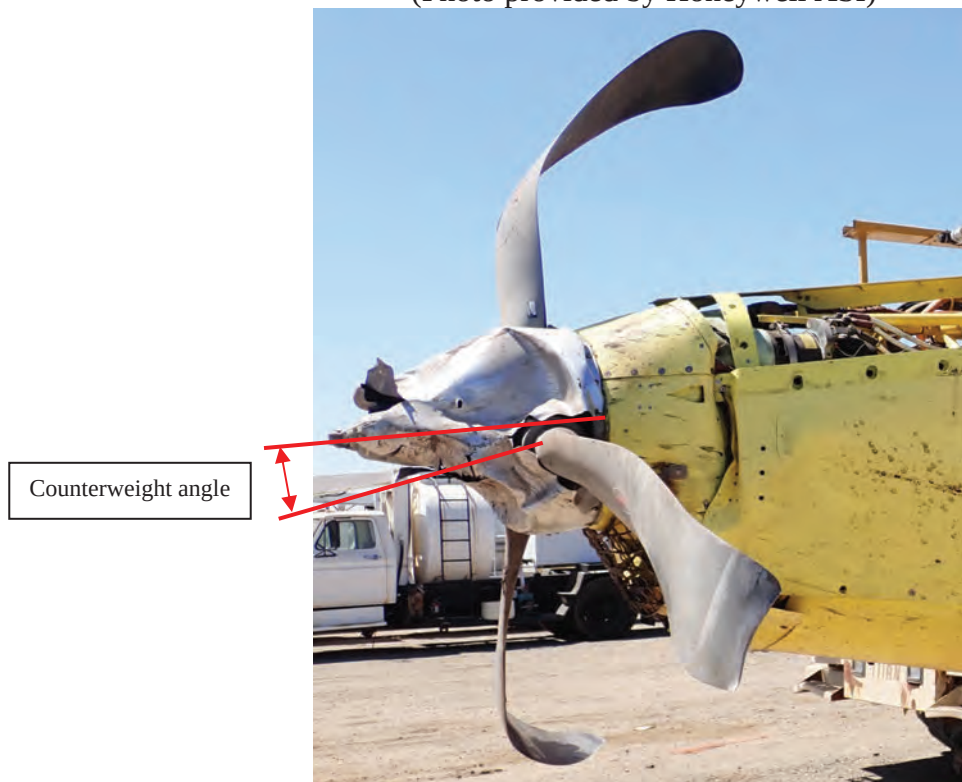
Photo #10 - Propeller on start locks after recover and before removal  
(Photo provided by Honeywell ASI)

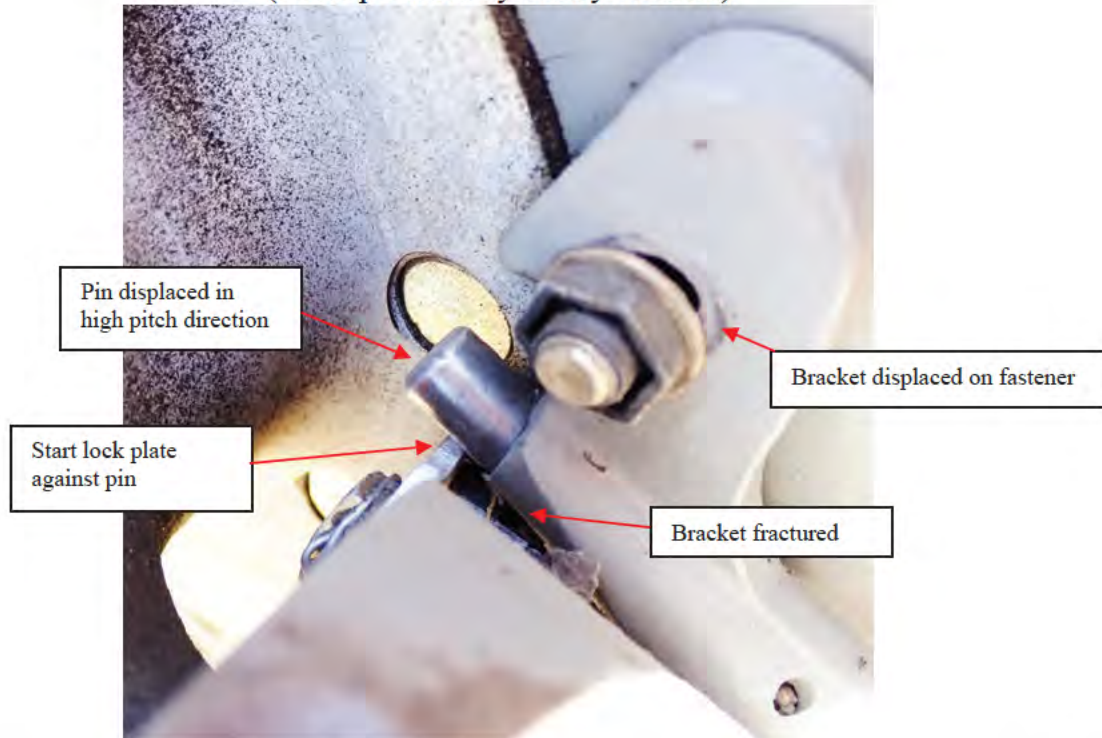
Photo #11 - Start lock bracket before propeller removal  
(Photo provided by Honeywell ASI)

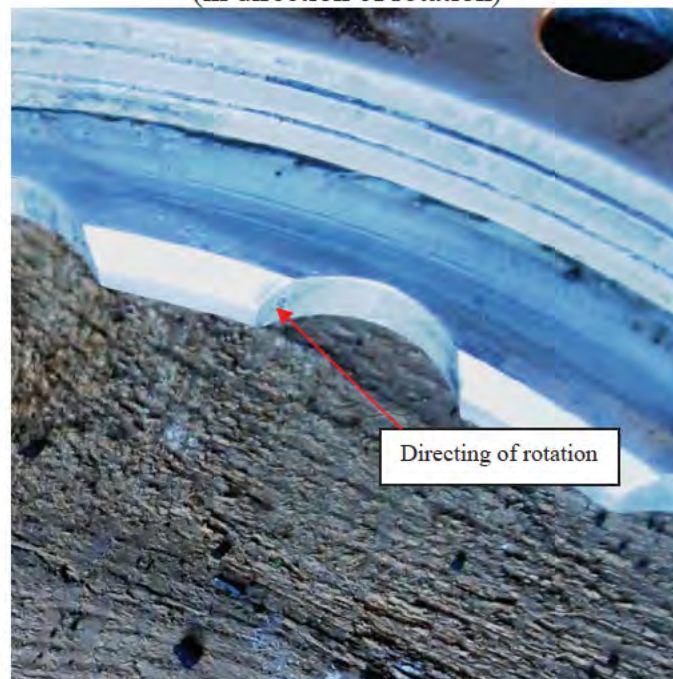
All three pilot tubes and bearing assemblies were intact. There were no remarkable hub-to-butt impact crescent marks, only indentations around the pilot tube/bearing bore on each blade butt. The spinner mounting plate had one indication the propeller shaft flange drive dowel made forceful contact in the direction of rotation (Photo #12). A dowel pin hole on the propeller hub had a corresponding contact mark (Photo #13) in the direction of rotation.

Photo #12 - Mounting dowel pin impact mark on spinner bulkhead mounting plate  
(in direction of rotation)

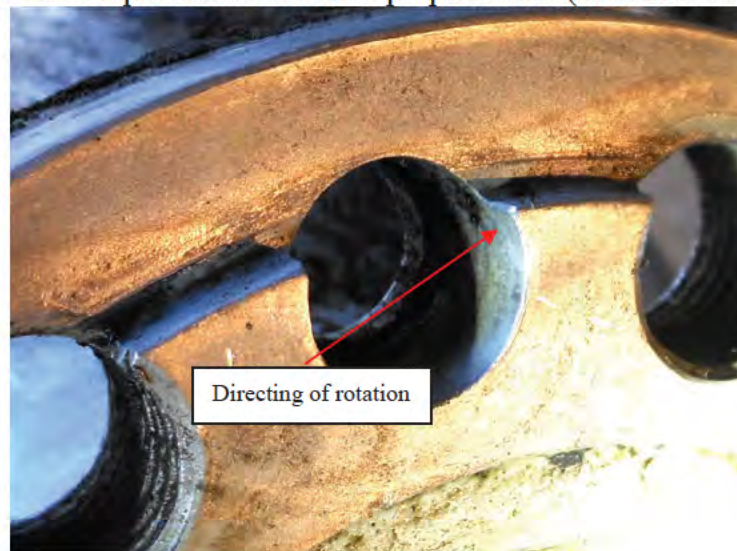
Photo #13 - Down pin contact mark on propeller hub (in direction of rotation)

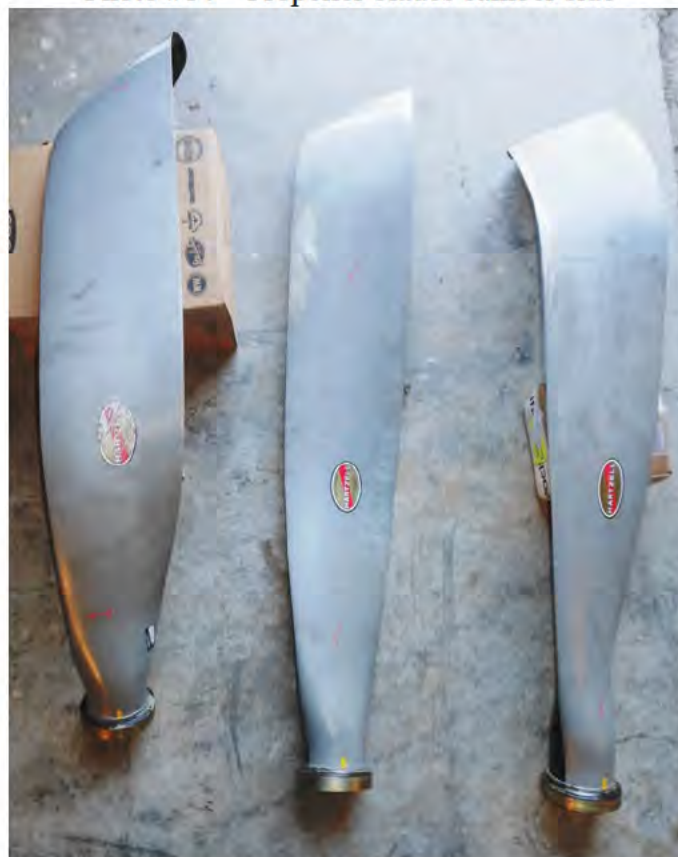
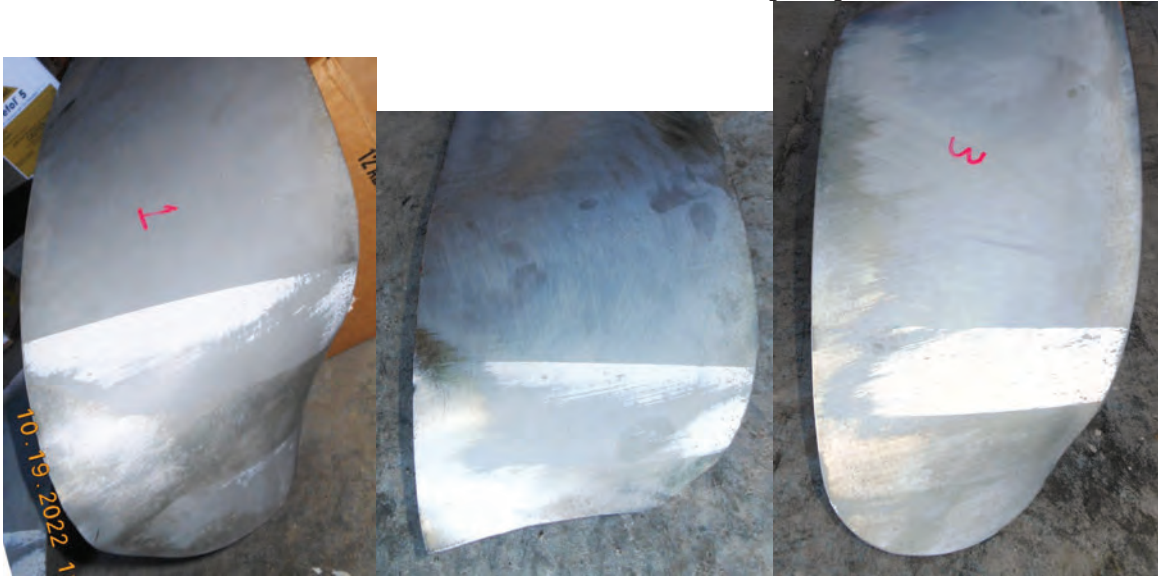
All three blades had chordwise/rotational scoring on the camber-side, primarily near the tip stripe area (Photos #14 and #15). Blade #2 had approximately 3" of the tip fracture-separated; the fragment was not recovered or not presented for examination. Blade #2 also exhibited some S-bend characteristics and all three blades were bent aft at the tip. Blades #1 and #3 exhibited some bending opposite rotation and twisting towards low pitch. Blade #1 had small, buckling wave-type bends near the tip. None of the blades had remarkable face-side rotational scoring, only some localized scuffing/abrasion (Photo #16). The blades when laid in sequence of rotation 2-3-1 exhibited progressive bending and twisting (Photo #17 and #18).

Photo #14 – Propeller blades camber side

Photo #15 - Blade camber side near tip stripes

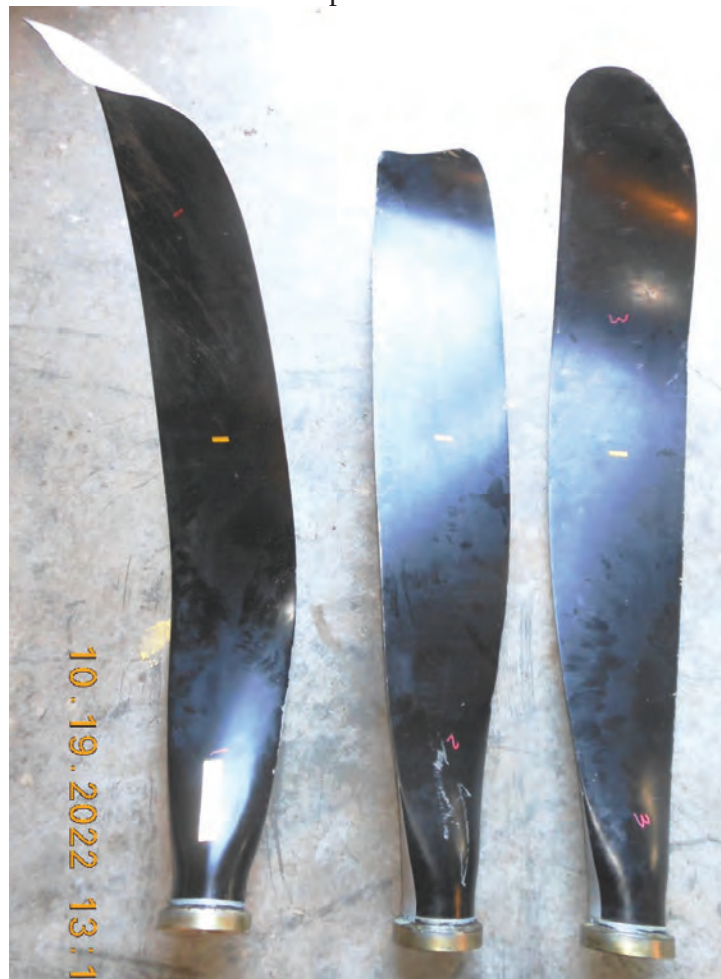
Photo #16 - Propeller blades face side

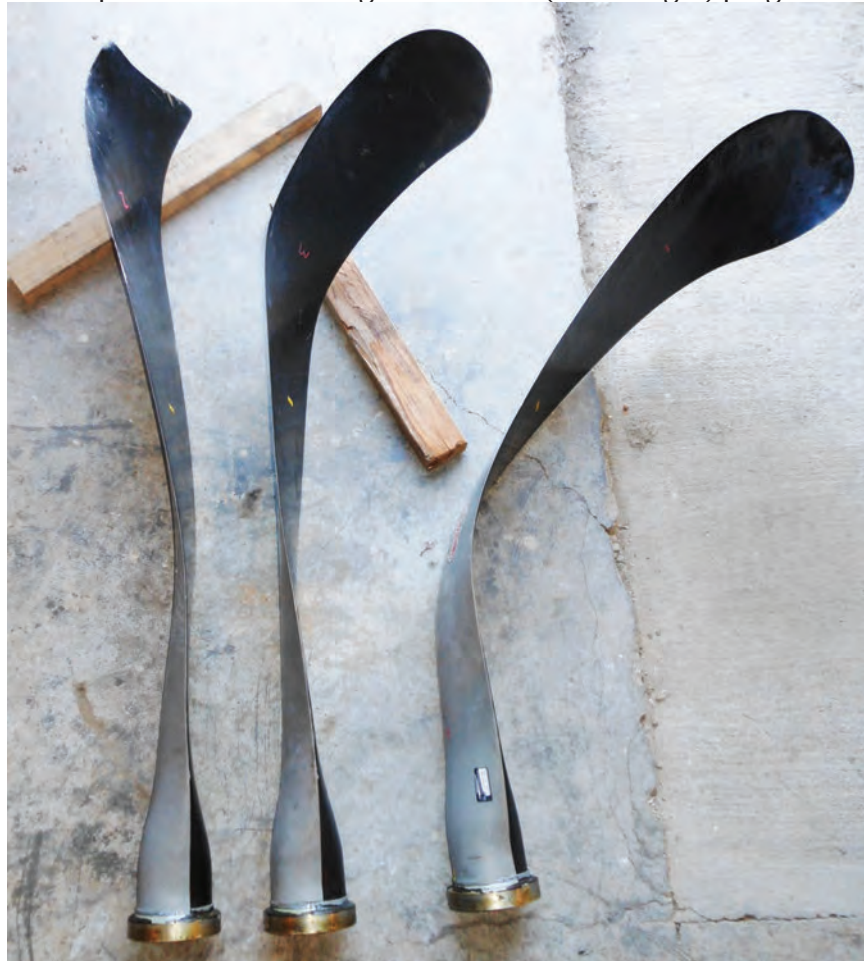
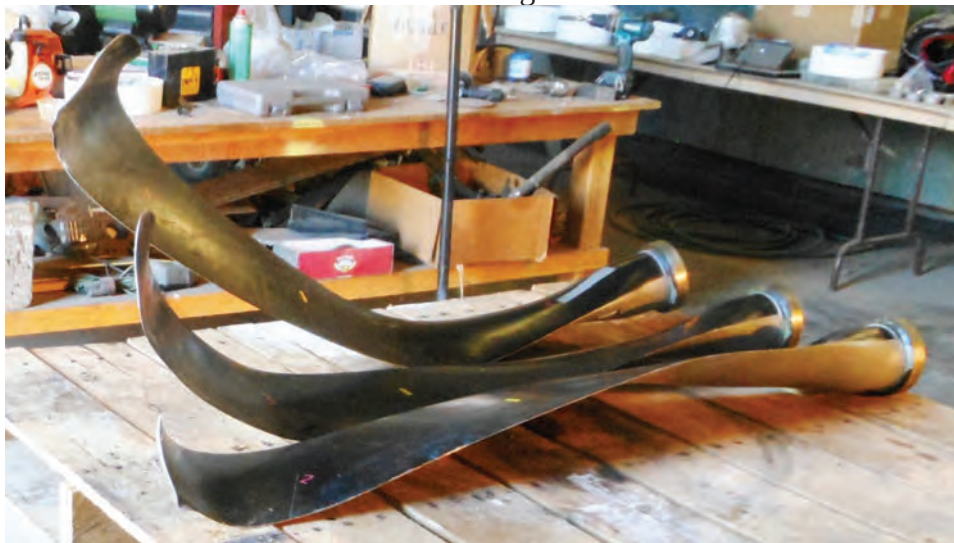
Photo #17 - Propeller blades trail edge view 2-3-1 (left-to-right) progressive bending

Photo #18 - Propeller blades trail edge view 2-3-1 (foreground to background) progressive bending

1. Compound bending aft/opposite rotation and twisting on blades #1 and #3.
2. Chordwise/rotational scoring primarily on the camber side.
3. No slip of the blades in the clamps and no remarkable link arm/pin/screw damage.
4. All three pilot tubes were intact and minimal blade-to-hub contact marks.
5. Blade #2 tip fracture indicating rotation at relatively high RPM.
6. Some deformation of one drive dowel hole in the direction of rotation.
