# NATIONAL TRANSPORTATION SAFETY BOARD

## MATERIALS LABORATORY FACTUAL REPORT

Report No. 22-034

Place : Amado, Arizona  
Date : August 2, 2021  
Vehicle : Piper PA-28-140, N44245  
NTSB No. : WPR21LA301  
Investigator : Andrew Swick, AS-WPR

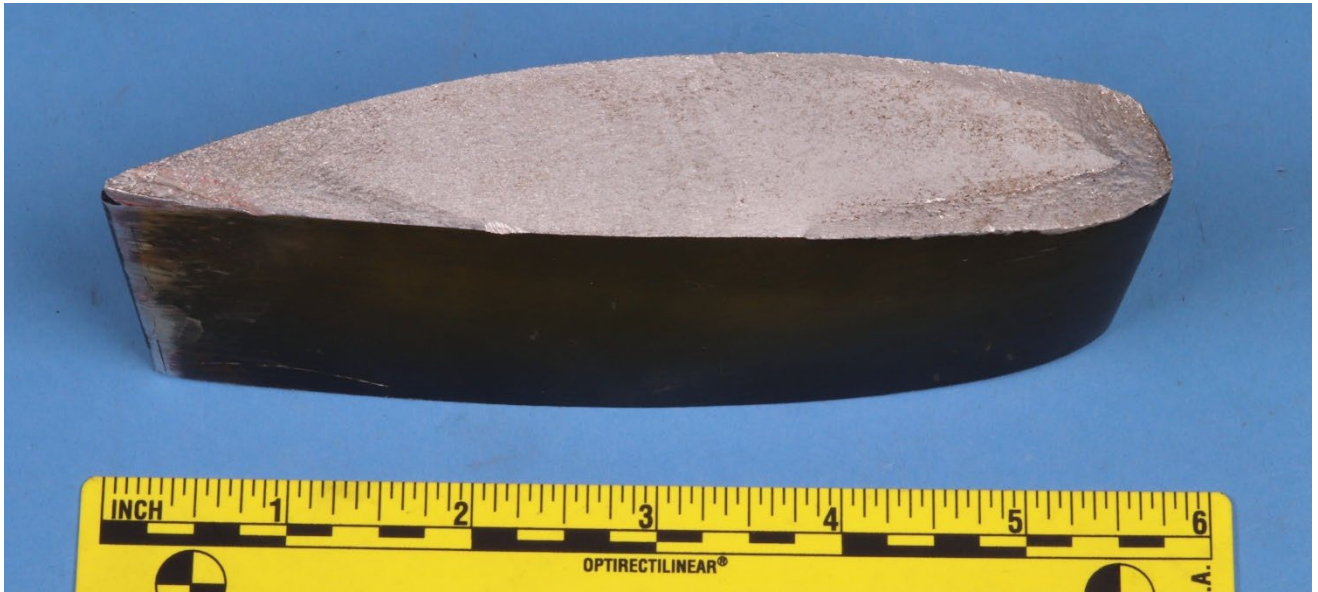
Figure 1 shows the propeller blade remnant, as received. The blade had fractured perpendicular to the longitudinal direction, with the remnant having been sectioned about 2.5 inches from the fracture surface (see Figure 2). Overall, the fracture surface of the blade remnant was generally flat in orientation, but closer to the leading edge was more tortuous with elevated features.

Figure 1 – Angled view of the propeller blade remnant, showing the fracture surface, as received.

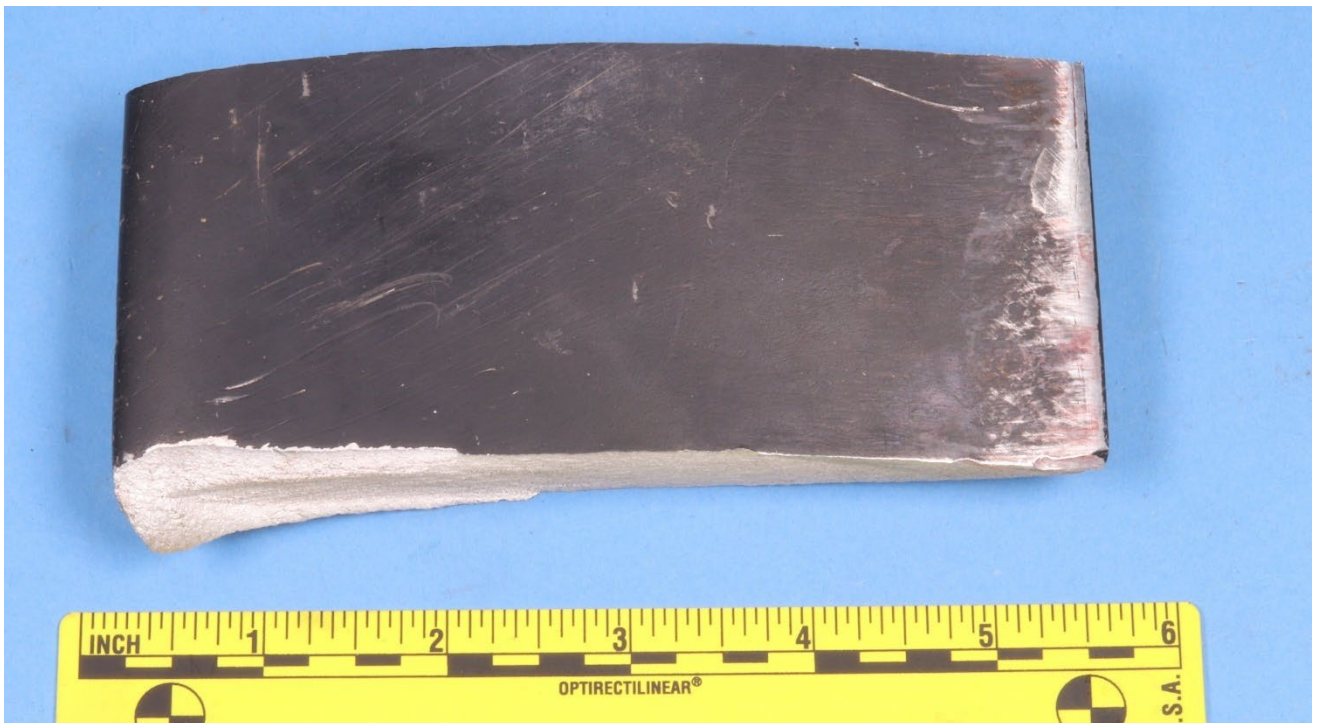
Figure 2 shows a view of the blade from the flatter face surface. This view showed a lack of paint along the trailing edge surface, which revealed the underlying metallic substrate material. This absence of paint was consistent along the face side trailing edge but was also accompanied by indications of a red paint transfer.

Figure 2 – View of the blade face surface of the propeller blade remnant, showing lack of paint and impact marks on the trailing edge (right in the figure).

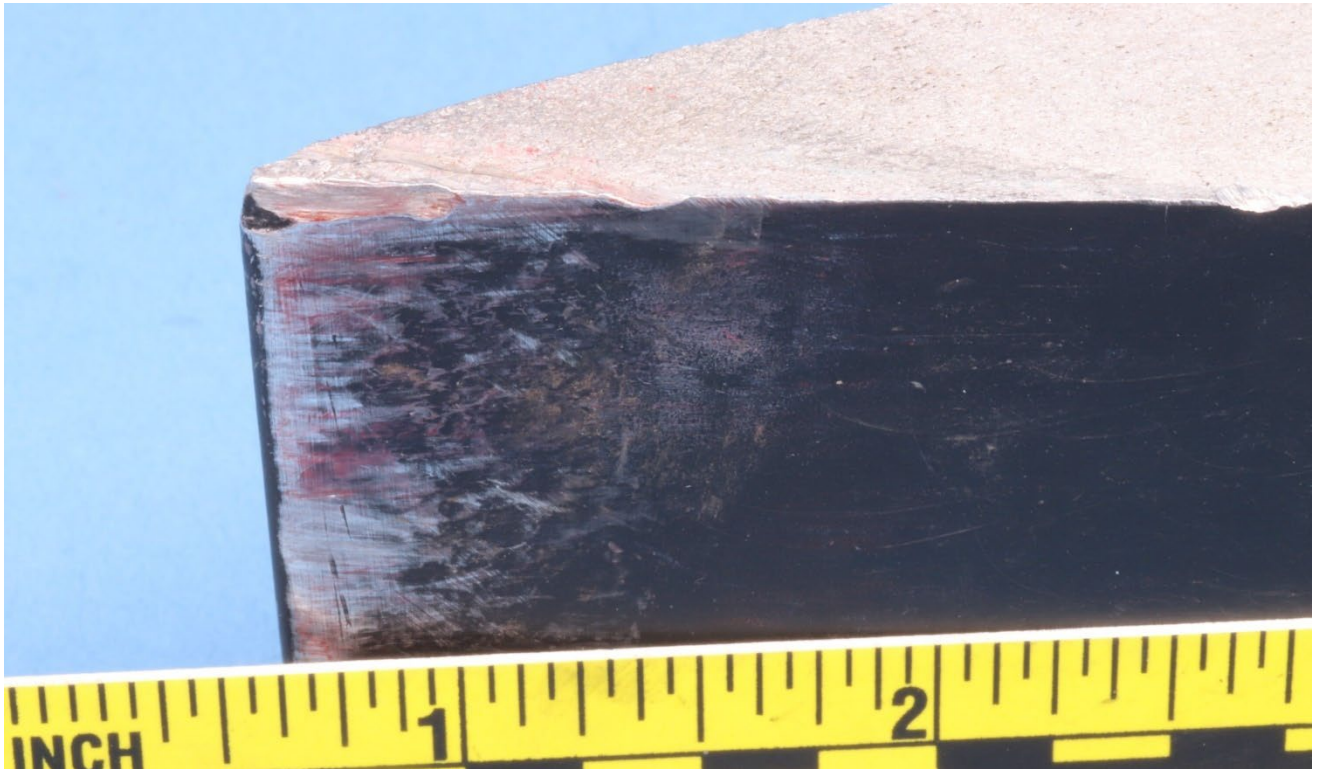
Figures 3 and 4 show closer views of the trailing edge of the fractured blade remnant. This area showed indications of impact marks, along with linear smearing marks.

Figure 3 – Closer view of the remnant trailing edge, showing smearing and impact marks.

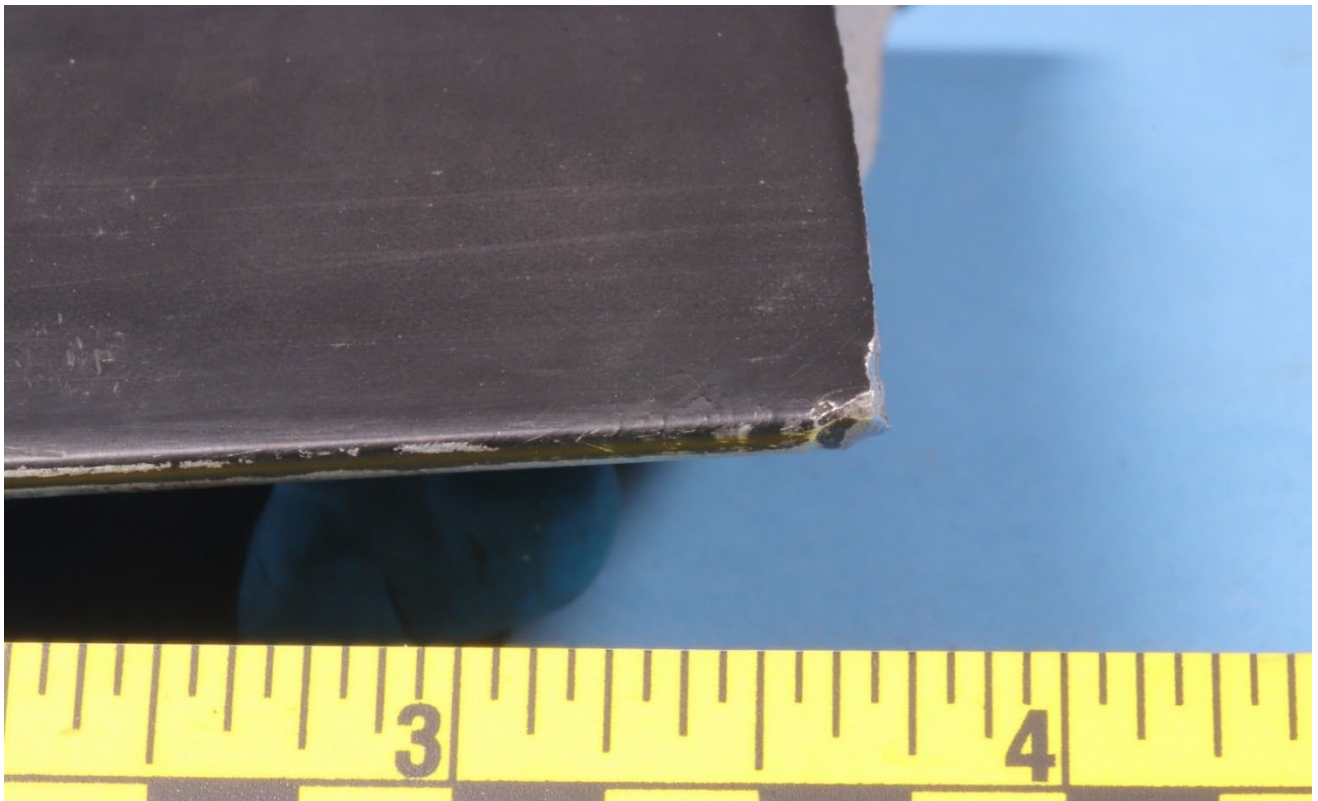
These witness marks were present on the fracture surface near the trailing edge tip, as well as along the edge with the blade face. There was still paint present up to the fractured edges along the back side of the blade, shown in Figure 4.

Figure 4 – View of the trailing edge of the fractured propeller blade, viewed from the blade back opposite the face surface that in Figure 3.

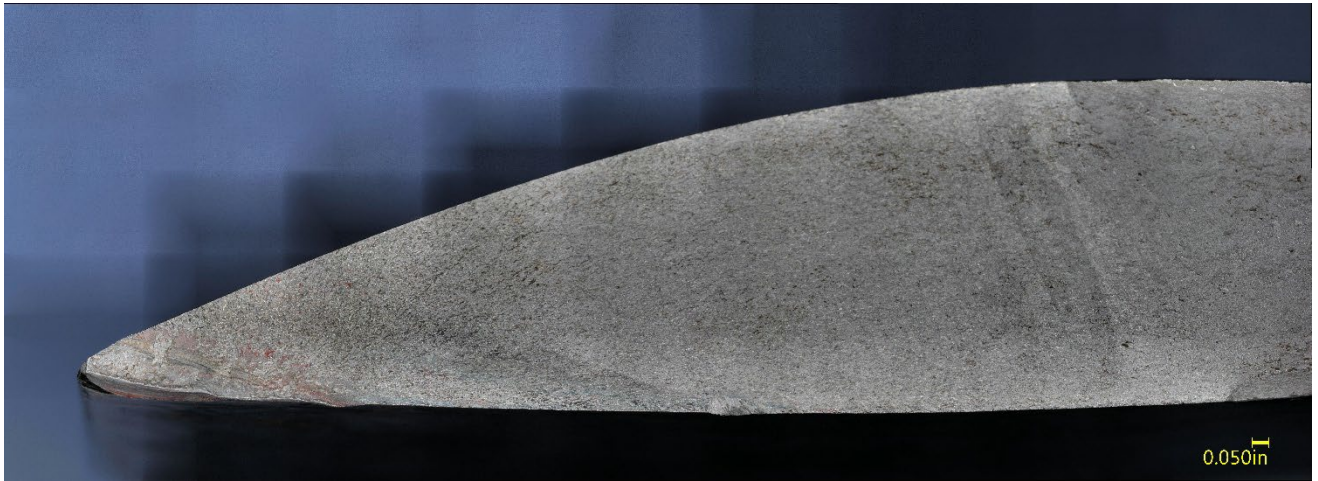
Figure 5 shows a montage view of the blade fracture surface. The left two-thirds of the fracture surface was relatively flat and exhibited a reflective luster. This area of surface exhibited convex crack arrest marks, consistent with progressive fracture modes. The arrest marks bowed away from the trailing edge tip, indicating the crack originated from that location. Outside of the progressive fracture, towards the right in Figure 5, the fracture surface was rougher and more elevated, exhibiting a dull luster. The length of the progressive crack region was 3.5 inches along the blade face, and 3.1 inches on the blade back from the trailing edge.

Figure 5 – Montage view of the propeller blade remnant fracture surface.

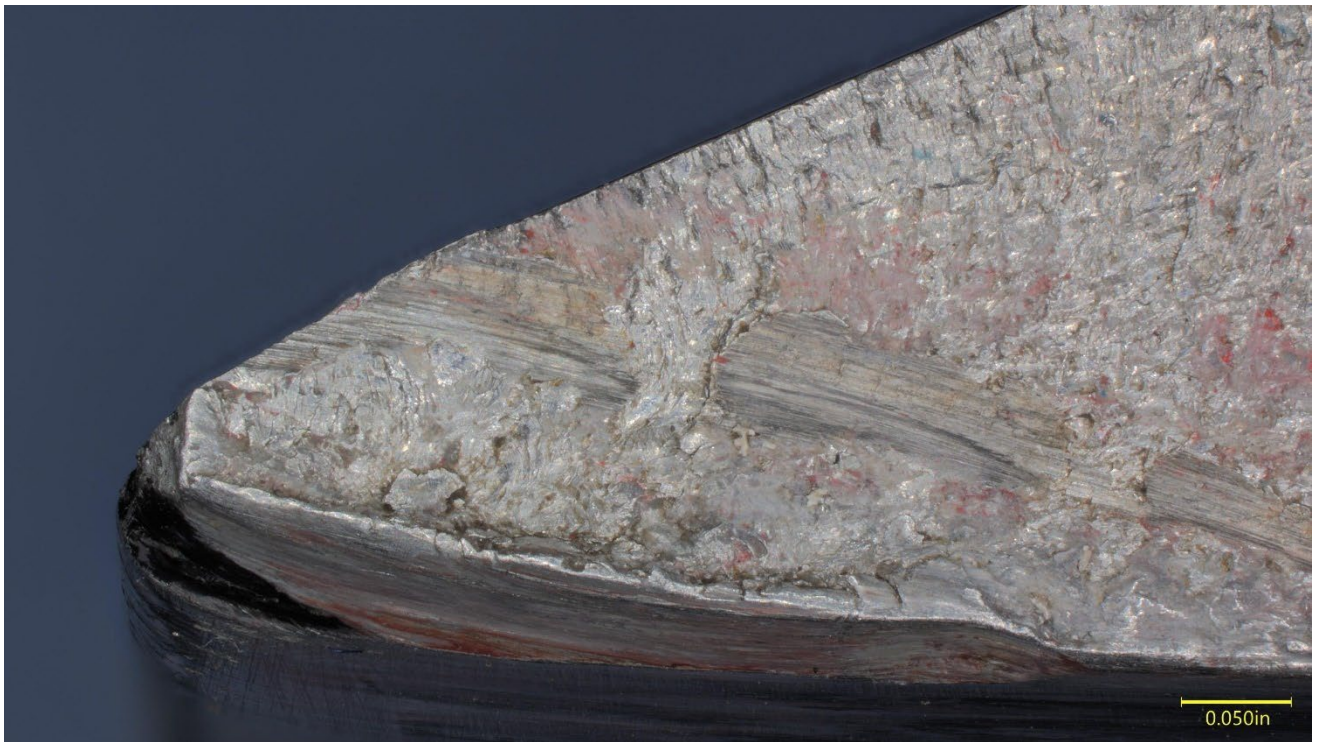
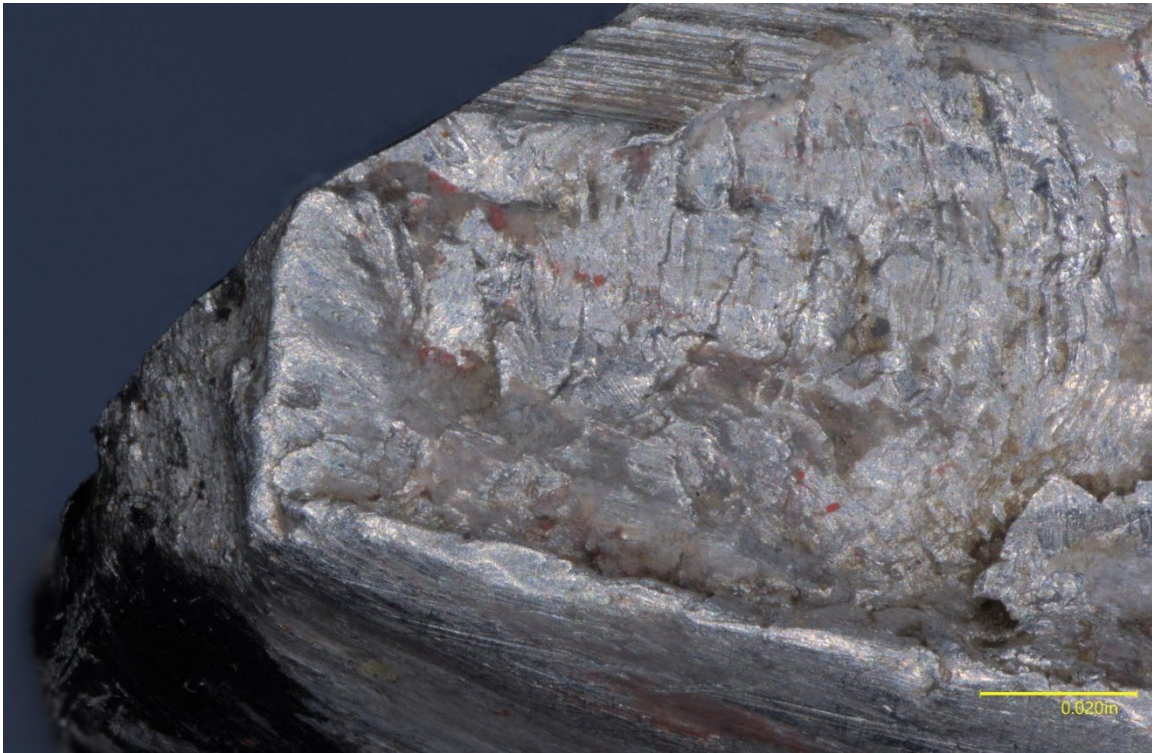
Figure 6 shows a closer view of the trailing edge of the fracture surface, with Figure 7 illustrating a higher magnification view. There was a discontinuous streak near the tip, consistent with post-fracture smearing of the surface. The edge of the fracture surface with the face exhibited a protruding lip, which folded upward slightly in the figure. Figure 7 also shows a small amount of missing or inwardly deformed material at the tip location. In addition, vertically-oriented features were observed radiating upward in the figure, from the face edge lip. These features were consistent with ratchet marks and river patterns, consistent with fracture propagation from the face surface near the trailing edge tip.

Figure 6 – Closer view of the trailing end of the propeller.

Figure 7 – Closer view of the trailing edge of the propeller in Figure 6.

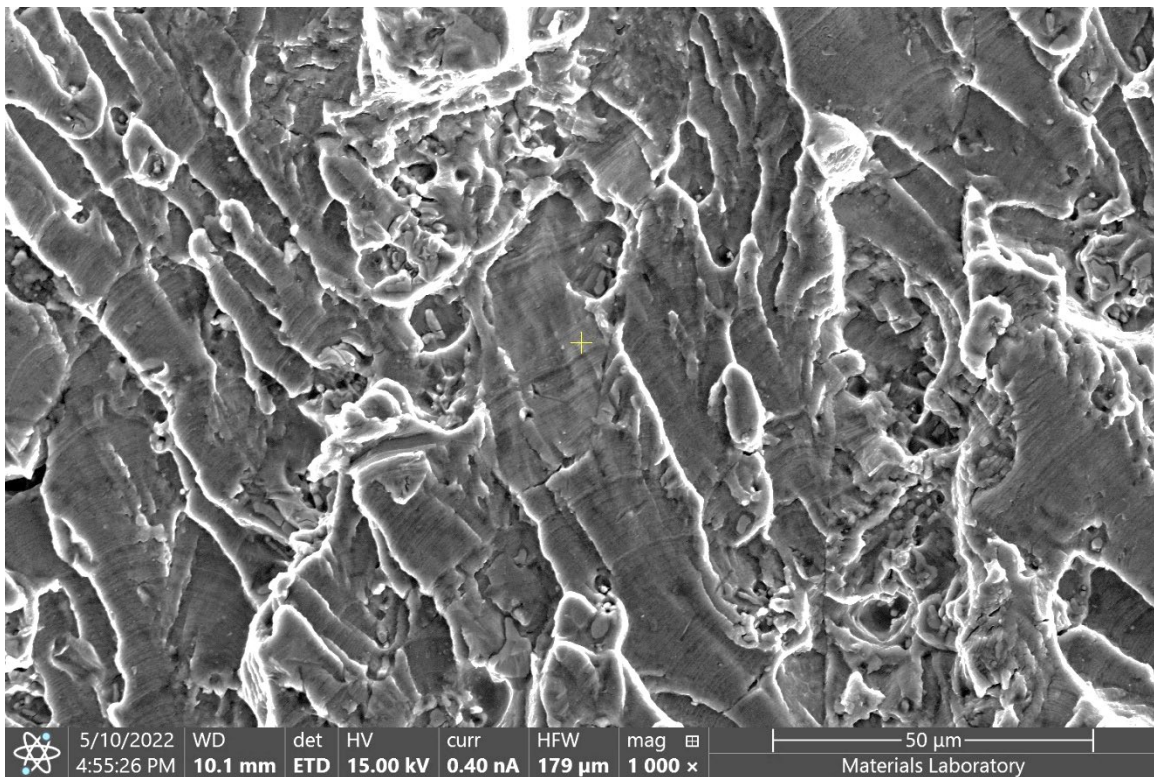
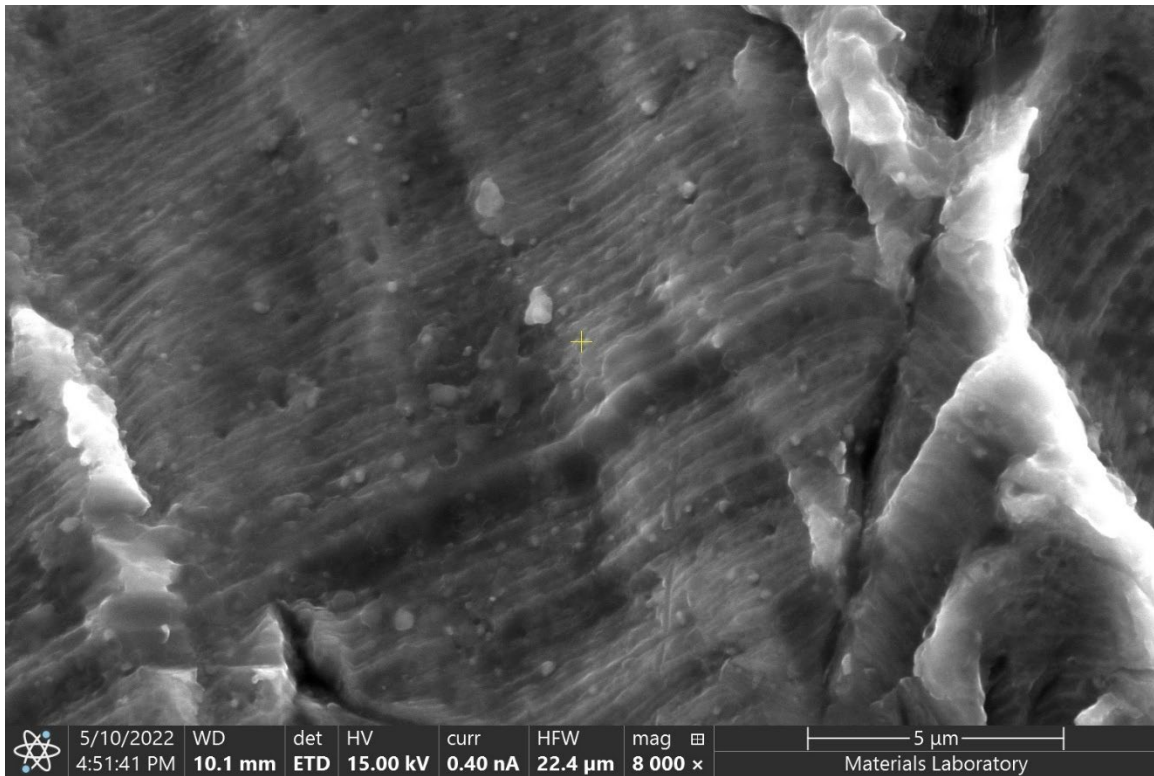
The blade remnant was sectioned near the fracture and cleaned with acetone in an ultrasonic bath. After cleaning, portions of the blade fracture surface were examined using a field emission scanning electron microscope (SEM). Figure 8 shows a typical view of the progressive region of the fracture surface. As highlighted in Figure 9, the fracture surface exhibited striations, consistent with fatigue crack propagation. The morphology of the striations was consistent with crack growth from the trailing edge inward.

Figure 8 – Secondary electron (SE) micrograph of a typical area of fatigue striations on the propeller fracture surface.

Figure 9 – SE micrograph of the fatigue striations in Figure 8.

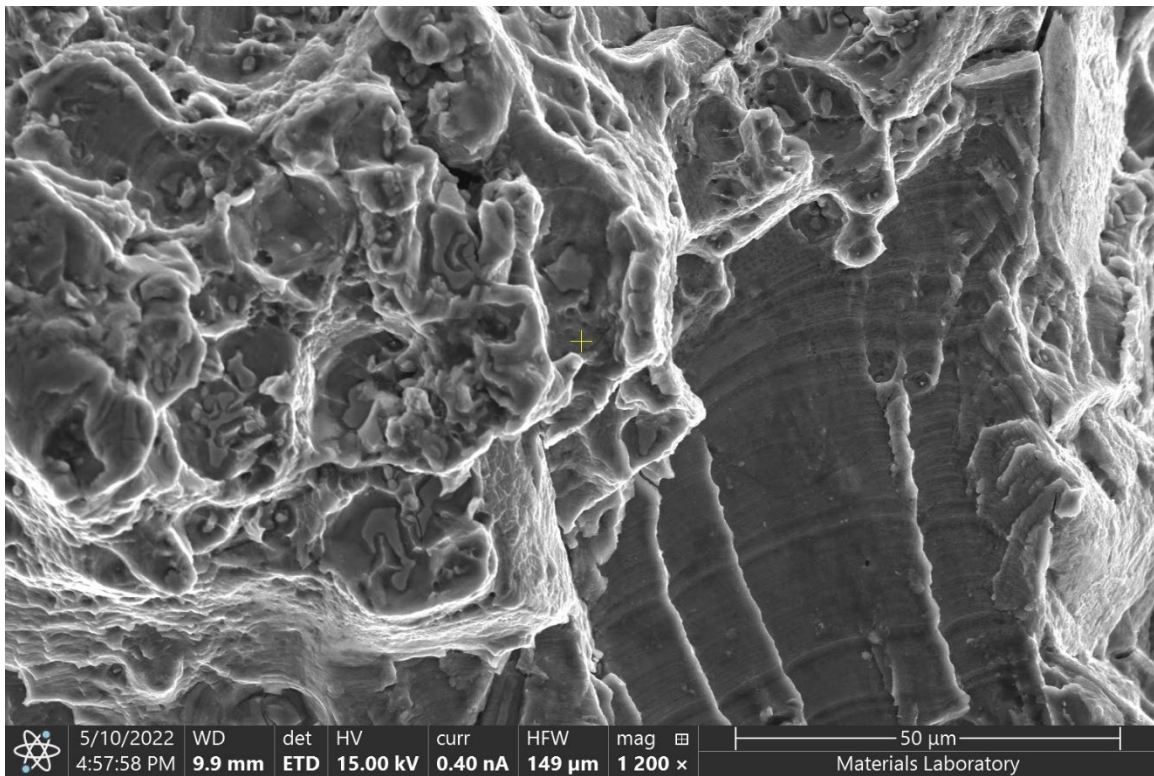
Figure 10 shows the terminus of the fatigue crack. This figure exemplifies fatigue striations until the crack ends, transitioning to a more tortuous surface morphology. Closer examination found the areas outside the fatigue crack to exhibit dimpled rupture, consistent with subsequent overstress fracture (Figure 11).

Figure 10 – SE micrograph of the terminus of the fatigue crack.

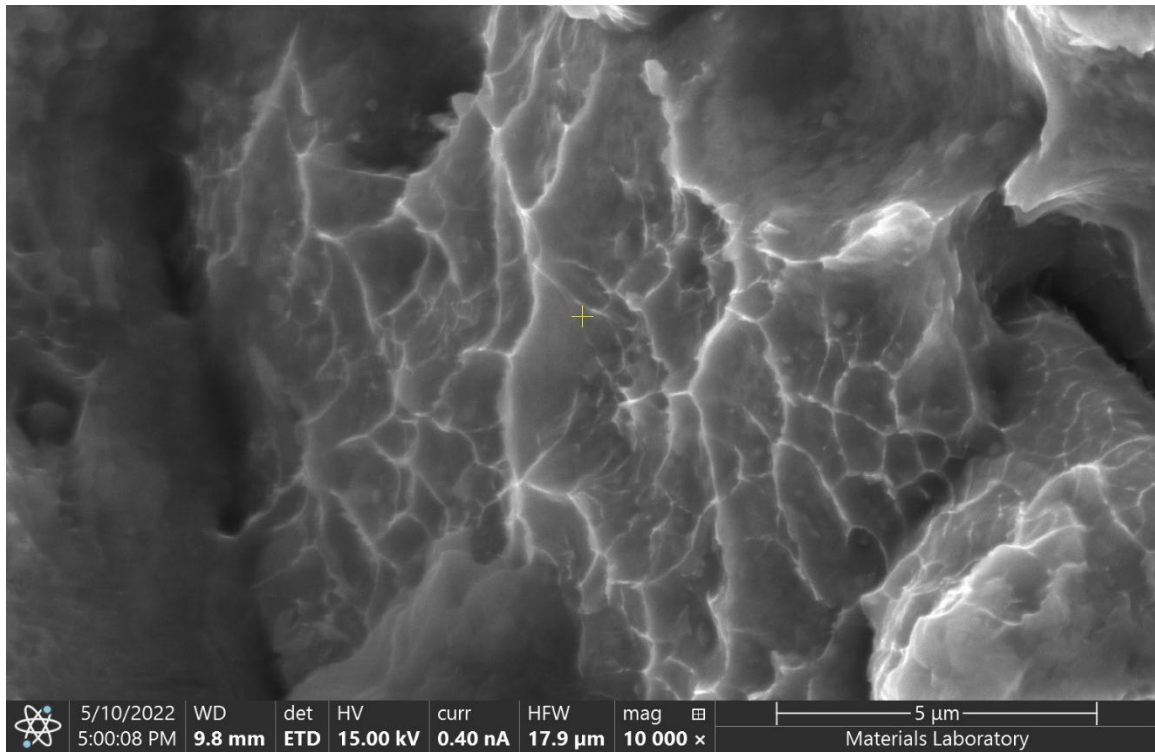
Figure 11 – SE micrograph of dimpled rupture past the fatigue crack terminus.

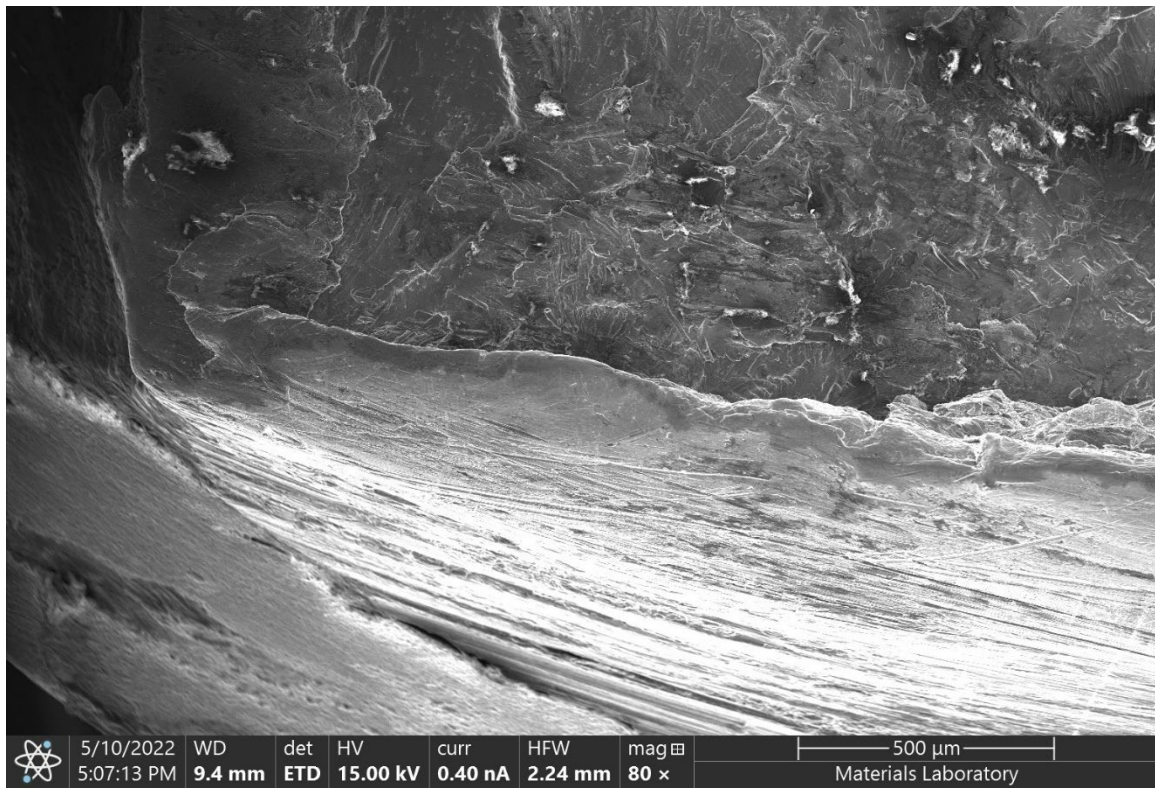
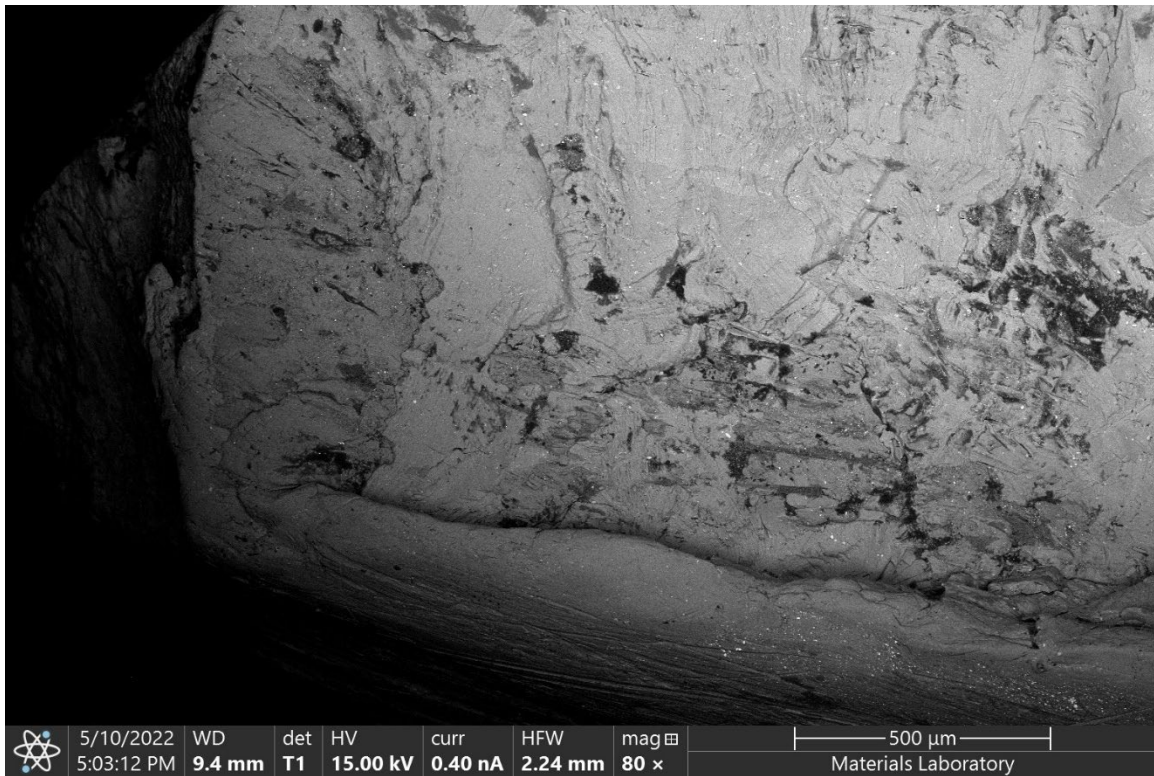
Figure 12 and Figure 13 show closer views of the fatigue crack initiation sites near the trailing edge. As shown in the figures, the fatigue striations and ratchet marks emanated from the edge with the blade face, rather than the trailing edge tip (see Figure 14). Additional crack initiation sites were found away from the trailing edge, as illustrated in Figure 15 and Figure 16.

Figure 12 – SE micrograph of the trailing edge, showing crack initiation sites, and material folded over the fracture.

Figure 13 – Backscattered electron (BE) view of Figure 12.

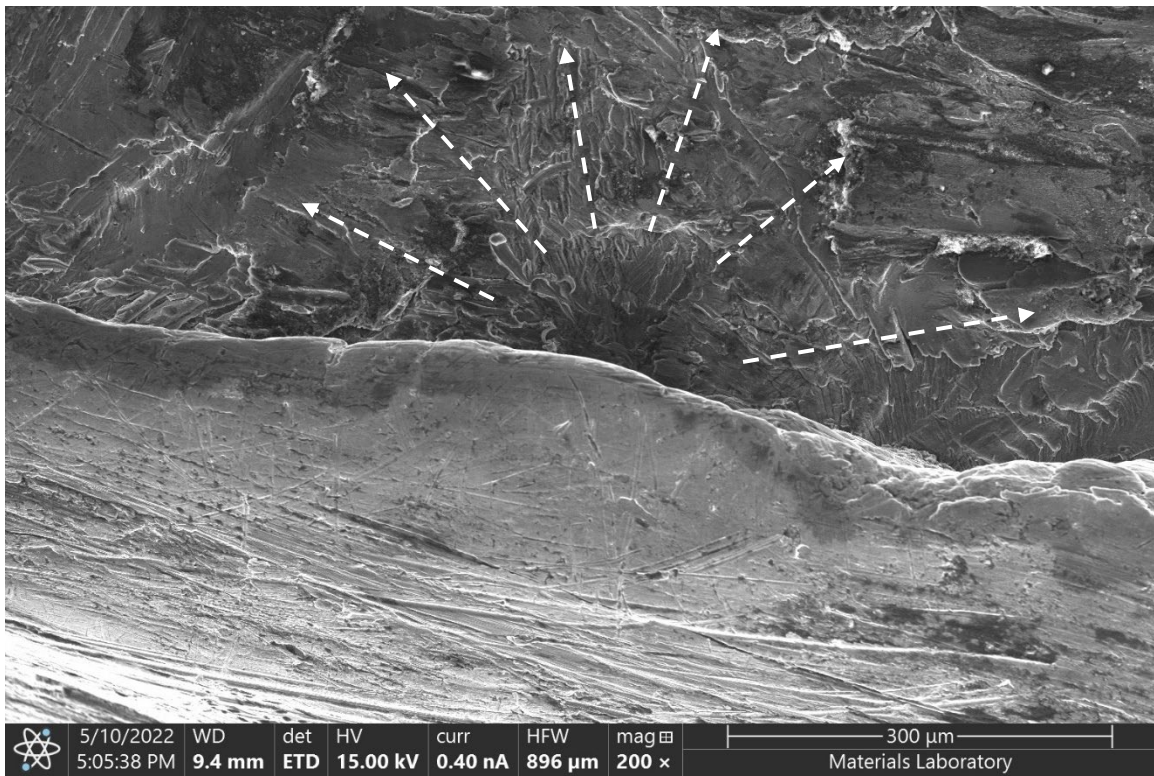
Figure 14 – SE micrograph of a closer view of a crack initiation site. The dashed white arrows demonstrate the crack growth directions.

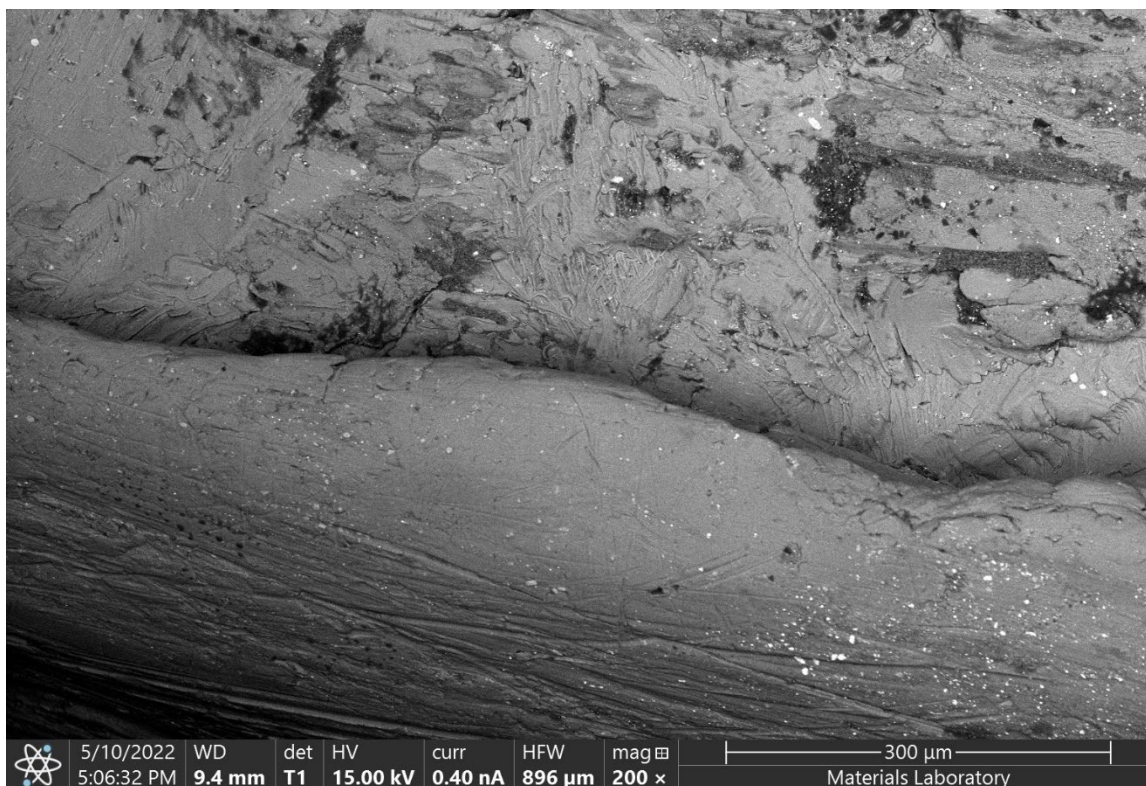
Figure 15 – BE micrograph of the initiation site in Figure 14.

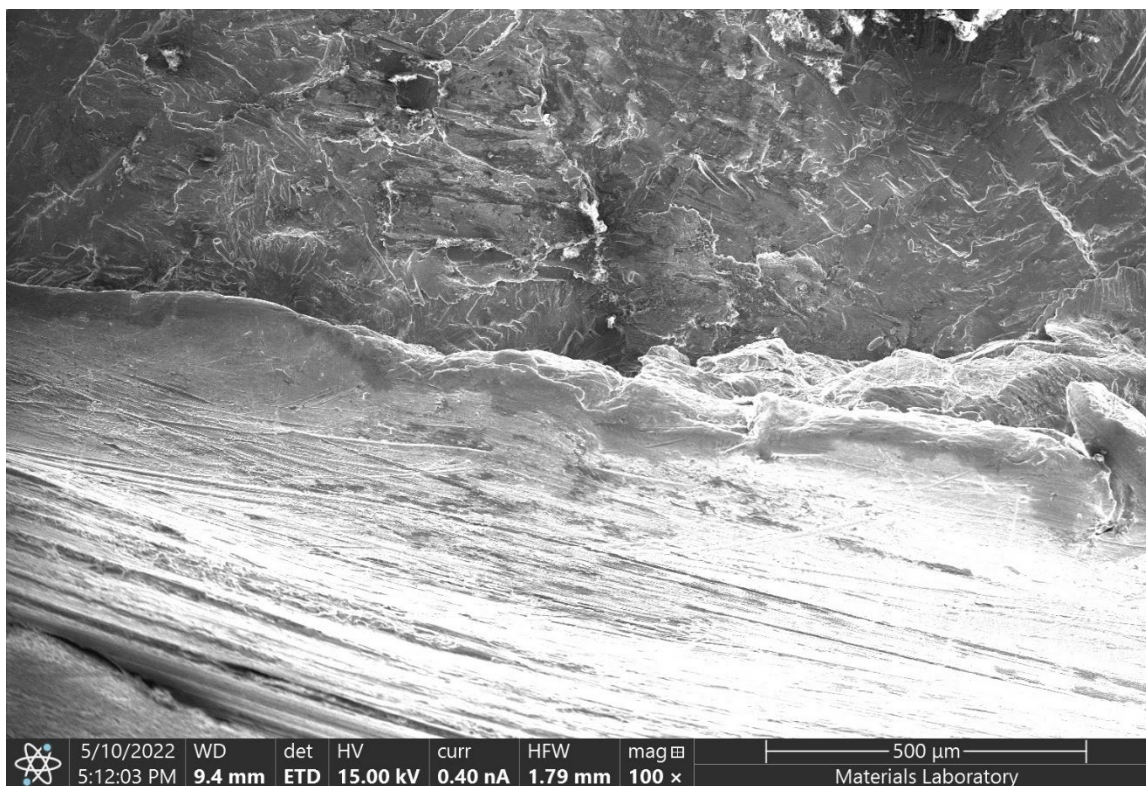
Figure 16 – SE micrograph of additional crack initiation sites along the (remnant bottom).

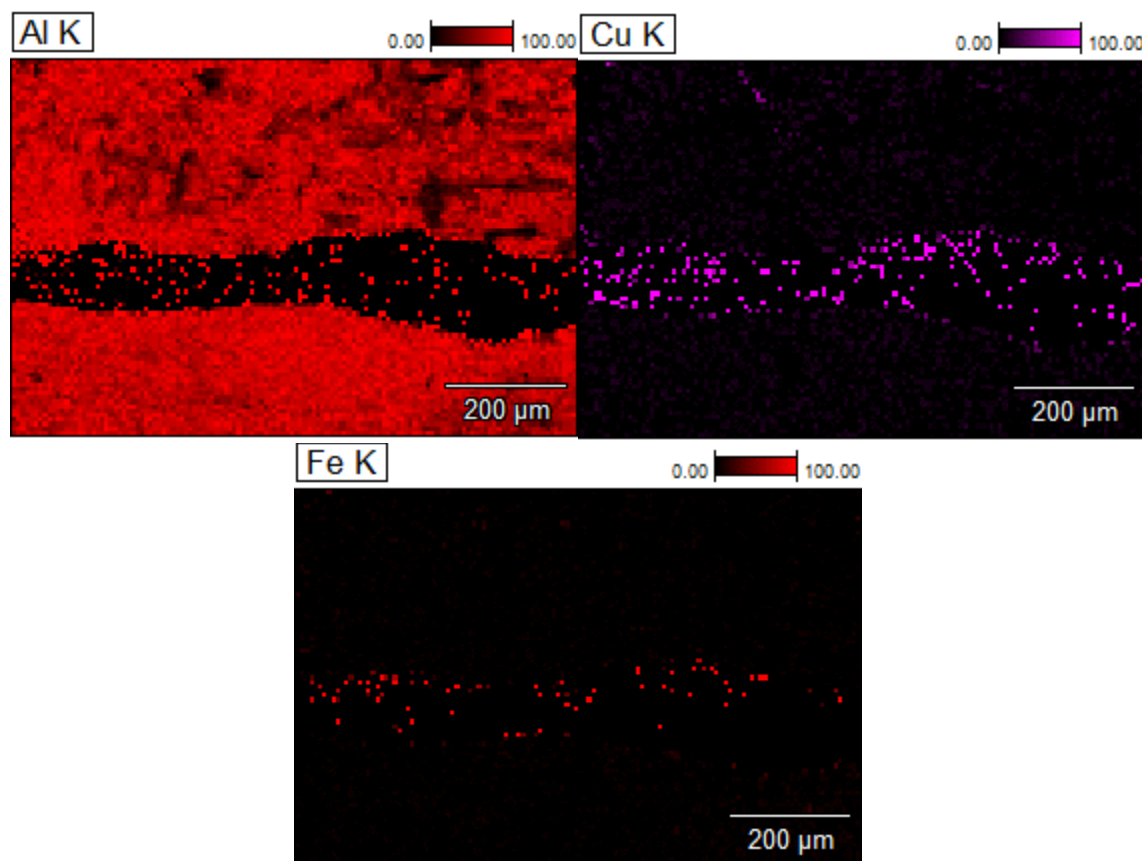
The edge of the fracture surface with the crack initiation sites was examined using EDS to map the area in Figure 14 and Figure 15. These x-ray maps provide compositional information on the concentration of specific elements in the area scanned, and areas of higher concentration are depicted with brighter color intensity, as depicted for aluminum and copper in Figure 17. While most of the area scanned exhibited primarily aluminum, the edge area was absent aluminum, and exhibited indications of copper, as well as iron and manganese. These indicate material transfer from an alloy dissimilar to that of the blade.

However, no additional details could be gleaned at the local start of the initiation sites, as the edge with the blade face had been deformed inward and folded toward the fracture surface.

Figure 17 – X-ray maps of the area in Figure 14 and Figure 15, showing an area absent aluminum but rich in copper and iron along the edge of the fracture surface initiation sites.
