## **NATIONAL TRANSPORTATION SAFETY BOARD**

# **AIRFRAME AND ENGINE EXAMINATION**

**WPR21LA303**

| Aircraft: | Cessna, 172S, N513WF |

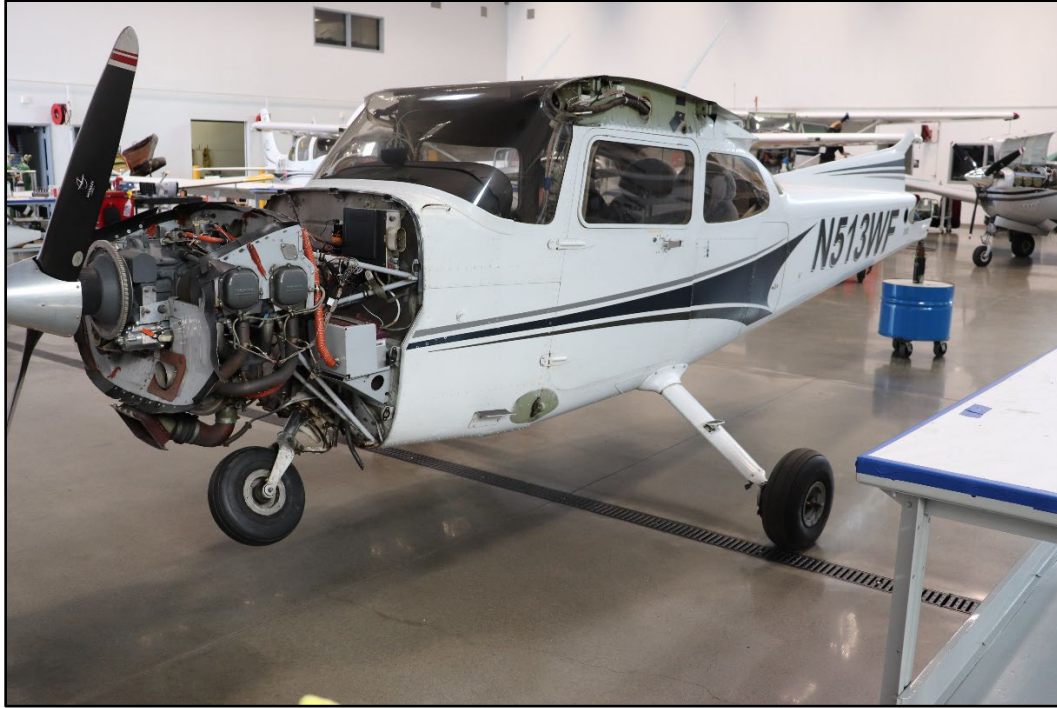
Examination of the recovered wreckage revealed that the nose landing gear had impact damage, the top section, at the firewall attachments was bent aft. The firewall from exhibited crushing and bending aft. Both wings, horizontal stabilizer, vertical stabilizer, rudder and elevator were removed by recovery personnel. Additionally, the recovery personnel had drained the fuel from both fuel tanks.

**Figure 1. View of airplane during examination**

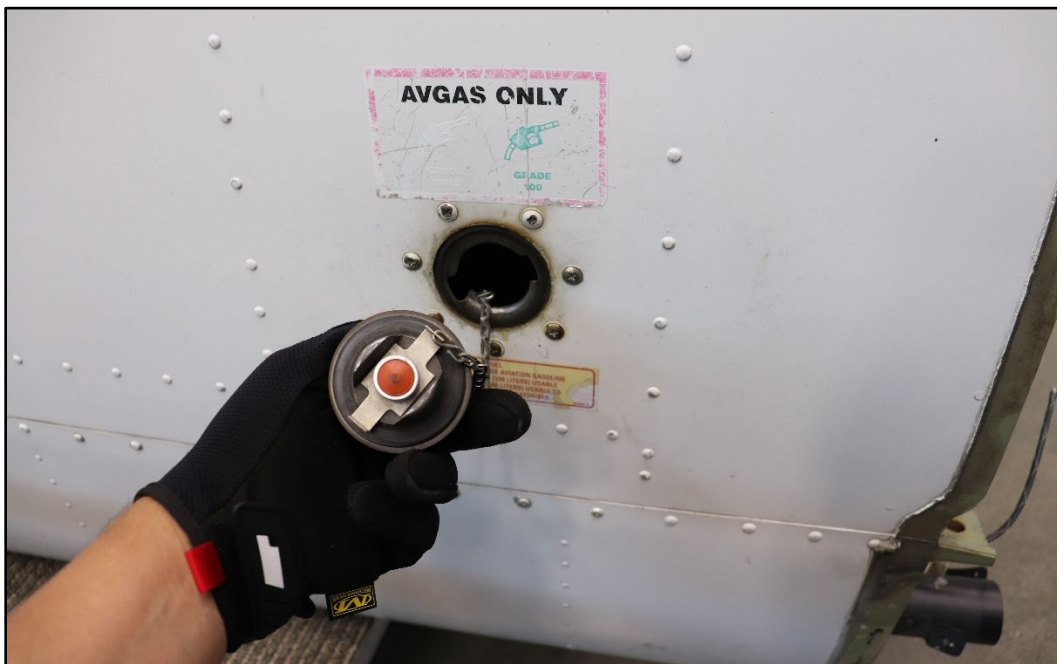
Visual inspection of the left and right fuel caps revealed that both fuel caps rubber seals appeared worn. The observed tach / MX hours meter time was 999.5 hours and the hobbs meter time was 9,595.6 hours.

**Figure 2. View of right fuel cap**

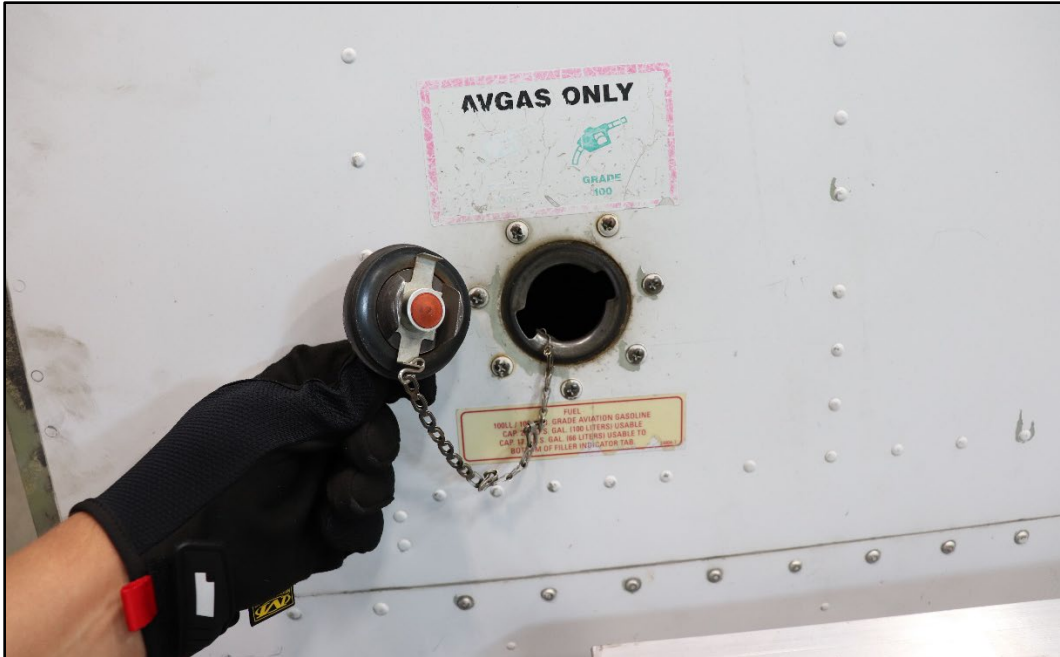
Figure 3. View of left fuel cap

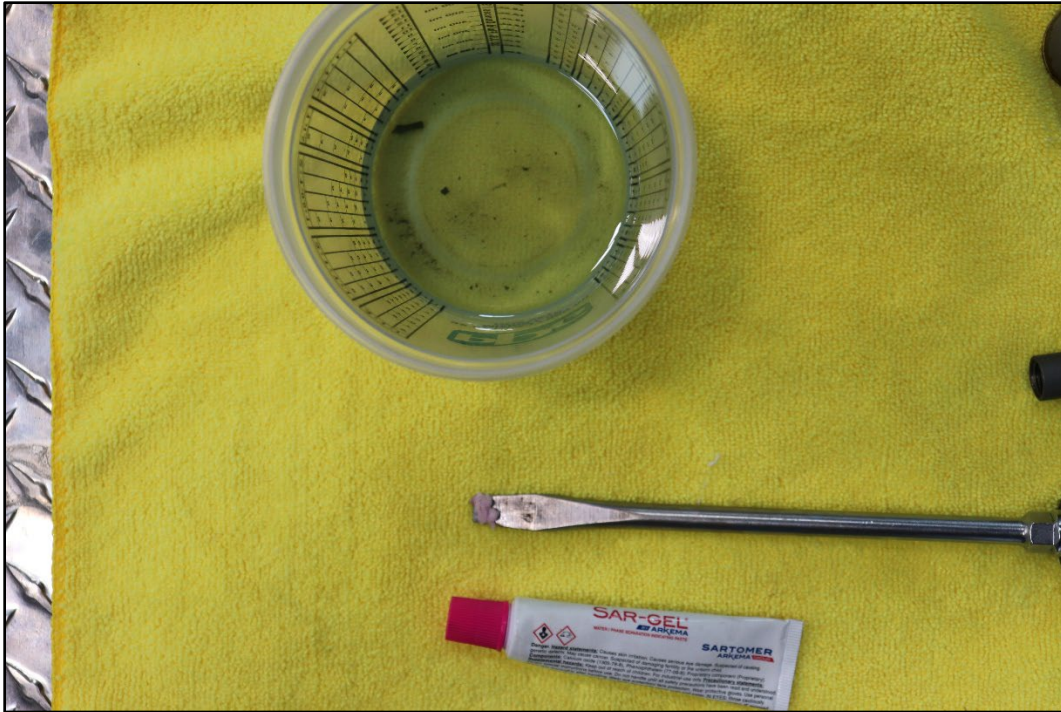
A visual inspection was conducted of the fuel system. Continuity was established from the main fuel tanks throughout the system to the fuel injector nozzles. Visual inspection of the gascolator fuel and minor debris consistent with normal operation. The fuel was tested for water using SAR-GEL water finding paste, with negative results. An external fuel tank was attached to the right-wing fuel line. The fuel lines from the fuel flow divider were disconnected from the fuel nozzles. When the airframe electric fuel pump was turned on, fuel expelled from all four fuel injector lines.

Figure 4. View of SAR-GEL water finding paste

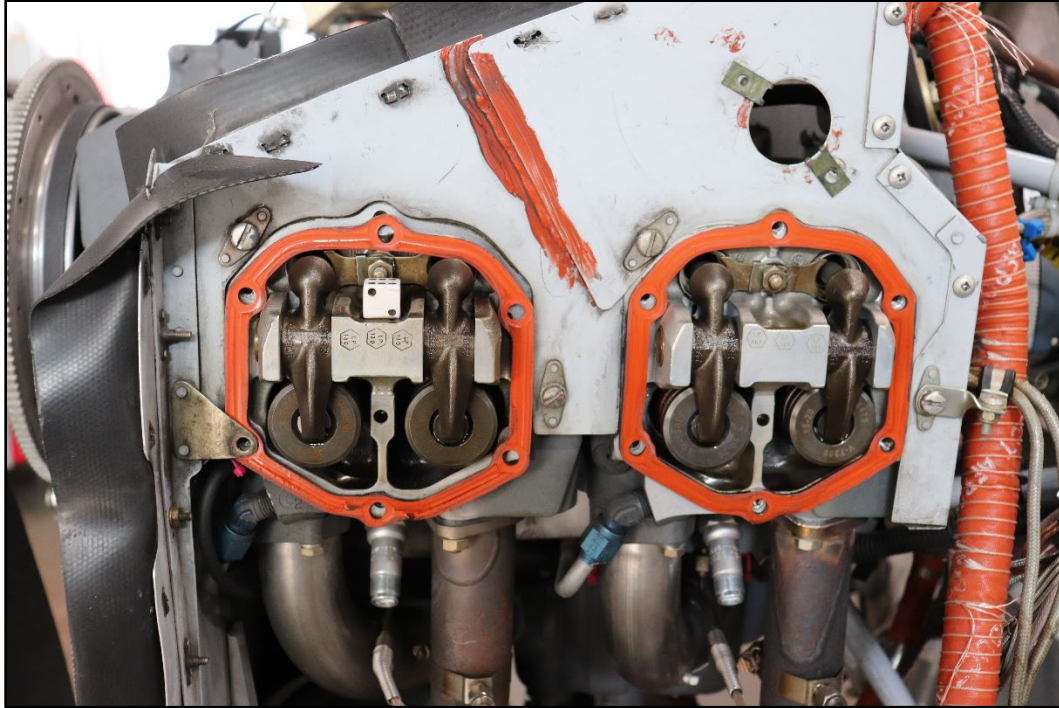
Examination of the recovered engine revealed that it remained attached to the engine mounts. All four cylinders and all engine accessories remained attached. All fuel and oil lines appeared attached to their respective fittings and were tight. No evidence of any mechanical damage was observed to the engine crankcase.

**Figure 5. View of left side of the engine**

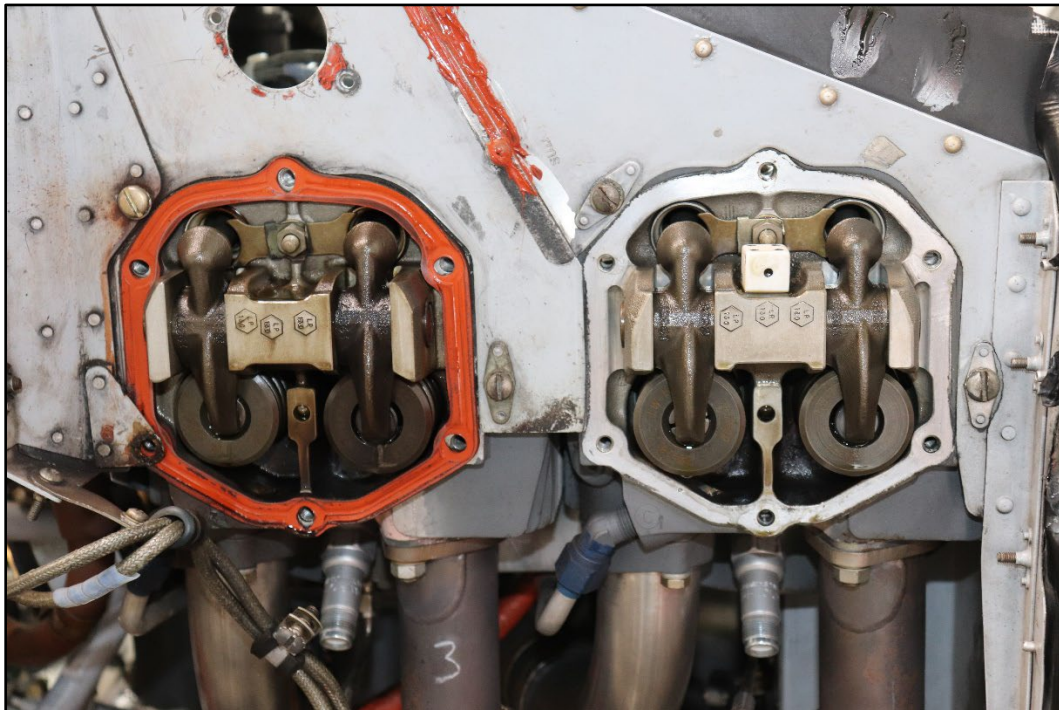
**Figure 6. View of right side of the engine**

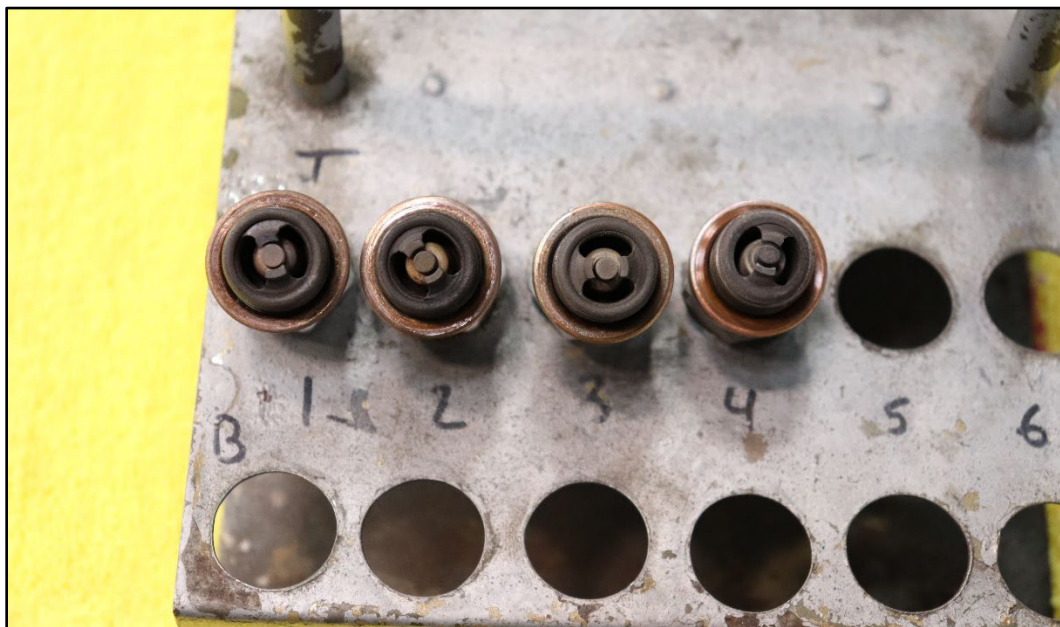
The top spark plugs were removed from the engine and they were the massive electrode type. Light gray coloration within the electrode areas was observed. When compared to the Champion Check-A-Plug chart, the sparkplugs exhibited NORMAL use signatures.

Figure 7. View of top spark plugs

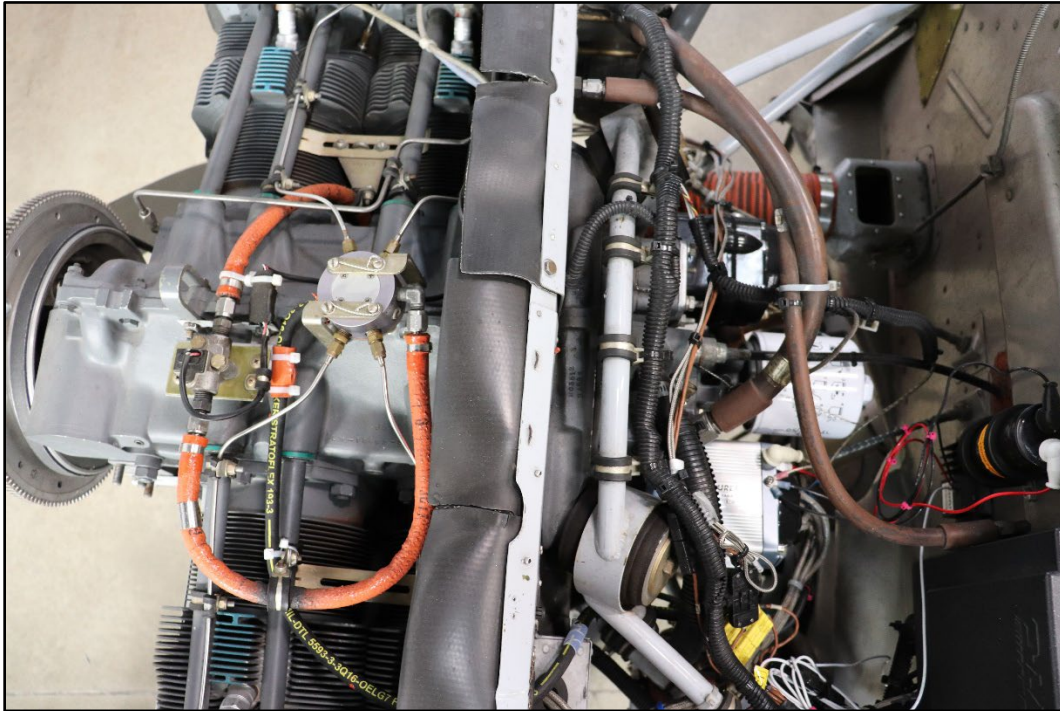
The left and right magnetos remained attached to the engine accessory case with no external damage noted. The right engine to magneto timing was verified at 25°. When the engine crankshaft was rotated by hand using the propeller, spark was produced on four ignition leads from the right magneto and impulse coupling engagement was heard. The left magneto was equipped with an electric ignition system.

**Figure 8: Overview of magnetos**
