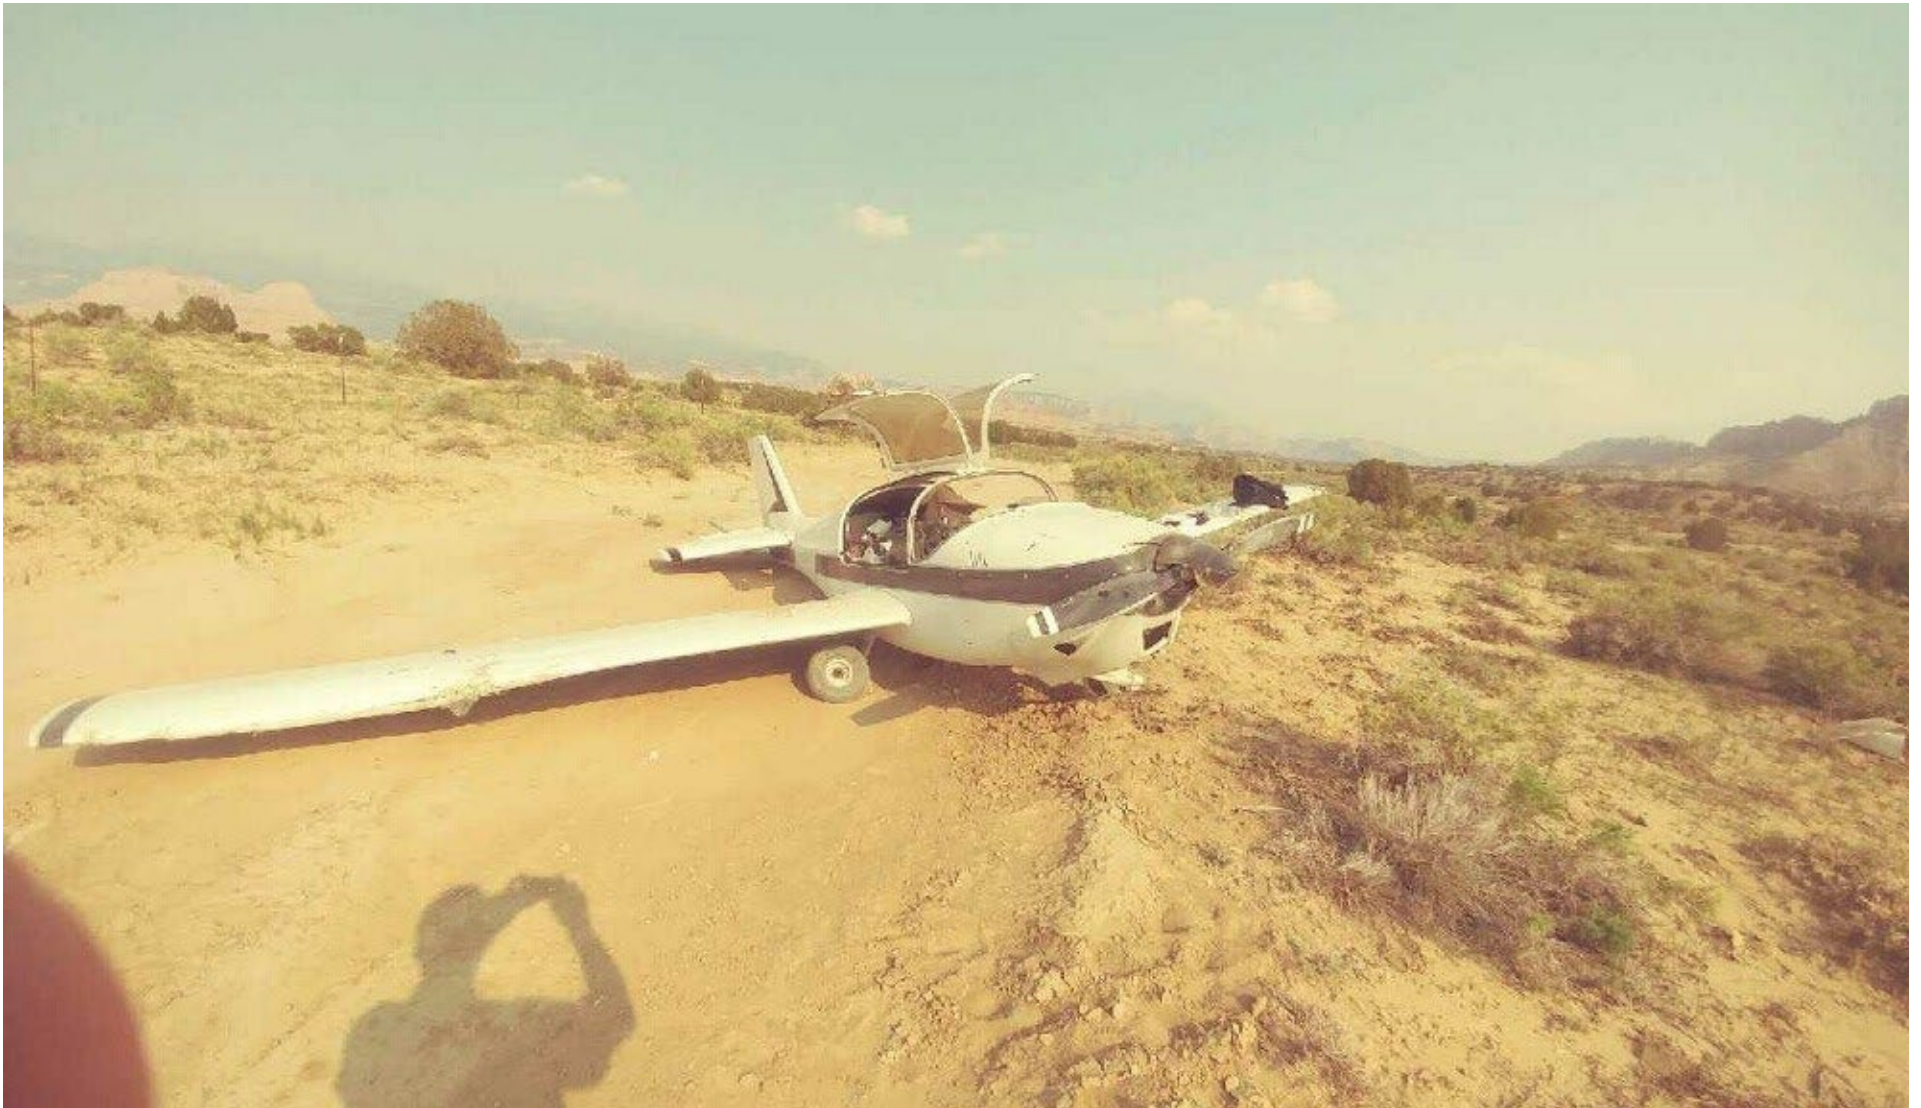
**Photo 1 – View of accident airplane (photo courtesy of the pilot)**

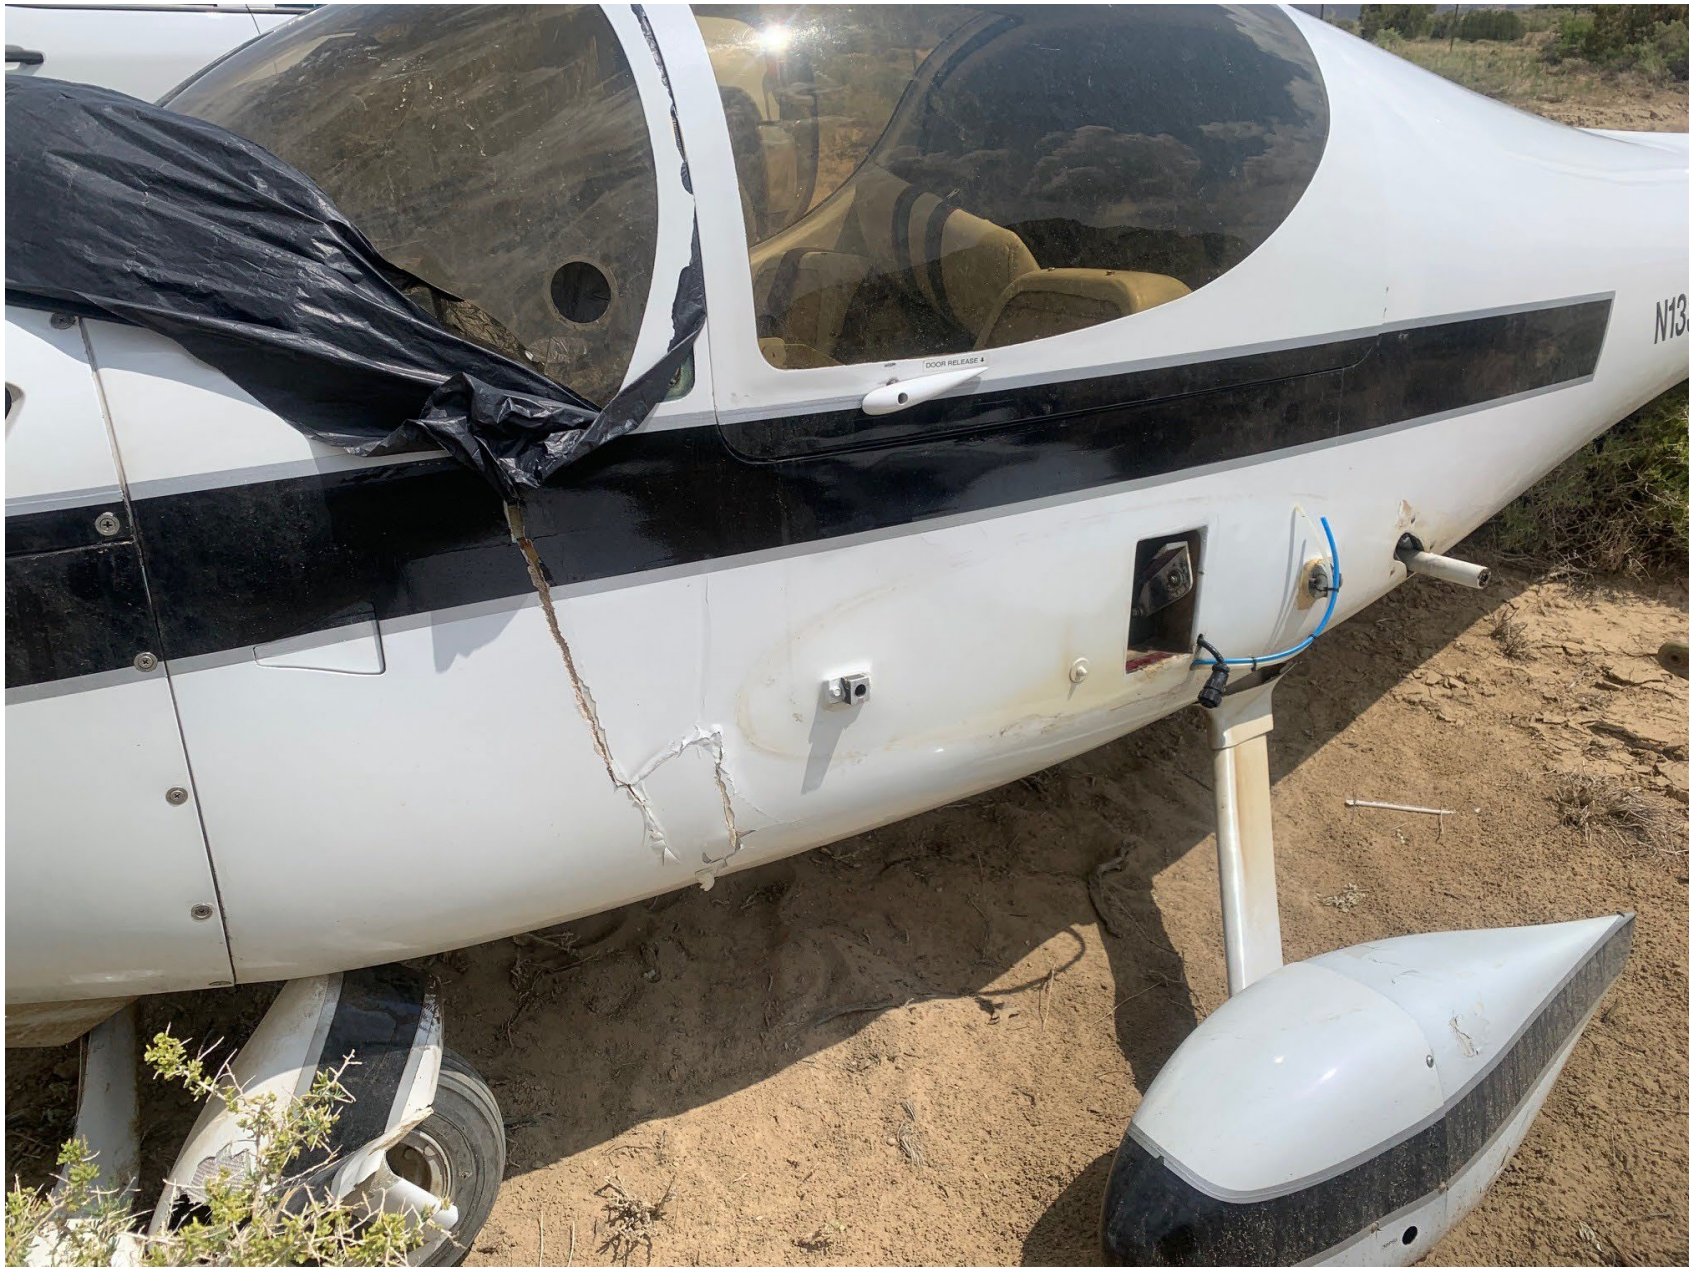
**Photo 2 – View of left side damage to fuselage (courtesy of the pilot)**

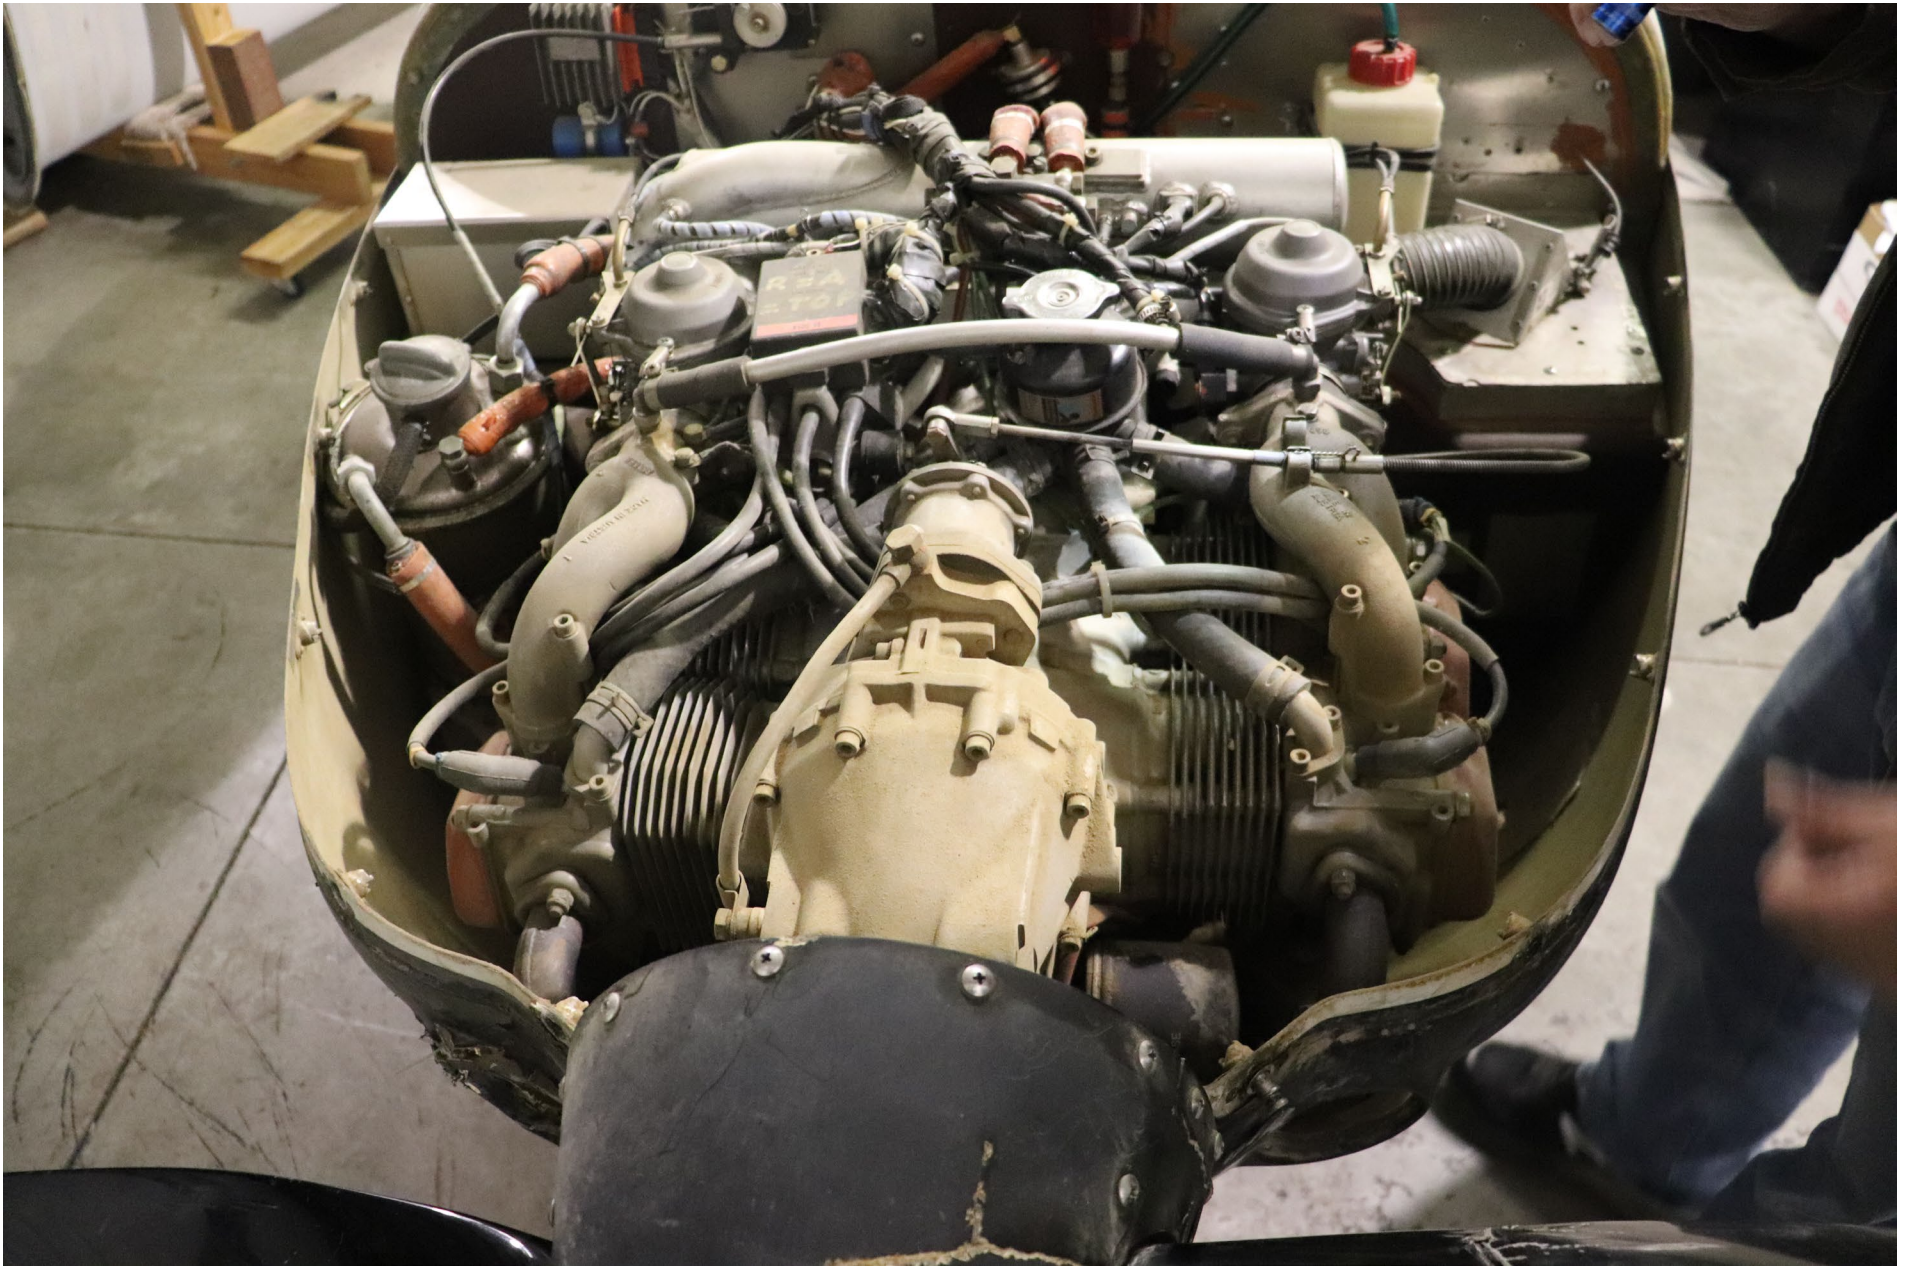
**Photo 3 – View of engine at examination**

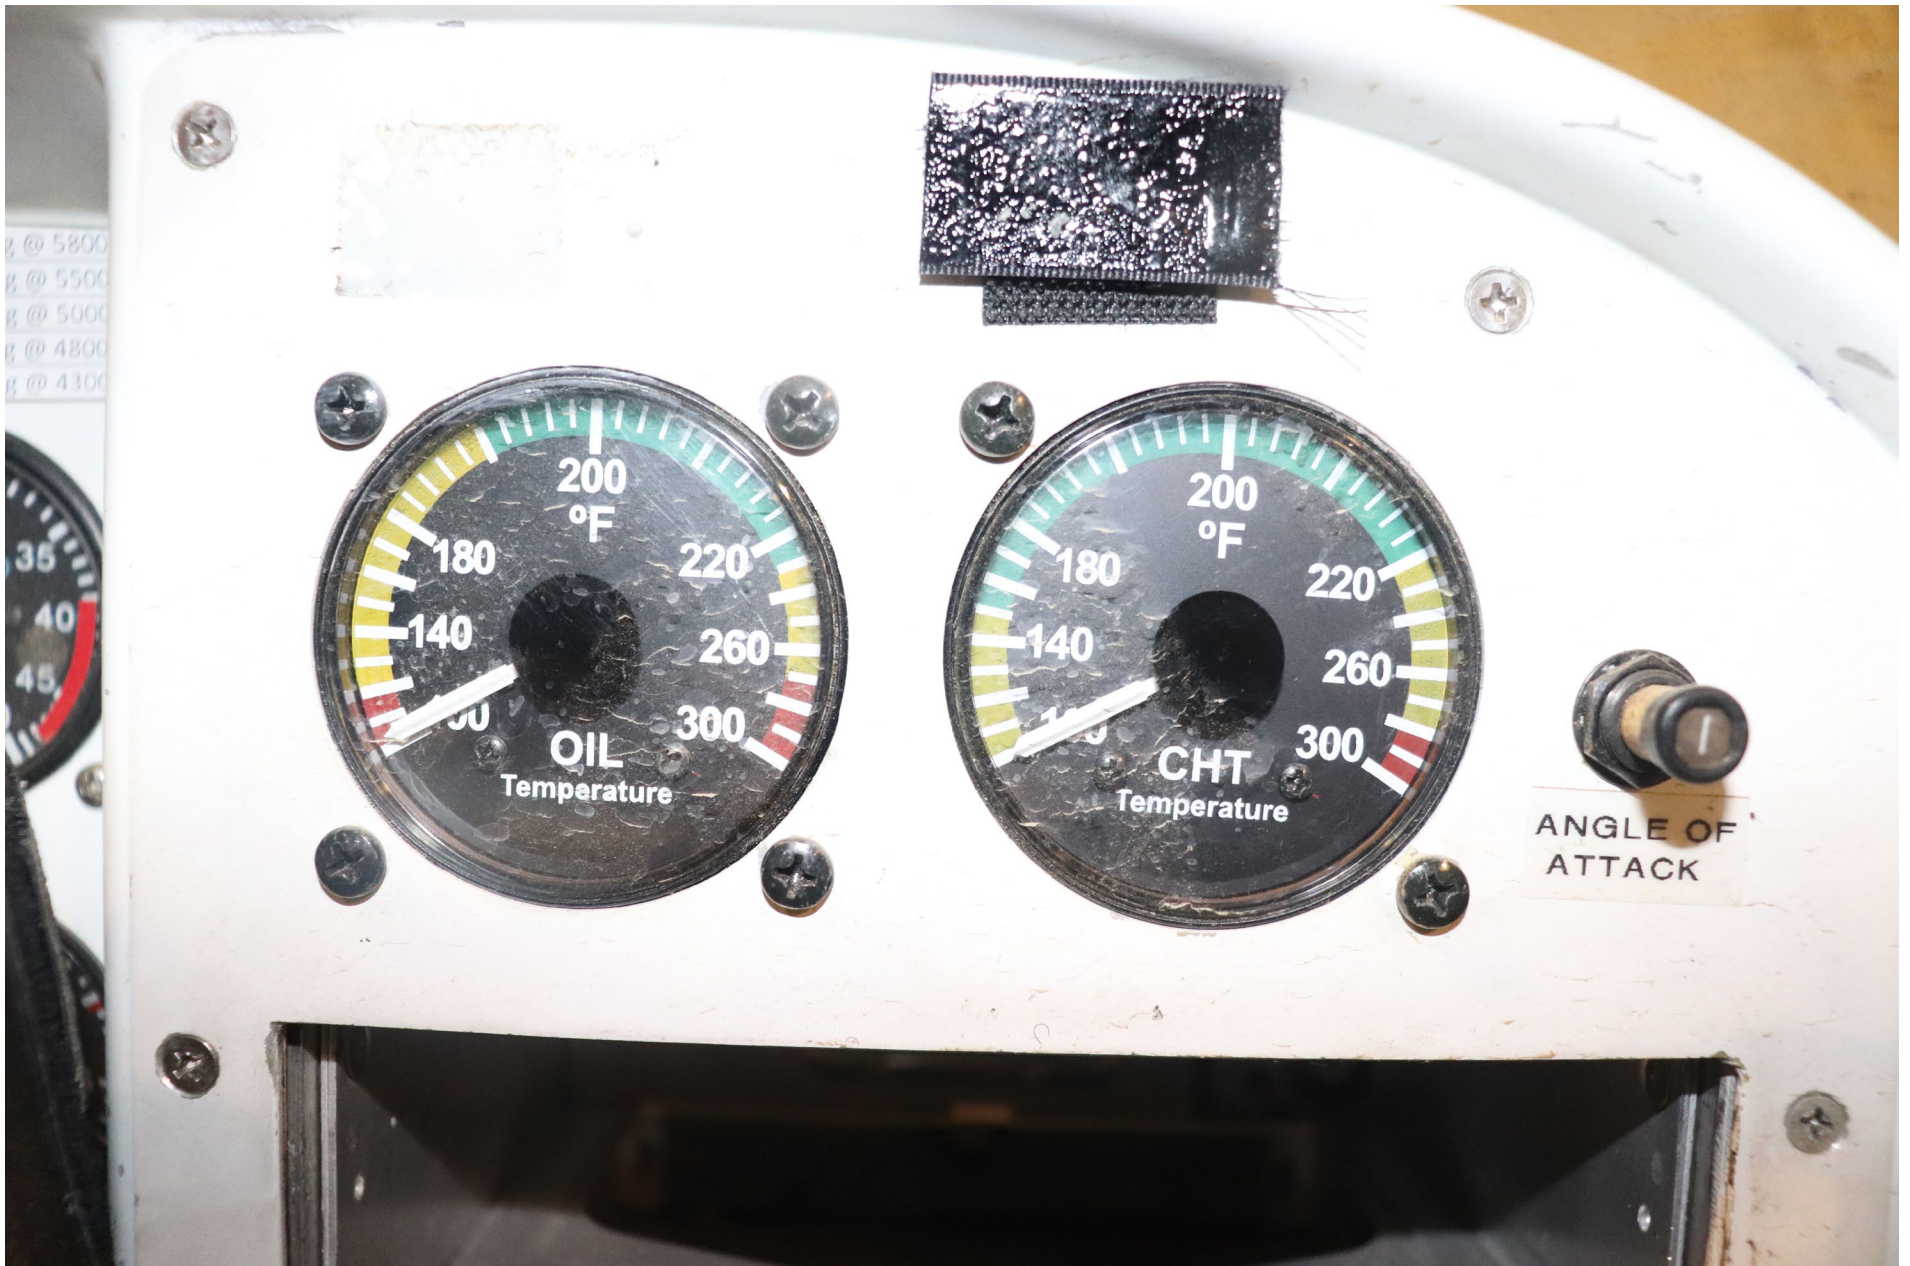
**Photo 4 – View of Oil and CHT temperature gauges**

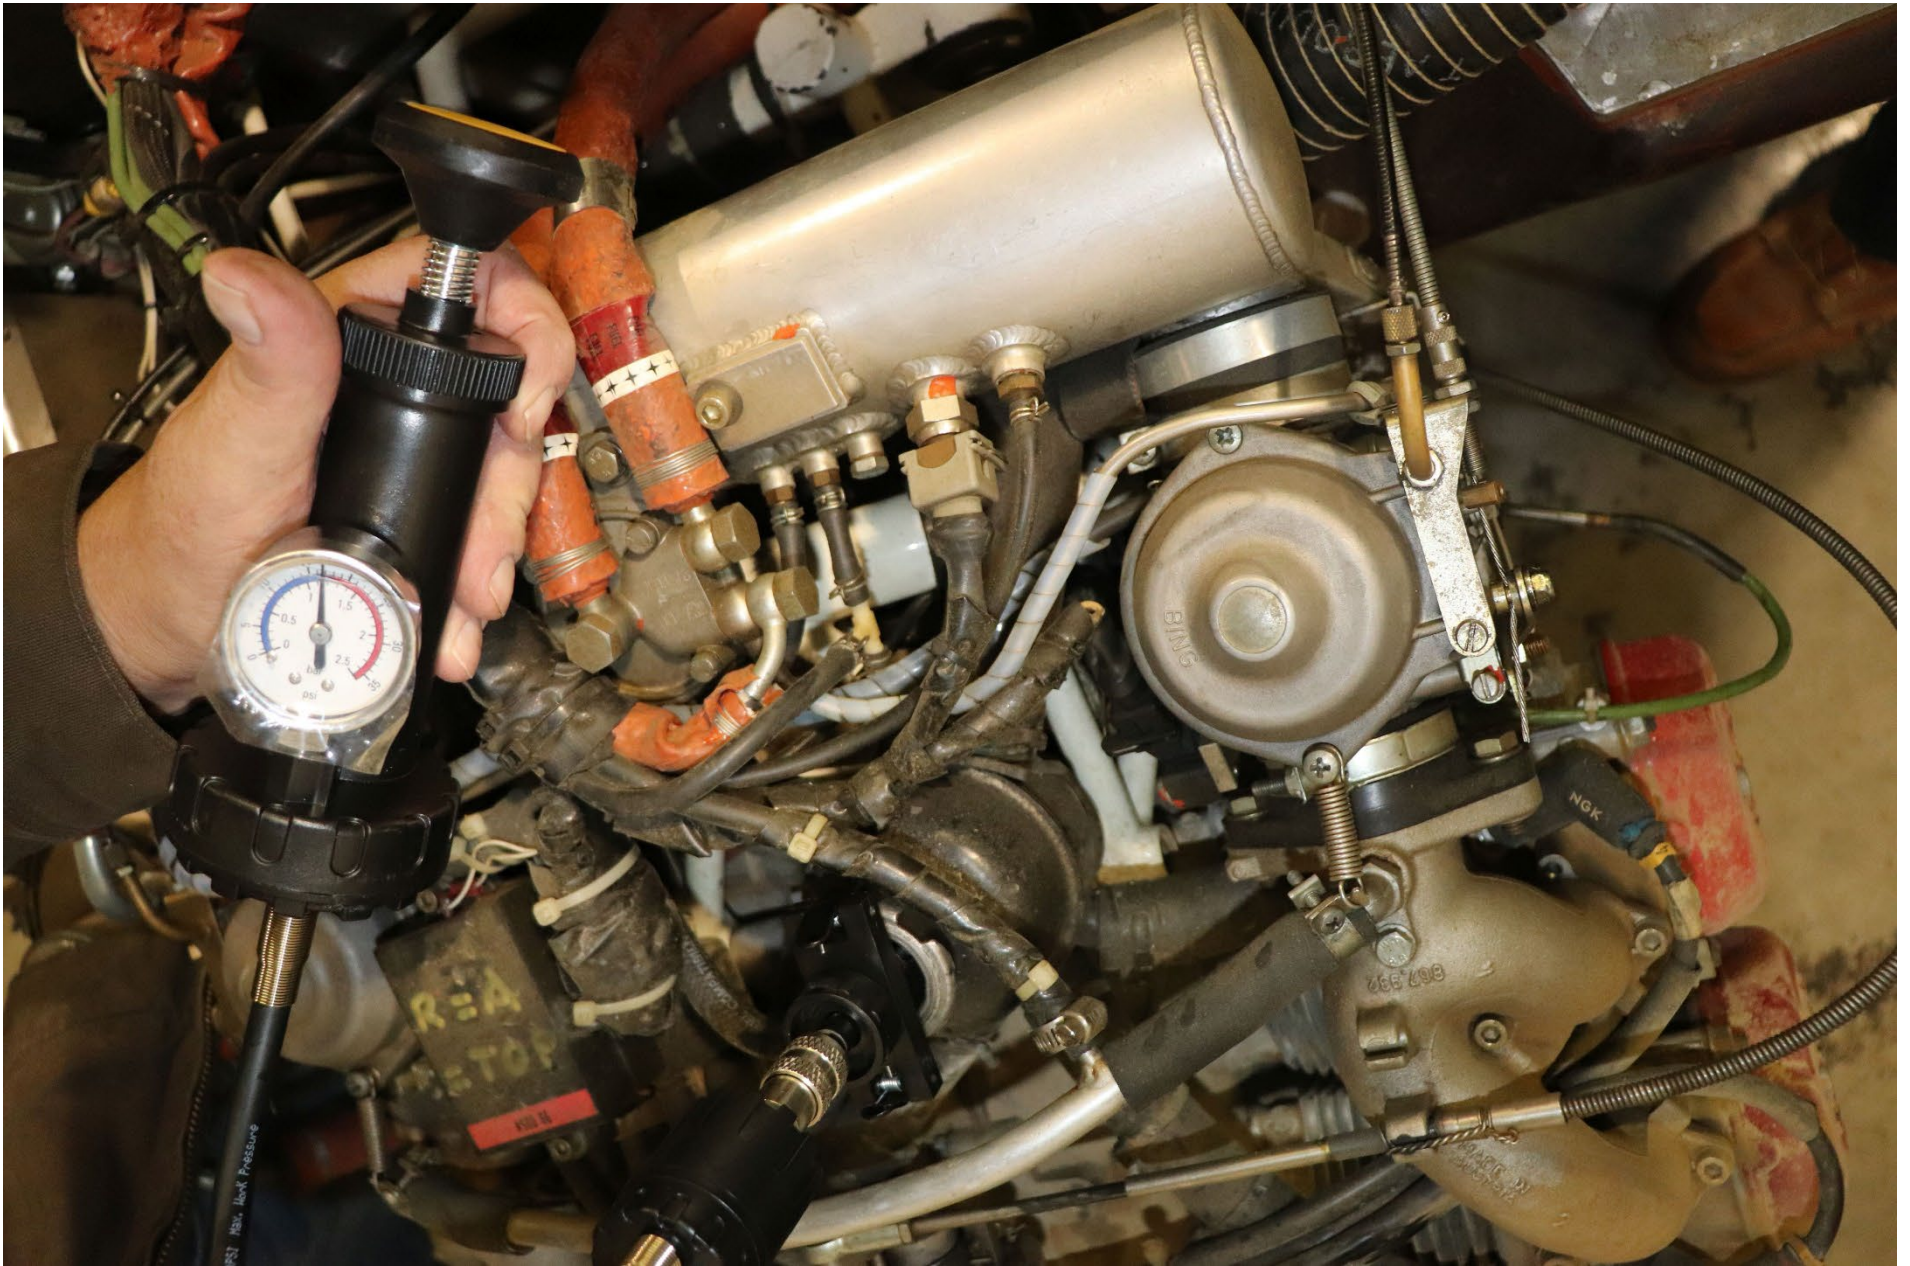
**Photo 5 – View of engine during pressure test of cooling system**

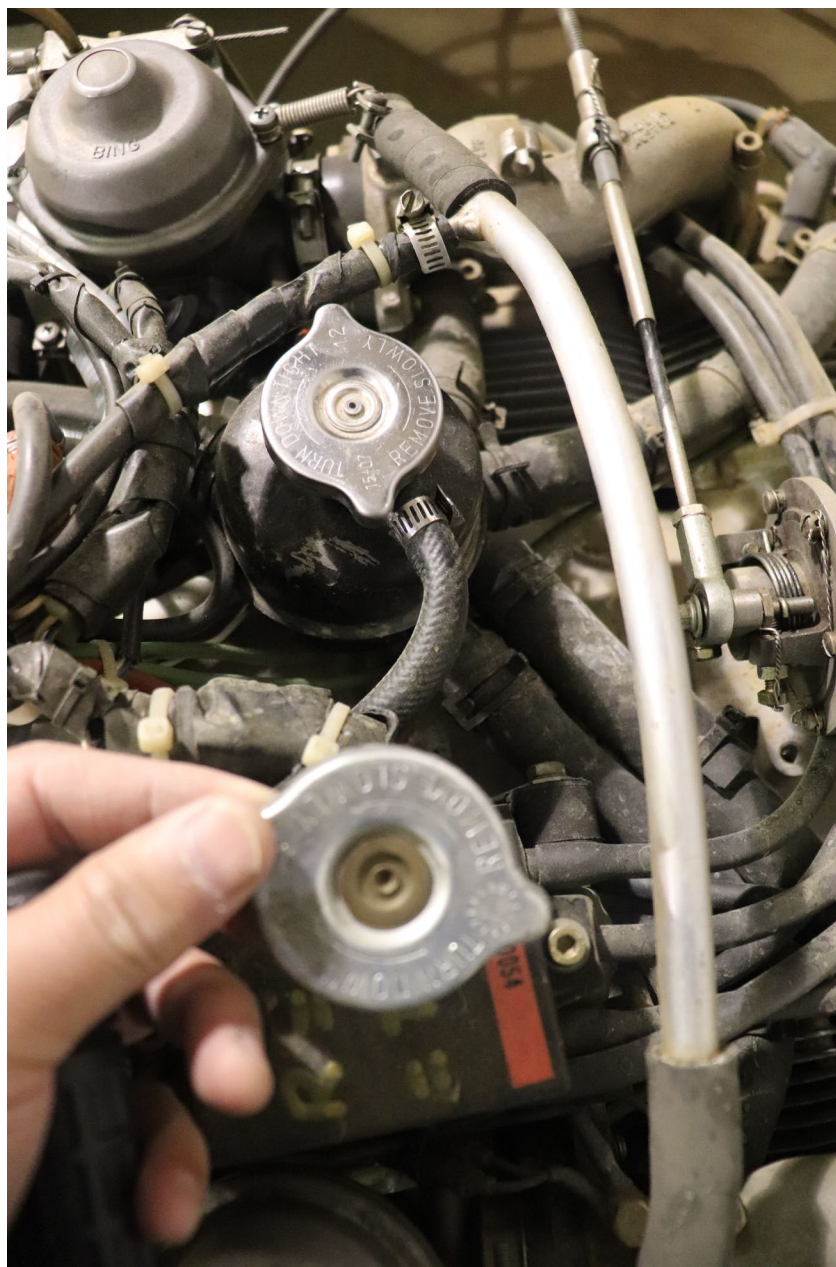
**Photo 6 – View of installed non-Rotax radiator cap installed on expansion tank and original Rotax radiator cap**

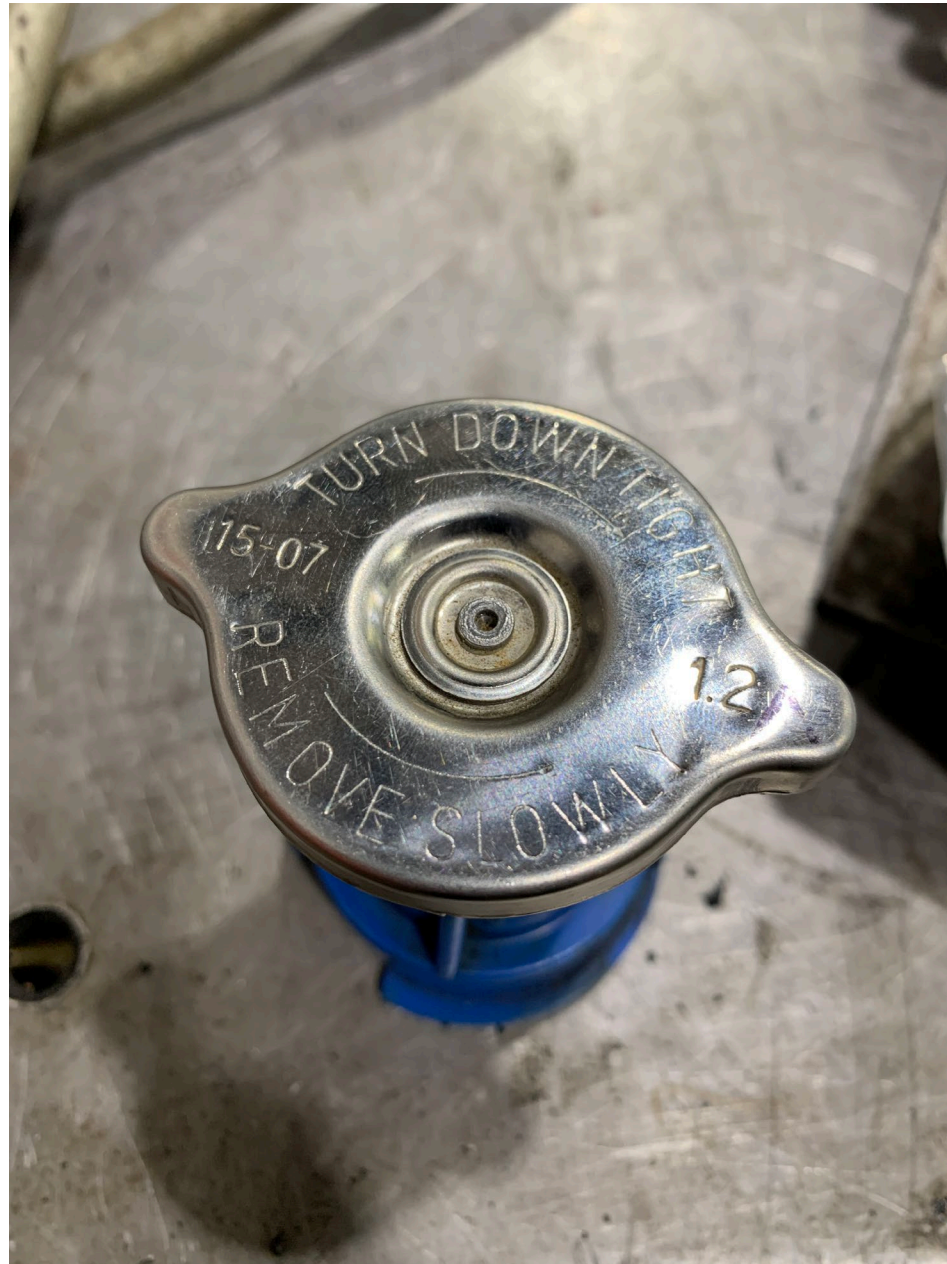
**Photo 7 – View of non-genuine Rotax radiator cap installed on pressure leak test adapter**

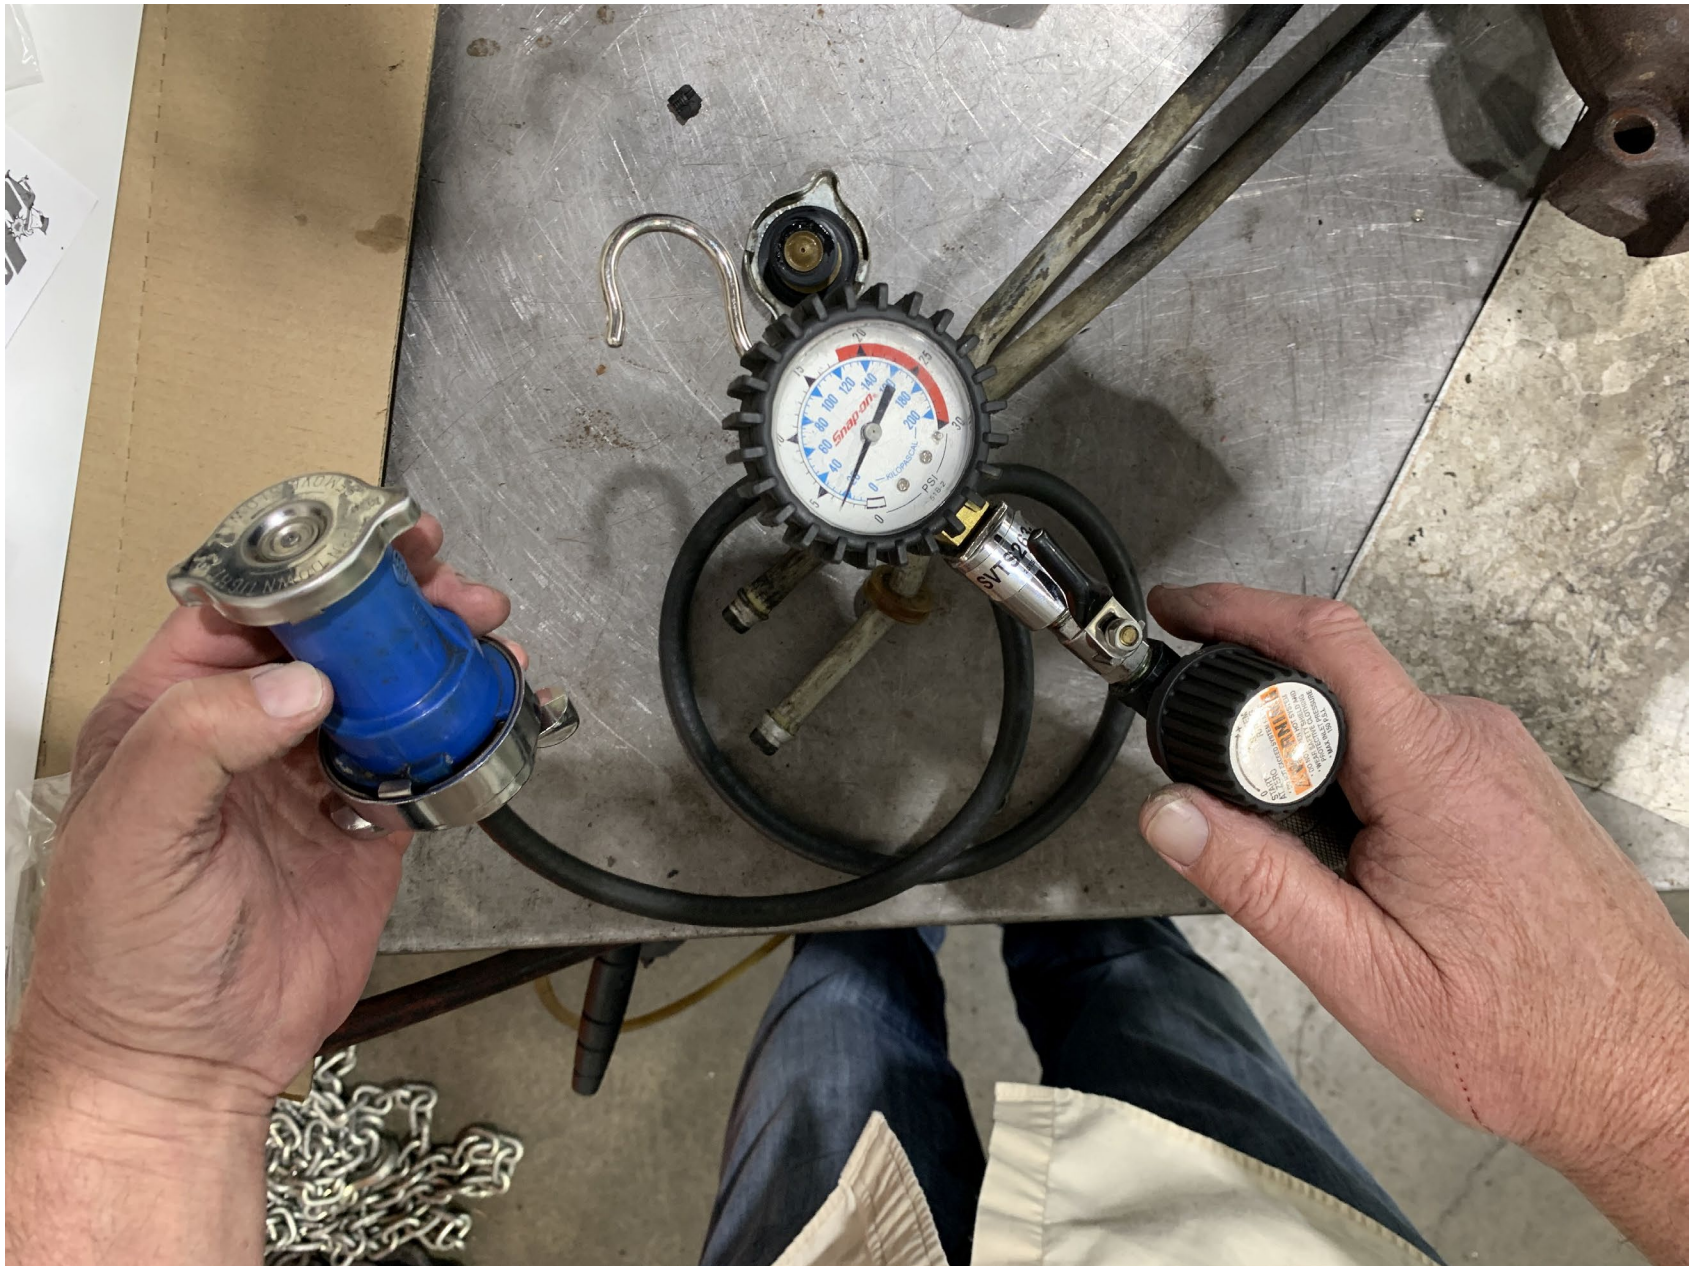
**Photo 8 – View of pressure leak test of non-genuine Rotax radiator cap**
