# National Transportation Safety Board

WPR21LA325

## **COOLING SYSTEM EXAMINATION NOTES**

Location: Hanksville, Utah  
Date: August 16, 2021  
Time: 1515 Mountain daylight time  
Airplane: N133AC

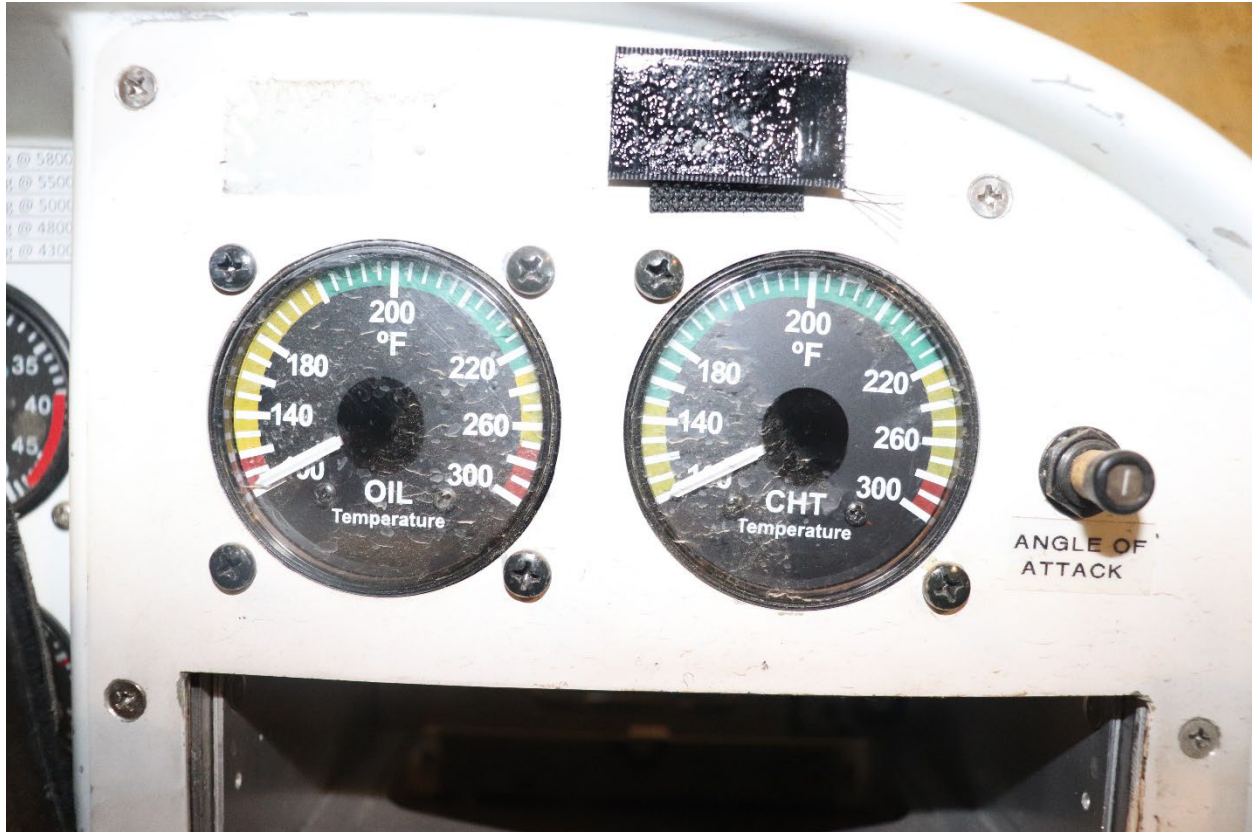
The pilot reported that he was in a "stair-stepped" climb out in an effort cool the engine. About 30 minutes after departure, he noted that the engine's cylinder head temperature (CHT) was in the red arc and immediately reduced the throttle setting to idle and prepared for a precautionary landing. While in the descent, the pilot cycled the engine off and on to reduce the CHT, but the temperature remained in the red arc. During the landing roll on an unimproved dirt road, the airplane impacted terrain.

**Figure 1. View of cylinder head temperature gauge**

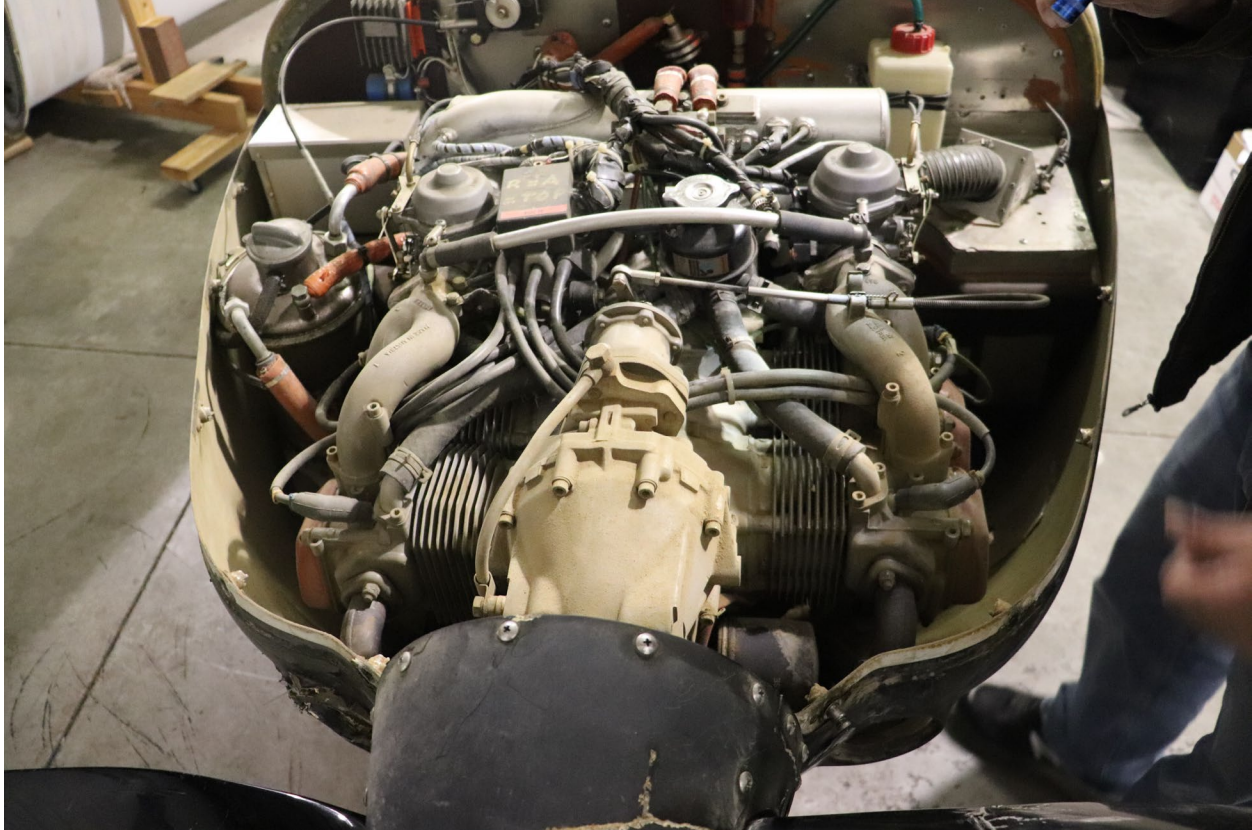
**Figure 2. View of accident engine**

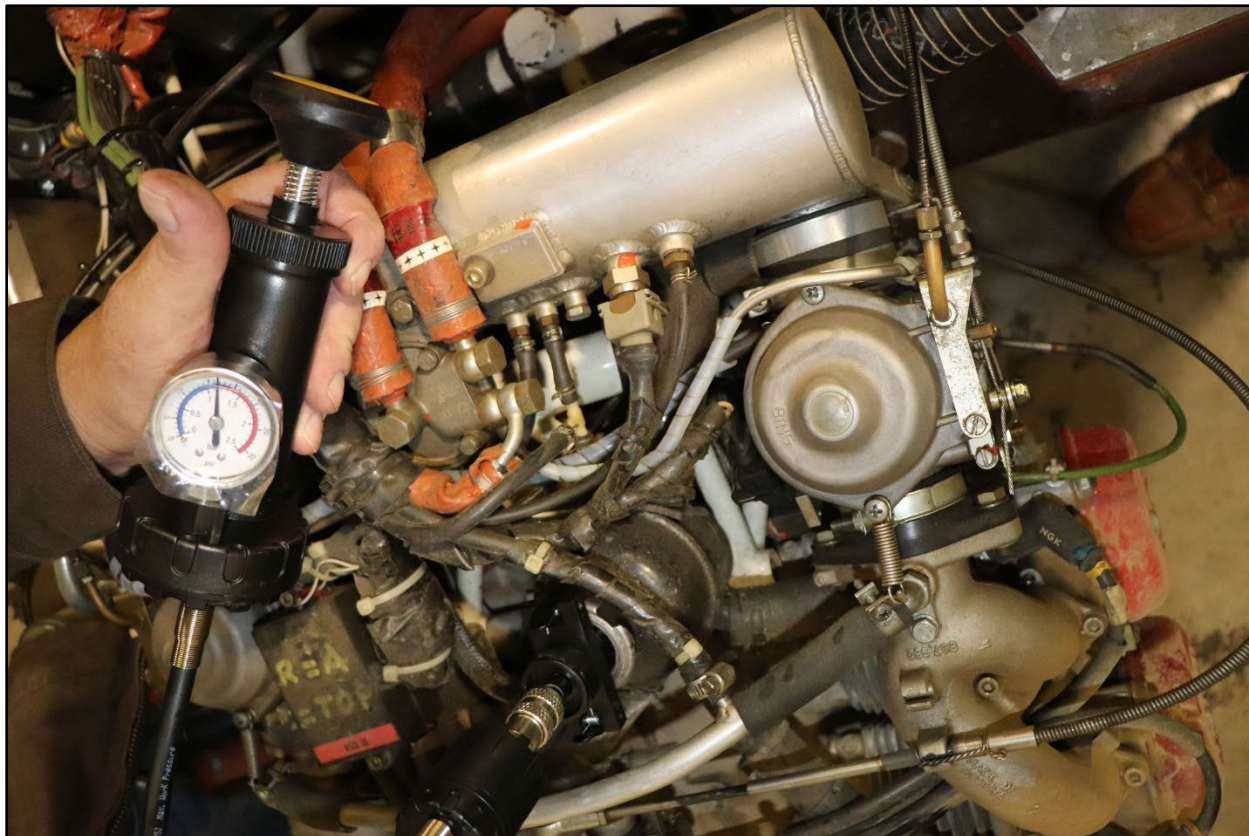
The system's internal pressure was set to 1.2 bar (18 psi) using a pressurization kit. Pressure testing revealed that there were no leaks throughout the cooling system.

Figure 5. View of pressure test of cooling system

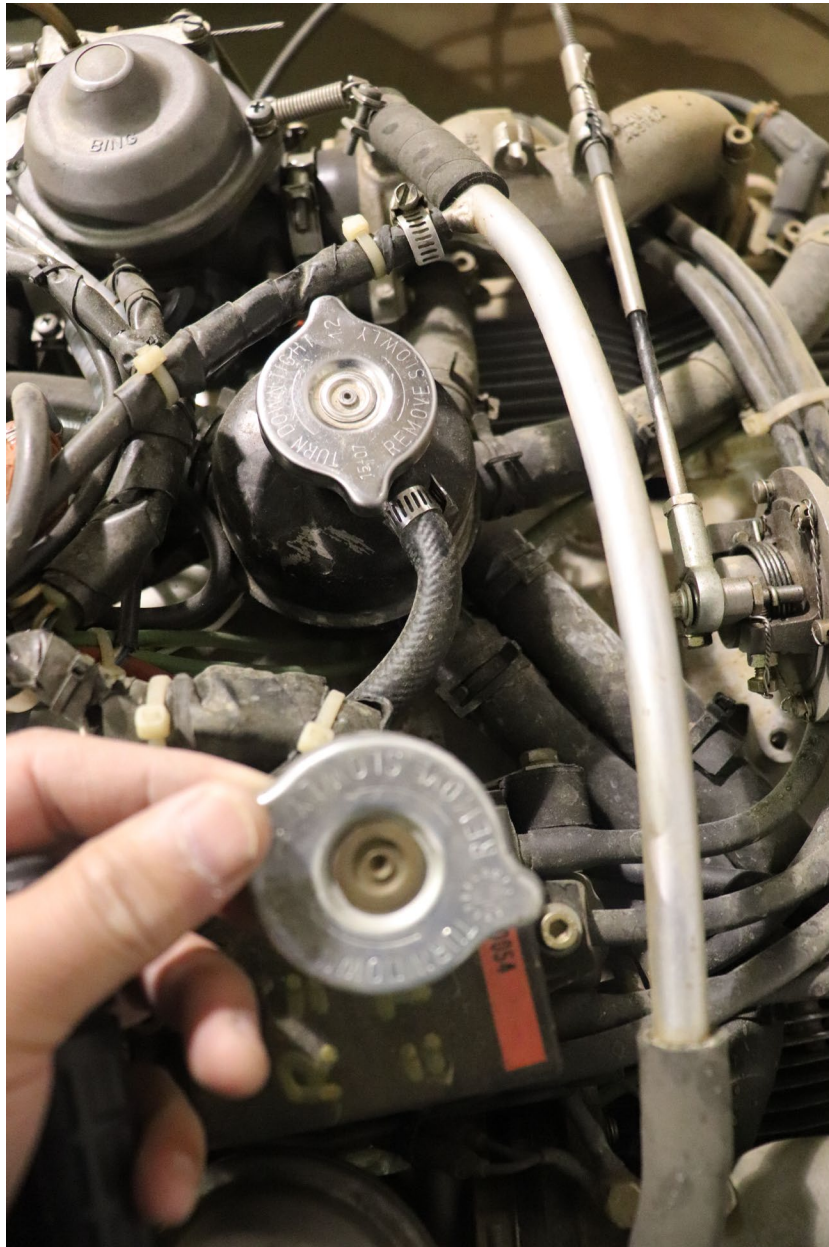
The expansion tank was intact and unremarkable but void of any fluid. The pressure cap installed on the accident engine was a non-Rotax (non-OEM) pressure cap, with a 1.2 bar pressure rating, identical to the OEM cap. Visual examination of both

removed and replaced radiator caps revealed that the upper seal, lower seal, pressure relief valve, return valve, and spring were intact.

**Figure 7. View of non-OEM installed on expansion tank comparing with the removed Rotax radiator cap**

The pilot reported during the examination that he replaced the original cap because the original cap was worn. He purchased the non-OEM part from an online motorcycle supply shop and installed it about 2 weeks prior the accident airplane. The caps were retained for further testing.

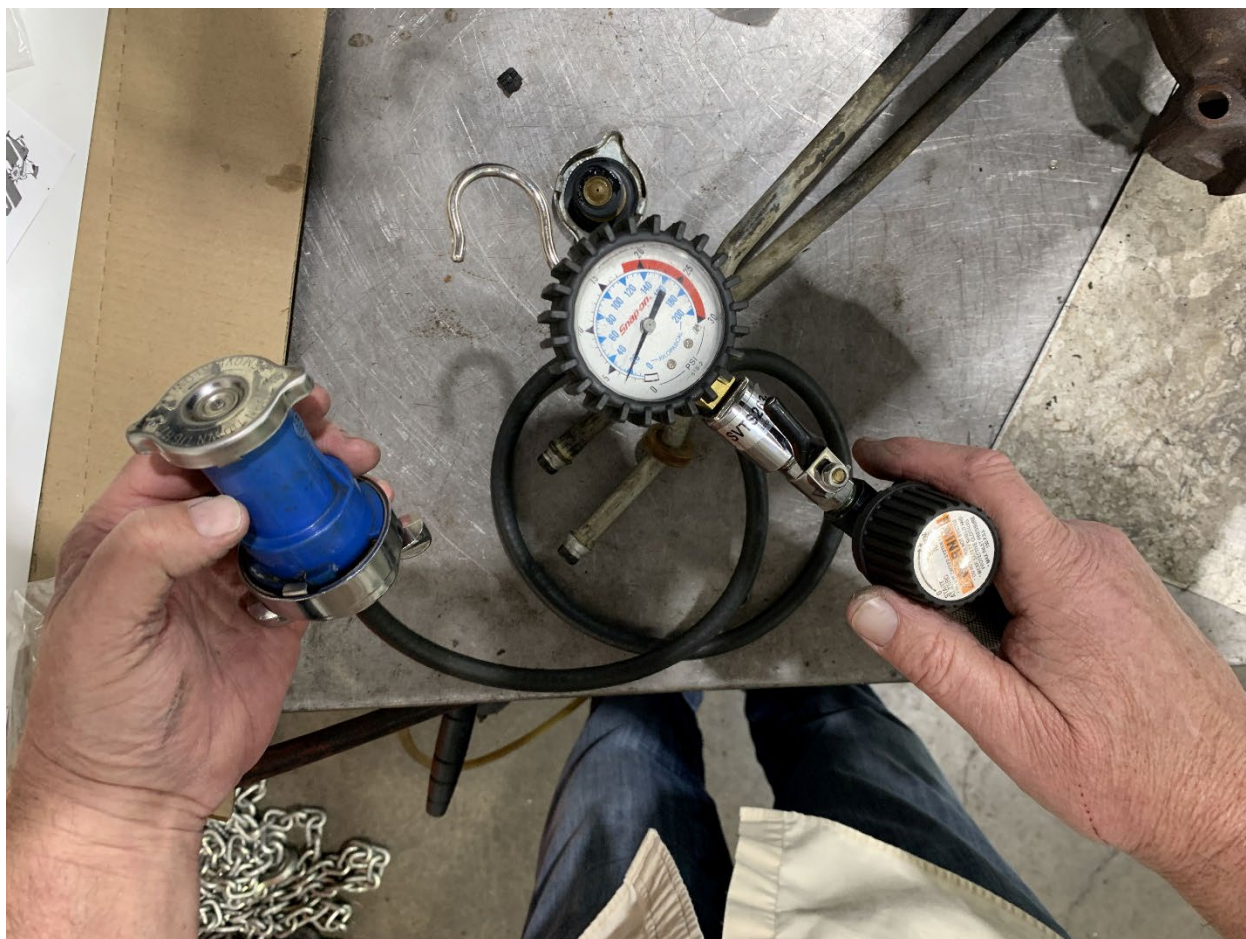
The radiator caps were tested at an automotive radiator shop in Federal Way, WA in June 2022. The radiator caps were screwed onto an adapter, which connected to a compressor line. Compressed air was introduced to determine what the opening value was for the pressure relief valve. An audible air leak would be heard and according to the manufacturer, the pressure relief valve was to open at 1.2 bar or 18 psi. The test revealed that the original Rotax cap opened the valve at 12 psi with a corresponding audible air leak; conversely, the non-OEM accident radiator cap revealed that the valve opened at 3 psi, also with an audible leak.

**Figure 9. View of radiator cap return valve test result**
