## **NATIONAL TRANSPORTATION SAFETY BOARD**

# **AIRFRAME AND ENGINE EXAMINATION SUMMARY**

**WPR21LA326**

| Aircraft: | N2843T, Piper PA-32-300 |

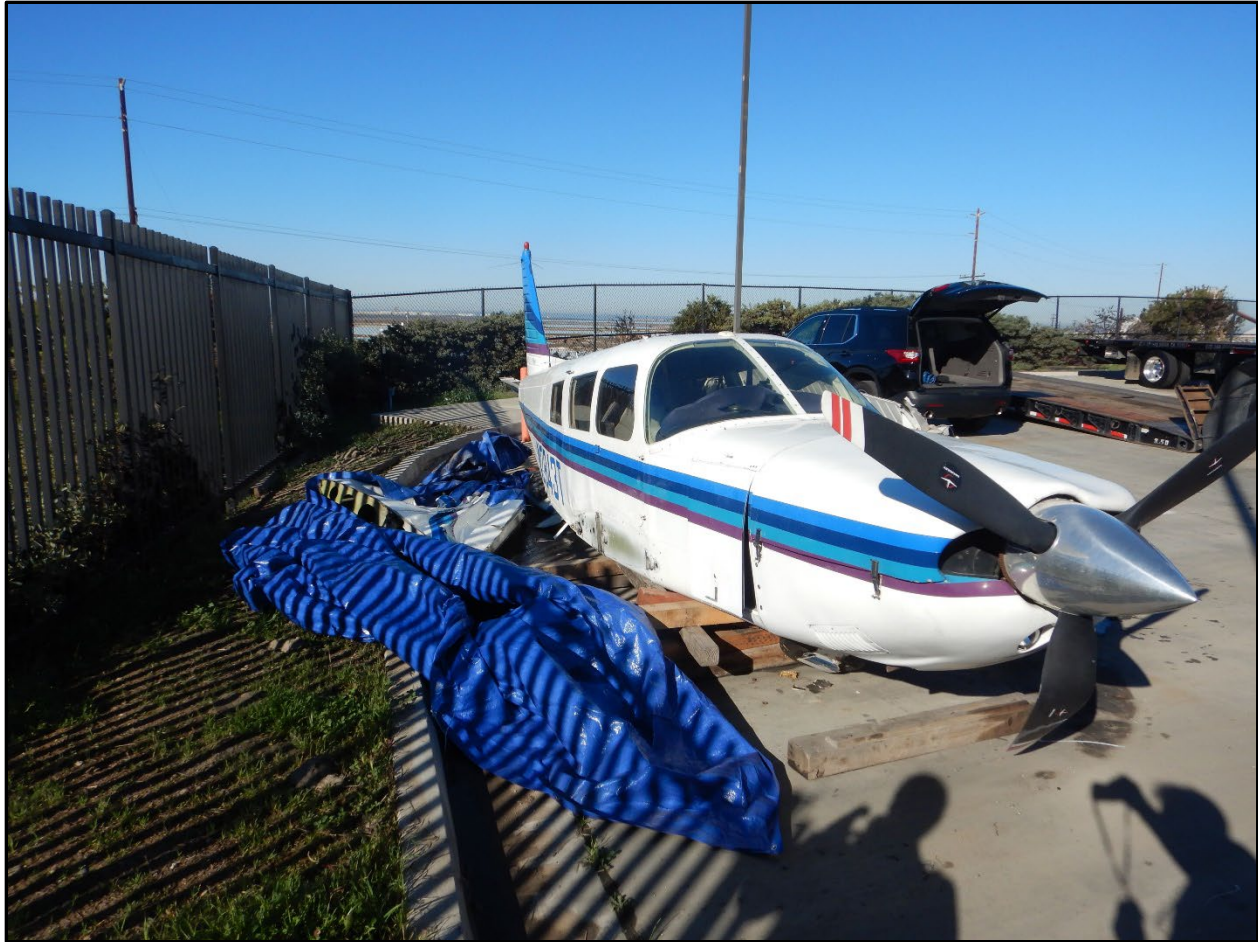
The airplane wreckage was stored at a parking lot with the fuselage set on the top of wood planks and covered by a tarp. The airframe sustained damage to the bottom of fuselage. The wings had been removed from the fuselage for recovery. The wings and horizontal stabilizers, were laid next to the fuselage. Both wings sustained leading edge impact damage. The left wing's aileron and flap were attached. The aileron control cables were disconnected at the turnbuckles. The left main fuel tank cap was not attached, and the sump drain was closed. Examination of the drain and fuel line between the left main fuel tank and wing root revealed no anomalies. The right wing was separated about mid-span and the outboard half was laid next to the fuselage.

The vertical stabilizer and rudder were relatively intact, and the rudder was attached. The stabilator was removed from the empennage and was laid next to the fuselage. The stabilator sustained damage to the right tip. The trim barrel had been removed from its mount and examination revealed about 1 ½ inch of extension from the barrel, which correlated to a partial nose up trim.

Figure 1 – Airplane wreckage as viewed from the front right side.

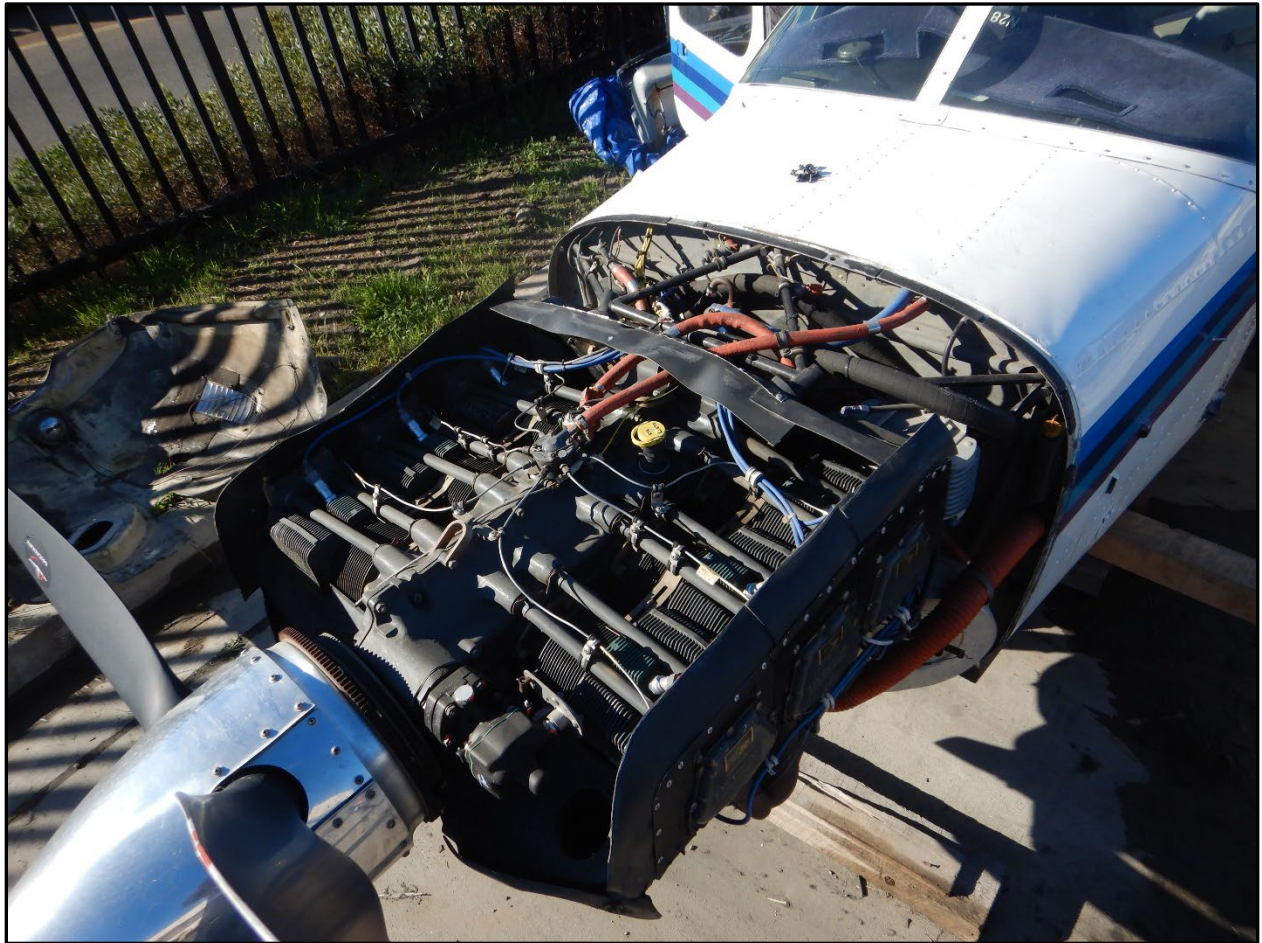
The Lycoming IO-520-K1A5 engine, (serial number L-12098-48) was attached to the fuselage and the engine mount assembly sustained damage to the bottom mounts that were bent upward. A “Corona Cylinder and Engine Overhaul” tag was attached to the crankshaft. The upper engine cowling was found to be not secured by screws or latches and the lower cowling remained attached and secured and had sustained impact damage near the area of the collapsed nose landing gear.

Figure 2: Engine as viewed from the top left side.

The upper and lower engine cowlings were removed, and the engine mounts were observed to have sustained impact damage near area of the collapsed nose landing gear. No other damage or anomalies were noted during the exterior examination of the engine. All of the engine fuel line b-nut fittings were secure and engine control continuity was established. The mixture control was noted not to have its full travel due to impact damage to the engine mounting structure near the mixture linkage.
