# National Transportation Safety Board

WPR21LA337

Factual Report 22-096

Location: Enterprise, Oregon  
Date: September 2, 2021  
Vehicle: Cessna 172E, N3965S  
Investigator: Fabian Salazar (AS-WPR)

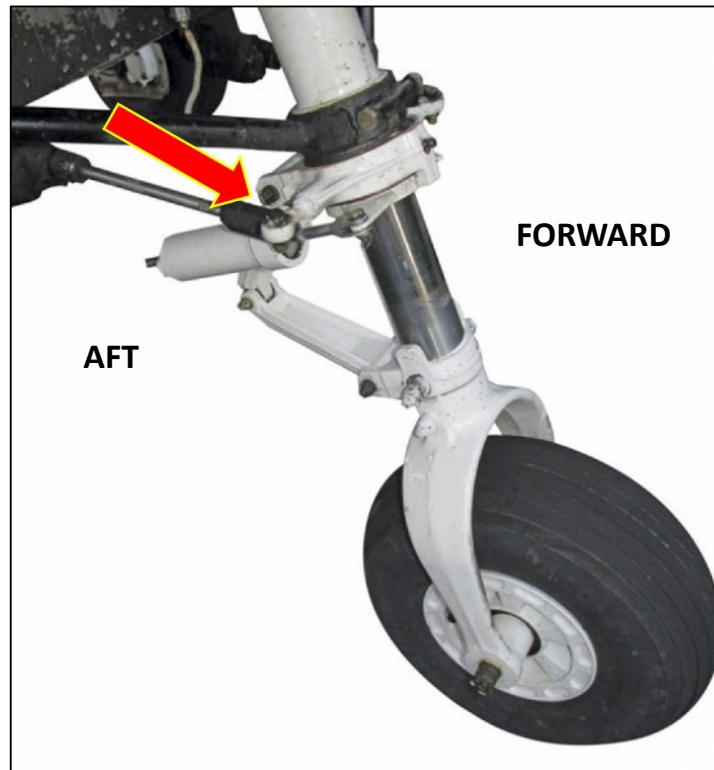
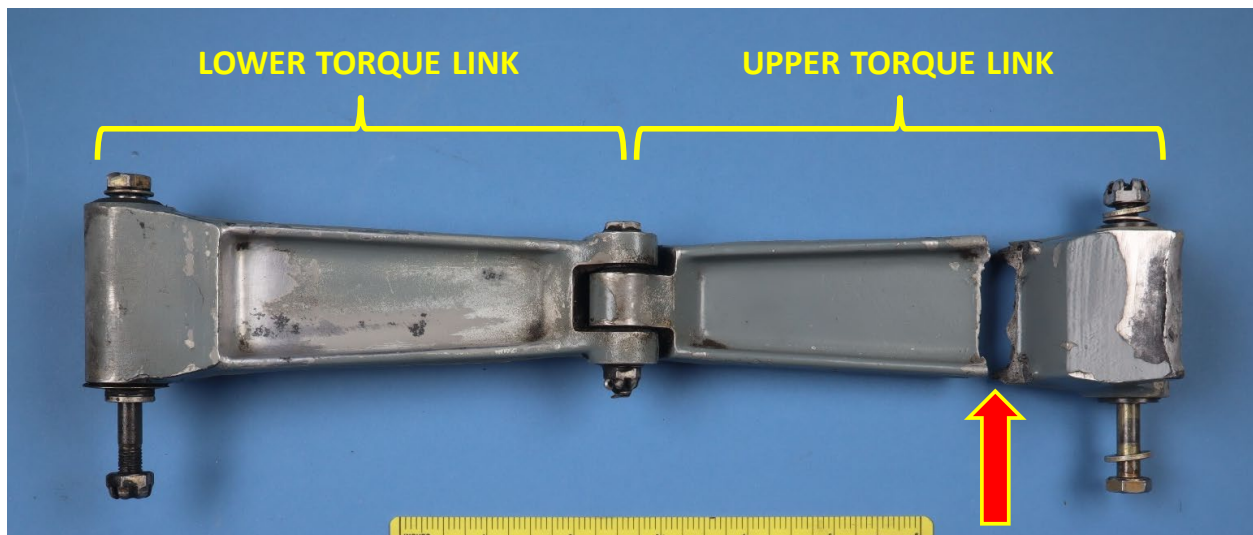
The upper torque link for the nose wheel landing gear was found fractured during post flight inspection after the aircraft veered left and nosed over during landing. Both halves of the torque link were disassembled from the aircraft and submitted to the NTSB Materials Laboratory for examination.

The submitted torque link assembly is shown in Figure 1. The fracture in the upper torque link is indicated by the red arrow. A photo of exemplar nose landing gear with a matching red arrow indicating the approximate location of the fracture is also shown in Figure 1.

**Figure 1.** (Bottom) Overall photo of the submitted nose landing gear torque link assembly. (Top) Image showing an exemplar nose landing gear assembly. The red arrows point to the fracture in the upper torque link.

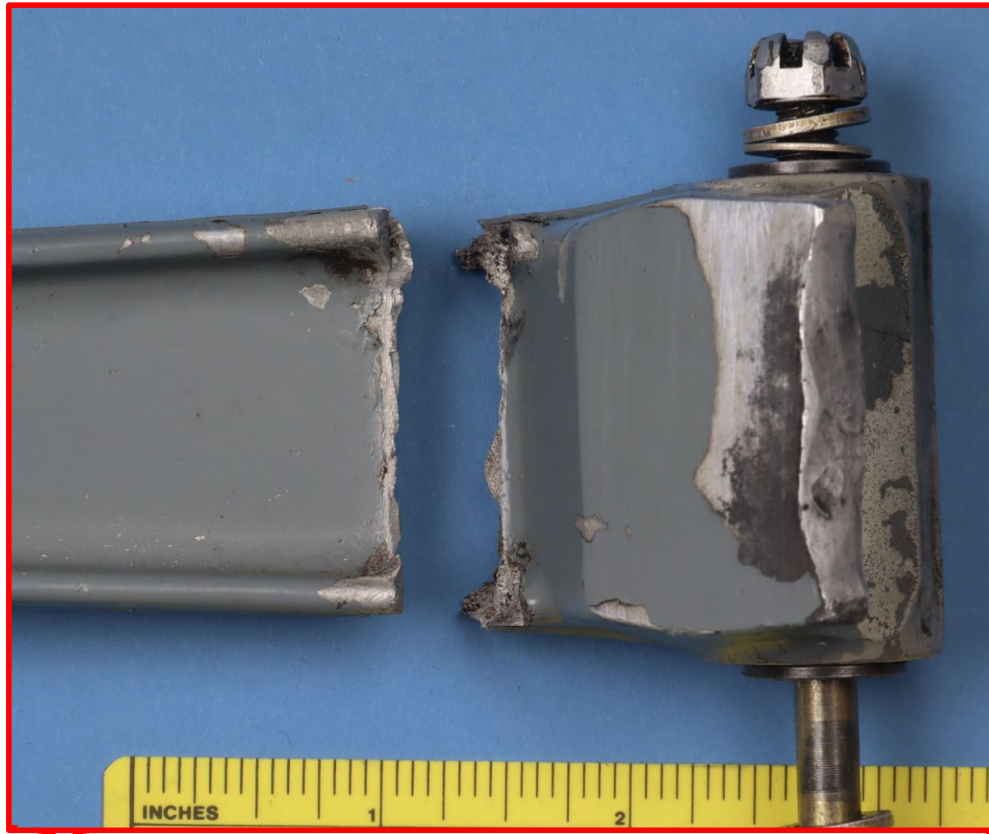
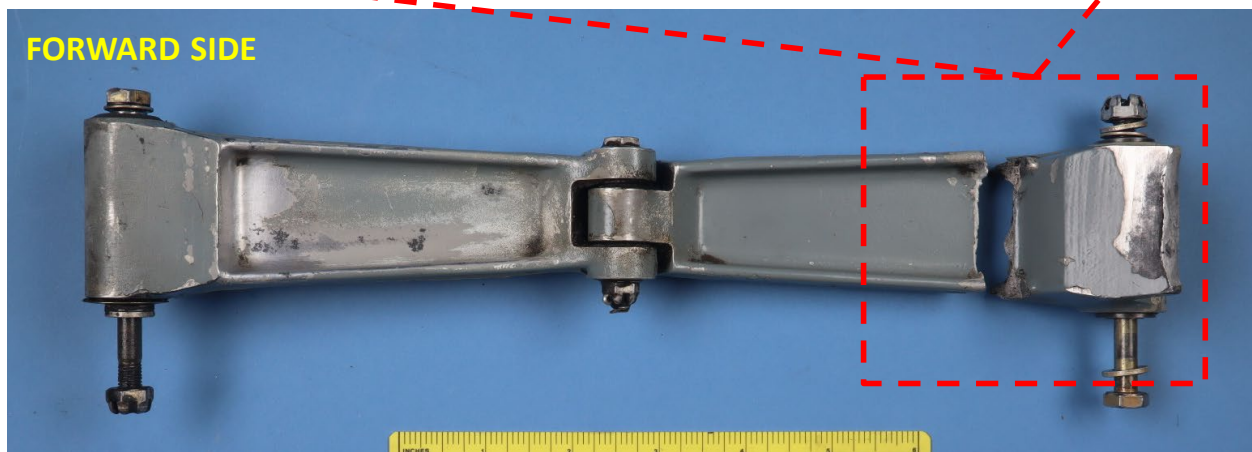
Figures 2 and 3 show the fracture in the upper torque link as viewed from the forward and aft sides, respectively. The resulting fracture surfaces of the upper torque link are shown in Figure 4. The fracture surface shown on the left in Figure 4 was sectioned from the longer upper torque link piece, then cleaned with mild detergent and rinsed in a methanol ultrasonic bath.

**Figure 2.** Overall and close-up photos of the forward side of the fractured upper torque link.

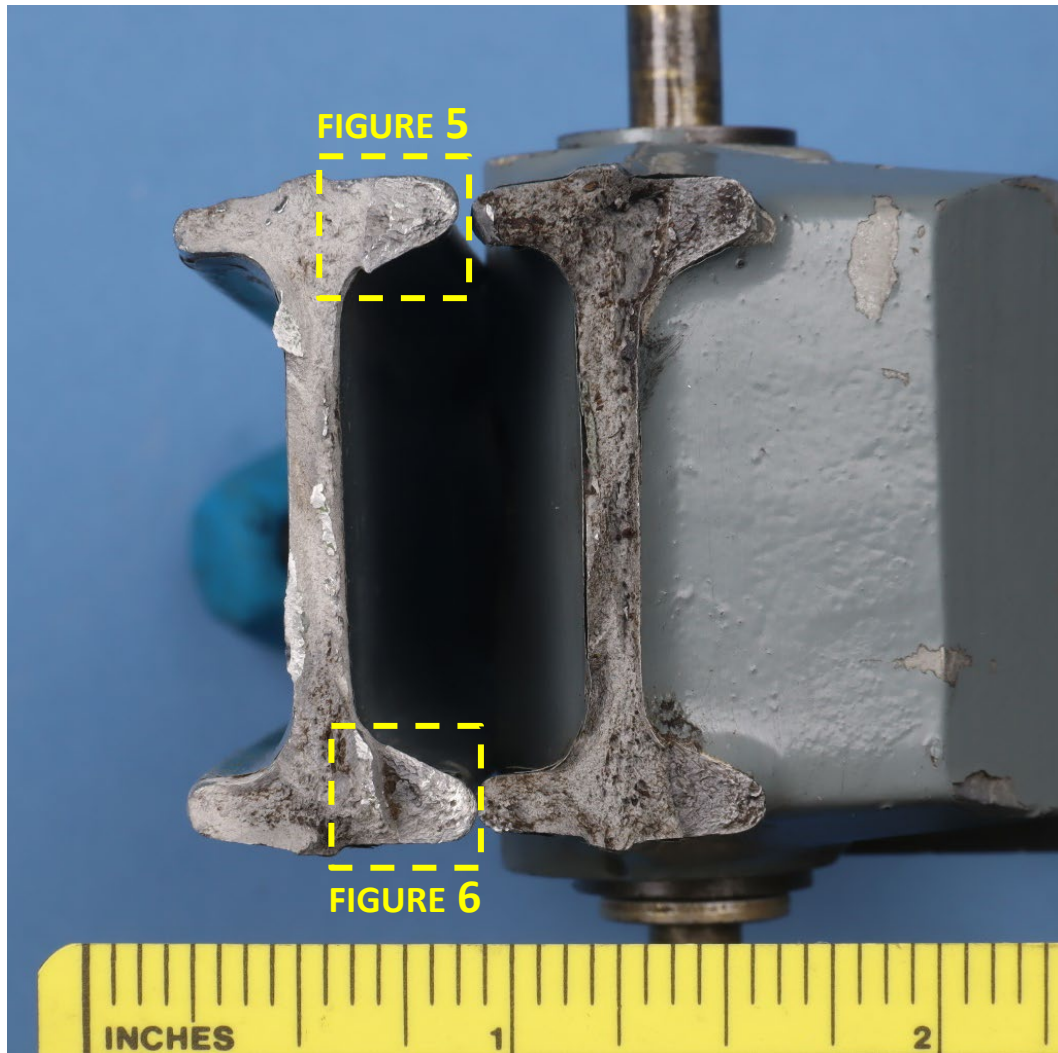
**Figure 4.** Close-up photo of the fracture surfaces of the upper torque link. The fracture surface on the left is shown after cleaning. The indicated areas are shown in more detail in Figures 5 and 6.

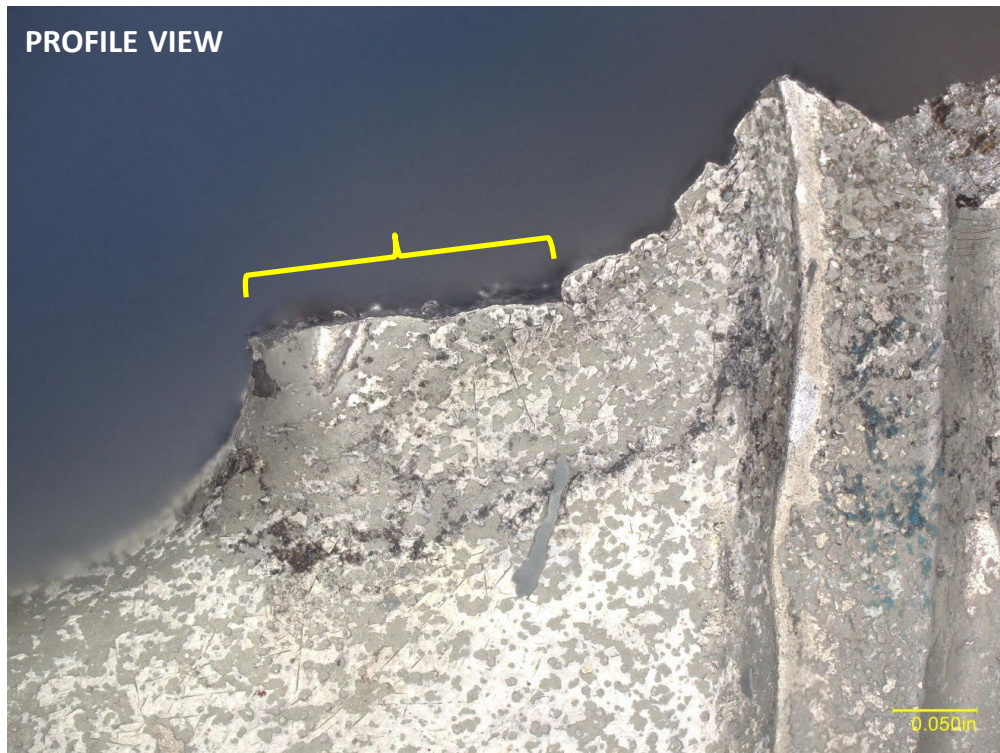
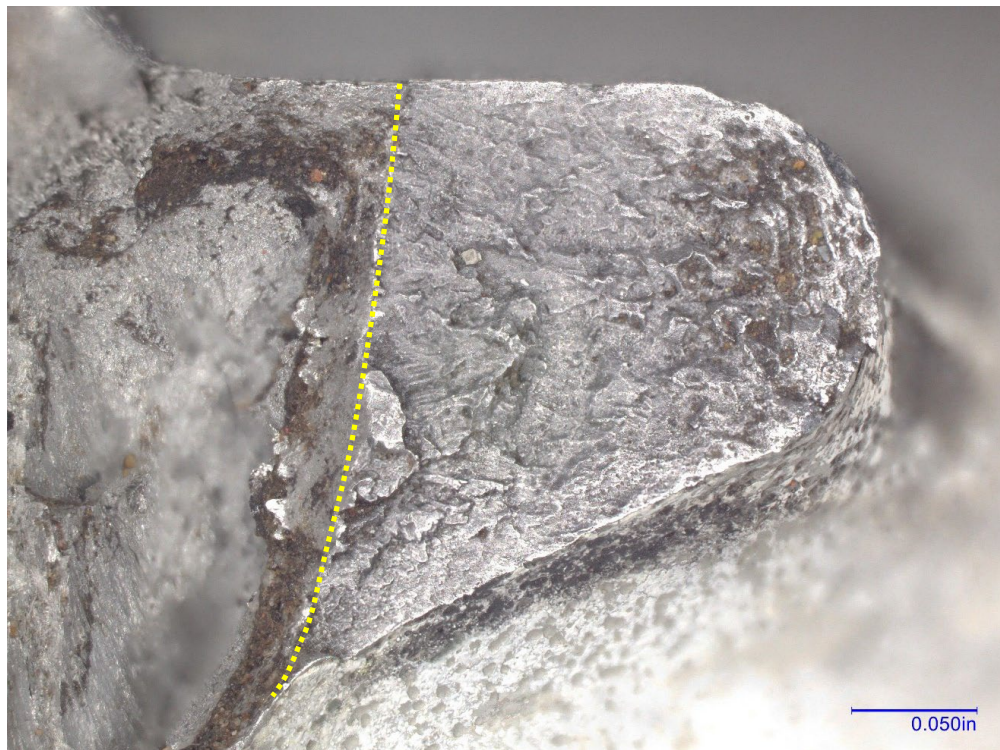
Flat areas were observed at the forward ribs on the fracture surface of the upper torque link. Digital microscope images of the forward ribs fracture surfaces are shown in Figures 5 and 6. Yellow brackets indicate the flat areas viewed in profile, while yellow dotted lines outline the flat areas on top-down views of the fracture surfaces. The flat areas emanated from the forward edge of the ribs and extended almost until the transition from the ribs to the web of the upper torque link.

**Figure 5.** Digital microscope images showing the flat area (yellow bracket) on the fracture surface of the top rib indicated in Figure 4. The yellow dotted line delineates the edge of the flat area.

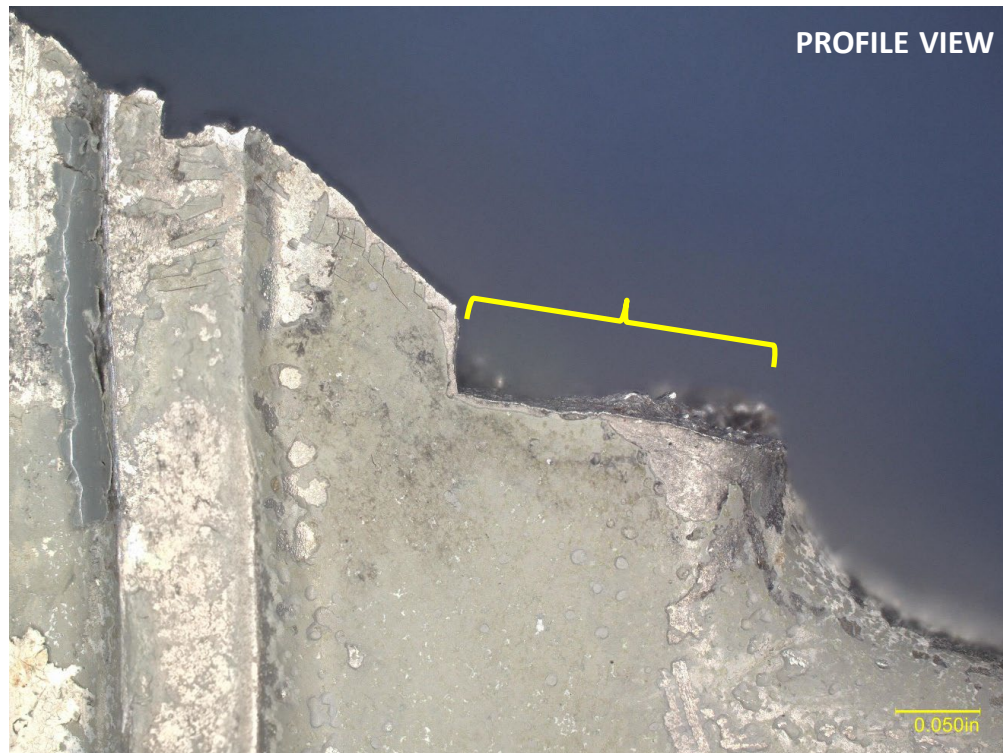
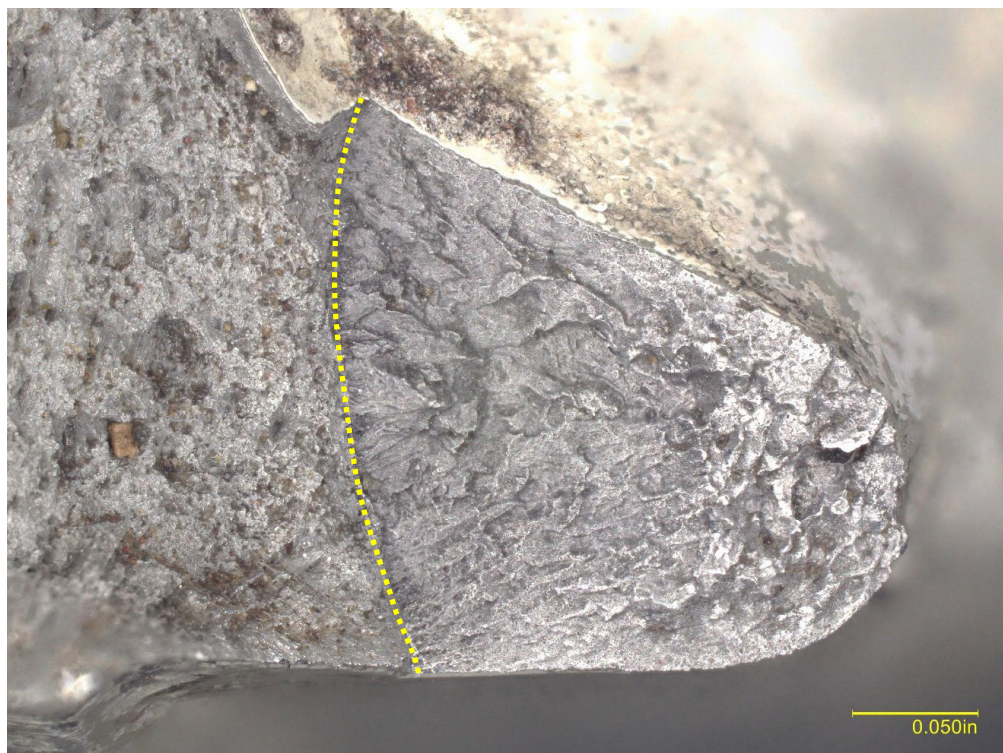
**Figure 6.** Digital microscope images showing the flat area (yellow bracket) on the fracture surface of the bottom rib indicated in Figure 4. The yellow dotted line delineates the edge of the flat area.

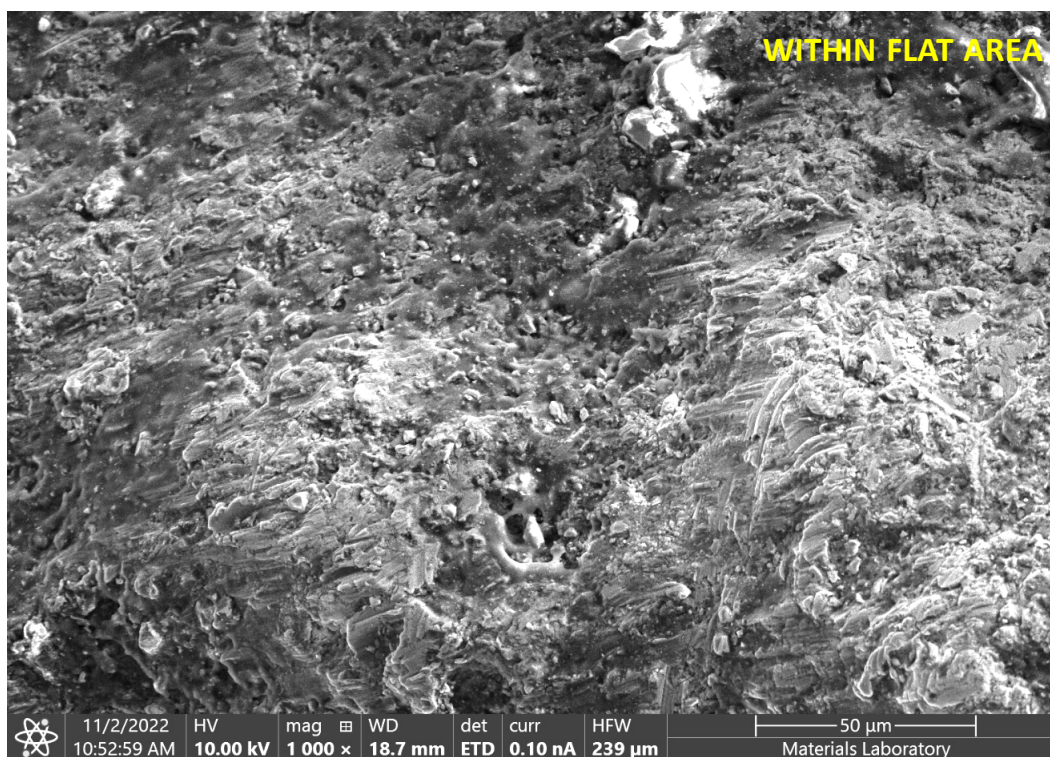
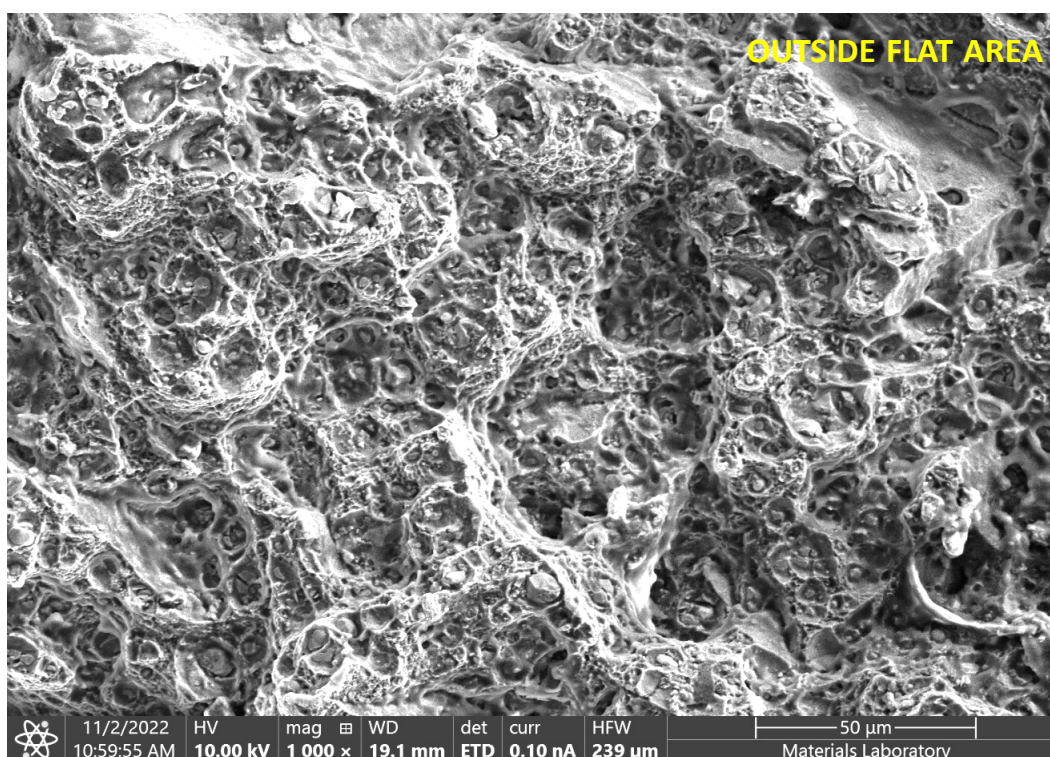
The cleaned fracture surface was examined using a Thermo Scientific Apreo 2 field emission scanning electron microscope (SEM). Within the flat areas on the fracture surface transgranular features consistent with fatigue cracking were observed

(top image, Figure 7). Outside the flat areas the fracture surface features were consistent with dimpled rupture from overstress (bottom image, Figure 7).

**Figure 7.** The top image is a secondary electron SEM image showing fracture surface features within the flat area on the bottom rib shown in Figure 6. The bottom image is a secondary electron image showing fracture surface features within the web of the fractured upper link piece, away from the flat areas on both ribs.
