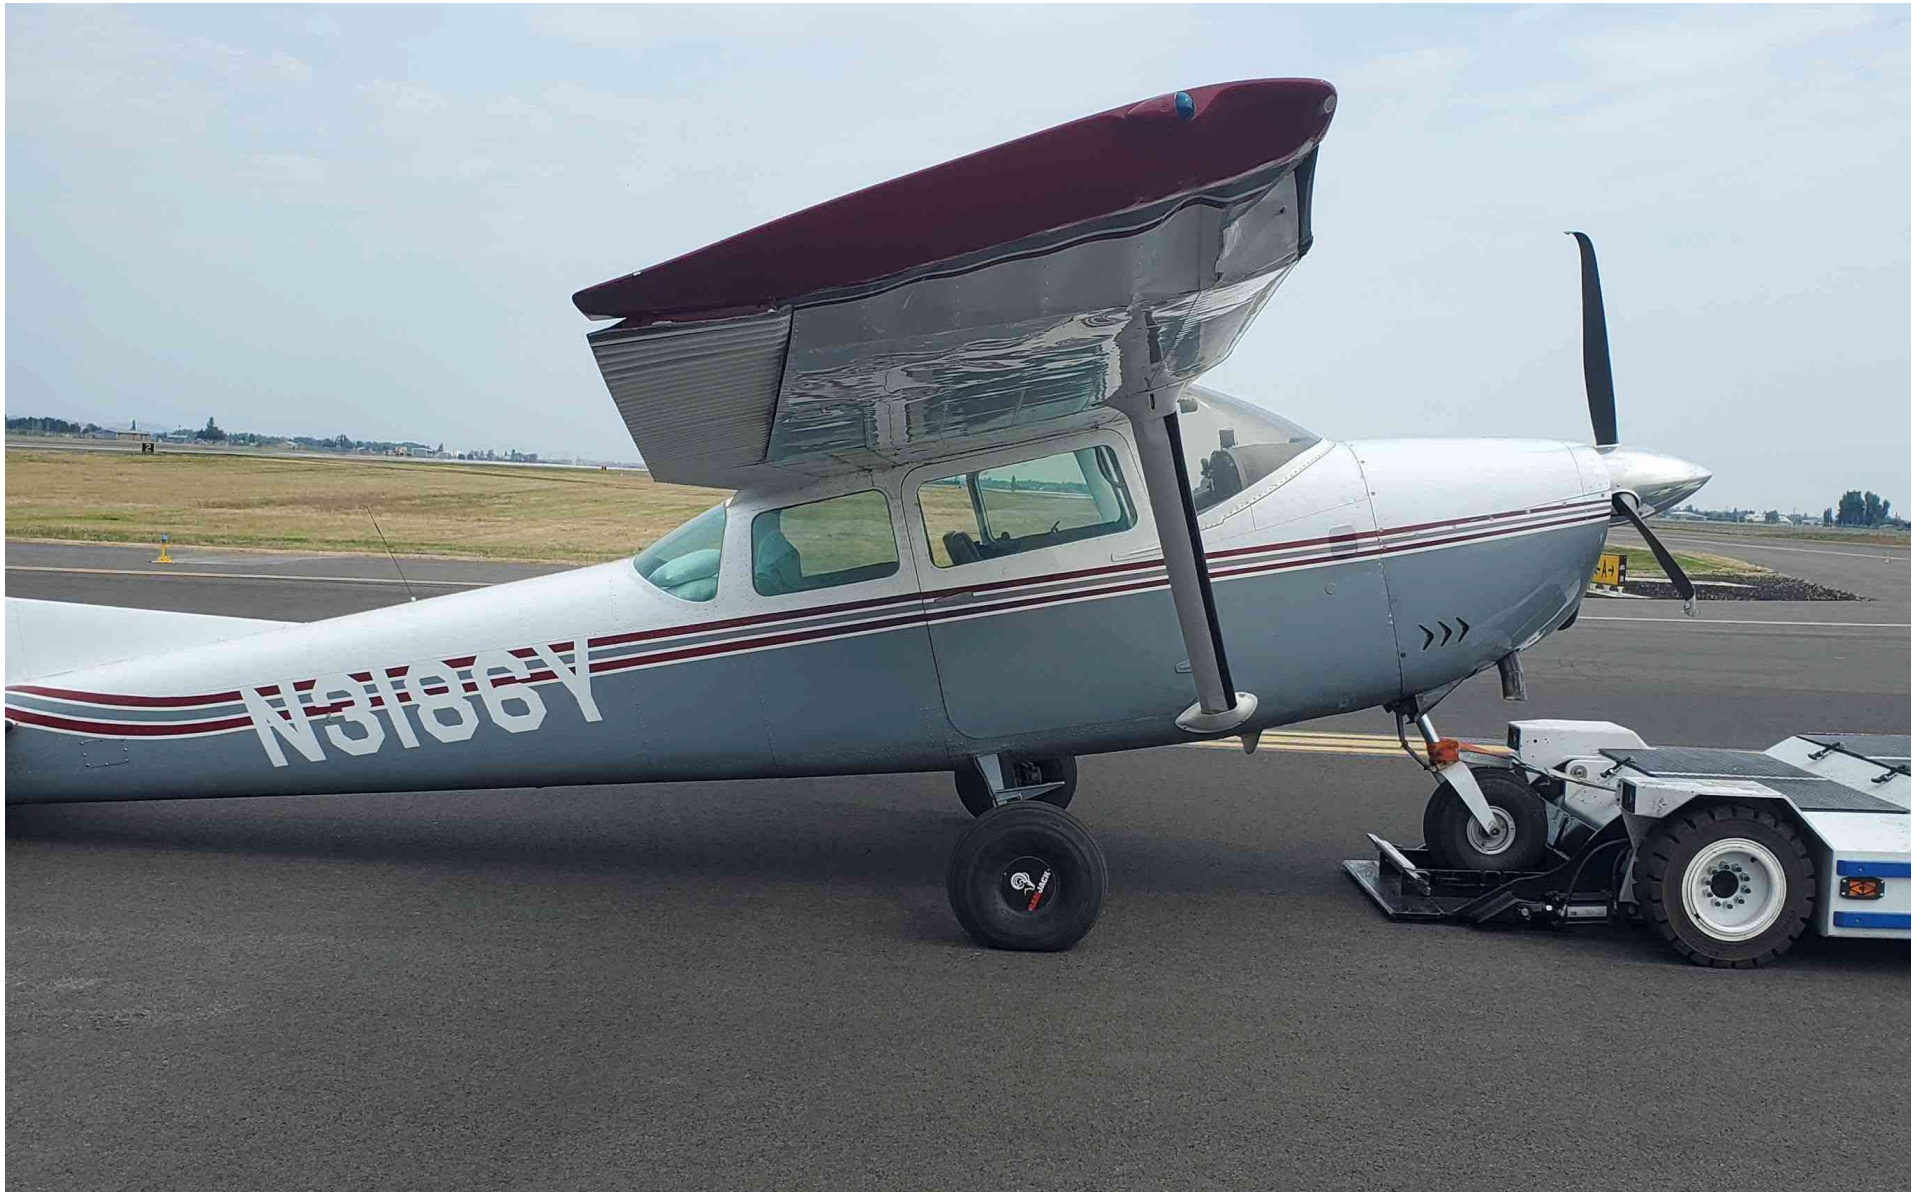
**Photo 1 – Airplane at the accident site**

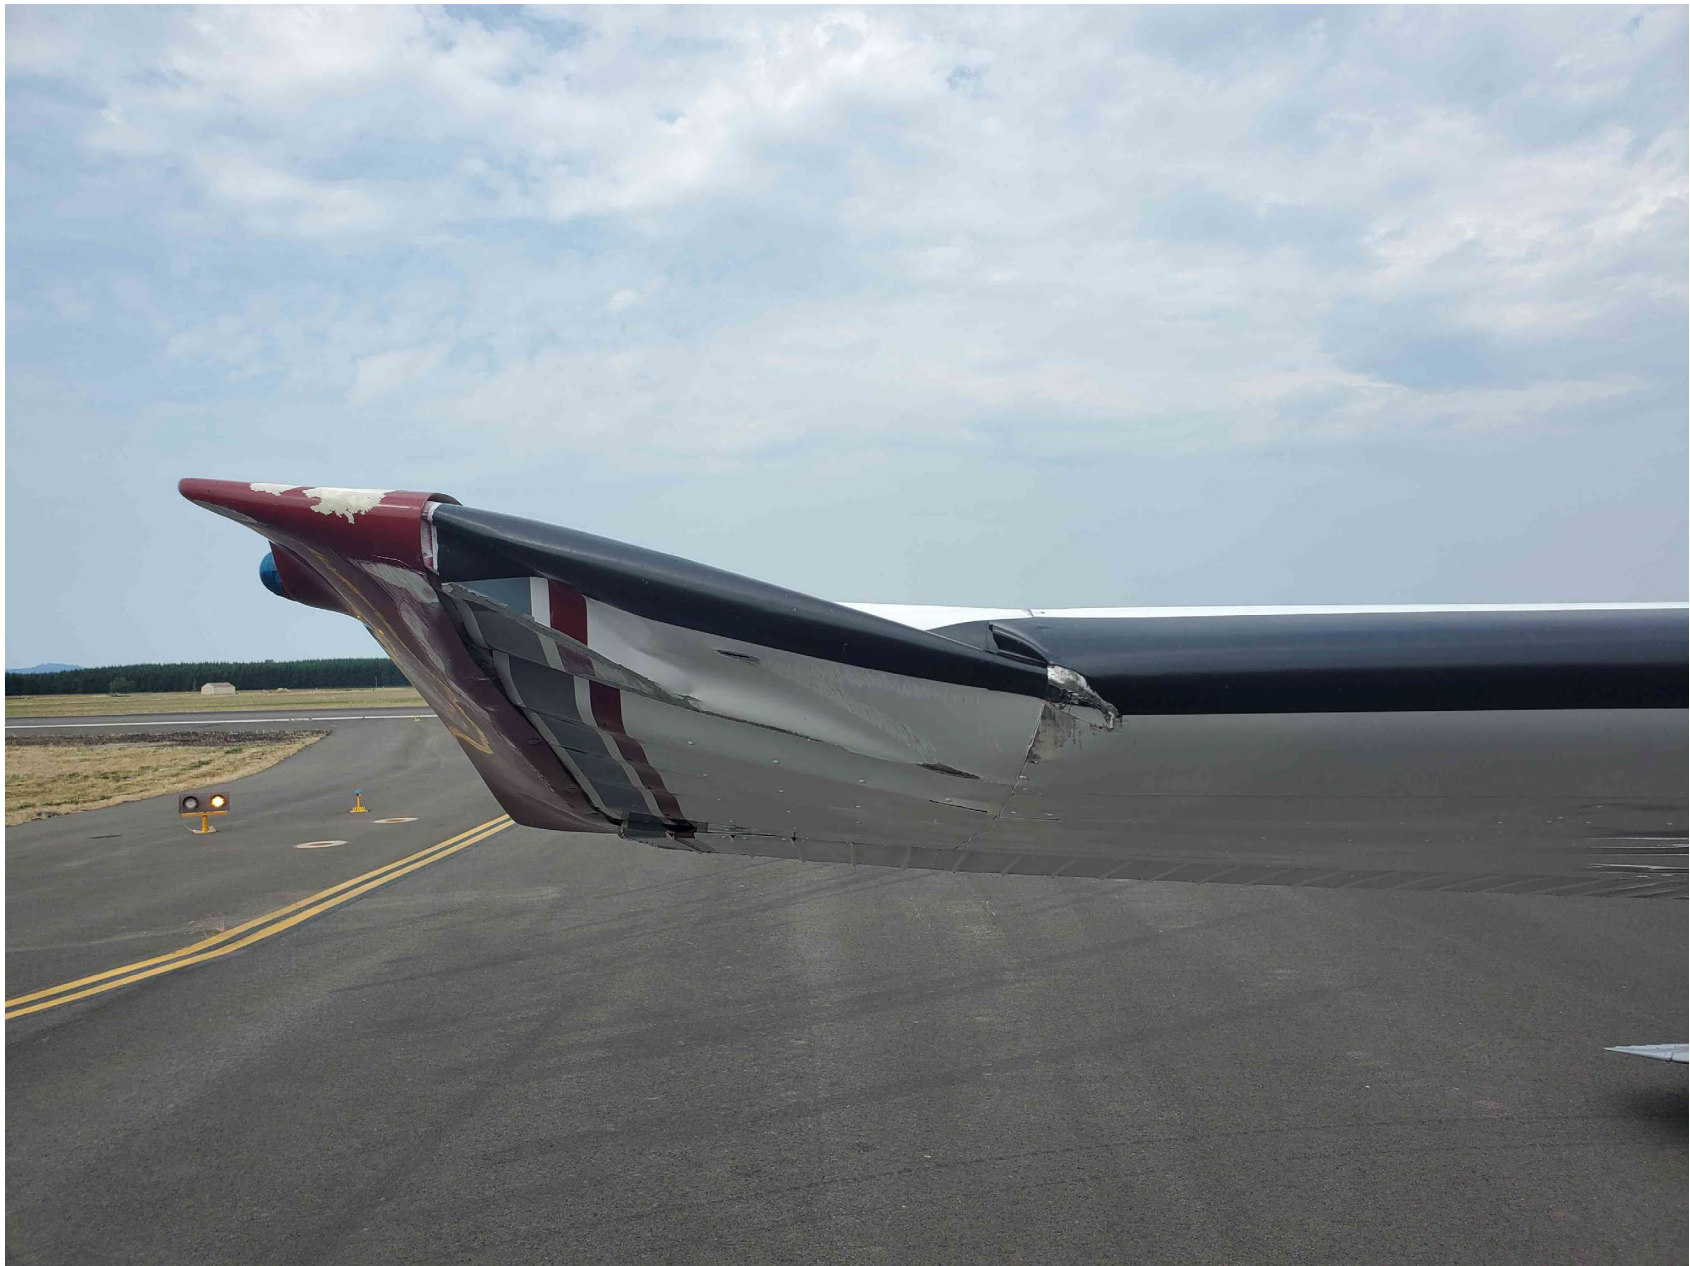
**Photo 2 – Right wing damage**

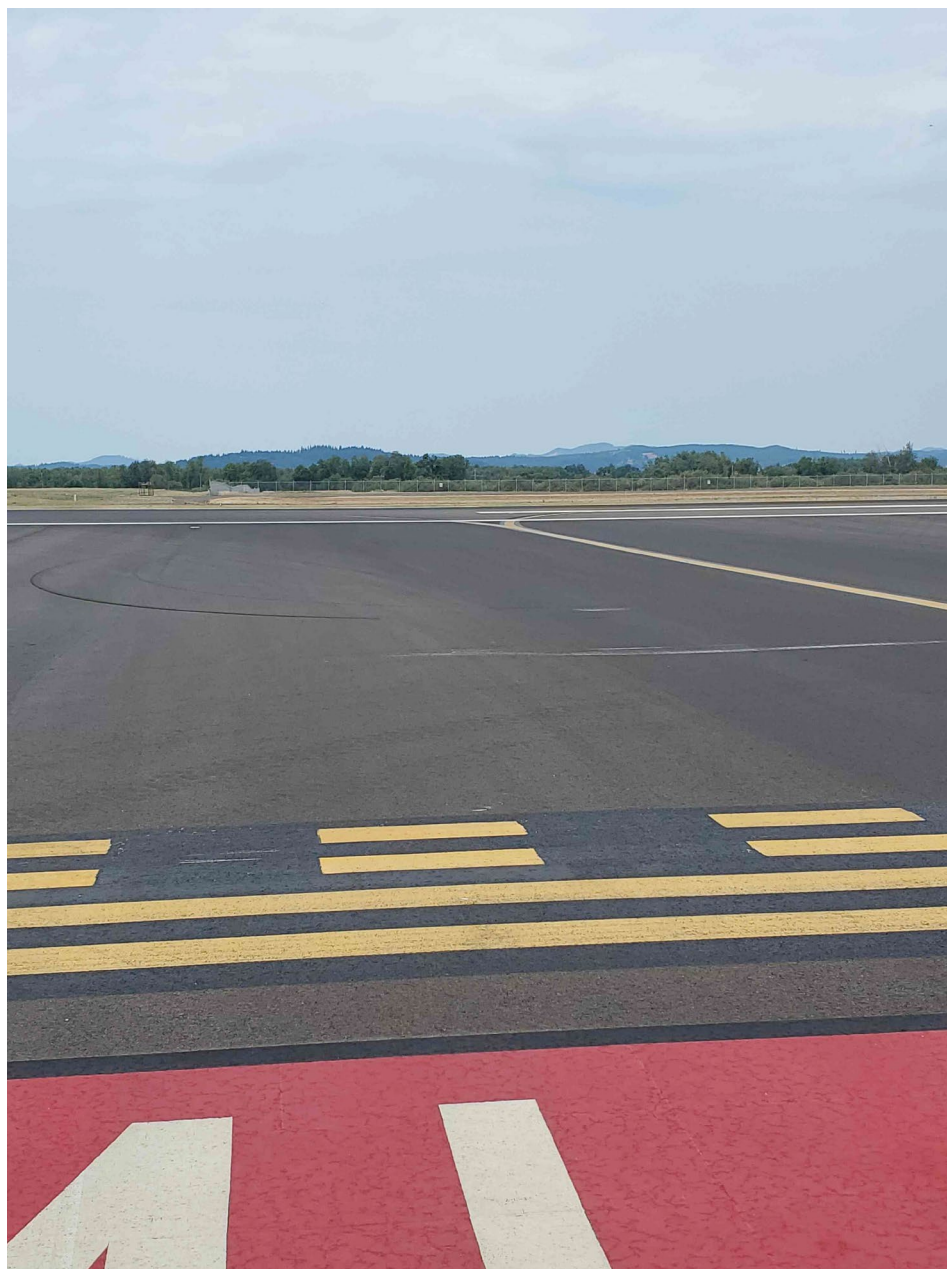
**Photo 3 – Tire, propeller, and wing transfer marks at east runway safety area, taxiway A3**

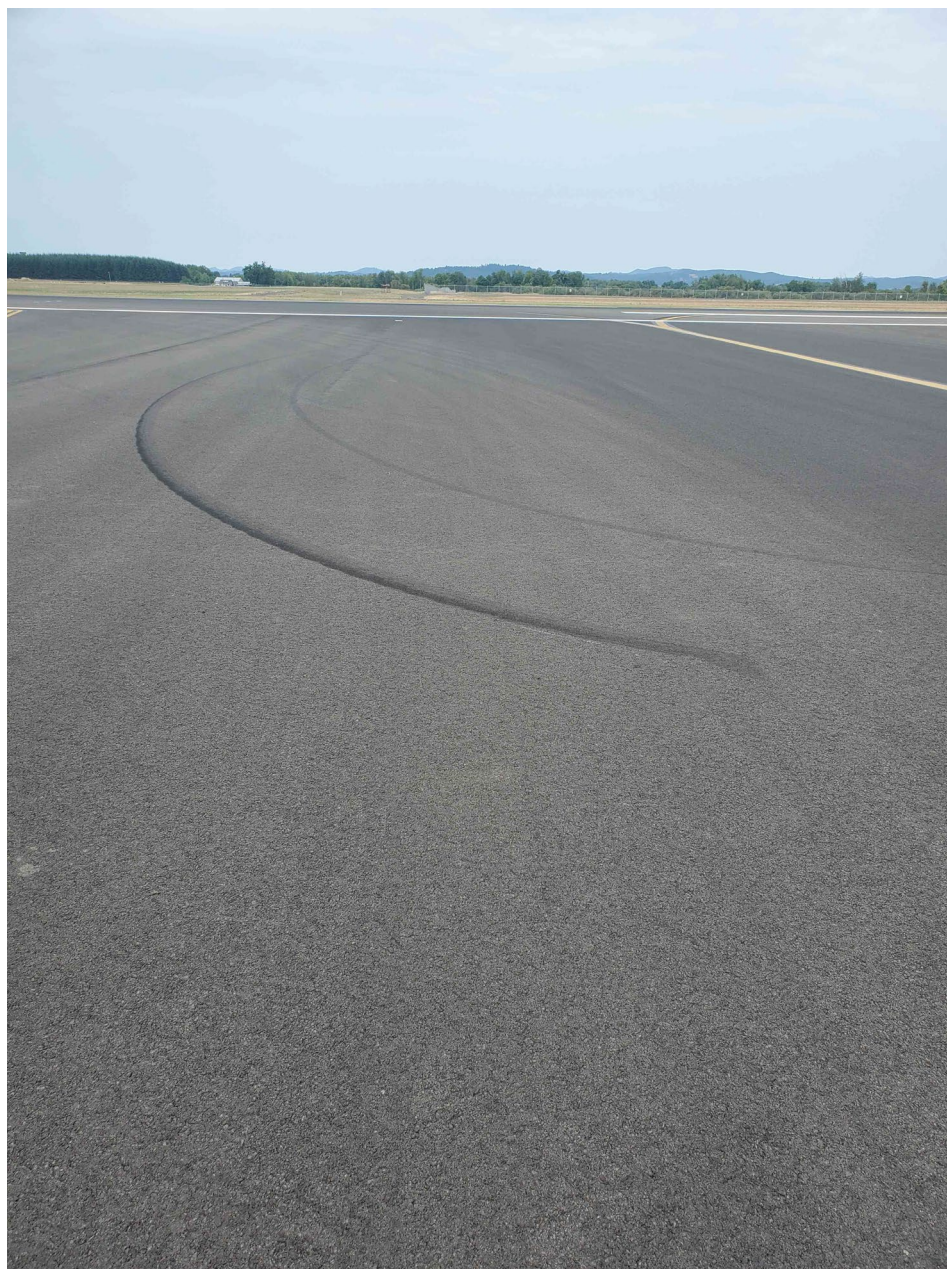
**Photo 4 – Tire marks at east runway safety area, taxiway A3**

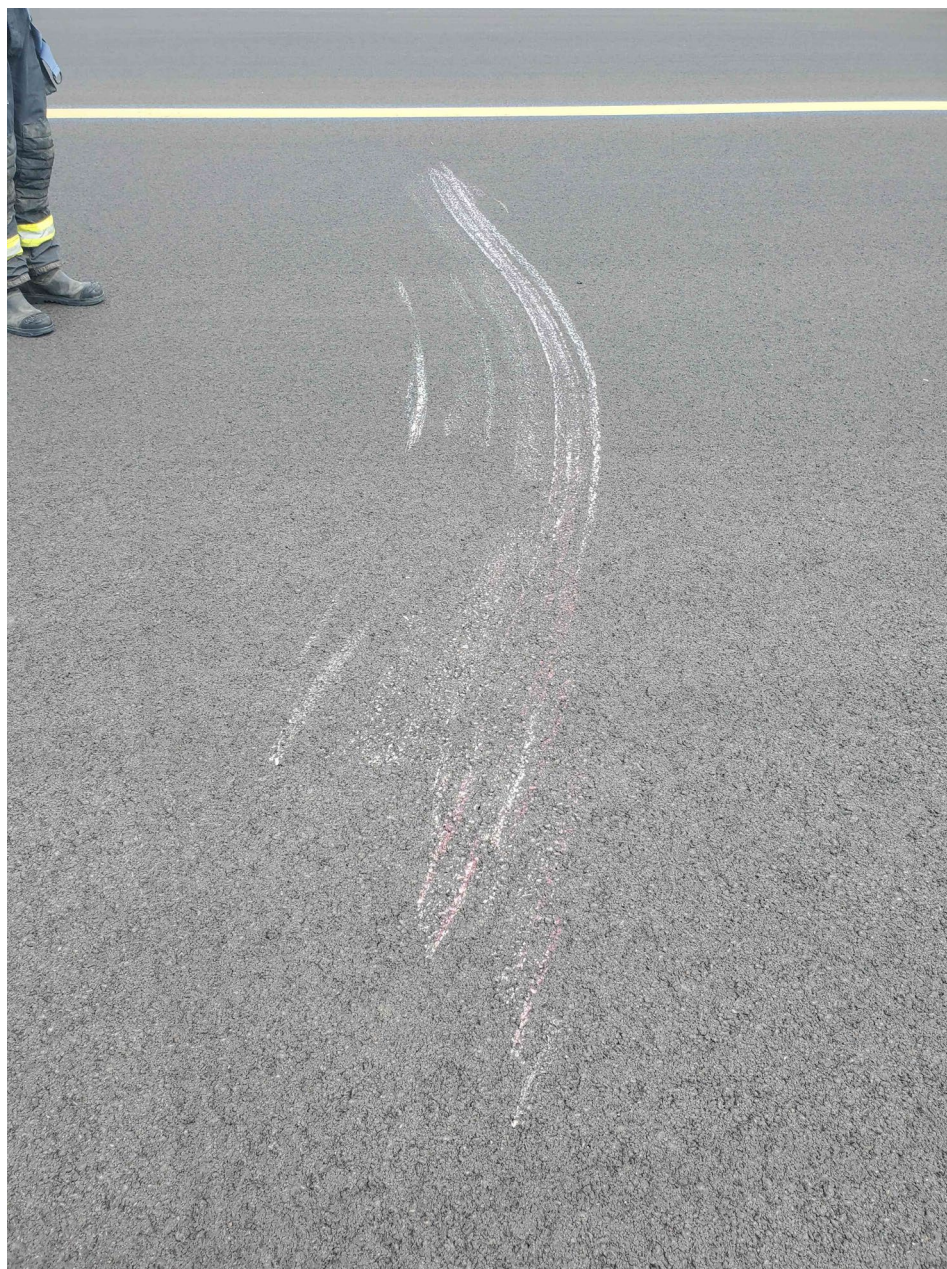
**Photo 5 – Wing transfer marks at east runway safety area, taxiway A3**

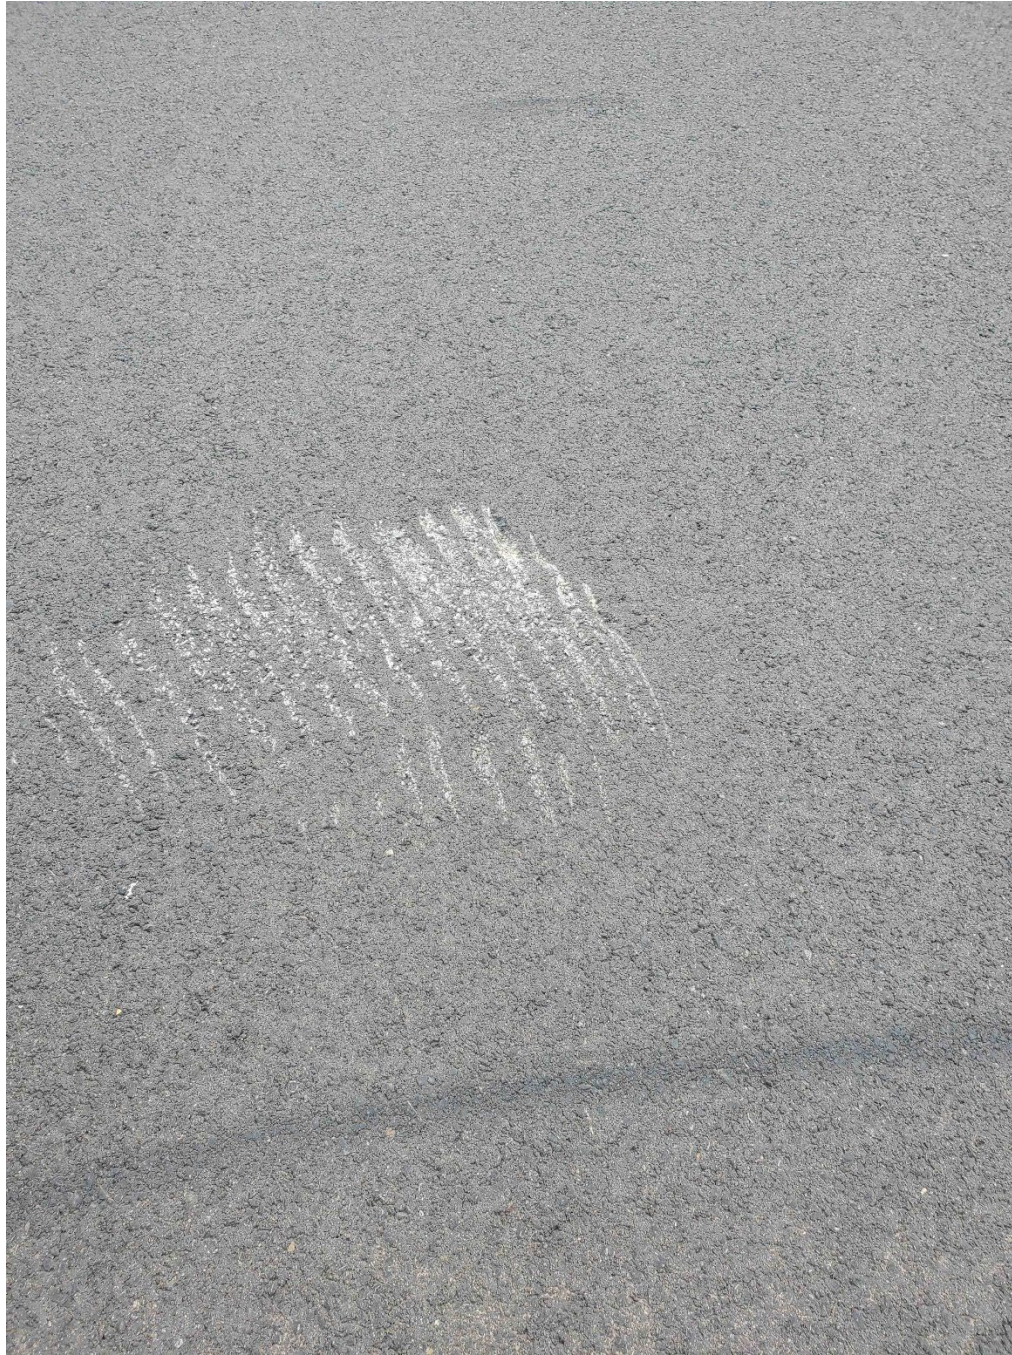
**Figure 6 – Propeller blade transfer marks at east runway safety area, taxiway A3**
